CLEARBROOK RAMP, CLEARBROOK, BUCKLAND MONACHORUM, DEVON

Results of a topographical survey and archaeological
watching brief

Dartmoor National Park Authority planning reference 0368/13,
condition 4

Document No: ACD828/2/0

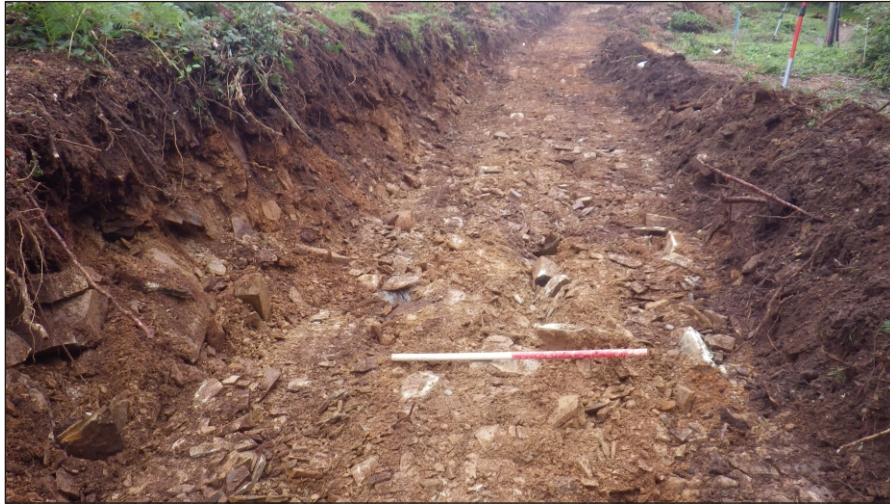
Plate 1: General view of excavations south of the earthworks, view to northwest. 1m scale

- 5.1** The groundworks for in the area of the tinner's pits comprised of a 3m wide excavation into the side of the slope, down to maximum depth of 4m, along with a drainage trench on its west side. Excavations involving the removal of topsoil down to the underlying natural were monitored (Plate 1).

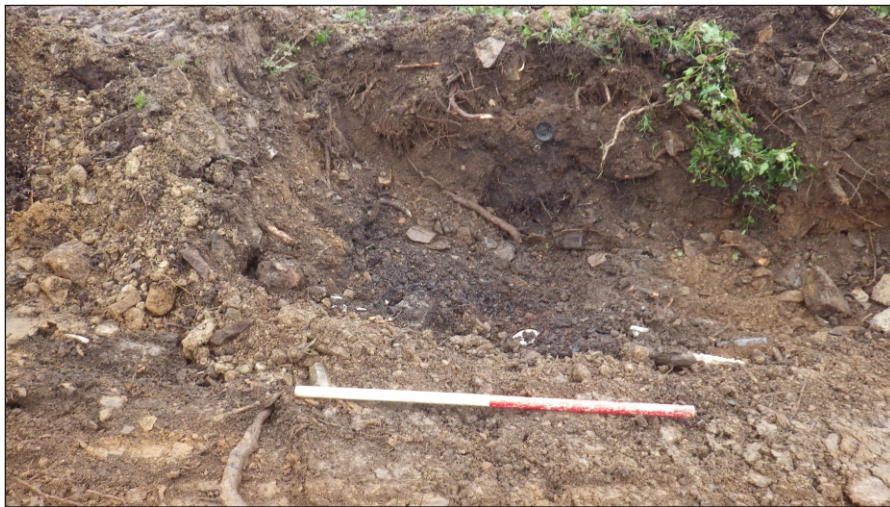
Plate 3: Pit F005 following initial exposure, view to northeast. 1m scale

- 5.3** The groundworks had an impact on two of the tinner's pits identified during the earthwork survey – (g) and (d). Following removal of topsoil, a pit (F005) associated with the spoil mound (d) was exposed (Plate 3). It measured 1.20m wide by 0.60m deep, and had been backfilled with a deposit (004) of dark brown moderate clayish silt that contained abundant glass bottles, china and coke/coal inclusions. A sample of these finds was collected. They comprise a sherd of yellow industrial ware, three sherds of white industrial wares, and a small glass meat or fish paste jar marked with H&C; all date to the twentieth century.

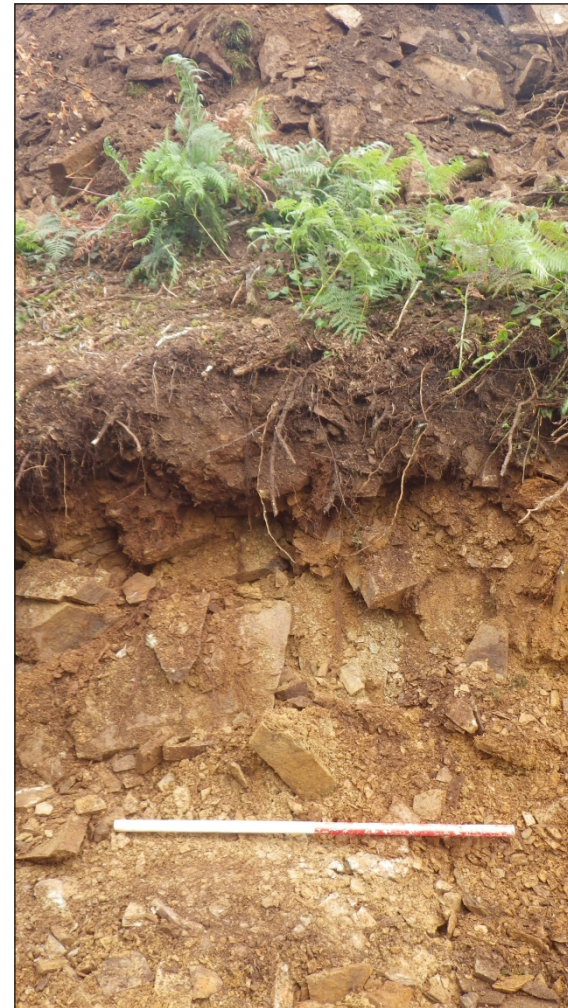
Plate 2: Typical deposit section, view to southwest. 1m scale

- 5.2** The following soil sequence was recorded: topsoil (001), which measured up to 0.40m thick, and comprised moderate dark brown clayish silt with occasional small to medium angular stones, which overlaid the natural (002) – moderate dark brownish-yellow clayish silt and solid Upper Devonian slates (Plate 2).

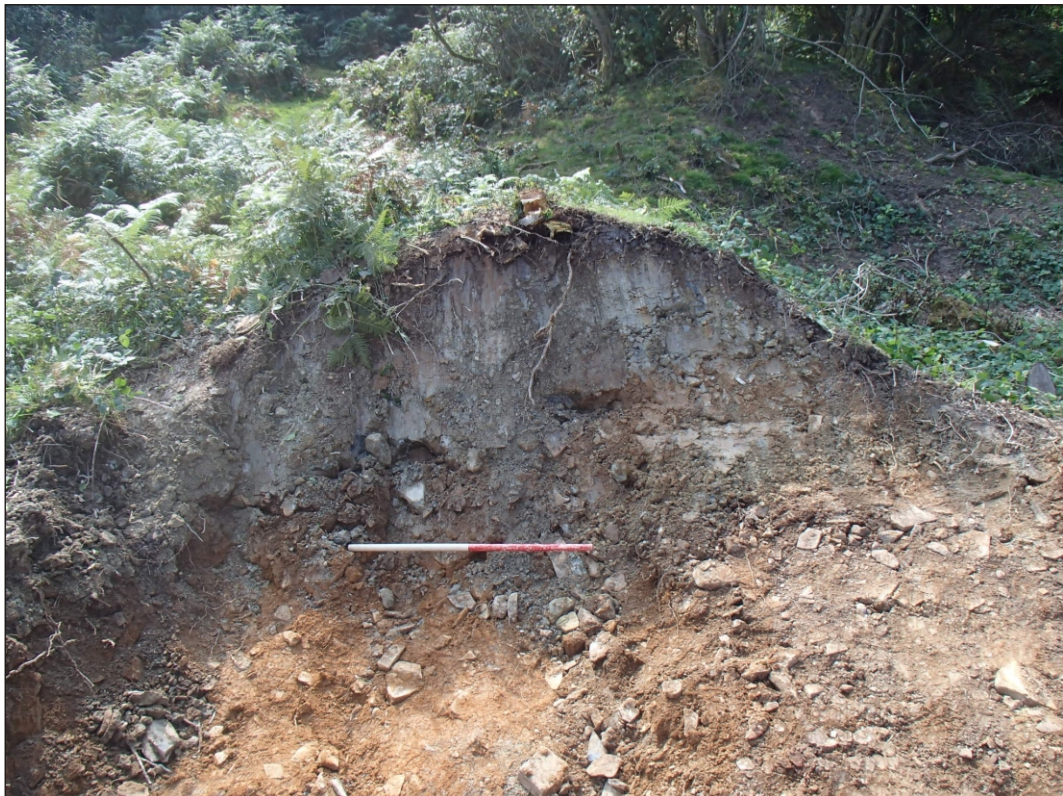
Plate 5: Spoil heap (g) showing main deposit 003, view to southwest. 1m scale

- 5.4** The northwest quadrant of the spoil heap associated with pit (g) was removed (Plates 4 and 5), and measured 3.2m long (north – south) by 1.3m wide (east – west). The spoil heap comprised a single deposit (003), measuring 0.90m deep, of light brownish-grey, moderate silty clay with rare, small to medium sub-angular stone. No finds were recovered. The spoil had been dumped directly onto the topsoil 001.
