EXEBRIDGE, MOREBATH, DEVON

Results of historic building recording

Document No: ACD963/2/0

Date: December 2014

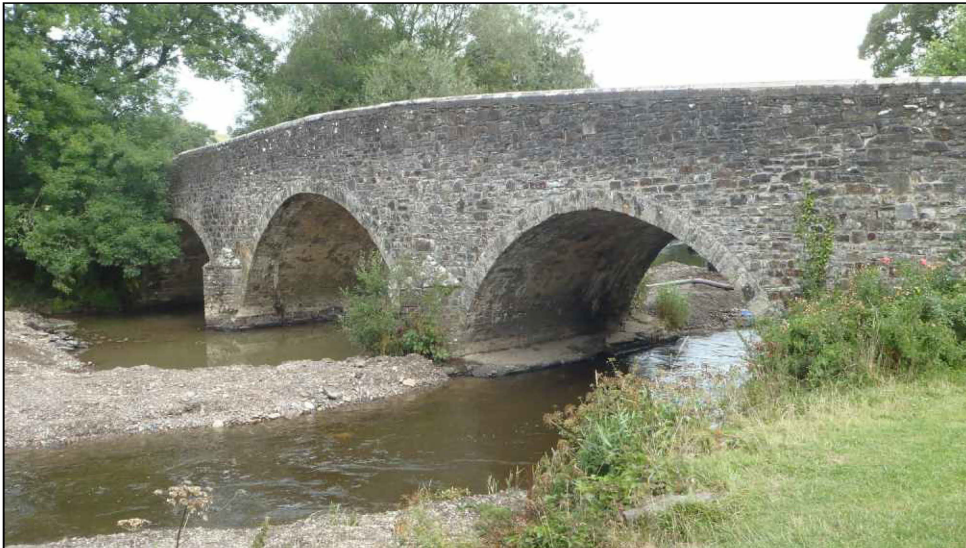
Plate 1: View of the downstream elevation of the bridge prior to commencement of groundworks, viewed from the southeast

The three spans of the bridge are constructed on top of four piers, labelled 3, 1, 2, and 4 when viewed from the north, looking downstream, with piers 3 and 4 located within the river banks and piers 1 and 2 located within the river bed (Fig. 2a; Plate 1).

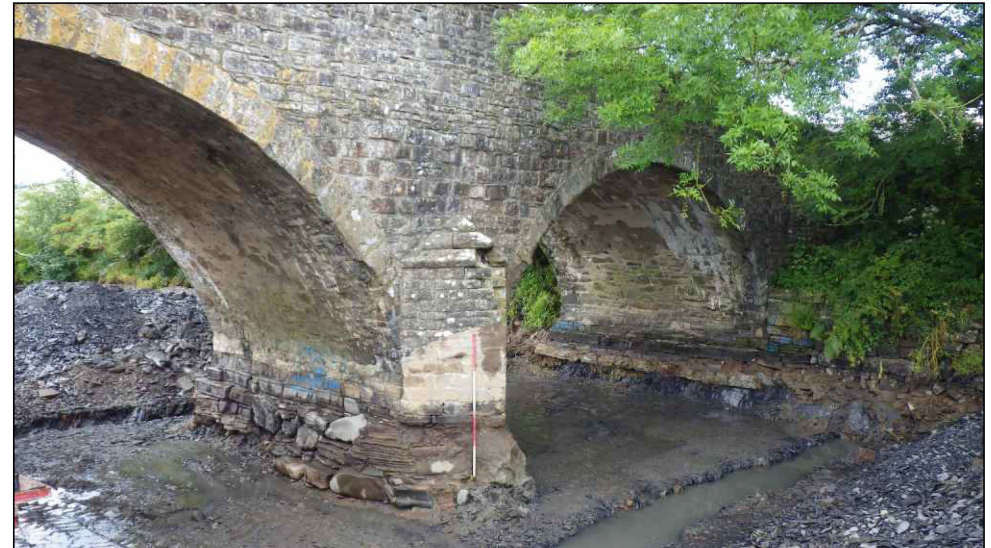
Plate 2: Pier 2 showing pier and cutwater foundations with pier 4 in the background showing foundations laid onto bedrock, viewed from the northeast. Scale 1m

The foundations of the bridge piers (103) are constructed directly onto the natural mudstone bedrock (104), and consist of three courses of roughly faced, rectangular blocks of local stone averaging 0.40m long, 0.20m wide and 0.20m deep, and large and medium-sized rounded river-derived gravels averaging 0.20m long by 0.10m wide and 0.10m deep, all bonded with a hard dark grey mortar (Fig. 2b; Plates 2-3). The foundations measure up to 0.60m deep, and project up to 0.70m from the face of the piers. They survived best on piers 3 and 4, but had been largely either washed away or removed in the central piers 1 and 2. Repairs had been made to both these piers (see 5.4 below; Plate 4).

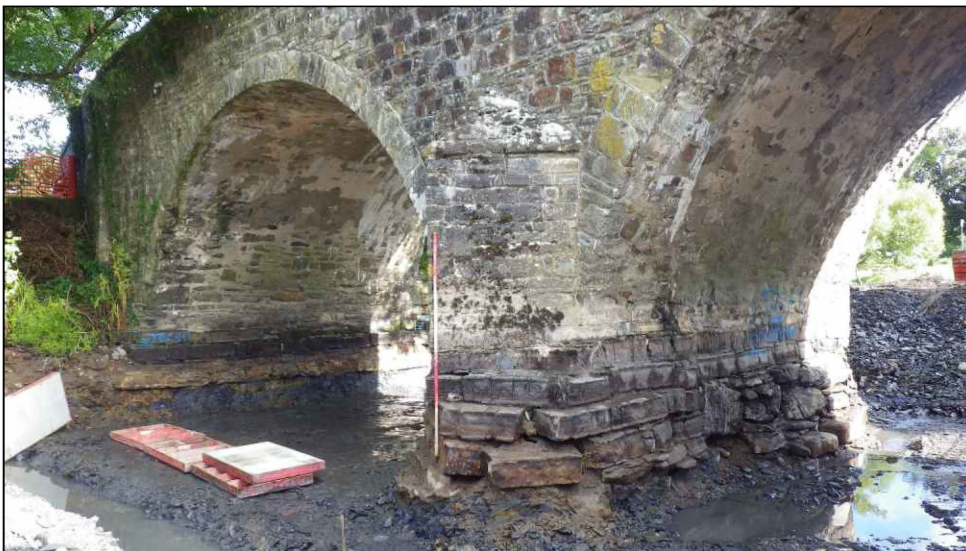
Plate 3: Pier 2 showing stepped cutwater foundations, viewed from the south. Scale 2m

Cutwaters are present on both the upstream and downstream sides of central piers 1 and 2. The lower courses of masonry are integral to the basal courses of the piers. Above this, due to the use of voussoirs on the arches, the facework is not bonded into the pier; the core material was not exposed. Tool marks were observed on one of the blocks of the downstream cutwater on pier 1. The cutwaters are finished with two styles of capping. On the upstream side of the bridge they have a stepped capping comprising three courses of large dressed blocks with vertical and angled faces (Plate 4). On the downstream side they have sloping capping consisting of four courses of small mudstone blocks (Plate 6).

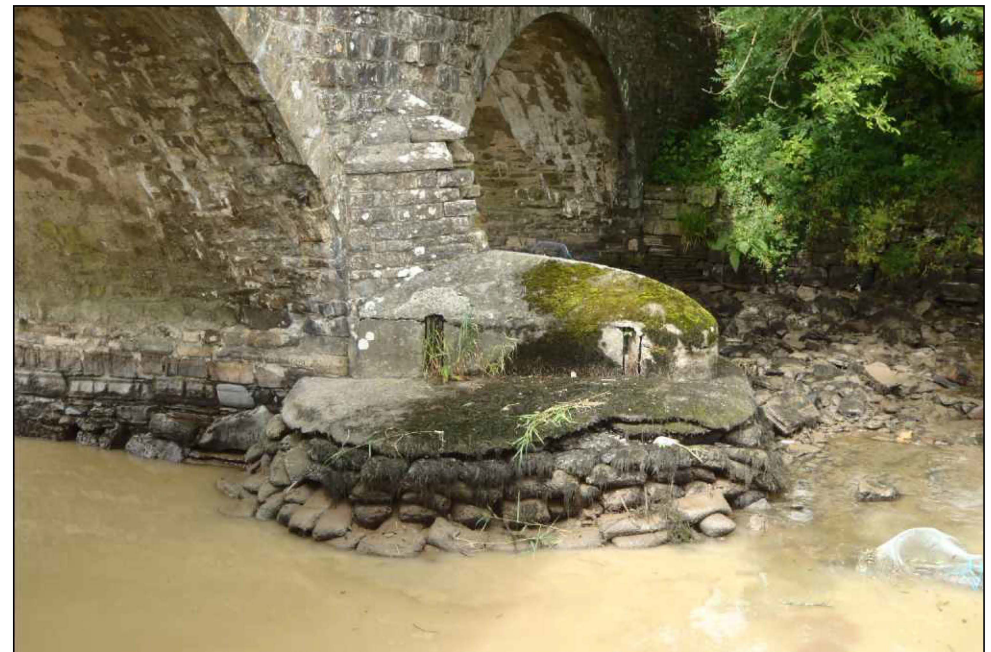
Plate 4: Pier 2 showing 20th-century repairs to the cutwater, viewed from the northeast

On the upstream side the cutwaters have been strengthened with the addition of further masonry constructed of concrete blocks finished with concrete and a concrete capping (Plate 4). These have been constructed onto concrete-filled sandbags. These additions were removed during the groundworks. A small area of the northwest side of the cutwater on pier 1 has been repointed with concrete.

- 6.4** There were patches of repair and repointing in concrete to the bridge piers and cutwaters, in particular on the upstream sides of the cutwaters of piers 1 and 2, which were extended in the second half of the 20th century.

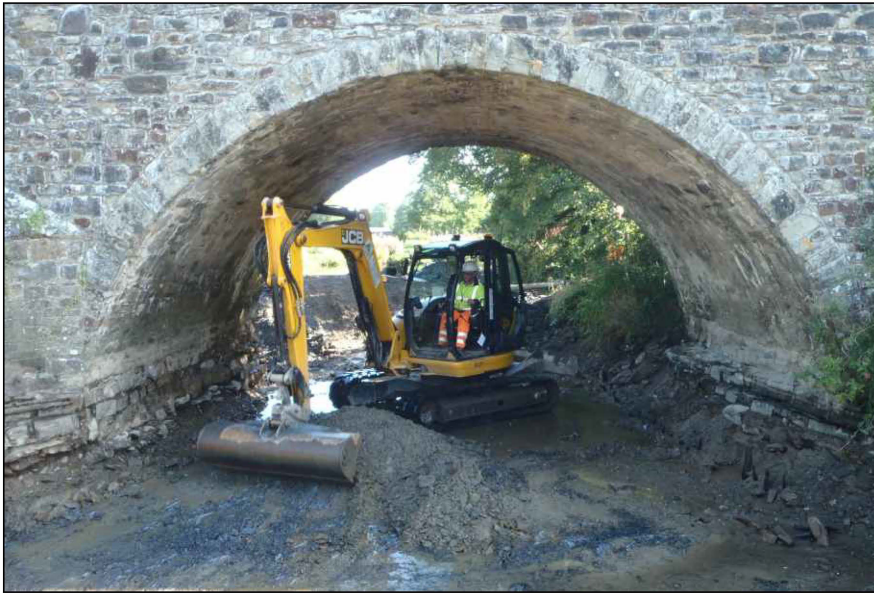
Plate 5: View of excavations between pier 1 and 3 showing the elevation of the arch, viewed from the southwest

Above the foundations, the main body of the piers (100) are constructed of neatly coursed rows of faced square and rectangular blocks averaging 0.50m long, 0.20m wide and 0.20m deep. The arches generally rise from between 2-3 courses above the base of the piers, and their faces are finished with rectangular voussoirs (Plate 5). The undersides of the piers have been partially repointed with concrete (102) in the recent past. This has obscured some areas of the masonry.

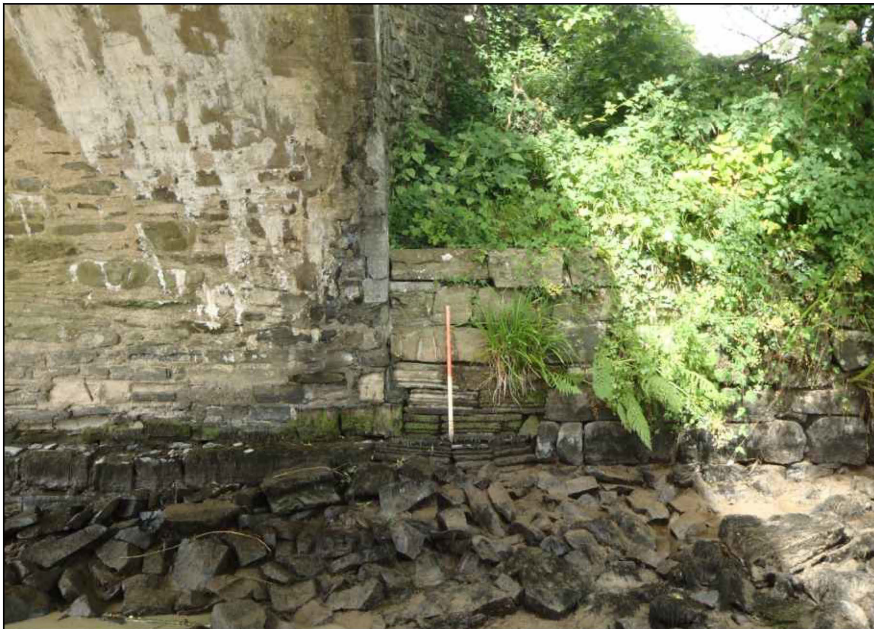
Plate 7: Revetment wall adjacent to pier 4, viewed from the southeast. Scale 1m

Only one section of the revetment wall at river level was visible – that on the upstream side of pier 4. It is aligned northeast-southwest, parallel with the river (Plate 7). It is constructed using the same techniques as the piers and cutwaters, although some of the blocks are a more laminar mudstone. It stands c. 1.3m high and extends for a distance of c. 10m upstream. The masonry abuts pier 4 including part of its foundation, although the lowest exposed course has been set into the pier foundation.

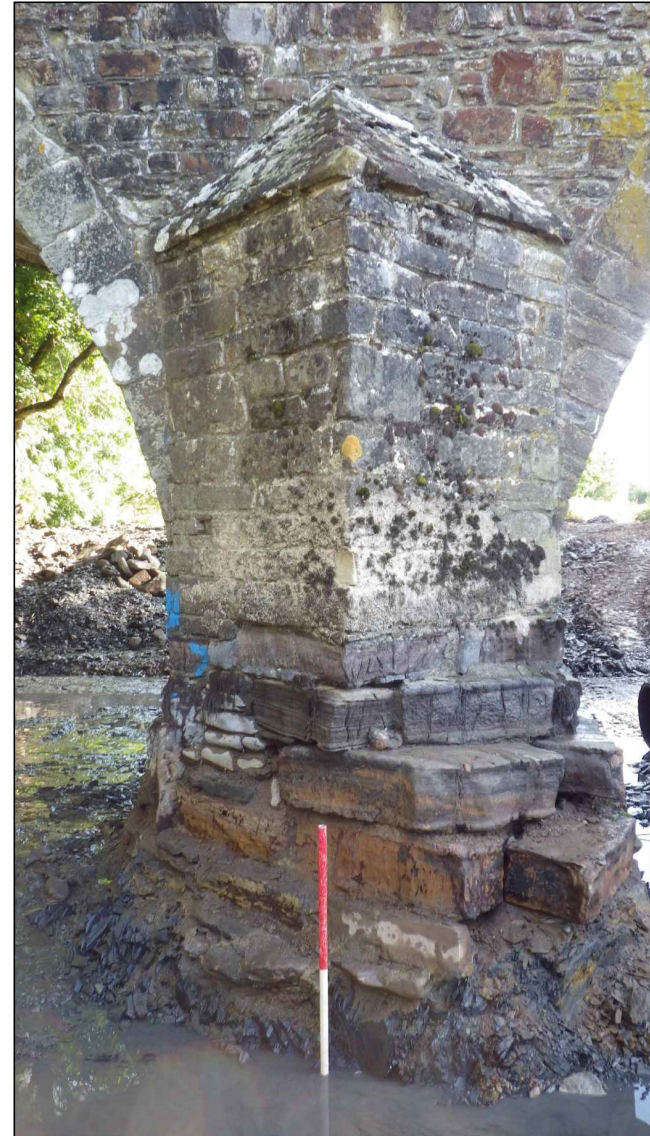
Plate 6: The downstream cutwater on pier 2 showing the construction details of the masonry abutting the pier, viewed from the southwest. Scale 1m

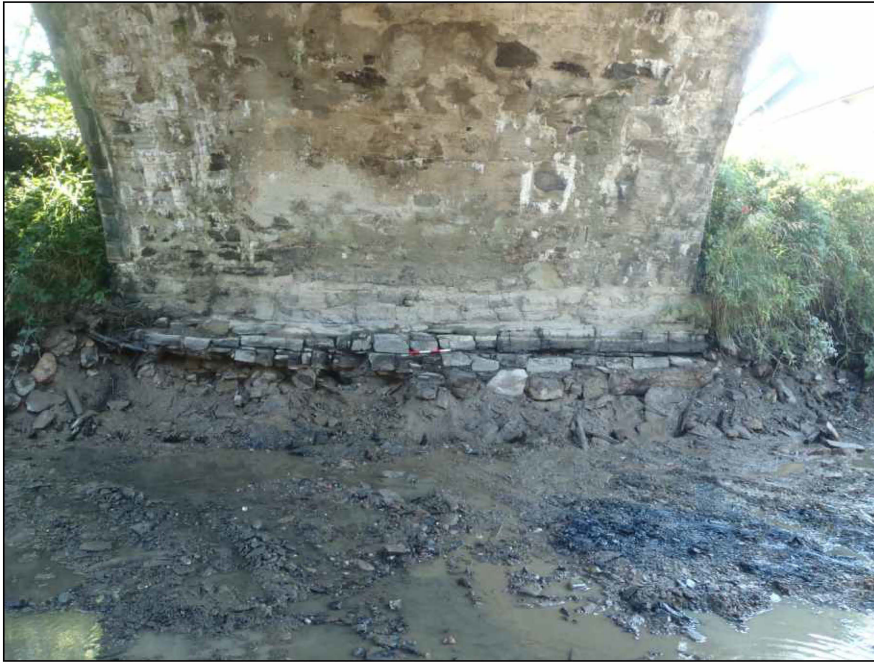
Plate 8: The foundations of pier 3 showing stakes 105, viewed from the northwest. Scale 0.40m

A number of oak stakes were exposed during the groundworks. A row of 25 stakes was exposed *in situ* aligned northeast-southwest, parallel to the base of pier 3 (105). The stakes were located between 0.50m and 0.80m away from the foundations of the pier, and generally set up to 0.30m apart (Fig. 2a). Two of the stakes at the southwest end supported the river bank. The stakes were driven directly into the bedrock up to a depth of 0.40m. The total length of the stakes was between 0.60m and 0.80m, and they were between 0.07m and 0.09m wide. They tapered to a point. No tool marks were observed. Other stakes, possibly from the same location, had been removed by the contractor (Plate 10). Two were pointed, and measured 0.50-0.70m long by 0.07-0.09m wide, and displayed between 4 and 6 faced sides.

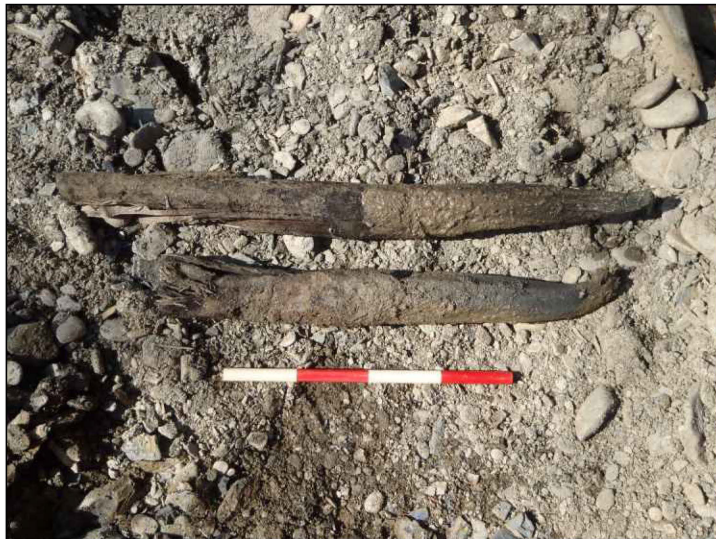
Plate 10: Timber stakes 105. Scale 0.40m

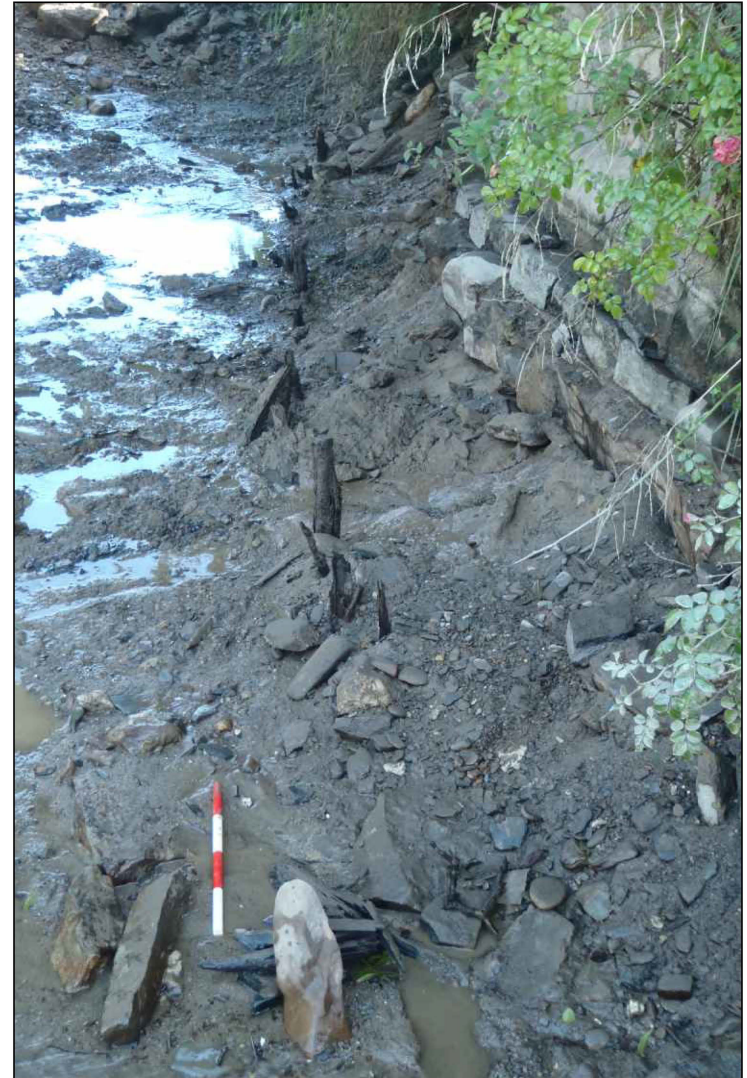
Plate 9: Row of timber stakes 105 adjacent to pier 3, viewed from southwest. Scale 0.40m

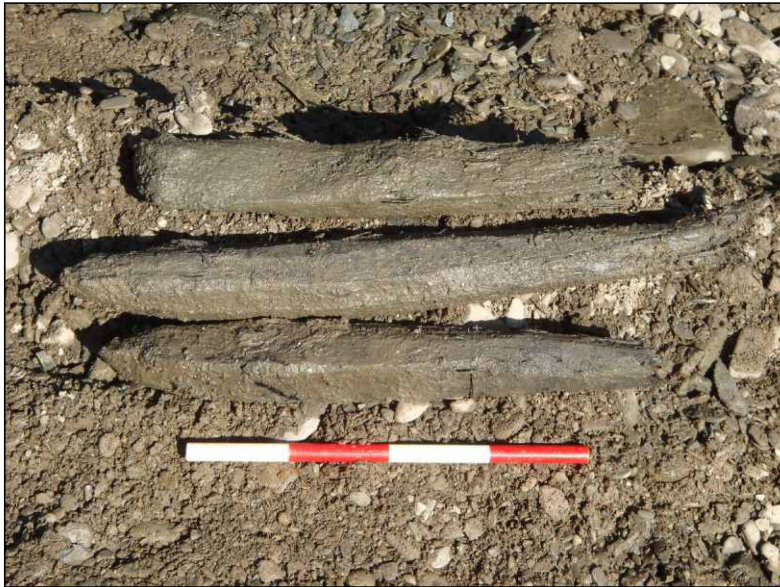
Plate 11: Timber stakes possibly from group 105. Scale 0.40m

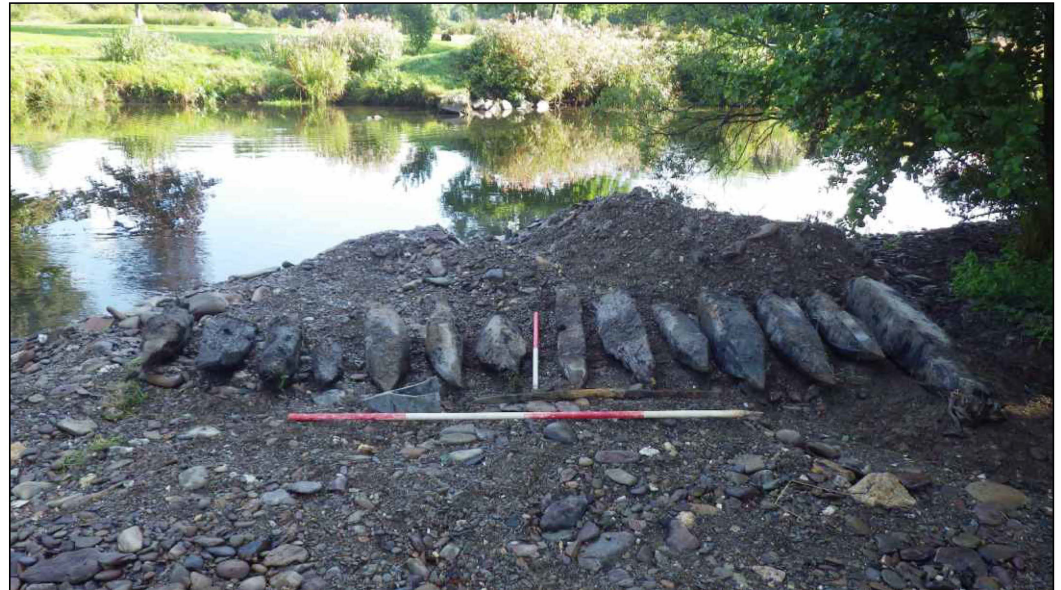
Plate 12: The stakes recovered by the contractor. Scales 1m and 2m

A single stake was recorded *in situ* adjacent to north side of pier 2 cutwater. A total of 15 stakes had been removed from this location by the contractors (Fig. 3; Plate 12). These had been located in a horseshoe-shaped arrangement around the north side of the cutwater, and were present below the modern concrete repairs. They had been cut from the heartwood of the trees, and were generally larger than those recorded adjacent to pier 3, and measured between 0.65-1.83m long by 0.10-0.26m wide. Many displayed several flat faces, and all were tapered to a point. Five of the stakes had been fitted with iron sheathes around their pointed ends, presumably to add their insertion into the ground. These comprised two versions – a simple V-shaped sheath with two short arms (Plate 13), and a version with four longer arms (Plate 14). All are fixed to the stakes with three hand-forged nails; several of the timbers without sheaths displayed nail holes. In addition to those attached to the stakes a further two loose sheathes – one of each design – were recorded (Plate 15).

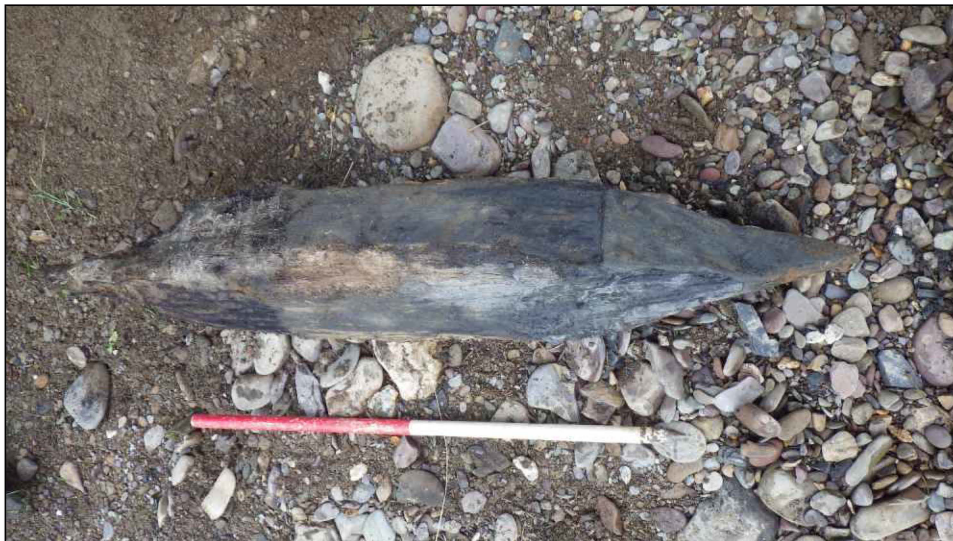
Plate 13: A stake with a two-armed sheath. Scale 1m

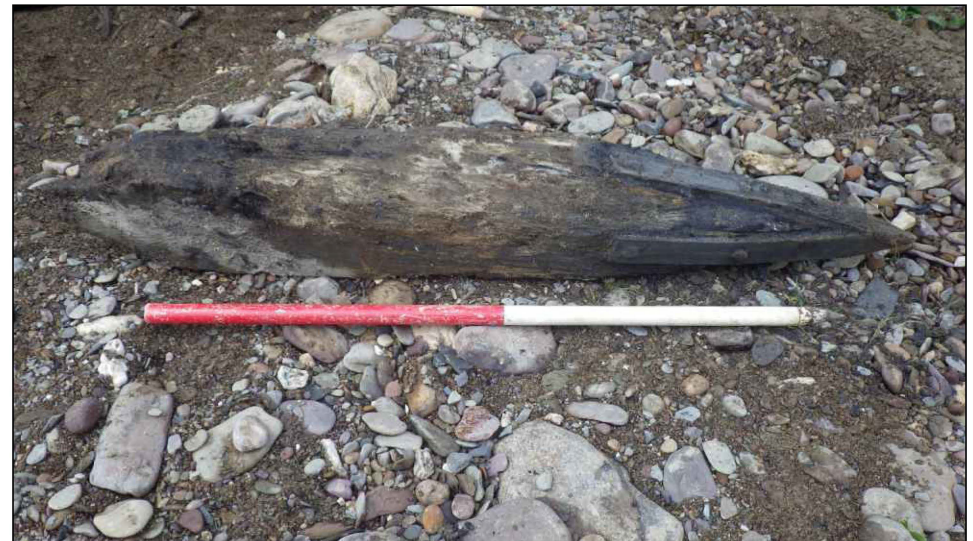
Plate 14: A stake with a four-armed sheath. Scale 1m

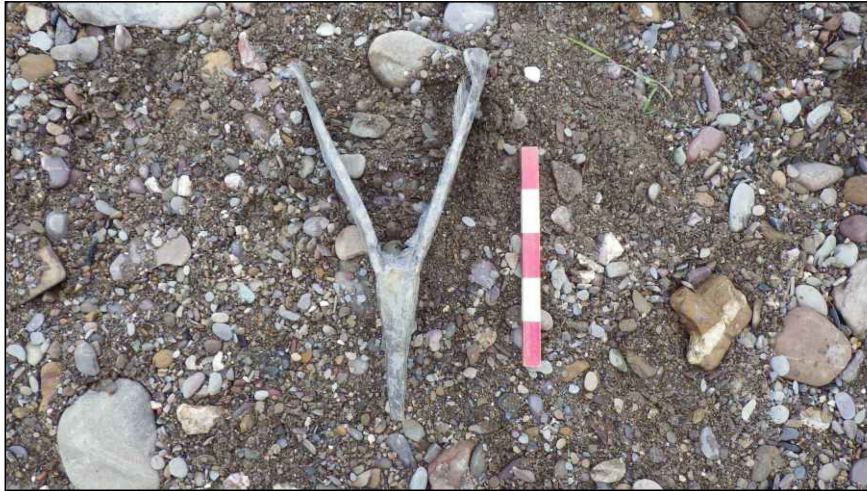
Plate 15: A loose two-armed sheath. Scale 0.50m

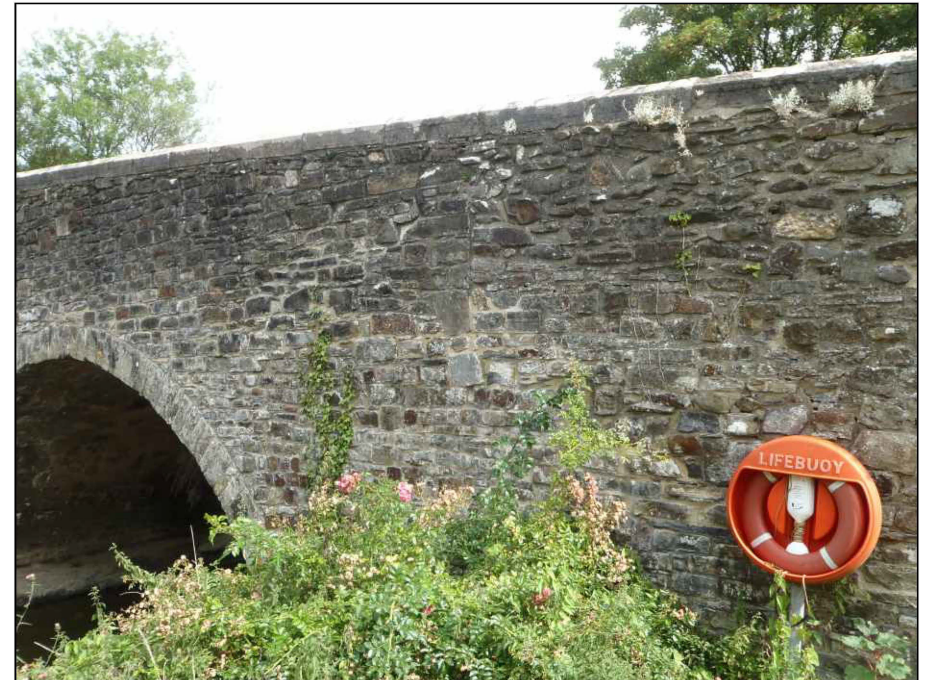
Plate 16: The vertical break in the southern parapet, viewed from the south

The parapets of the bridge are heavily repointed in cement obscuring any historic bonding materials. On the southeast side of the bridge the parapet had been rebuilt in stone (cf the Listed Building description), probably using the masonry from the earlier parapet. This is defined by a horizontal and vertical break (Plate 16). To the east, the earlier wall continues forming a revetment to the road and supports a modern wooden fence.
