PHASES 5 AND 6 DEVELOPMENT AREAS, SEATON NEIGHBOURHOOD, PLYMOUTH

Results of an archaeological trench evaluation

Plymouth City Council planning ref: 12/02027/OUT (Condition
43)

Document No: ACD998/2/0

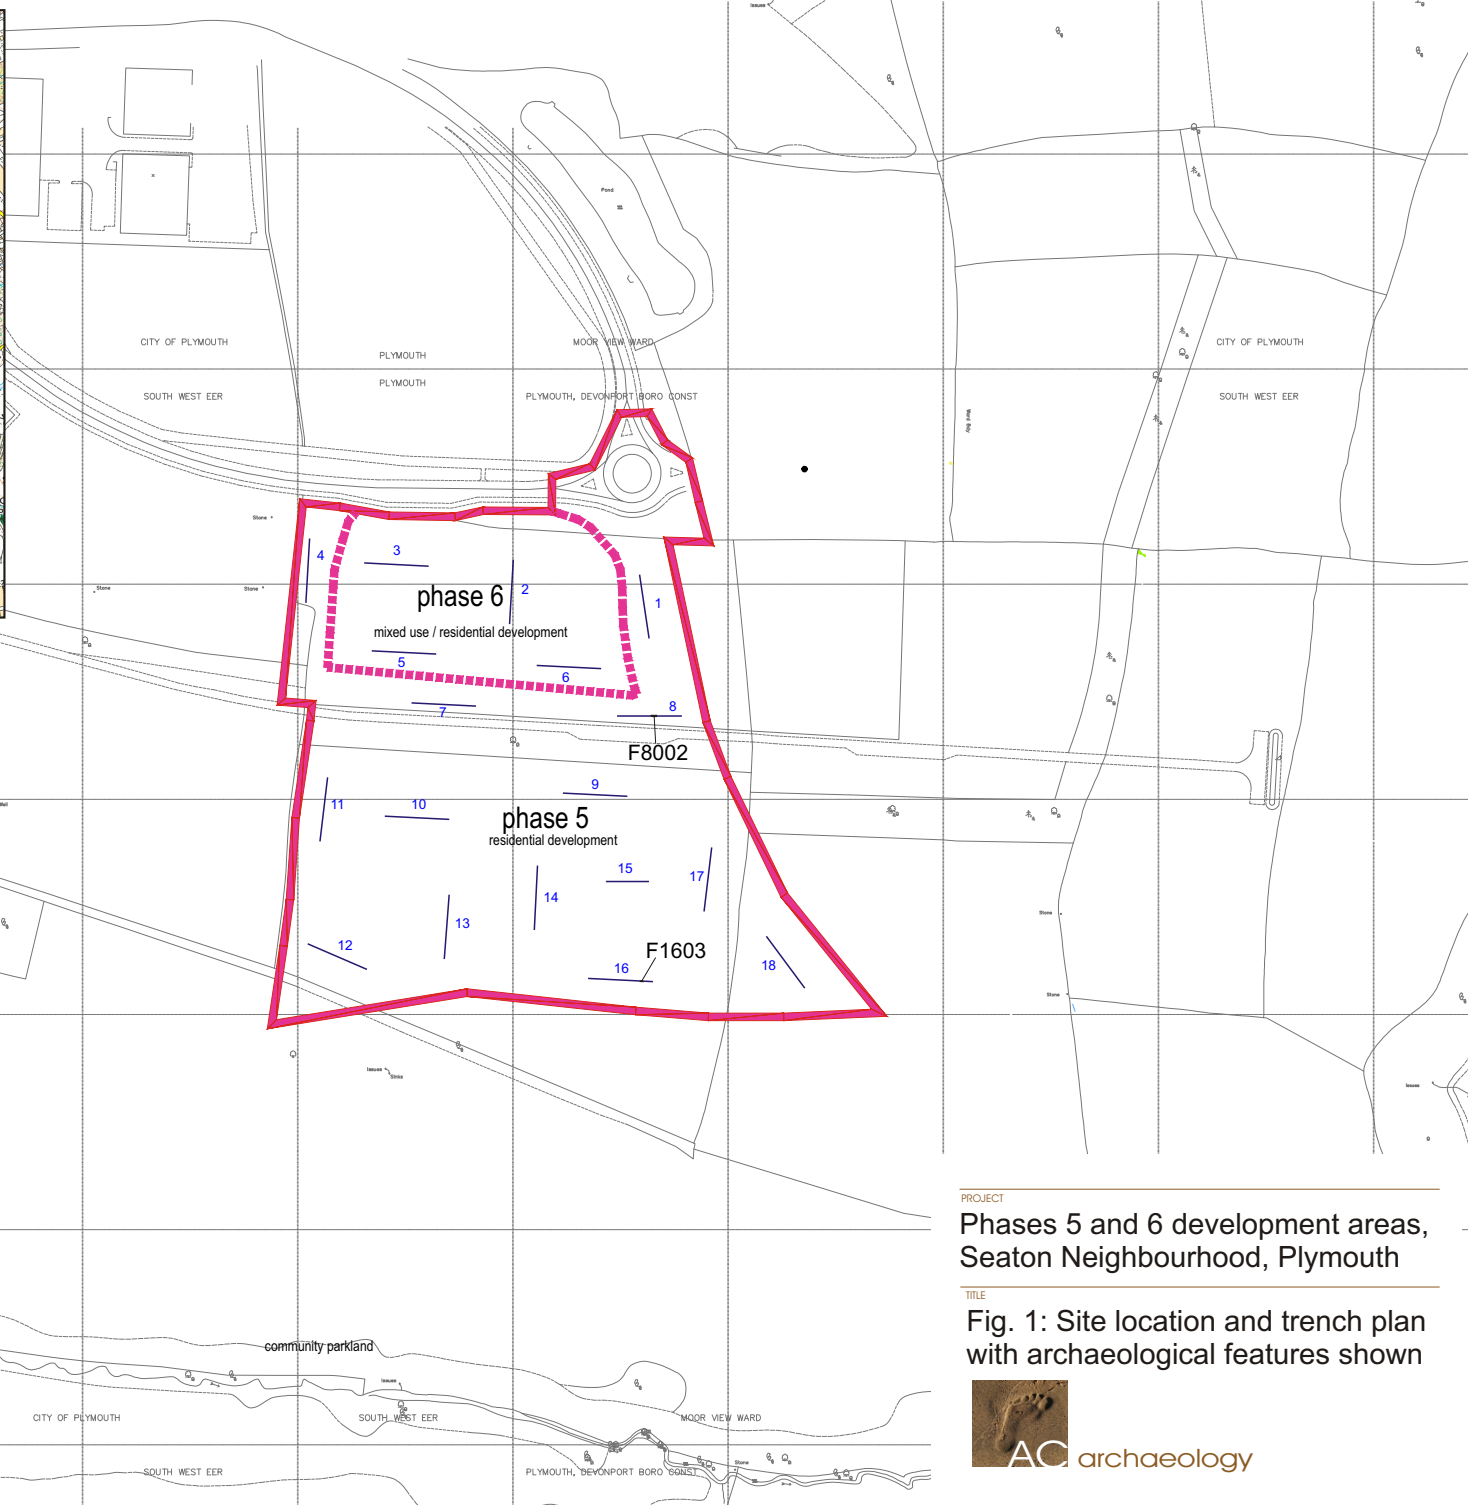
TITLE
Fig. 1: Site location and trench plan
with archaeological features shown

- Site boundary
- Evaluation trenches with archaeological features shown

- 1.1** This document describes the results of an archaeological trench evaluation carried out by AC archaeology between 23 and to 30 October 2014 on land forming phases 5 and 6 of the Seaton Neighbourhood development, Plymouth (NGR SX 497 588; Fig. 1). This work was commissioned by Persimmon Homes South West and required as a condition (No. 43) of outline planning permission granted by Plymouth City Council for phases 5 and 6. Advice on the scope of the archaeological investigations was provided by the Plymouth City Council Historic Environment Officer (hereafter PCCHEO).

- 4.1** The trench evaluation comprised the machine excavation of 18 trenches totalling 520m in length, with each trench 1.5m wide. The trenches were located in areas that will be affected by development in order to provide representative coverage of the site, and where the topography has the potential for survival of buried archaeological remains.

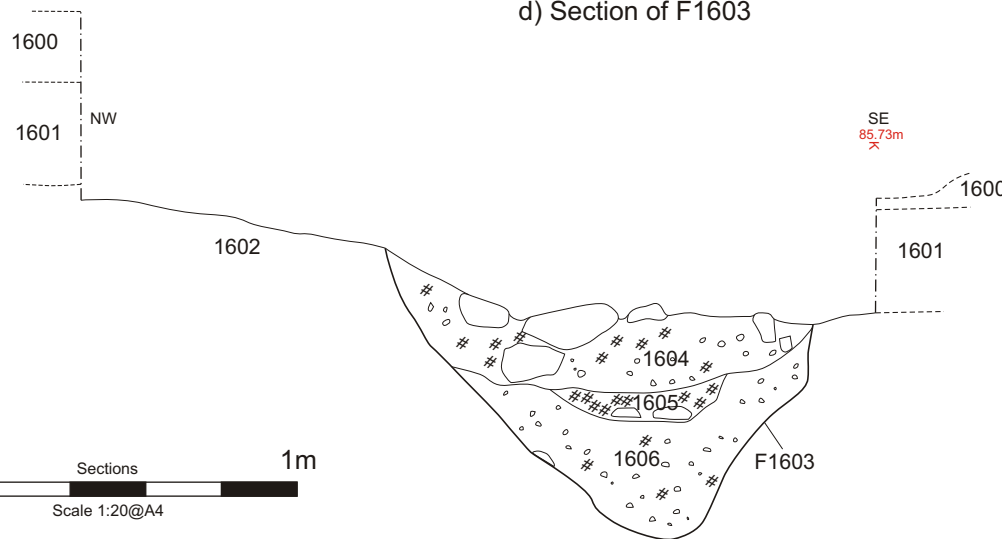
d) Section of F1603

Feature F1603 was ovate in plan and measured at east 1.60m long, 1.25m wide and up to 0.75m deep. It had a broadly symmetrical profile with sharp, steep sides and a relatively flat base. The primary fill (1606) was 0.26m thick and consisted of light greenish grey to light grey silty sandy clay with inclusions of shillet fragments and sub-rounded quartz and quartzite fragments. This was sealed by secondary fill 1605 which was 0.14m thick and consisted of reddish orange compacted silty clay with common charcoal fragments and small sub-round to sub-angular quartz and shillet fragments, some of which were burnt. Tertiary fill 1604 was 0.20m thick and consisted of light to mid grey silty sandy loam with inclusions of shillet throughout and larger quartz pebbles and cobbles at the top of the deposit. No finds were recovered from this feature. The upper fill material was sealed by the subsoil 1601.

7.3 Feature F1603 was located on the sloping ground in the southern portion of the site. It appears to represent a natural tree bowl with evidence for *in situ* burning of a large tree stump, rather than being a dug feature.

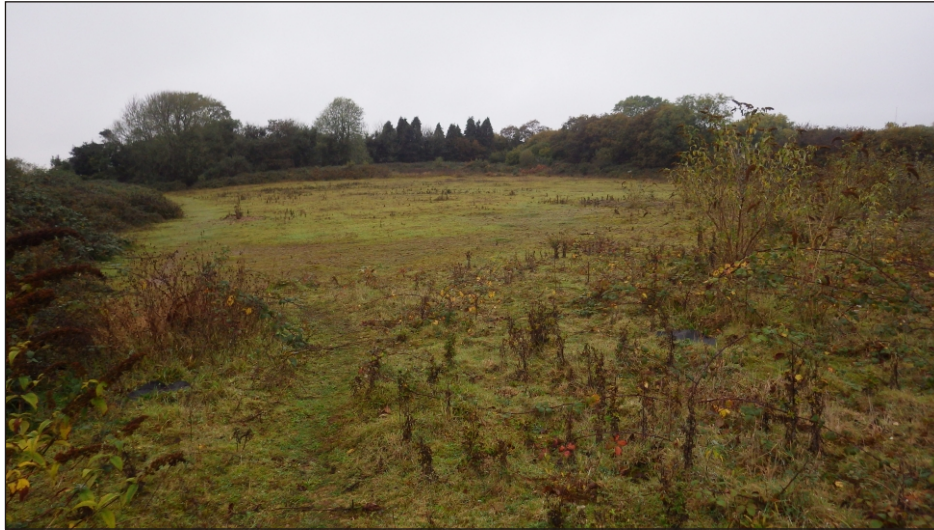
Plate 1: General view of northern portion of site, looking west.

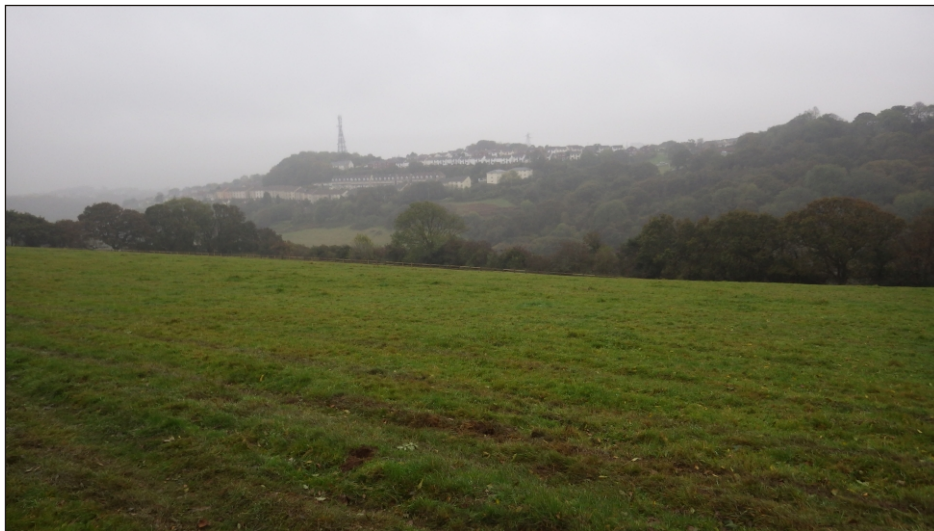
Plate 2: General view of southern portion of the site, looking southeast.

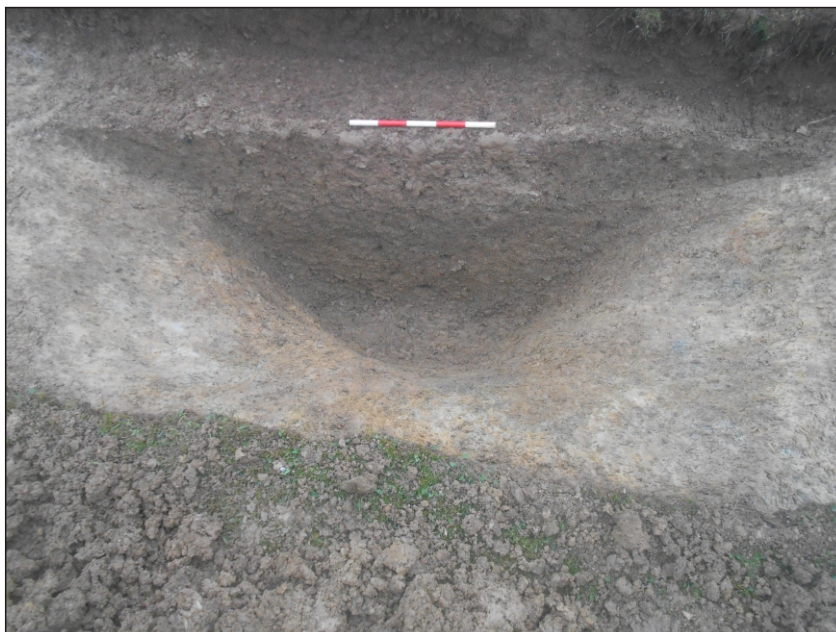
Plate 3: Section of F8002, view from the southeast, 0.50m scale.

Pit F8002 was roughly circular and measured 2.72m long by at least 1.50m wide and 0.9m deep. It had moderate, slightly undulating and tapering sides and a well-rounded base. The fill sequence consisted of a basal primary fill (8003) which was 0.14m thick and consisted of compact mid yellow to grey brown silty clay with moderate amounts of angular shillet inclusions (>40mm long), deriving from initial weathering of the cut edges and upcast material. This was followed by a secondary fill (8004) which was 0.22m thick and consisted of compact mid red brown silty clay loam. The tertiary fill (8005) was 0.24m thick and consisted of mid grey-brown compact silty clay with occasional stones and abundant charcoal flecks. The feature was capped with an upper fill (8006), 0.35m thick, consisting of mid red brown compact silty clay. No finds were recovered from any of the fills. The upper fill was sealed by the topsoil 8000.

7.2 Pit F8002 was located within the footprint of the former training ground. The fills indicate it may have remained open for a period of time before being deliberately backfilled. The purpose of this feature remains unclear but given its very regular profile it is probably associated with the former training ground.
