THE SOUTH DEVON LINK ROAD, KINGSKERSWELL, DEVON - DECOY INDUSTRIAL ESTATE LINK ROAD

Results of historic building recording

Document No: ACD895/5/1

Date: November 2014

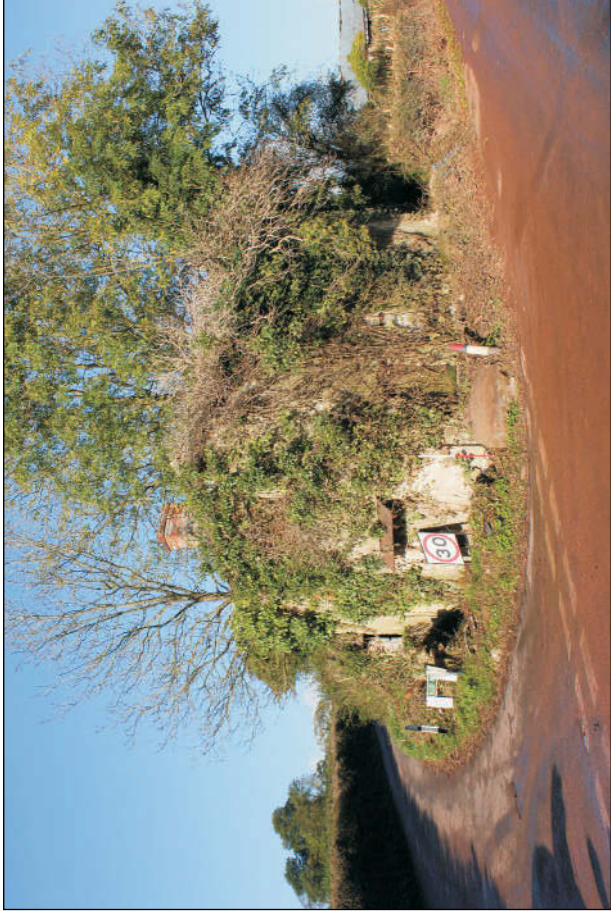
Plate 2: The toll house prior to demolition, viewed from the southeast. 1m scale

The building is located within a small enclosure and positioned at the junction of Kingsteignton Road and Priory Road, aligned alongside the former (Plate 2). The enclosure is defined by mortared rubble limestone walls that have been removed at the road junction. The main body of the building is rectangular with a rounded southeast corner fronting the road junction. It is constructed of limestone and the external elevations have been rendered. The building is two storied under a hipped roof with hips at the north and south gables. The roof covering is slates with ceramic ridge tiles. A brick chimney projects above the roofline on the west side and is constructed of drilled red bricks laid in stretcher bond.

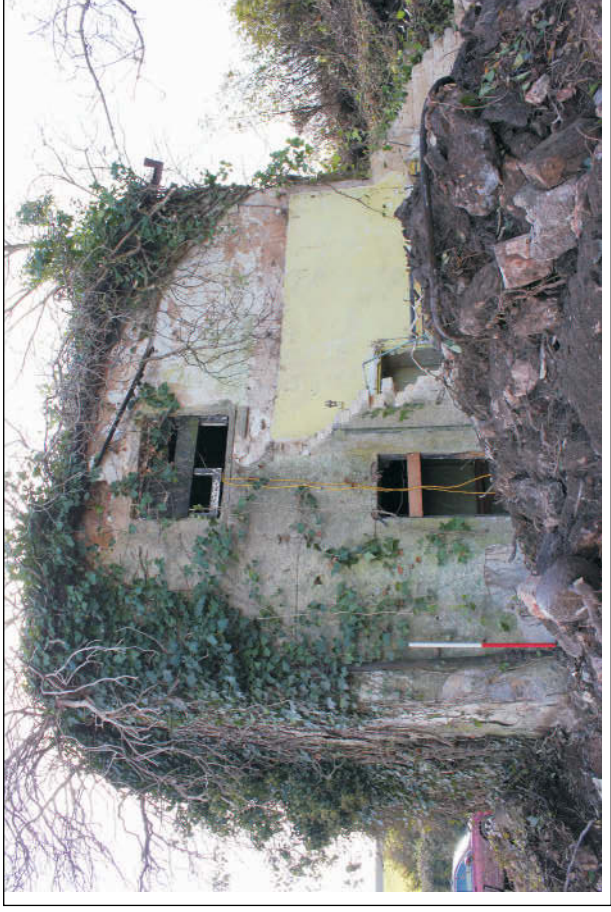
Plate 3 : The north elevation following partial demolition of the kitchen extension, viewed from the northwest. 1m scale

On the ground floor of the north elevation there is a low doorway at the east end with a wooden frame. Two internal steps lead down into the building. To the west there is a single-storey kitchen extension entered from a doorway in the rear room of the house (Plate 3). It is constructed of yellow candy bricks laid in stretcher bond, and incorporates a wooden-framed window in its north wall. The exterior elevations have

been rendered in cement. The extension has a pitched slate roof that had been repaired with corrugated iron sheeting. On the first floor there is a single wooden-framed side-opening casement window that is missing its glass; it appears to be a later insertion.

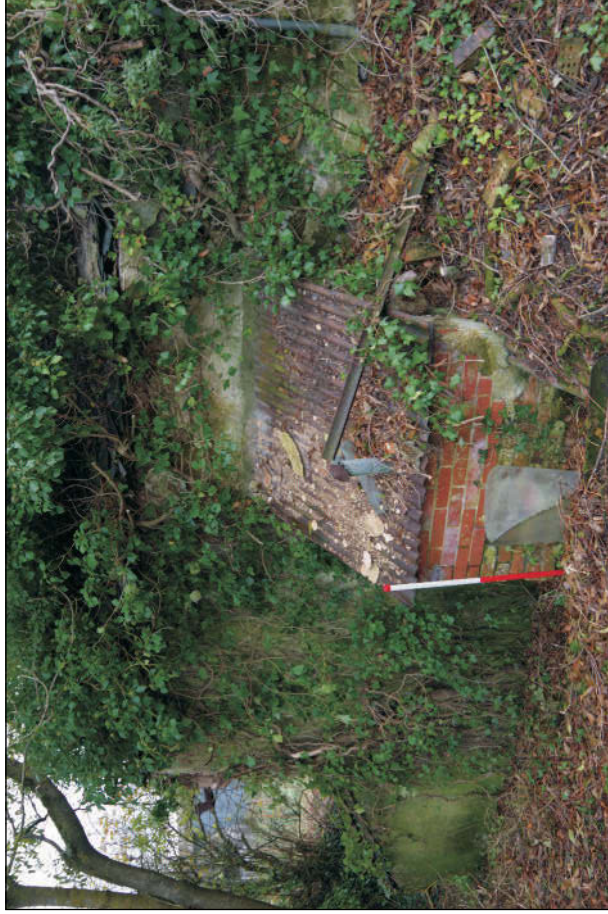
Plate 4: The brick water closet, viewed from the west. 1m scale

No openings were visible in the west elevation from the exterior but a wooden-framed window can be seen on the first floor from the interior. There are two single-storey extensions on this side of the house. At the front of the property is a limestone rubble store entered via a doorway from Priory Road. The wall is finished in lime plaster, most of which has fallen away. It has a pitched corrugated iron sheet roof. Attached to the rear of the store is a water closet, constructed of red brick laid in stretcher bond that has been rendered in cement although most has now fallen away (Plate 4). It has a pitched corrugated iron sheet roof through which a metal vent pipe exits.

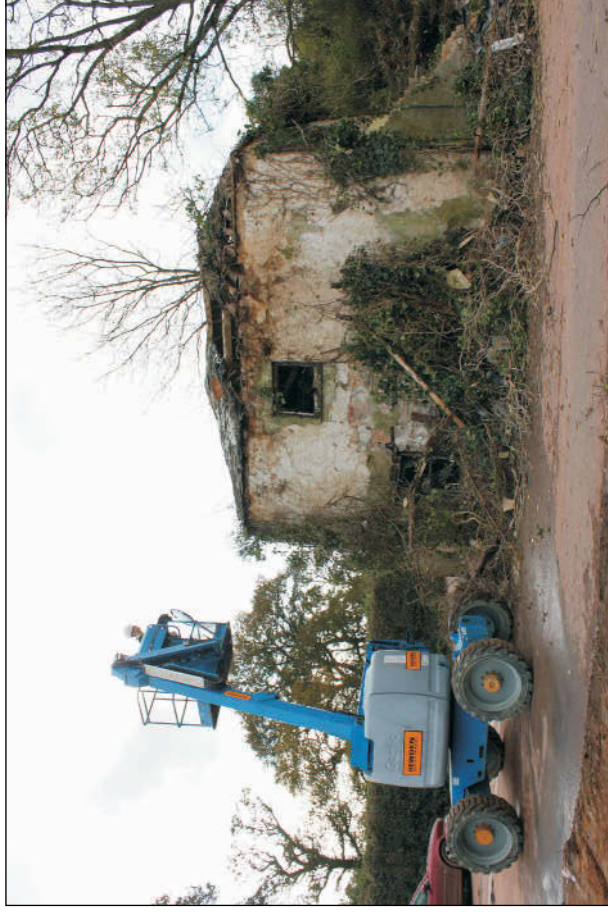
Plate 5: The east elevation during demolition, viewed from the east.

The east elevation currently incorporates a single ground-floor wooden-framed two-light window and the remains of a first-floor, probable two-light, window (Plate 5). The former is under a thick wooden lintel. It may be set within a larger original opening that extended to the north. This is defined by a long wooden lintel under a row of wide, vertically-set limestone voussoirs, with bricks used as the blocking material (Plate 6).

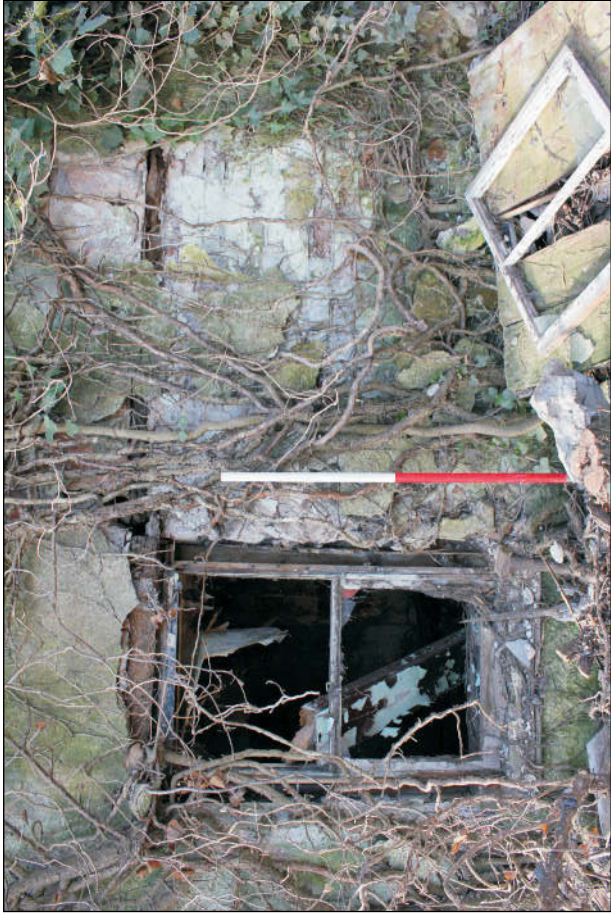
Plate 6: The ground-floor openings in the east elevation, viewed from the southeast. 1m scale

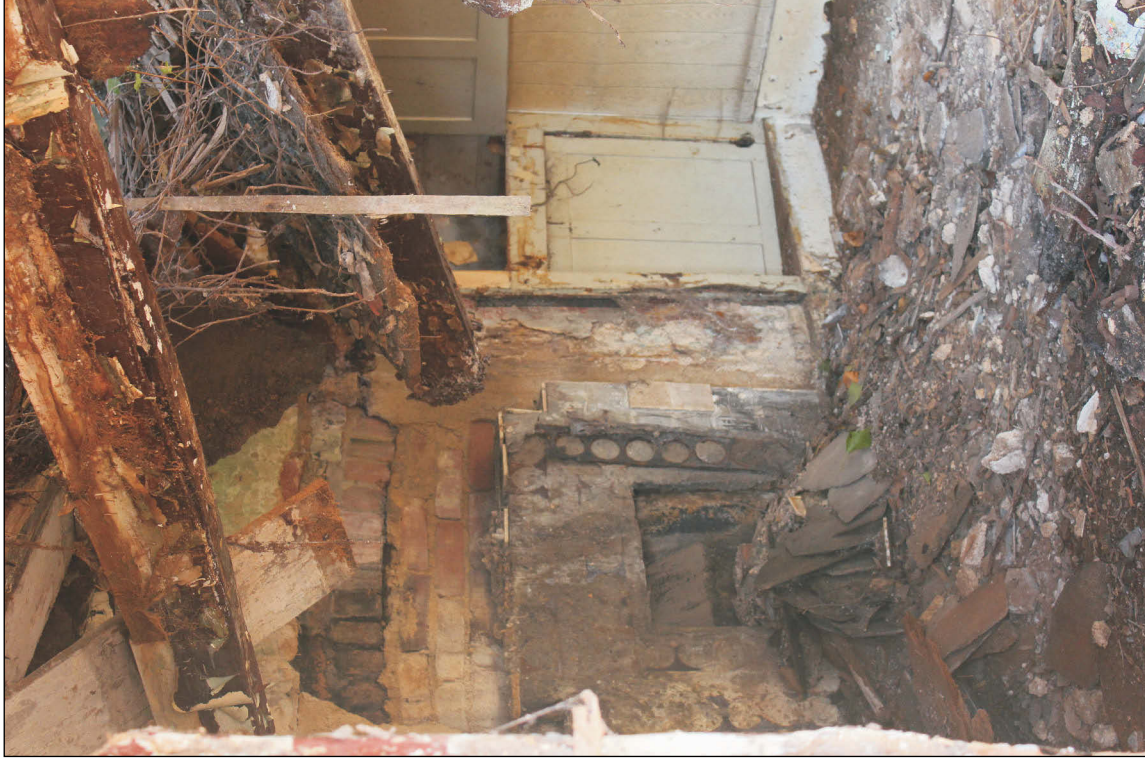
Plate 8: The south room, viewed from the southeast looking in the front door

On the ground floor the toll house contains two rooms divided by a timber tongue and grooved partition. The southern room is larger, occupying approximately two-thirds of the original footprint. The floors in both rooms are concrete and there is a slight step up from the south room to the north room. In the centre of the west wall of the south room is a fireplace. The fire grate is missing but would have sat within a brick surround which itself had been constructed within a larger, earlier brick-arched opening (Plate 8). To the north of the fireplace is a cupboard with a pair of two-panel doors. The ceiling of this room is plastered and has collapsed.

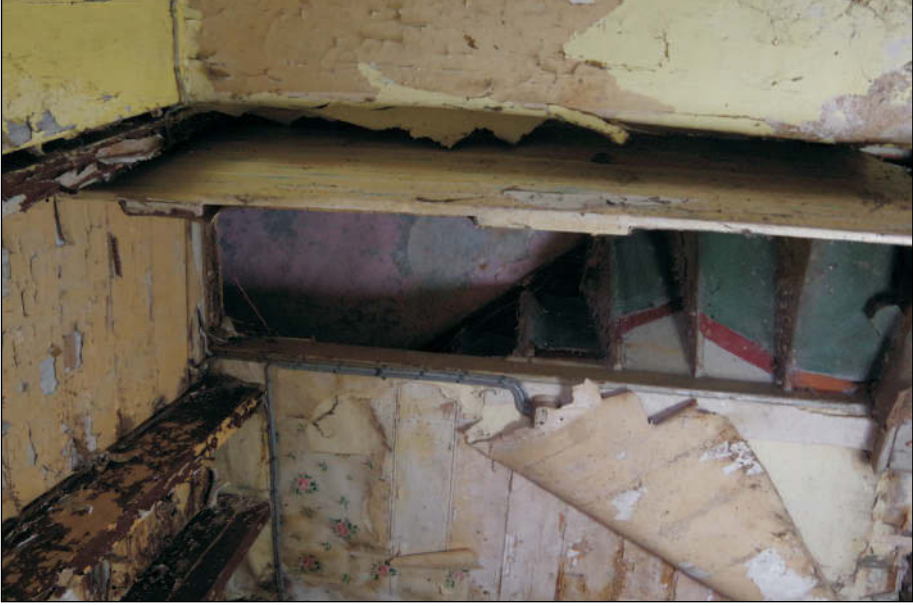
Plate 9: The stairs in the rear room, viewed from the east looking in the rear door

The stairs to the first floor are located in the northwest corner of the north room (Plate 9). To the south of these is a small lobby or cupboard with a door.

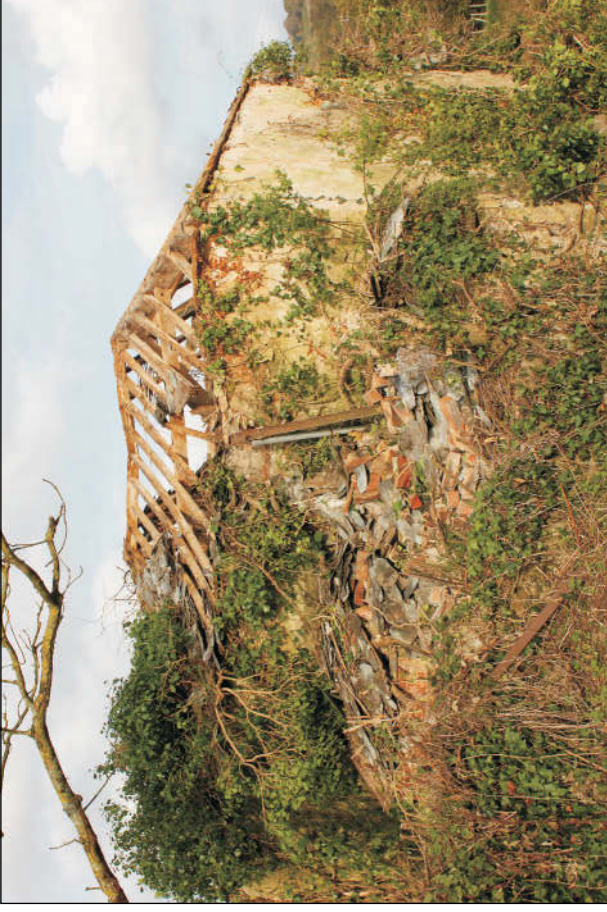
Plate 10: The southwest side of the roof during demolition showing exposed timbers, viewed from the southwest

The roof is supported on two trusses with principal rafters set into tie beams at eaves level. There is a single row of side purlins; these are both trenched into and laid onto the back of the principal rafters, and are nailed to the sides of the hip rafters. These and a ridge purlin support closely-spaced secondary rafters onto which battens are laid. Where visible all joints are nailed.
