BURY BARTON FARM, POLBURY, LAPFORD, DEVON

Results of an archaeological watching brief

Mid Devon District Council planning reference 14/00393/PNAG

> > Document No: ACD970/2/0

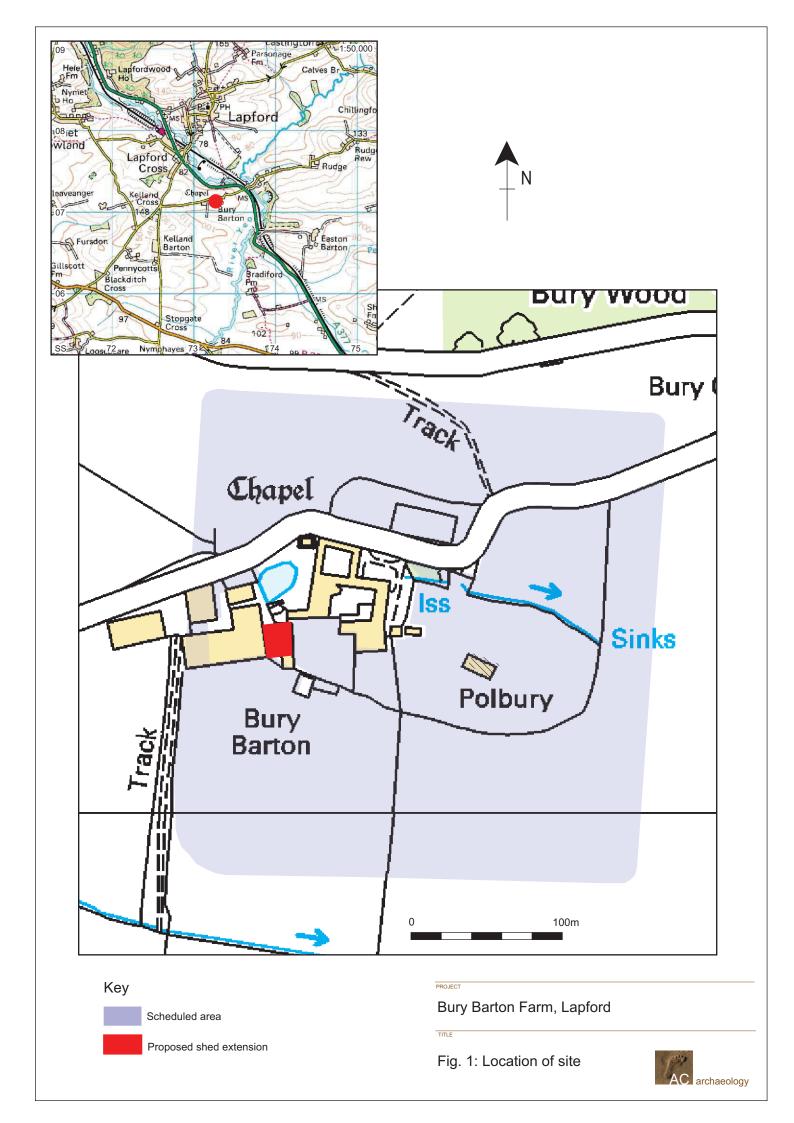
Description of works (Fig. 1)

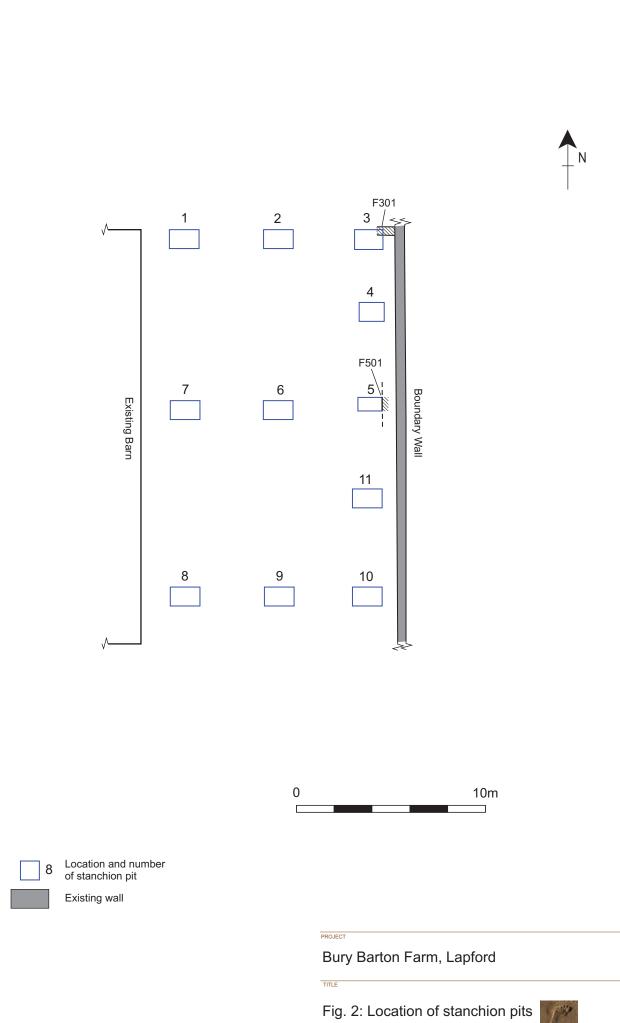
Results (Fig. 2; Plates 1-2)

The extension covers an area of 22m by 14m on the east side of the existing barn. A total of 11 stanchion pits were machine excavated and monitored. The deposit sequence in each pit is summarised below:

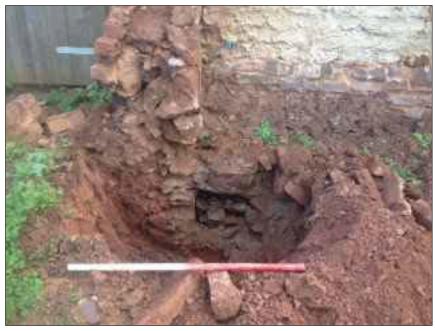
- *Pit* 3 (1.50m by 1m by 0.90m deep): 0.80m dark brown silty clay topsoil with brick and mudstone inclusions overlying natural mudstone. The topsoil was disturbed by (the remains of) an east-west aligned mudstone wall (F301) bonded with mud and pointed in cement mortar.

Plate 1: Pit 3, showing wall F301, looking east. 1m scale

The extension to the barn is located on a terrace that has been formed from raising the ground using redeposited natural deposits. This activity is probably contemporary with the construction of the barn to the west. The topsoil below the raised ground is also of modern date and represents topsoil in the field west of the historic farm and gardens before the present modern agricultural buildings were constructed. Limited exposures of the natural, below the topsoil, were made, and no archaeological deposits or features were exposed. No finds were recovered. Wall F301 is the remains of a continuation westwards of the upstanding boundary wall between the garden to the

east and the field and farm to the west. This is depicted on 19th-century Ordnance Survey maps. Wall F501 may represent an internal feature to a former structure attached to the west side of the boundary wall.					
Archive This report and the associated OASIS entry represent the archive for the project.					
A plan as well as any other relevant drawings must be attached showing the location and extent of site, areas investigated and features exposed.					
Recorder:	Date sent to HER:				
Kerry Kerr-Peterson (AC archaeology)	23 December 2014

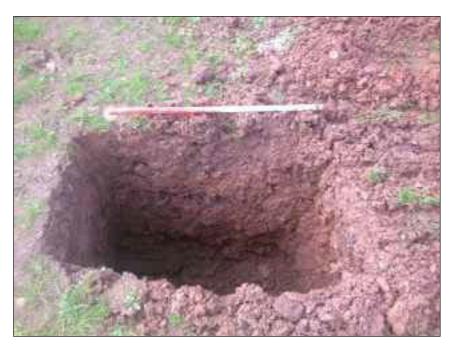
- Pit 7 (1.50m by 1m by 1m deep): redeposited natural mid brown silty clay containing decomposing manure that continued below the base of the pit.
- Pit 8 (1.60m by 1m by 1.30m deep): redeposited natural mid brown silty clay containing decomposing manure overlying dark brown silty clay former topsoil with brick and mudstone inclusions that was exposed at the base of the pit.

Plate 2: Pit 8, looking east. 1m scale
