VIRGINSTOWE BRIDGE, VIRGINSTOWE, DEVON

Results of historic building recording

Torridge District Council planning reference
1/1091/2014/FUL, condition 4

Document No: ACD1049/2/0

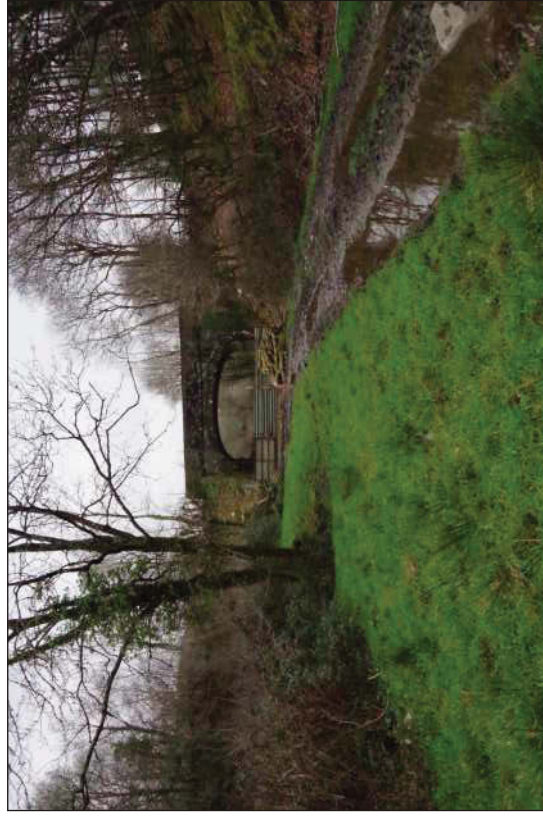
Plate 1: The bridge viewed from the former railway line to the south showing the cutting at the base of the hillside to the east. 2m scale.

The railway was located in the base of the river valley on the east side of the floodplain; it was terraced into the base of the hillside on the east side of the valley (Plate 1). To the north and south of the bridge the railway was laid in a cutting. The bridge spans the railway from the top of the cutting on the east side to an embankment on the west side that carries the road down to the floodplain and the modern Middle Bridge to the east. (In the nineteenth century the road crossed the River Carey via a ford.)

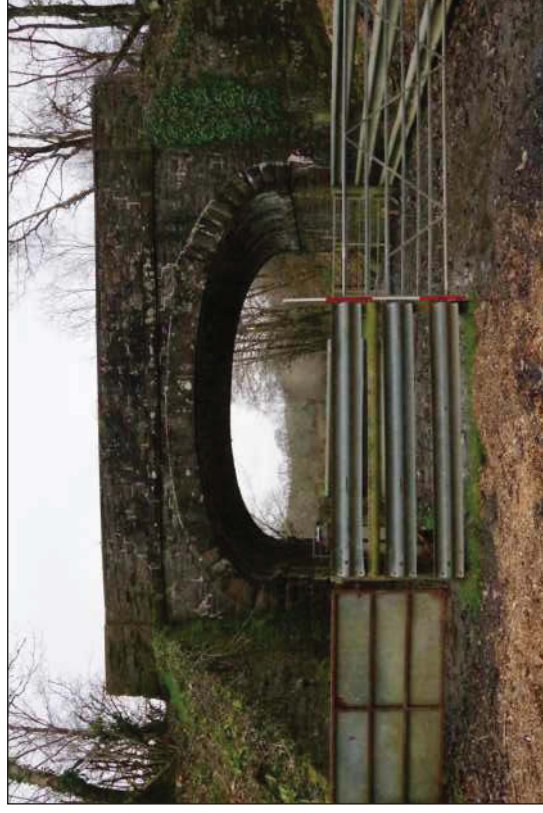
Plate 2: The south elevation, viewed from the south. 2m scale.

The bridge and its abutments are constructed of rectangular roughly finished blocks of coursed purple to red local stone with ribbon pointing in hard grey cement mortar (Plates 2-3). Episodes of repointing have taken place in recent years. It has a depressed arch of wedge-shaped voussoirs finished with pitch facing and plain margins. It rises from string courses featuring the same decoration. At road level above the arch there is a further string course on each elevation, again treated with the same finish (Plate 4). Above the string course are parapets that measure approximately 1.25m high (Plate 5). These extend over the abutments (see below) where they project out from the masonry of the main bridge span (see Plates 2-3). These areas of wider masonry incorporate large quoins. On the north elevation the parapet has limestone capping; however on the south elevation they have been removed and replaced with a concrete slab. The end coping stones over the wider masonry on the north side of the bridge are finished with pitch facing and plain margins, and also appear to be replacements.

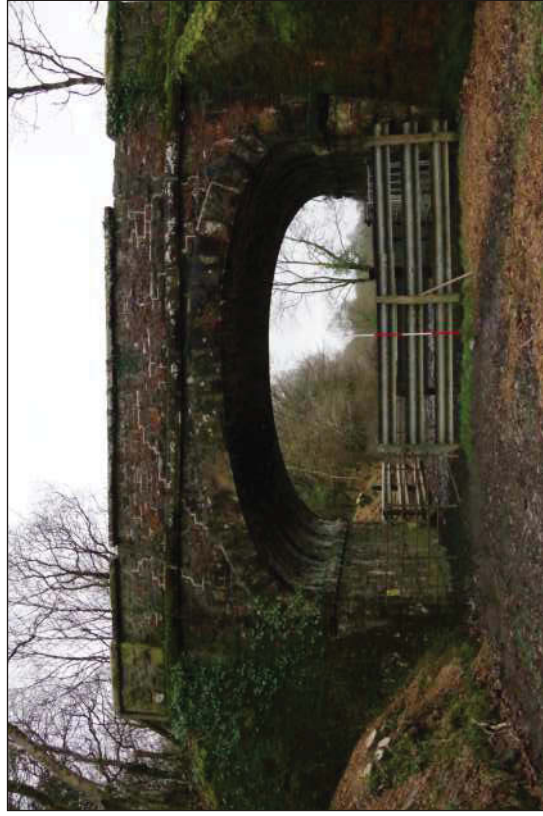
Plate 3: The north elevation, viewed from the north. 2m scale.

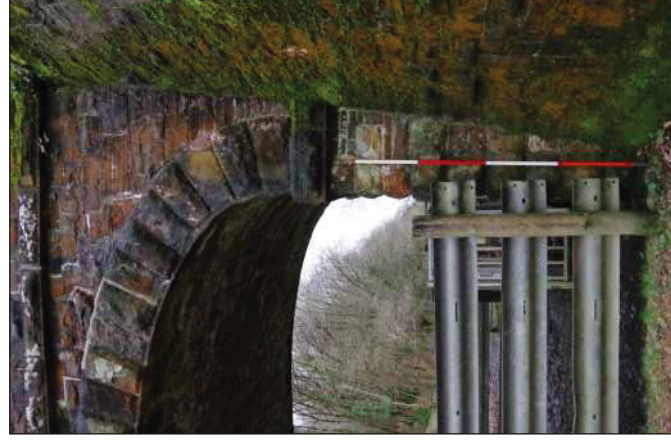
Plate 4: The south elevation showing the architectural detailing of the arch and string courses, and the tapered profile of the abutment, viewed from the south. 2m scale.

On the west side of the bridge the embankment is supported by two retaining abutments. The southern abutment is at a right angle to the bridge whilst the north abutment is angled slightly to the west (Plate 6). Both abutments taper back from the base of the bridge (see Plate 4). On the east side of the bridge the abutments are aligned at 45° to the structure, and support the cutting and the road above. The south abutment tapers back from the base of the bridge (Plate 7), whilst the lower courses of the north abutment also taper back, but above the string course for the arch they rise vertically to road level (Plate 8). All of the abutments were constructed separately from the main fabric of the bridge, but are contemporary and their tops support the projecting masonry at the ends of the parapets.

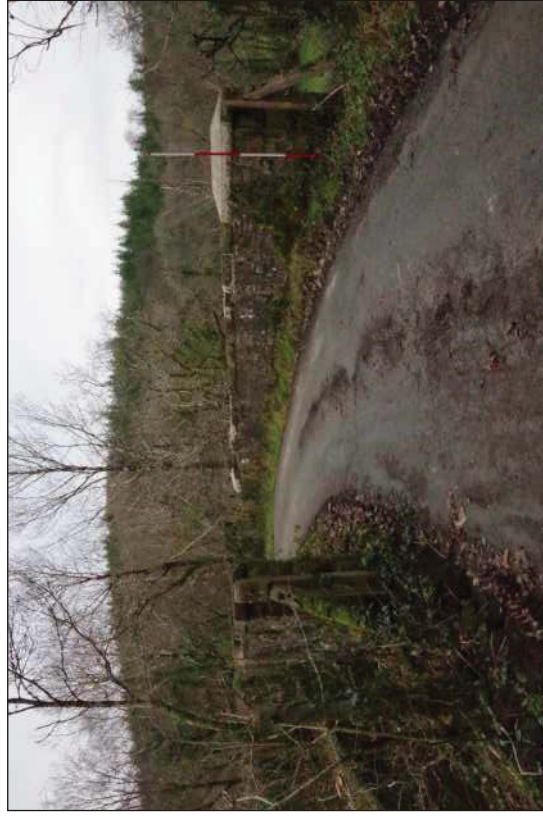
Plate 5: The parapets viewed from the eastern approach to the bridge, viewed from the southeast. 2m scale.

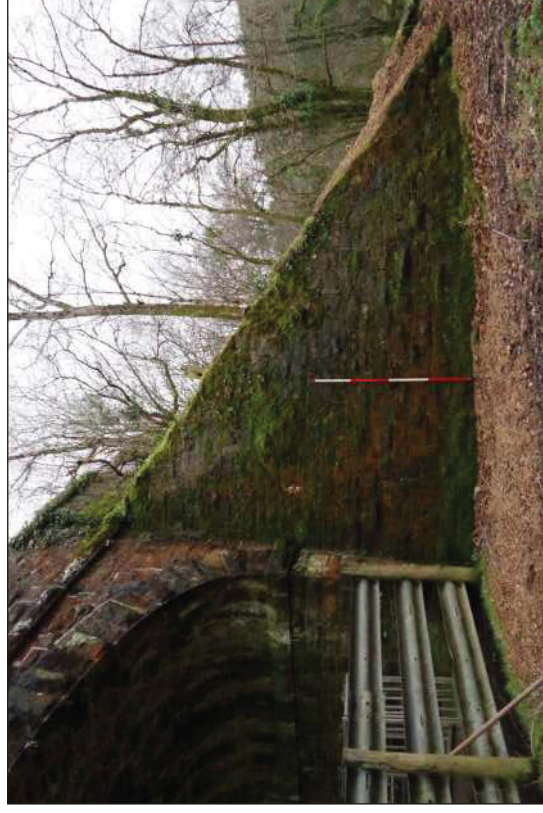
Plate 6: The northwest abutment, viewed from the east. 2m scale.

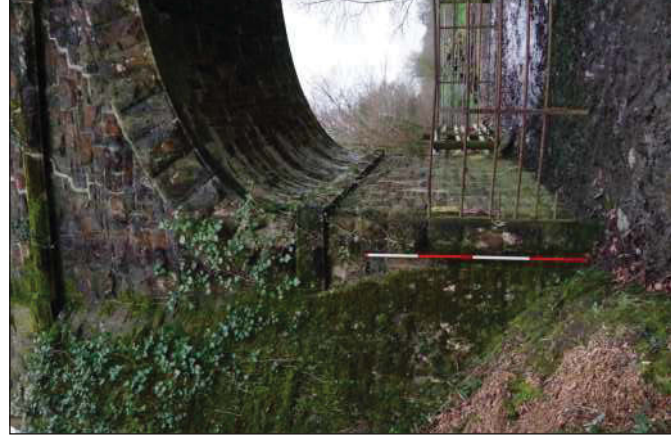
Plate 8: The northeast abutment showing the change in profile above the level of the arch, viewed from the northwest. 2m scale.
