# LAND AT TREVONE HOUSE, DENMARK ROAD, GLOUCESTER

## Results of an Archaeological Trench Evaluation

Report No: ACD1062/2/0

Date: January 2015

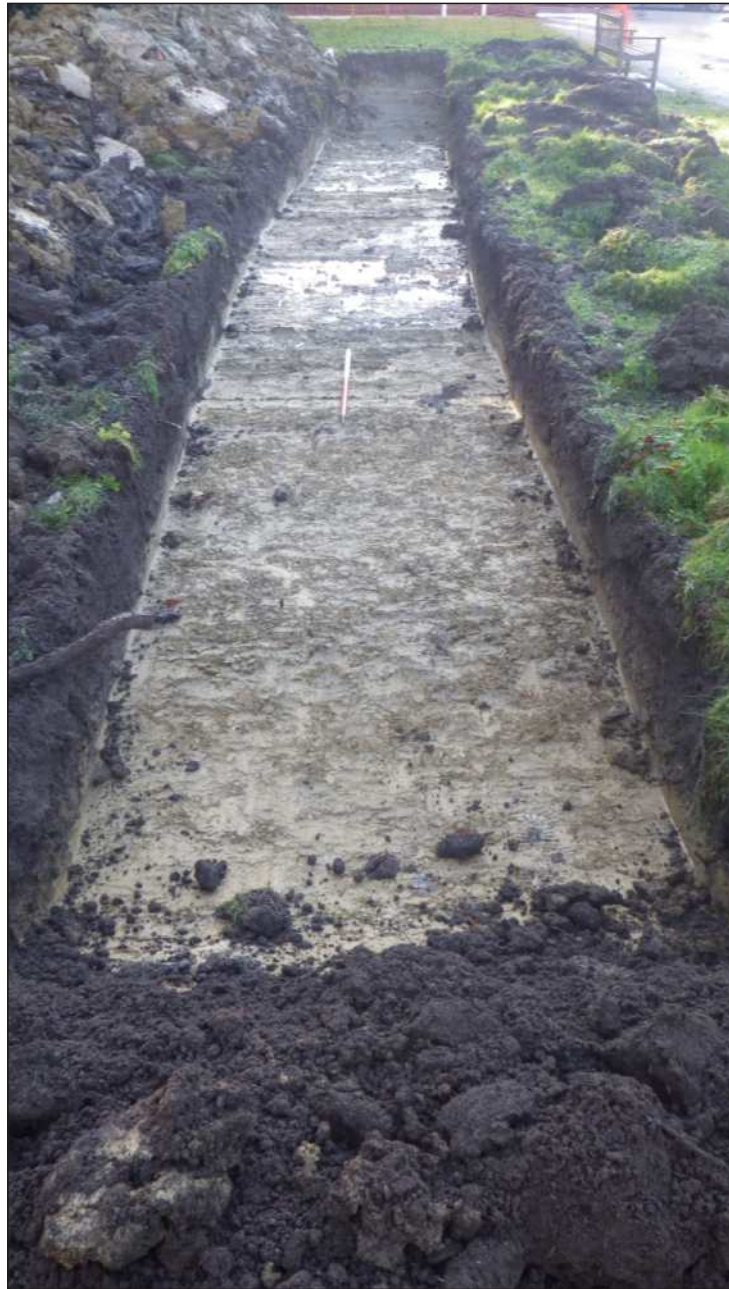
Plate 1: General view of Trench 1, view to southwest (scale 1m)

- 5.1 The trench was excavated to a maximum depth of 1.10m below ground level into clay natural subsoil (context 102). The overlying layer sequence comprised 0.25-0.40m of topsoil (100) directly above a light yellow to brown clay natural subsoil (102). In the southwest part of the trench, at a depth of 0.25m, was a demolition layer (101), composed of a 0.60m thick grey clay containing frequent red brick fragments and rounded stones, directly overlying the natural subsoil and sealed by the topsoil. This extended for 3.20m towards the northeast before petering out within an artificial sloping of the natural subsoil.

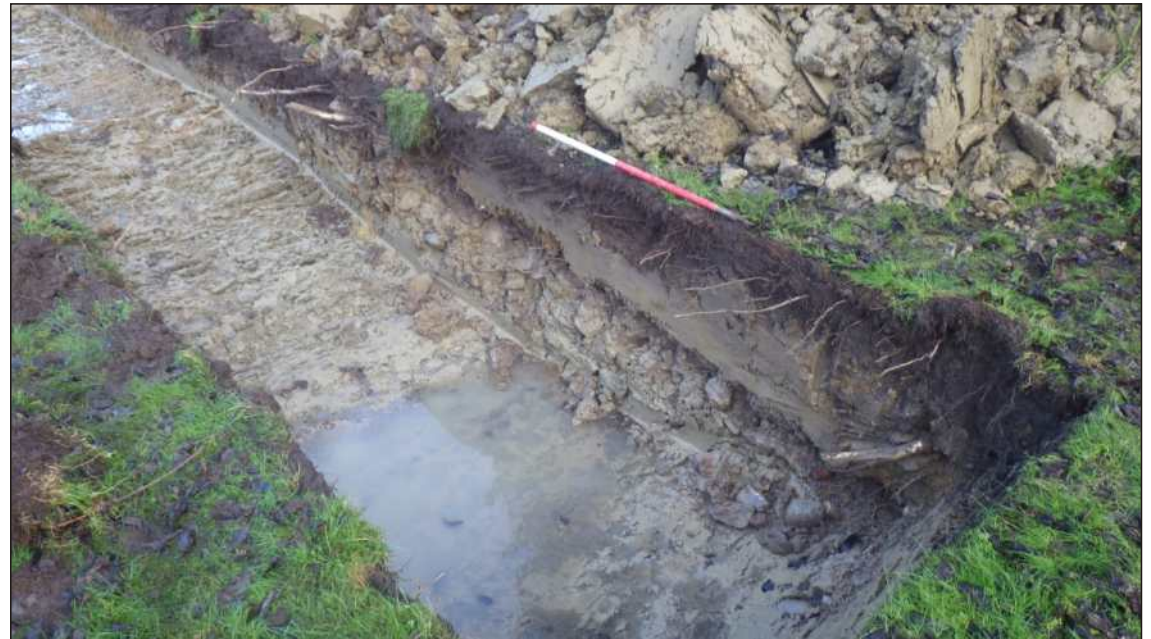
Plate 2: Southwest end of Trench 1, showing demolition layer 101. View to northwest (scale 1m)
