LAND AT ANGEL HILL, ST ANDREW STREET, TIVERTON, DEVON

Results of an archaeological trench evaluation, watching brief,
and historic building recording

Mid Devon District Council planning reference 13/00298/MFUL,
Condition 12

Document No: ACD1004/2/1

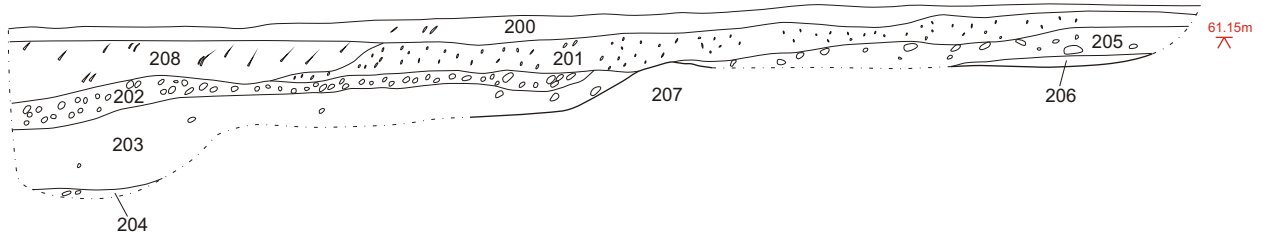
b) Trench 2 section

Trench 2 was located approximately 20m to the south of Trench 1, measured 15m long and was excavated onto natural river terrace gravels (207) at depths of 0.70m (southeast end of trench; Plate 3) and 2.20m (northwest end of trench; Plate 4) below the current ground level. In the deeper northwest end of the trench 207 was overlain by 0.10m of very compacted grey alluvial silts (204) which was in turn sealed by up to 1m of yellowish brown very compacted alluvial silts (203) with sparse pebble inclusions. This deposit was overlain by 0.34m of pale brown very compacted clayey silt (202) with frequent pebble inclusions. Above 202 was a 0.70m thick layer of modern made ground (208) sealed by 0.08m of modern tarmac (200).

In the shallower SE end of the trench 207 was overlain by 0.10m of yellowish red very compacted clayey silt (206), which was in turn sealed by 0.40m of yellow brown, very compacted alluvial clayey silt (205) with occasional river pebbles and cobbles. Above 205 was up to 0.50m of dark brown, highly organic clayey silt (201) with frequent pebble inclusions, overlain towards the northwest end of the trench by modern made ground 208, and at the southeast end of the trench sealed by the modern tarmac 200.

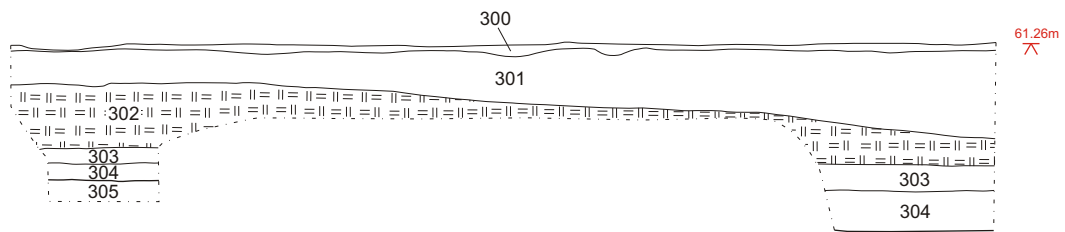
c) Trench 3 section

Trench 3 was located approximately 15m east of the River Exe, measured 15m long and was excavated onto natural river terrace gravels (305) at 2.30-2.50m below the current ground level (Plate 5). The initial overlying layer sequence consisted of 0.50m of light yellow brown, very compacted alluvial slightly clayey silt (304), and 0.35m of dark brown clay loam (303) with sparse slate, mortar and CBM fragments. Deposit 303 was sealed by up to 0.80m of light reddish brown coarse sand (302) with abundant (c.90%) unconsolidated bricks and brick rubble mixed with sparse slate and mixed stone inclusions, overlain by 0.45m of mixed dark brown silty clay loam and mid red brown clays and soils (301) with varying quantities of slate, mortar and poorly sorted gravels. This in turn was sealed by a 0.10m thick modern tarmac surface (300).

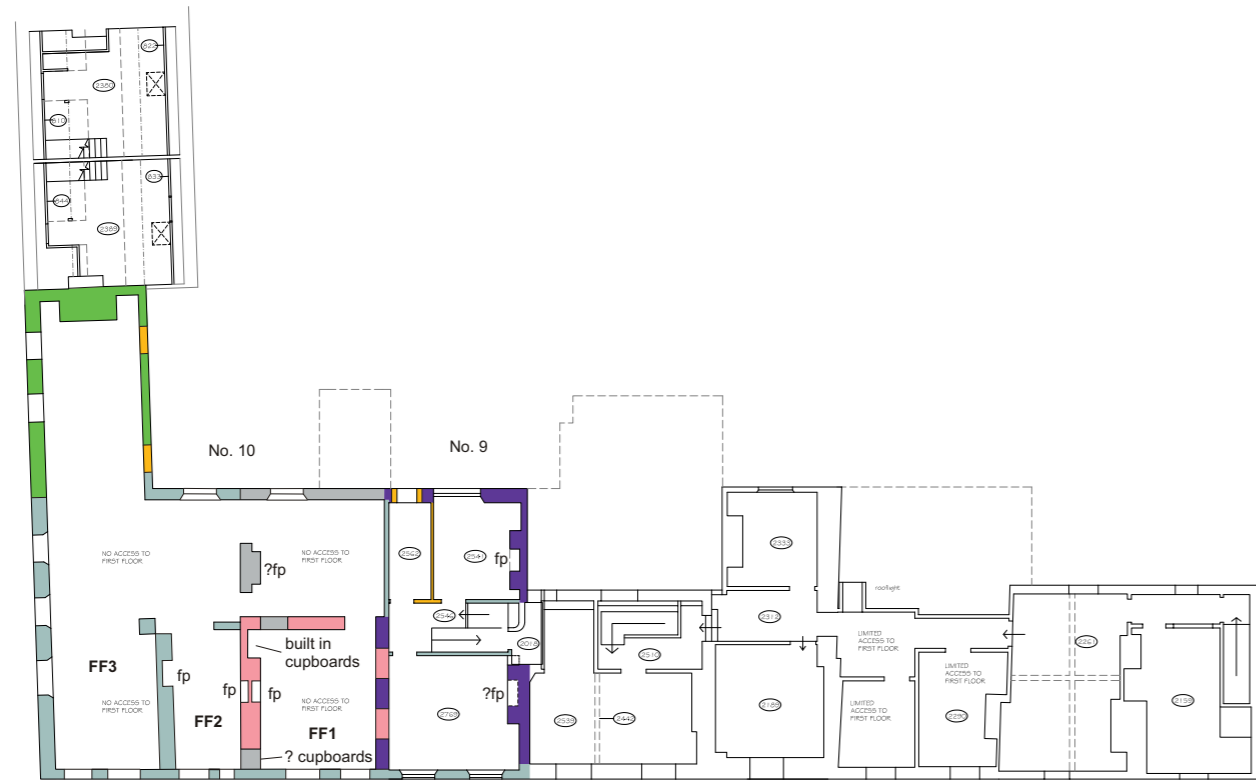
FIRST FLOOR PLAN

There was limited initial access to the first floor of No. 9 as the floors were unsafe. It is accessed via a two-flight staircase. The handrail survives on the lower flight and has a turned newel post, square balusters, and a ramped rail. In No. 10 the floors had been removed and the observations were made from below. The layout of No. 9 consists of a small modern bathroom off the landing, which also gives access to two bedrooms. The western bedroom contains a fireplace in the north wall; a similar feature may be obscured in the eastern bedroom.

FF1 – in this room there is a (now open and gutted) fireplace in the south wall, to the west of which is a built-in cupboard with a pair of three-panelled doors and to the east of which is a blocked feature. This appears to be divided horizontally by stone work, and may represent a pair of cupboards. Exposed stone masonry is visible above in the former roof space. This elevation forms the south gable (and party) wall of No. 9. In the west elevation is a large opening, which may represent an altered 19th-century doorway. To the south of this is a flat-headed brick blocked window. In

the north elevation is a pair of blocked windows, both with limestone surrounds and projecting keystones.

FF2 – in this room a fireplace in the north wall backs onto that recorded in FF1. A second fireplace is exposed in the south wall; this has a modern tile surround.

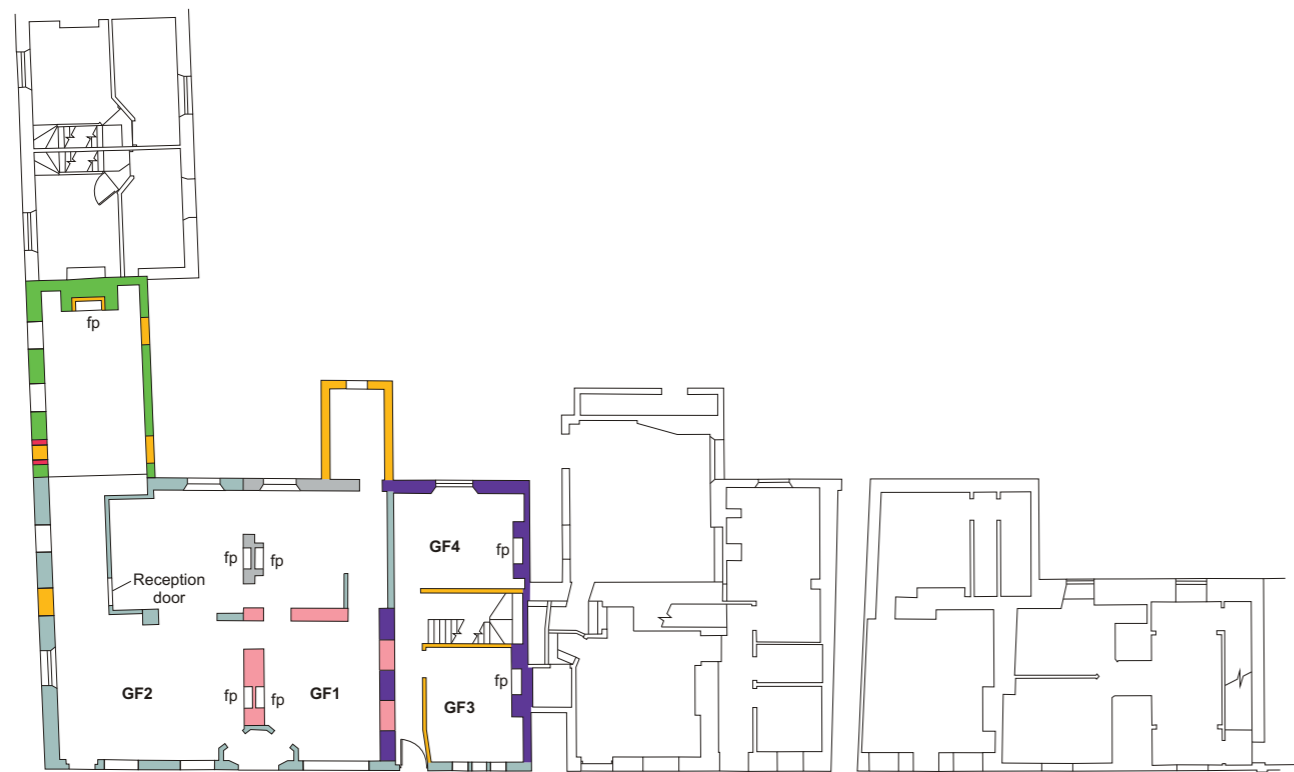
GROUND FLOOR PLAN

GF1 – this room had been gutted and the first floor above had been removed. In the north wall are two blocked openings – a doorway set towards the west and a window towards the east. They both have limestone surrounds with projecting keystones. The quality of the finish of the stonework indicates that this was originally an external wall to no. 9. There is a small fireplace on the south wall that has a brick surround but is missing its grate. The room to the west was not accessible as the floor had been removed but there is a fireplace in the south partition wall.

GF2 – this space had been gutted and the first floor above had been removed. The (partially removed) internal partitions have been constructed using brick in contrast to the stone exterior walls. In the east elevation, between the two windows appears to be a blocked opening. Externally, this corresponds with a pilaster. The western doorway has a limestone surround with a recess for a door fitting. This surround may have been reused from the original construction of No. 9. There are two fireplaces on the ground floor backing onto those recorded GF1 and the room beyond. One of the fireplaces has a modern tile surround, whilst the other has a modern plain surround. In the west side of the room there is a reception door with a central open panel to enable the receptionist to receive guests. To the south, a corridor leads to a rear room that was not accessible since the floor had been removed. The only observed features are an inserted brick fireplace in the west elevation and an adjacent cupboard to north.

GF3 – this is the front room in No. 9, and is entered via a corridor along the south side of the property. It has a modern finish, with the only feature being a fireplace in the north wall. Following stripping out, the two blocking openings recorded in room GF1 were exposed in the south wall. The finish of the stonework was not as high quality on this side of the wall as on its south side, indicating that this face was internal and intended to be covered up.

GF4 – this is the rear room in No. 9, separated from GF3 by a staircase within an enclosed well. The south wall is constructed of cement-bonded brick laid in header bond, with wooden spars inserted to allow the attachment of shelves. This wall is a replacement associated with the conversion of the building to a public house in the mid 19th century. The only original feature is a small fireplace opening in the north wall. In the north wall beneath the stairs is a small high-level blocked opening; its function is unknown.

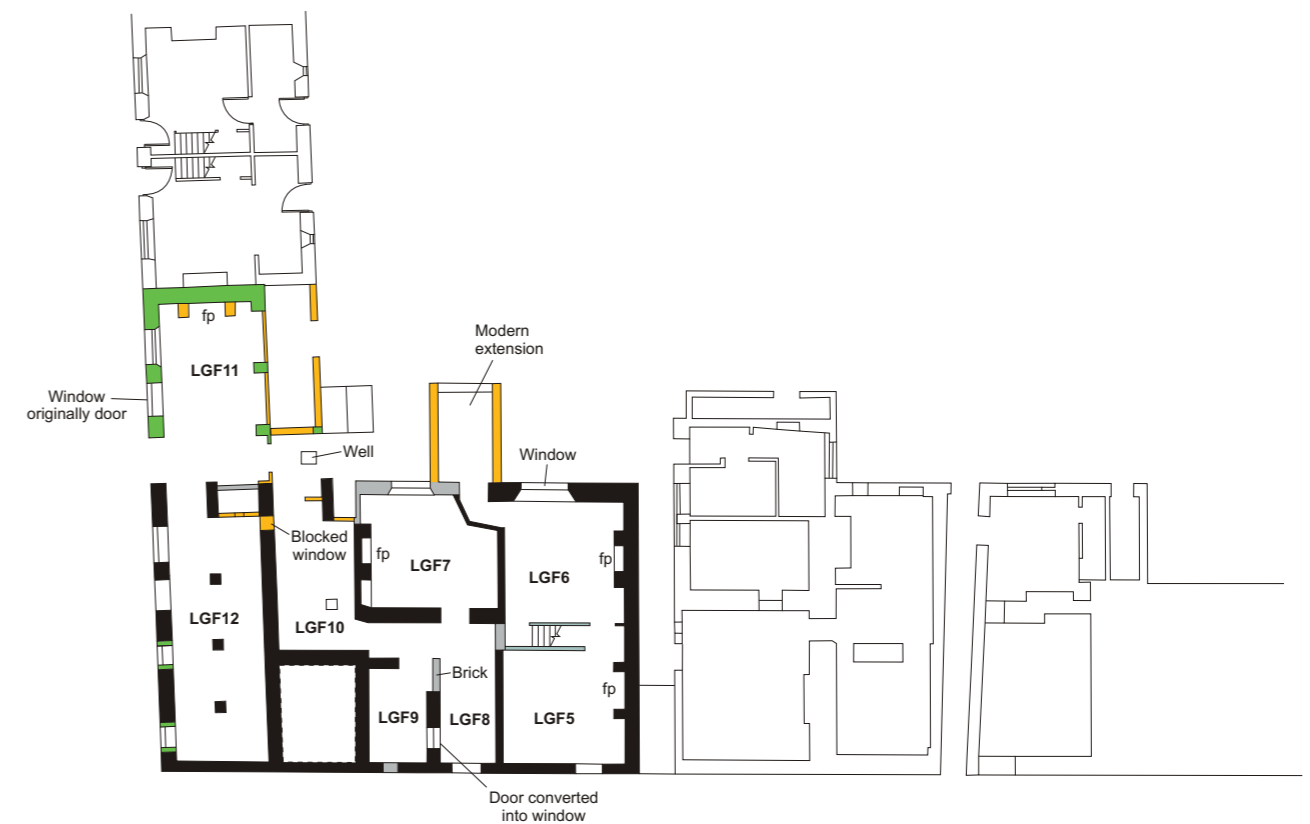
LOWER GROUND FLOOR PLAN

LGF7 – this room has a fireplace in the south wall. This was originally of the same design as that in room LGF5, but the lintel stones have been partially removed and replaced with a concrete lintel at a higher level. All the walls are of mixed stone construction. In the recess east of the fireplace is a small high-level cupboard within the wall masonry.

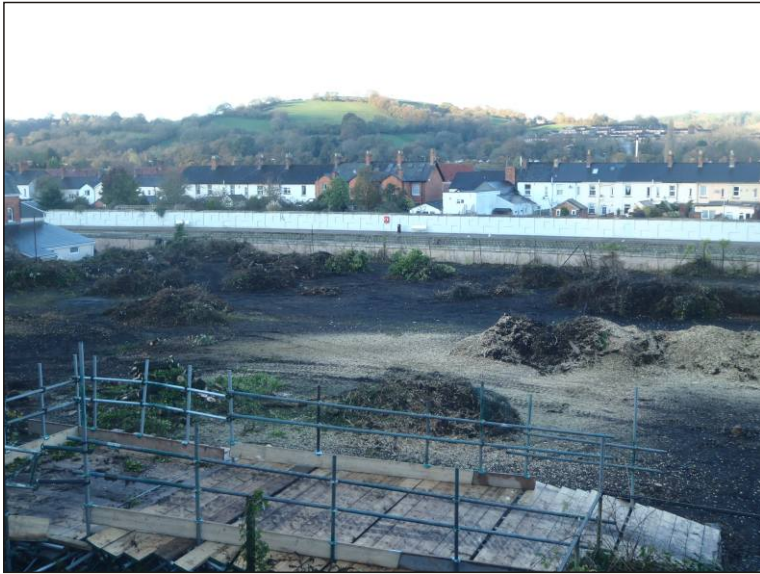
5.1 The archaeological trench evaluation was located in the western half of the site, in the area formerly occupied by tennis courts immediately east of the River Exe (Plate 1). It comprised the excavation of 3 1.5m wide trenches, totalling 45m in length. All three trenches were sterile in terms of archaeological features. However, the exposed deposits provided useful information on the former nature of the site and the course of the River Exe prior to its canalisation. The exposed layer sequences in each trench are discussed below. In order to expose the full layer sequence, sections of Trench 2 and 3 were excavated to well below safe working depths. These sections of trench were therefore not entered and were recorded from ground level.

Plate 1: View of the former tennis courts looking west from the higher eastern part of the site

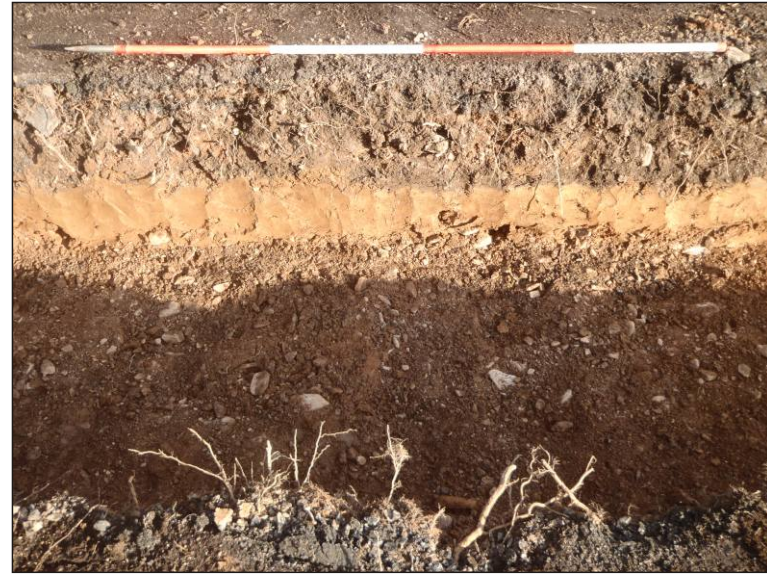
Trench 1 was located in the northwest corner of the former tennis courts, measured 15m long, and was excavated onto natural river terrace gravels (103) at a maximum depth of 0.85m below the current ground level (Plate 2). The overlying layer sequence consisted of 0.35m yellow brown, very compacted, alluvial silty clay with sparse rounded pebble inclusions (102) overlain by 0.15m reddish to yellowish brown, very compacted silty clay with frequent pebble inclusions (101). This deposit was sealed by 0.20m of mixed, heavily bioturbated modern made-ground material sealed by a thin layer of tarmac (100).

Plate 2: Trench 1, west-facing section. 2m scale

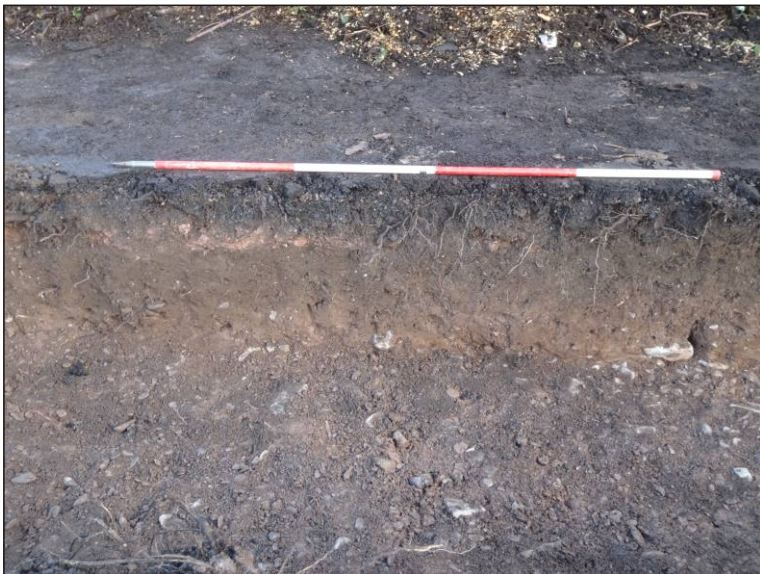
Plate 3: Southeast end of Trench 2, southwest-facing section. 2m scale

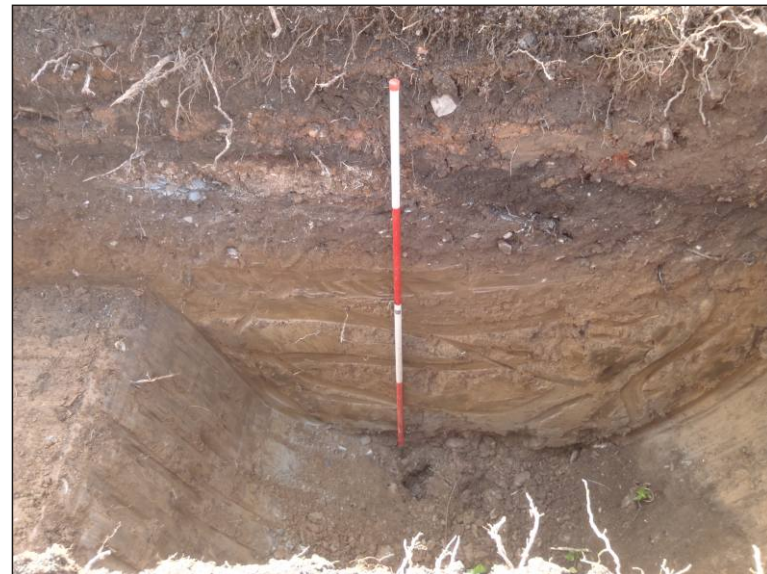
Plate 4: Northwest end of Trench 2, southwest-facing section. 2m scale

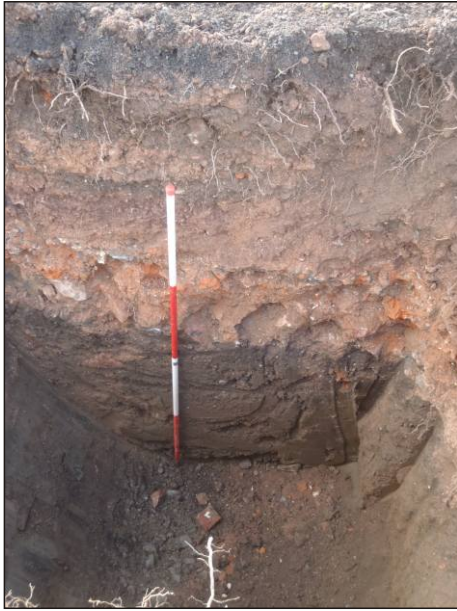
Plate 5: Trench 3,
west-facing section.
2m scale

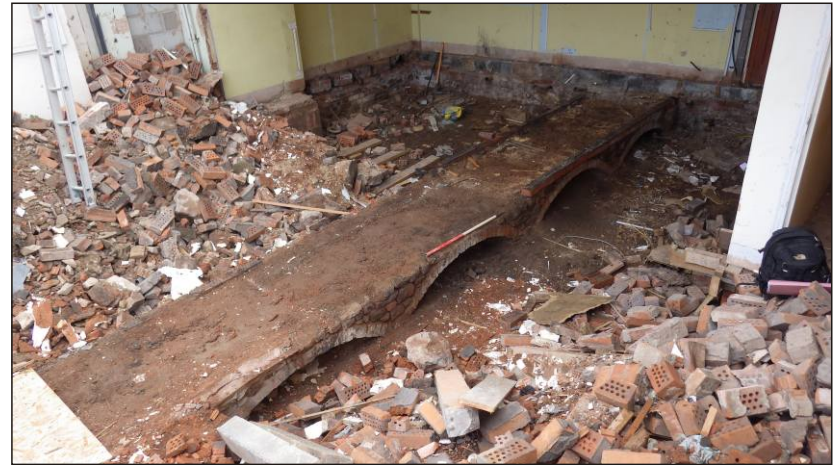
The watching brief was mainly carried out following the removal of all internal features from the ground and first floors, and the demolition of the rear (west) wall, of Nos 1 and 2 St Andrew Street, which is a 1960s building. Removal of the ground floor exposed structural features relating to an earlier building. The main feature consisted of an east-west (front to back) aligned walkway supported on four brick arches (Plates 6-7). Each arch spanned 1.60m, while the entire structure measured approximately 10m long (it was not possible to view in its entirety as the western end was covered with demolition rubble) by 1.25m wide. The arches were constructed of header-bonded brick, bonded with a yellow-beige coarse sandy mortar, with recessed pointing. The elevations of the structure consisted of a mixture of greensand, schist and limestone cobbles and boulders (0.06-0.30m long), roughly faced and laid in uneven horizontal courses, and bonded in the same mortar as the bricks, a material which also formed the (surviving) surface of the walkway. At the east end of the walkway were the remains of walls consisting of a single course of header-bonded drilled red bricks, bonded in a dark grey to black coarse mortar (Plate 8). The upper face of the bricks also had traces of the same mortar indicating it would have had at least one more course. These appear to have supported floor joists within the 1960s building. The walkway is not keyed into the footings of the east wall, and appears to be earlier than the surviving historic stone footings of the north and east walls.

Nos 1 and 2 St Andrew Street were demolished to make way for a new access road. The upstanding building was a 20th-century rebuild. Observations identified that earlier stone foundations forming a cellar survived under the later building. The cellar had an arched ceiling and a cobbled floor surface.

Plate 6: Nos 1 and 2 St Andrew Street,
top of cellar arches looking
northeast. 1m scale

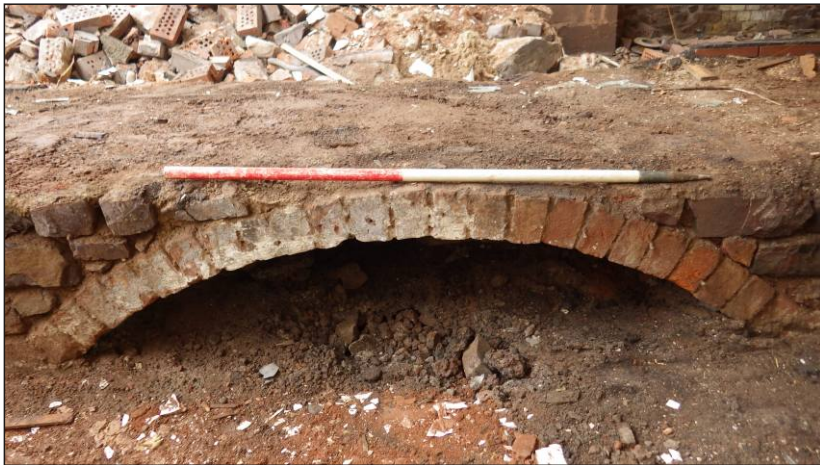
Plate 7: Nos 1 and 2 St Andrew Street,
top of cellar arch looking
north. 1m scale

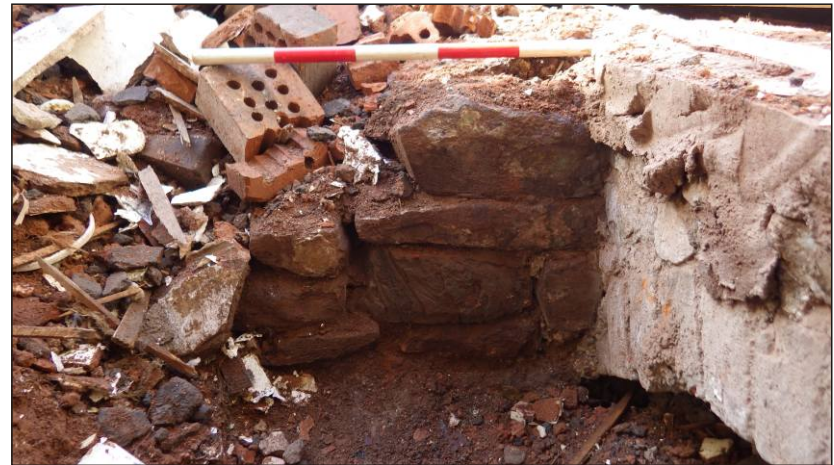
Following the demolition of nos 1 and 2 St Andrew Street observations were made during the excavation of service trenches alongside the north wall of No 1 that had been retained (Plates 9-10). The front (eastern) section of masonry forms the gable of the Town Hall. This is rubble masonry, and unlike the ashlar stone above, was clearly never designed to be seen. To the east the surviving stone masonry of No 1 projects out from the Town Hall, although may be incorporated into a boundary wall defining a small courtyard at the southwest side of the building. The masonry is mainly rubble stone with later additions. These include (from east to west) a blocked doorway into the yard to the north, a chimney stack, with ground floor fireplace heating the rear room of No. 1, and with foundations extending down to the level of natural deposits, and a large brick rebuild that is contemporary with the demolished west wall. All the brickwork is executed in drilled red bricks, bonded in a dark grey to black coarse mortar, and is associated with the 20th-century rebuild of Nos 1 and 2. East of the chimney stack a small integral stone pier, visible only within the cellar due to the inserted ground-floor doorway above, probably represents the position of a former internal partition. Further east, a single pier abutting the stone masonry along with a scar in the stonework are probably remains of another brick chimney stack associated with the front room of the house. In one of the excavations a cobbled surface, forming the base of the cellar, was exposed sealed beneath approximately 2m of made ground consisting largely of unconsolidated brick rubble and sand.

Plate 8: Nos 1 and 2 St Andrew Street,
wall south of cellar
arches looking west. 0.50m scale

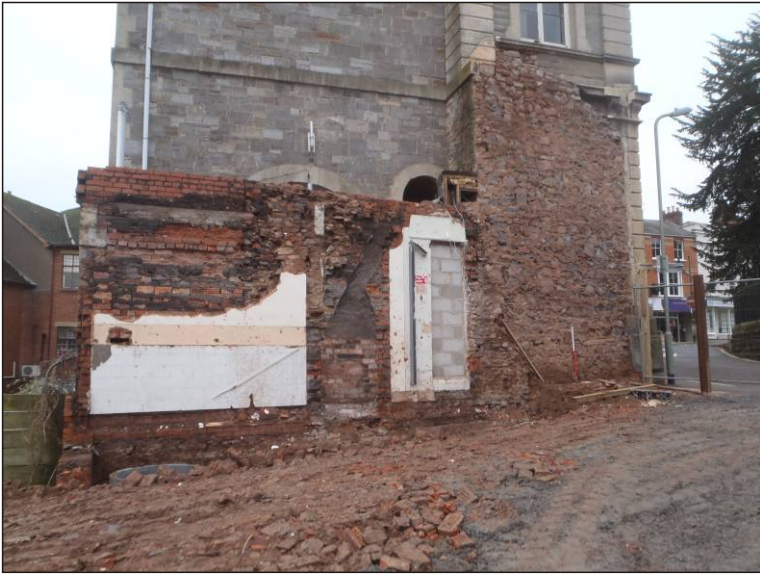
Plate 9: Nos 1 and 2 St Andrew Street, party wall with the Guildhall, looking northeast. 1m scale

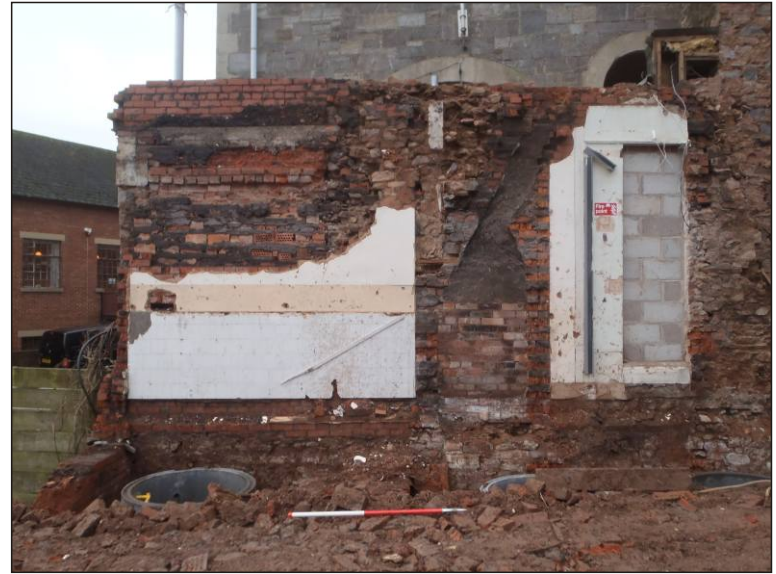
Plate 10: Nos 1 and 2 St Andrew Street, party wall with the Guildhall, looking north. 1m scale

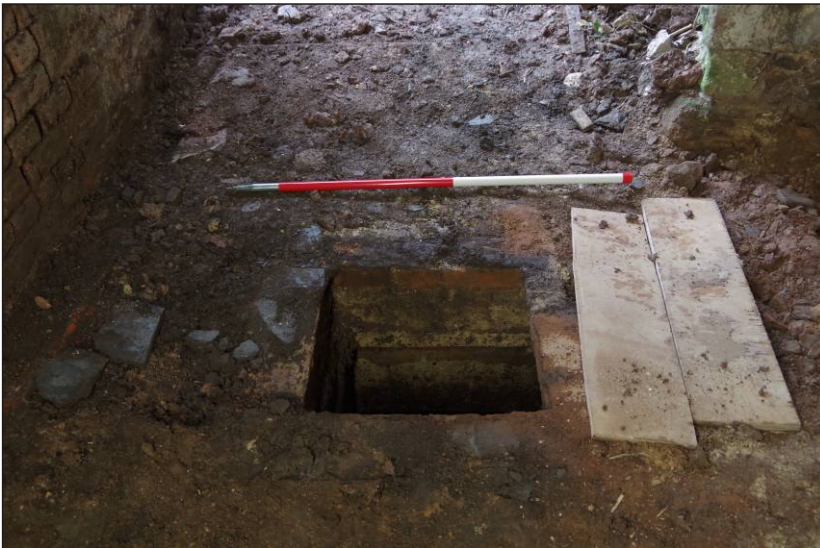
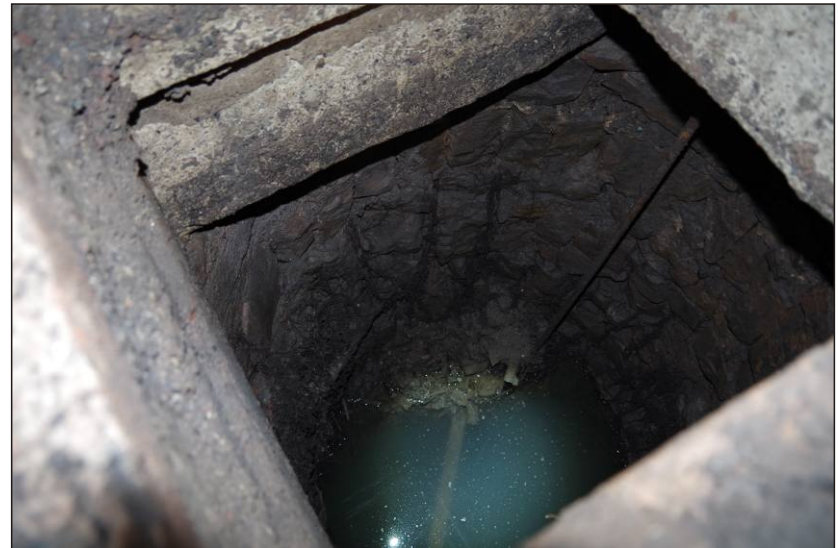
Within a covered rear area forming part of room LGF10 in the lower ground floor level of this property, the floor was removed exposing a well (Plates 11 and 12). This was stone lined and had been later covered with a concrete ringbeam supporting three courses of brick with fragments of slate over the top course, perhaps representing the remains of a cover. The concrete ring was approximately 1.2m wide and the well was measured to a depth of 5.6m. The date of the feature is unknown.

Plate 11: Well in No. 10 St Andrew Street, looking north. 1m scale

Plate 12: Well in No. 10 St Andrew Street, looking northwest.

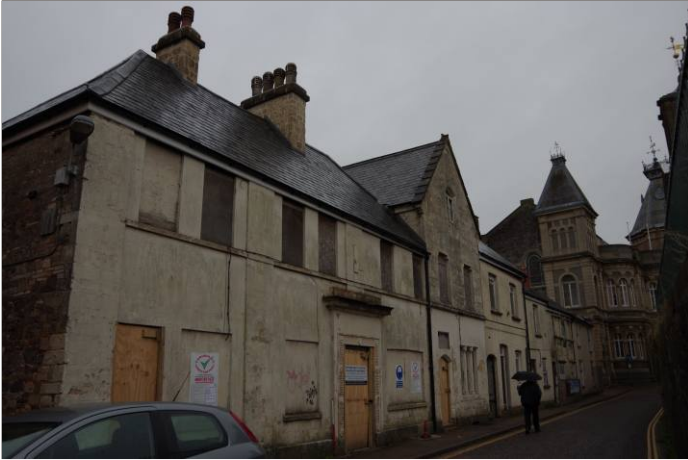
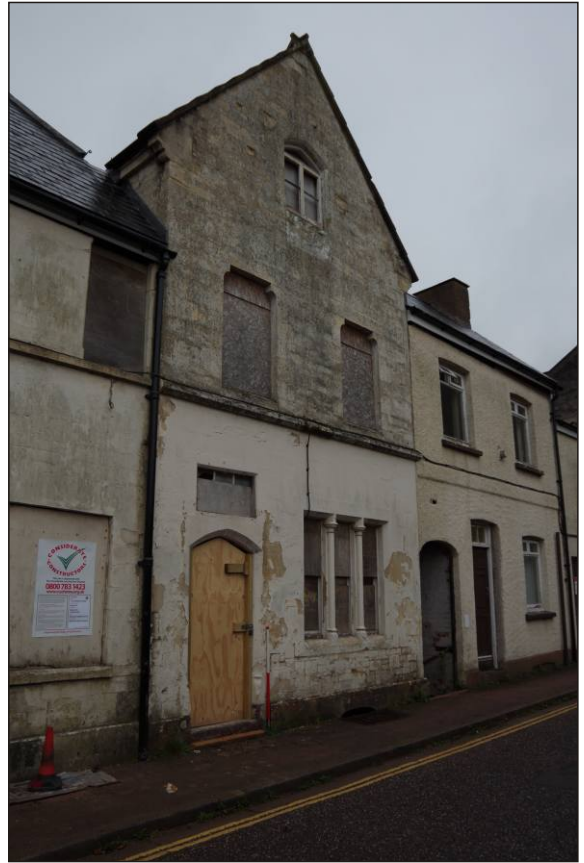
The re-fronted elevation of No. 9 gives the appearance of a tall gabled cross-wing to No. 10. It is constructed of ashlar blockwork, of what appears to be Bath stone, which has been painted on the ground floor and retains a crumbling coarse render to the upper storeys. There is an off central doorway on the ground floor with a shallow pointed arch, above which is a small rectangular three-light window. The archway is chamfered and terminates in bar and flat stops. To the west of the doorway is a three-light window divided with near circular gothic style stone mullions. Between these mullions are four-pane sash windows. There is a thick chamfered string course defining the first-floor level. On the first floor there are two windows with shouldered heads, but a straight lintel, under a relieving arch. There is a single two-light four-pane window on the second floor with a shallow pointed arch. This incorporates shallow chamfers terminating in run out stops. The gable has a stone coping with kneelers and trefoiled finial.

The re-fronted elevation of No.10 is a continuation of the masonry of No. 9, but with the whole façade painted. It is divided into three bays by pilaster strips. The main door is located off centre to the north and is set below one of the pilasters. It has a slightly projecting architrave decorated with recessed plain arcade moulding

interspersed with raised circles. It is topped by a slightly projecting hood with the same plain arcade moulding, below which is an ovolo-moulded cornice. There is a second door to the south, within a plain opening. There are also three windows on the ground-floor, the northernmost having a slightly arched head. This contains four lights, each of which have four vertical panes (the top two opening) divided by slim wooden mullions. The other two windows are identical with two lights. Their top sections incorporate four vertical, bottom-opening, panes divided by slim wooden mullions.

The first-floor level is defined by the narrow, plain string course. There are six windows on the first floor; the two in the northern bay have chamfered jambs with run-out stops. Three of the four windows (lighting rooms FF2 and FF3) are sashes with six panes.

Plate 13: The St Andrew Street frontage looking northwest. 1m scale

Plate 14: The St Andrew Street frontage of No. 9, looking northwest. 1m scale

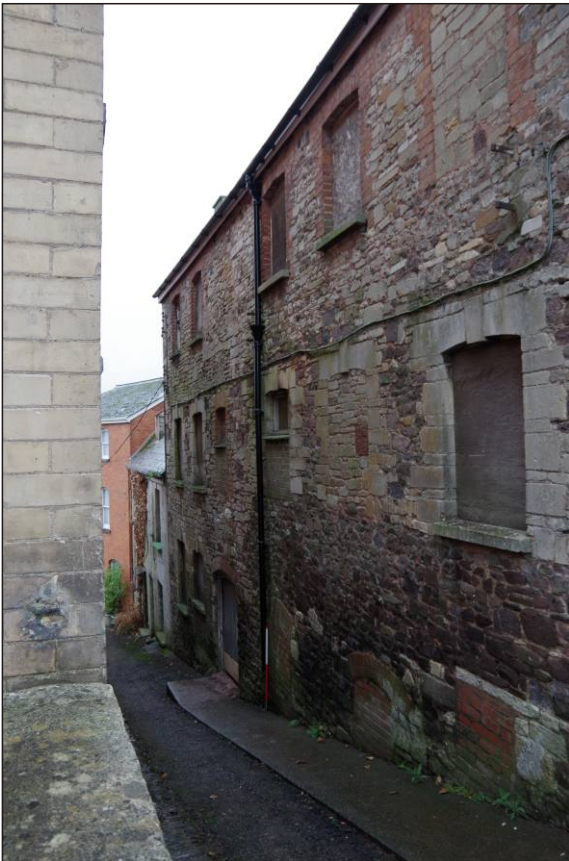
This elevation is constructed of mixed stonework (volcanic trap, grey limestone, purple sandstone, Ham stone and reused fragments of a finer limestone) and rarely brick laid in rough courses. Some parts of the wall have particularly concentrations of one particular kind of stone. At lower ground floor the masonry is predominantly purple sandstone, whilst the ground and first floors have much more mixed stonework, with concentration of limestone at eaves level. These probably reflect different phases of construction. A vertical break corresponds with the main rear wall of No. 10 indicating that the western half of this elevation is an extension.

On the lower ground floor, closest to St Andrew Street there are two brick-blocked openings with flat limestone lintels. These have been partially obscured by the raising of the ground level of Ham Place, which may indicate that the land and St Andrew Street have been raised in height. Beyond is a window with a brick arched head and then a doorway, again with a brick arched head. Both have been blocked in brick and to differing degrees these have been obscured by raising of the level of Ham Place. To the west there is a further brick-blocked doorway with a brick arch. Beyond is a further doorway that has been converted into a window and another window. Both these windows have limestone surrounds with projecting keystones. They are set within masonry containing large quantities of fine limestone.

On the ground floor there are five windows, four of which are set within limestone surrounds with projecting keystones. One has been blocked with stonework and one has been partially blocked with brick to create a smaller window. The eastern window (lighting GF2) is a six-pane sash window. The fifth window has a brick surround, and is also partially blocked with brick to form a smaller window. Some of the openings have brick arches and surrounds whilst others have limestone surrounds with projecting keystones.

On the first floor there are five windows with brick surrounds incorporating slightly arched heads and concrete cills, one of which has been blocked with stonework.

Plate 15: The Ham Place frontage of No. 10, looking northwest. 1m scale

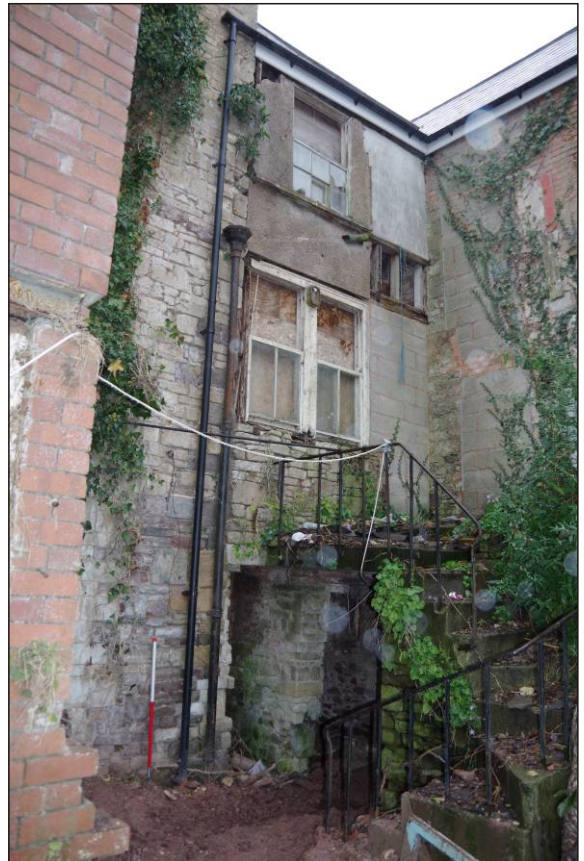
A strip of early masonry, comprising white limestone, survives at the east end of the elevation, along with sandstone rubble stonework at the west end. Within the limestone masonry are a pair of tall openings on the ground and first floors; these have been infilled with concrete blocks. Internally a wooden lintel is visible between these openings. The upper part of the wall has been rebuilt in brick and incorporates a first-floor opening, now blocked in brick, with an arched head. To the west pairs of ground-floor and first-floor openings have also been infilled with brick.

A modern extension has been added to the north side of No. 10 which contained an external set of concrete stairs to the front range. The majority of the extension had been demolished prior to this survey, with only limited stonework and brick masonry surviving at lower ground floor level below the stairs.

The infill section of No. 10 is constructed of roughly coursed squared blocks of white limestone. There are two open doorways at lower ground floor level. Above is a blocked doorway, possibly a fire escape, and a large window containing two sashes each of two panes. At first-floor level the wall is rendered in concrete and incorporates a low three-light window within what appears to be a blocked doorway, and a six-pane sash window.

Plate 16: The northwest corner of No. 10, looking southeast. 1m scale

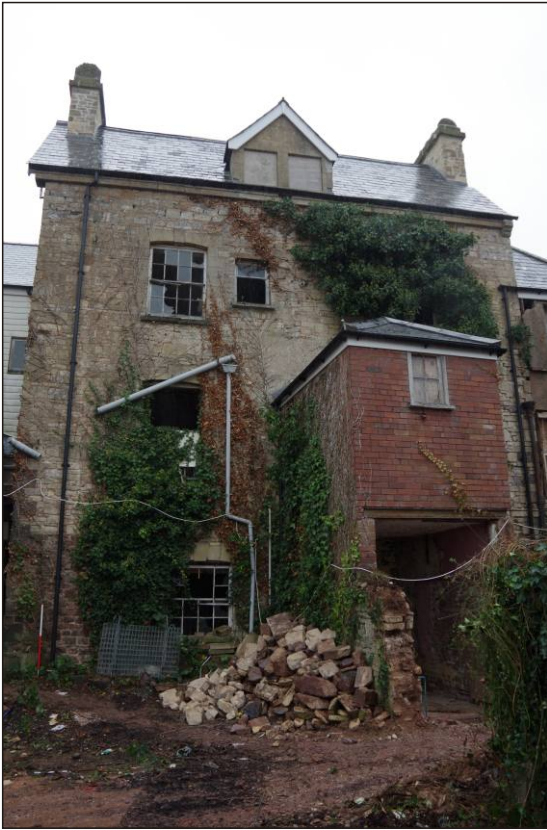
The lower ground floor of this elevation is constructed using purple sandstone with purple volcanic trap quoins, whilst the rest is a rebuild in white fine limestone. The lower ground and ground floors are partially obscured by later extension (see below). On each of the three floors there is a pair of eight-pane sash windows set within limestone surrounds with projecting keystones. There is an inserted small two-light 20th-century window on the first floor with a concrete lintel and a concrete cill. There is a central dormer constructed of limestone, containing a pair of windows.

The extension is constructed of red brick laid in five rows of header bond interspersed with a row of stretcher bond under a gable pitched slate roof. The west elevation incorporates a full width and height doorway on the lower ground floor under a rolled steel joist, and a high-level four-pane window on the ground floor.

Plate 17: The west elevation of No. 9, looking east. 1m scale

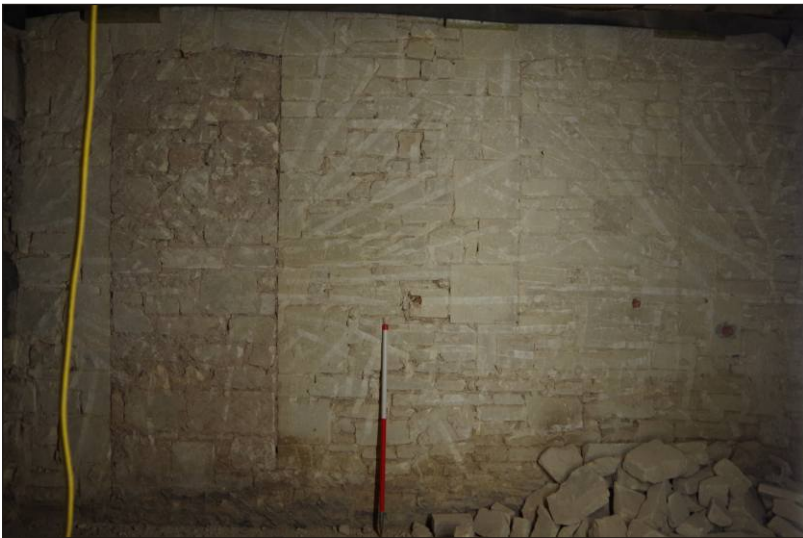
Plate 18: Room GF1 – blocked openings in north elevation, looking north. 1m scale

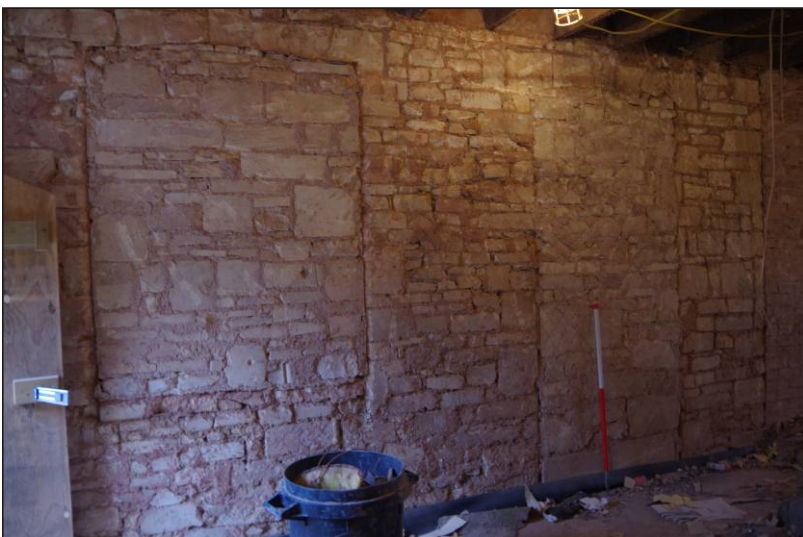
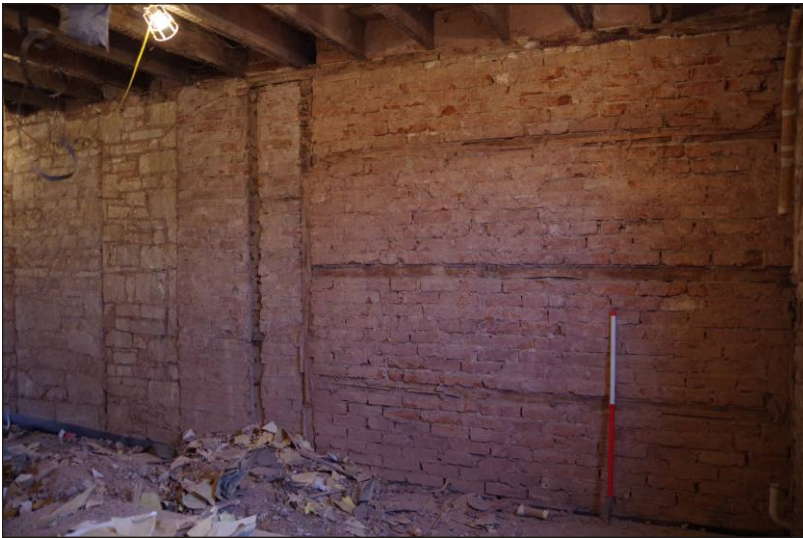
Plate 19: Room GF3 – blocked openings in south elevation, looking southwest. 1m scale

Plate 20: Room GF3 – rebuild west end of south elevation, looking southeast. 1m scale

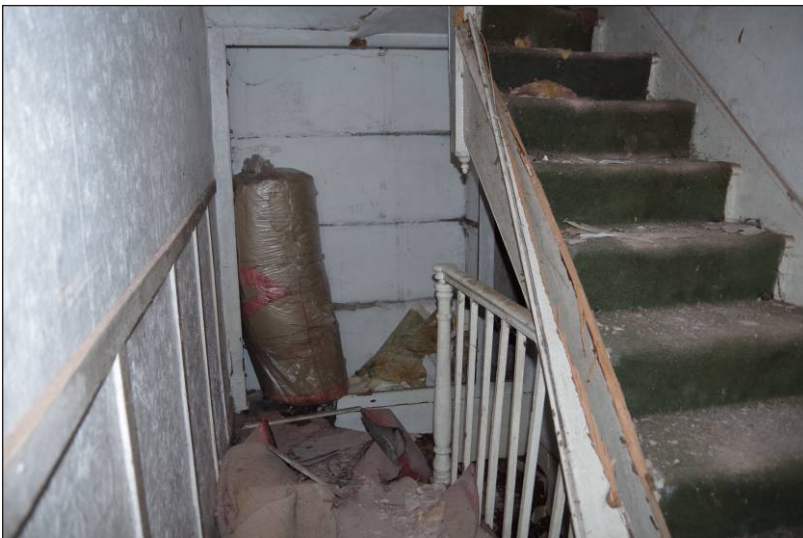
Plate 21: The staircase in No. 9, looking north.

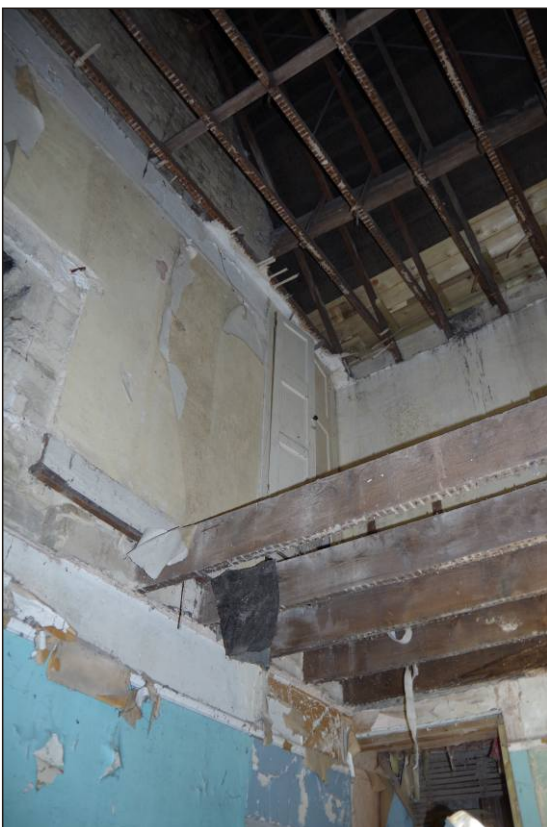
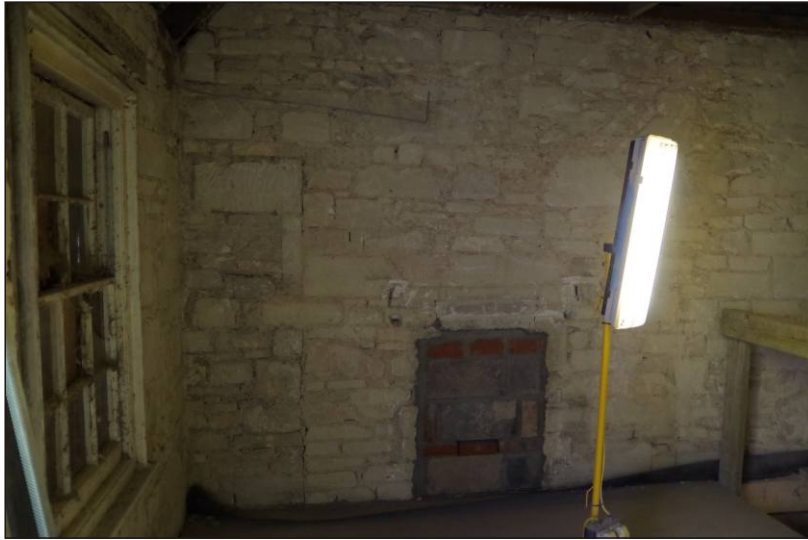
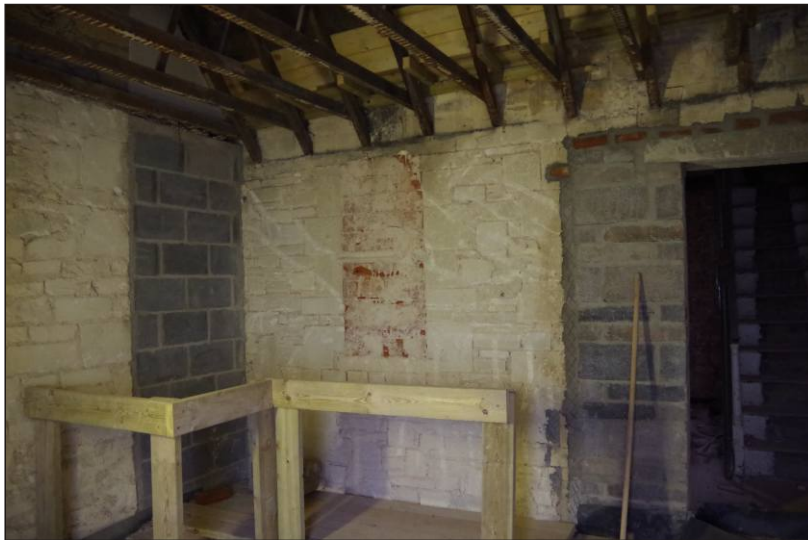
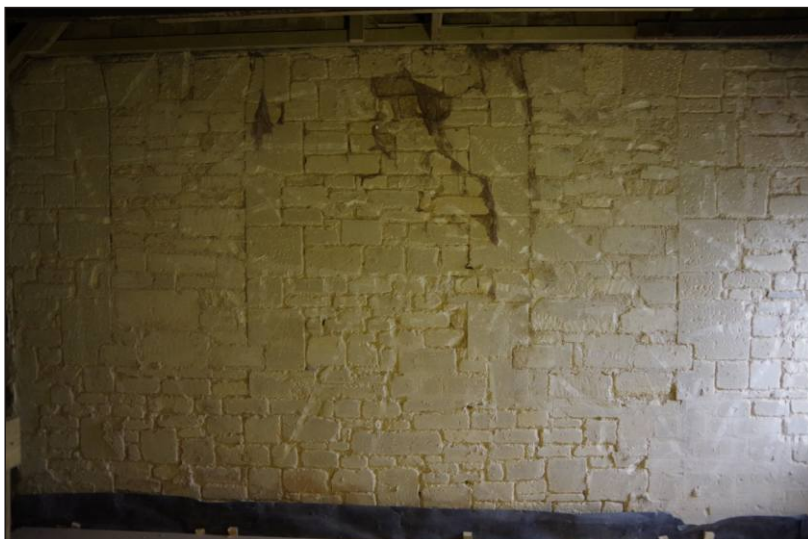
Plate 22: Room FF1 in No. 10 showing cupboards, looking southwest

Plate 23: Room FF1 in No. 10 – blocked opening east of fireplace, looking south.

Plate 24: Room FF1 in No. 10 – blocked cupboards as well openings in west elevation, looking southwest

Plate 25: Room FF1 in No. 10 – blocked openings in north elevation, looking north.

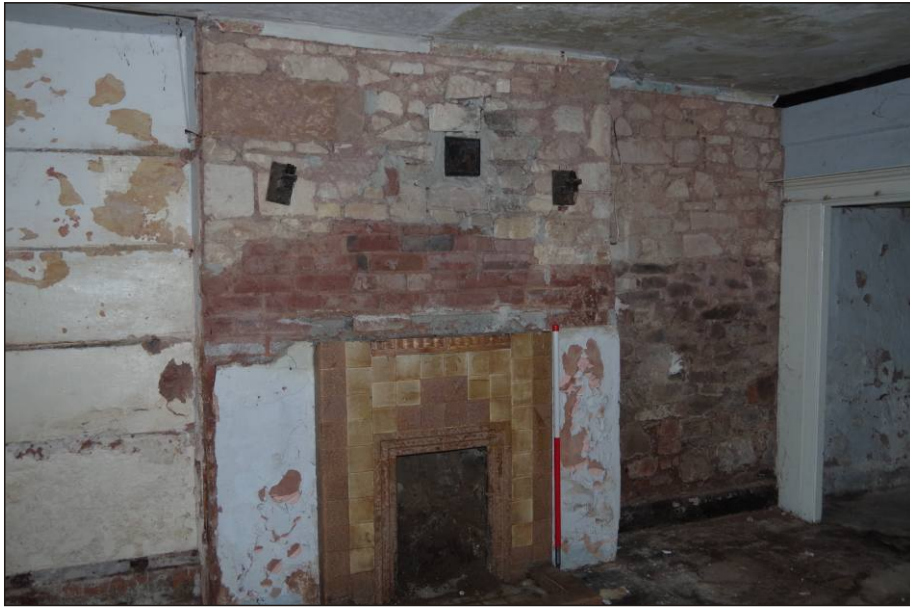
Plate 26: Room LGF6 showing horizontal break in main wall, looking northeast. 1m scale

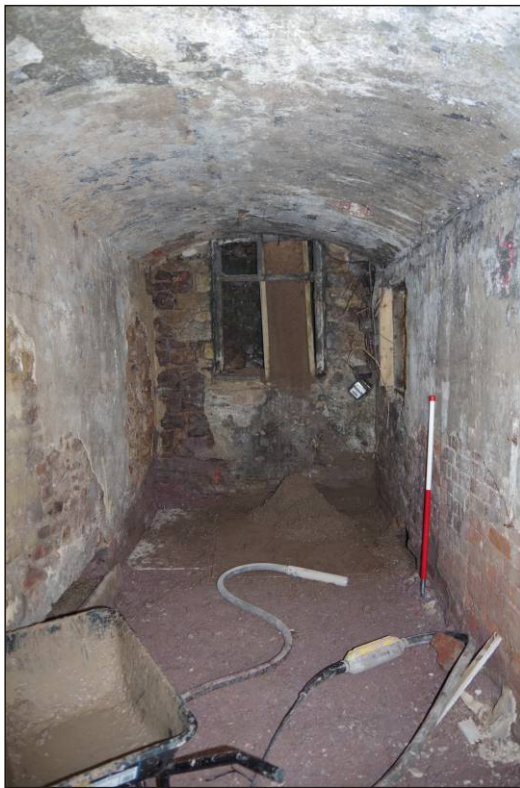
Plate 27: Room LGF8 – barrel-vaulted cellar, looking east. 1m scale

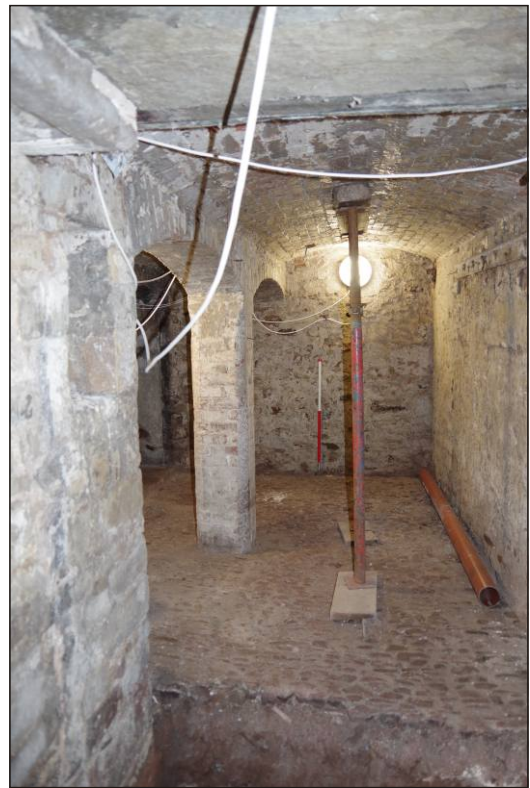
Plate 28: Room LGF10 – barrel-vaulted cellar, looking east. 1m scale

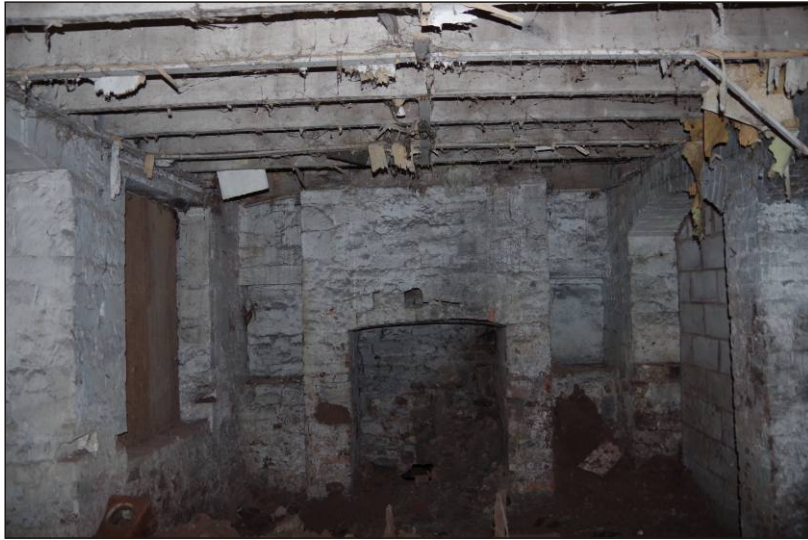
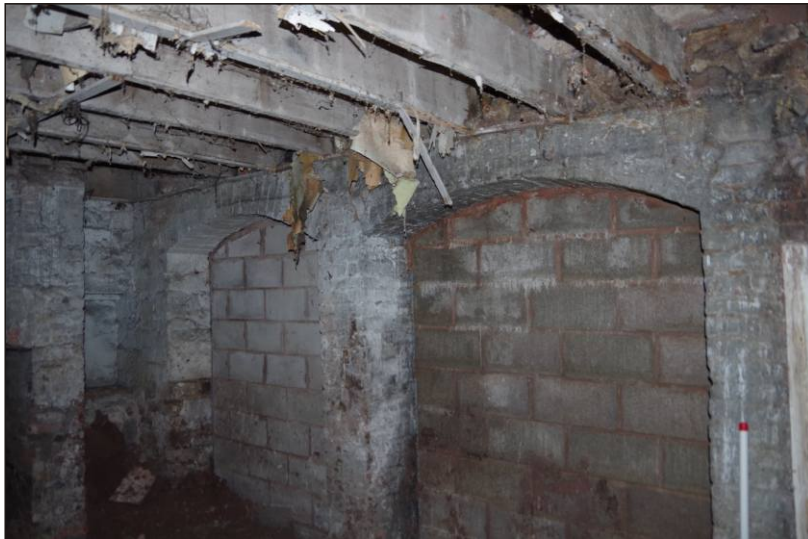
Plate 29: Room LGF11 – basement room showing fireplace and blocked arches, looking west.

Plate 30: Room LGF11 – basement room showing blocked arches, looking northwest.
