LAND AT ANGEL HILL, ST ANDREW STREET, TIVERTON, DEVON

Results of an archaeological trench evaluation, watching brief,
and historic building recording

Mid Devon District Council planning reference 13/00298/MFUL,
Condition 12

Document No: ACD1004/2/1

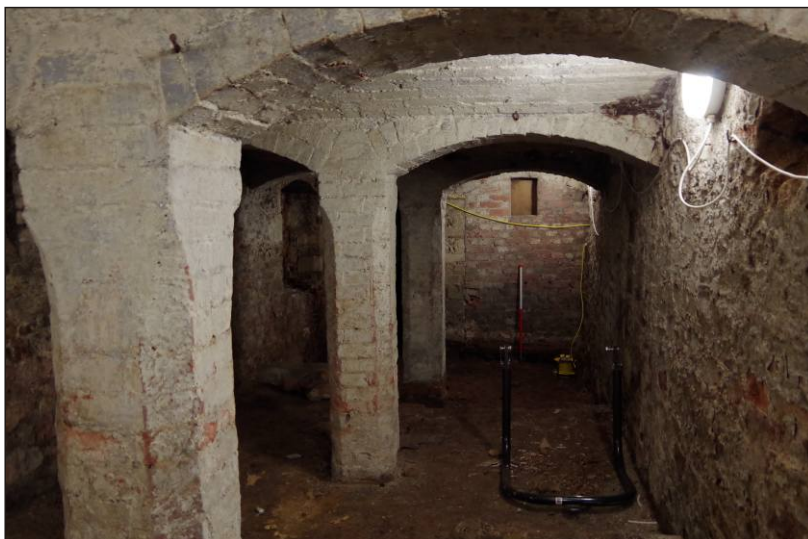
Plate 31: Room LGF12 – barrel-vaulted cellar, looking east.
1m scale
