STOCKLEIGH POMEROY VILLAGE HALL, STOCKLEIGH POMEROY, DEVON

Results of historic building recording

Mid Devon District Council planning reference
13/00906/FULL, condition 3

Document No: ACD1059/2/0

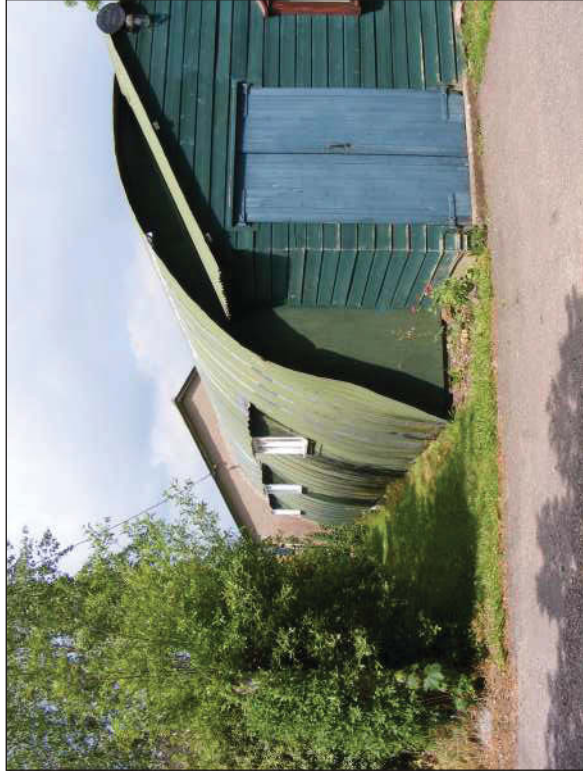
Plate 1: The south side of the hall showing the entrance lobby, viewed from the southeast. Photograph © Mike Passmore

4.1 The village hall is located on the west side of the village, to the west of the Church of St Mary. The demolished building was located against and parallel to the southern boundary of the plot, with the remainder of the site laid down to grass (Plates 1-2).

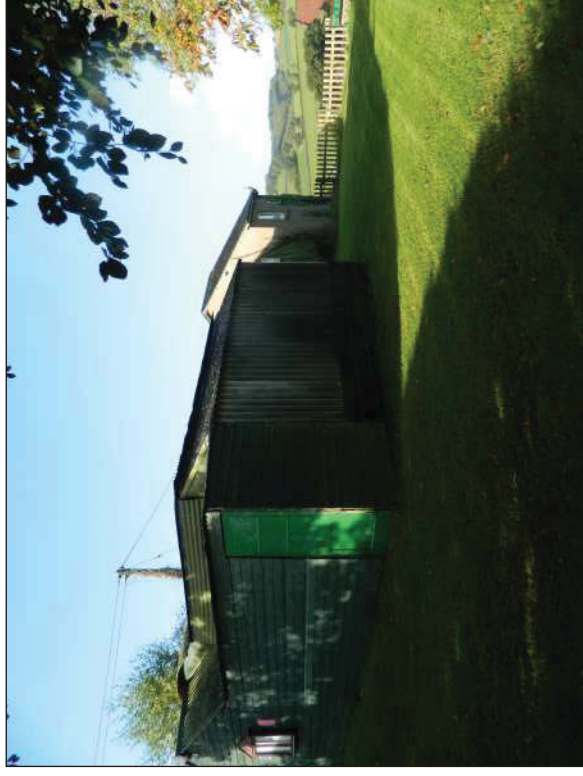
Plate 2: The hall viewed from the northeast showing its location within the plot.

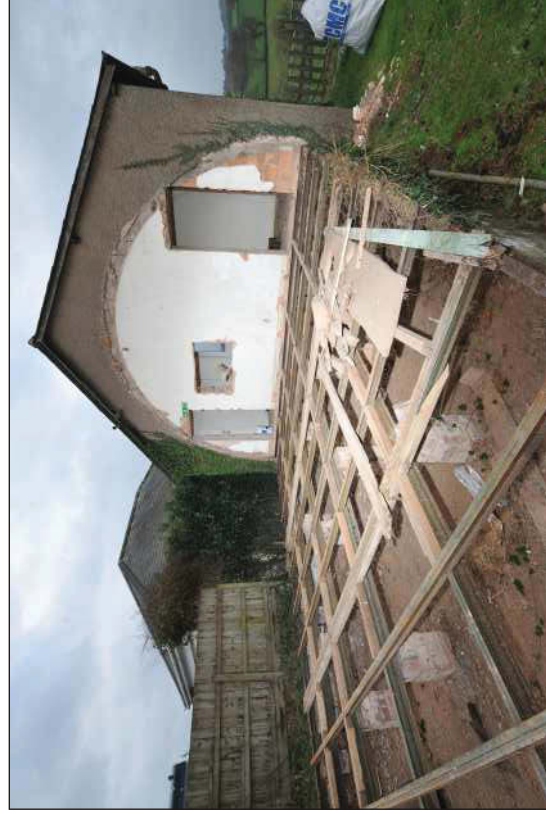
Plate 3: The hall during demolition showing the metal frame base supported on brick piers, and the internal wall to the kitchen, viewed from the east.

- 4.5** The kitchen (incorporating an integral cloakroom) was located at the west end of the building (Plates 3 and 8) and was constructed of rendered concrete blocks under a pitched tiled roof. Internally there were two doors into the rooms, along with a serving hatch, whilst there was also an external door in the south elevation. It was lit by windows in the north, south and west elevations. A further cloakroom had been added to the west end of the building.

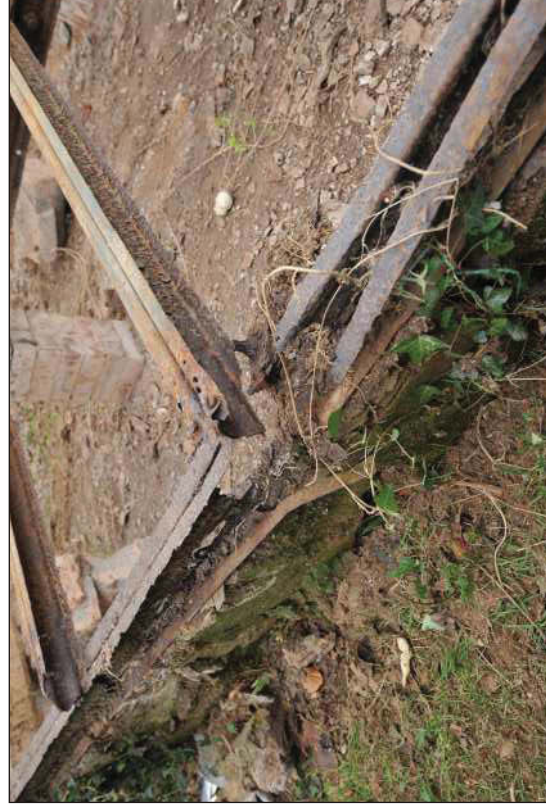
Plate 4: A close-up view of the metal frame base, viewed from the northwest.

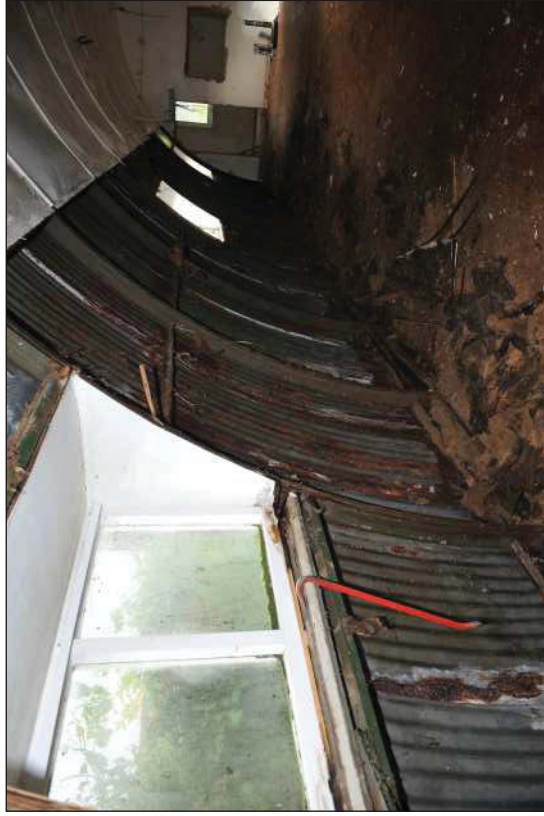
Plate 5: The hall during demolition showing the ribs and purlins supporting the outer covering and inner lining, viewed from the east.

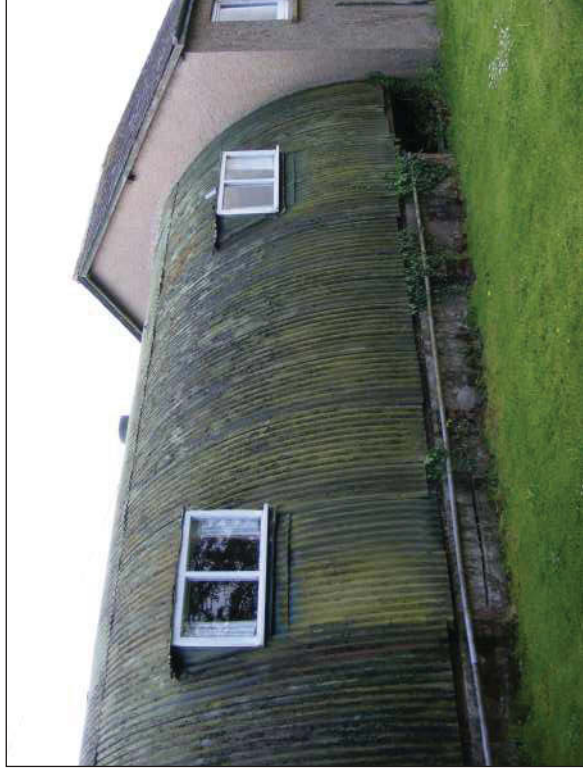
Plate 6: The north side of the hall showing the corrugated iron covering and windows, viewed from the northeast. Photograph © Mike Passmore

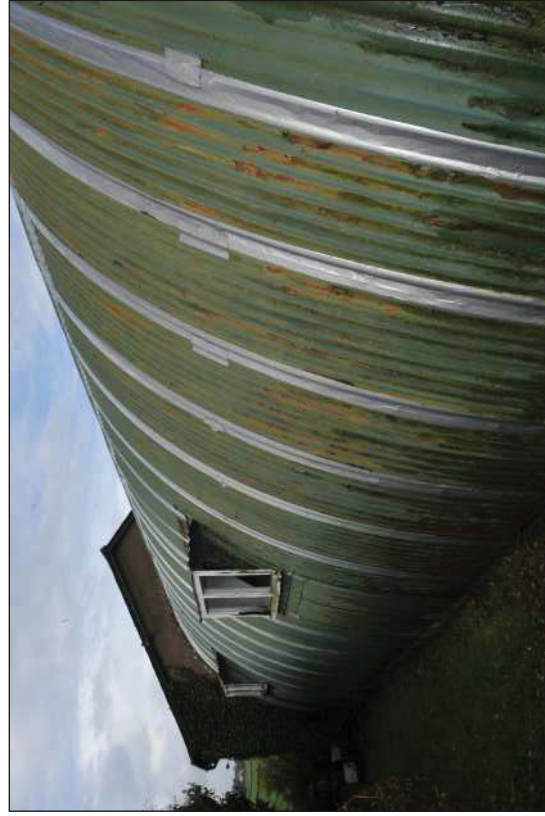
Plate 7: The south side of the hall showing the corrugated iron covering and windows, viewed from the southeast.

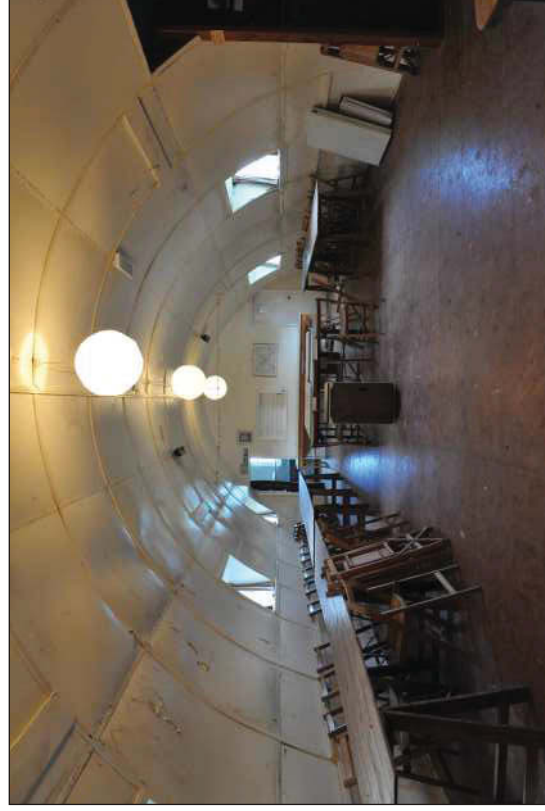
Plate 8: The interior of the hall showing the interior lining, viewed from the southeast.

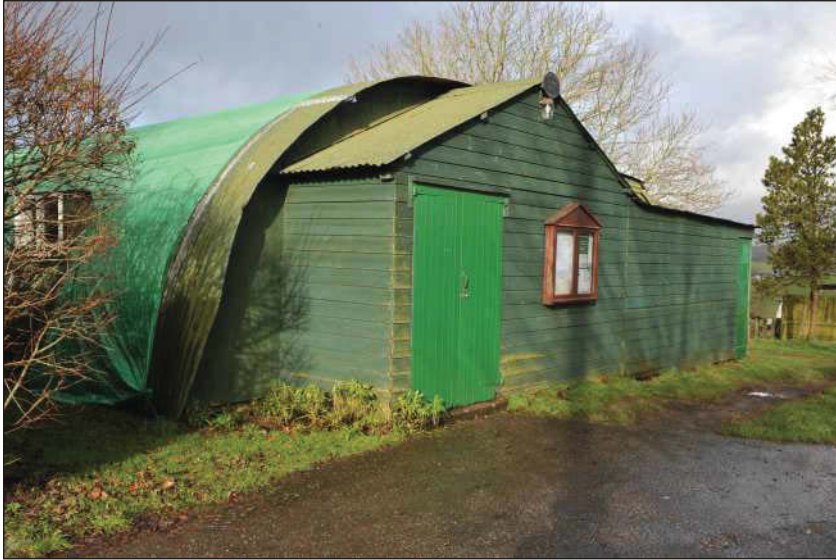
Plate 9: The lobby, viewed from the south.

- 4.6** The lobby at the east end of the hall was within a narrow wooden-framed, weatherboard structure under a pitched roof (Plate 9). The external double doors are modern replacements; they were originally glazed with frosted glass. The lobby had been extended to the west with a flat-roofed timber-framed extension, incorporating a further external door (Plate 3). When this was added the whole of this part of the hall was re-clad in wood. It had been further extended to the west to form a bar/store. The north and west walls had concrete block bases supporting timber framing finished with corrugated asbestos sheets on the west side and a row of windows set into asbestos cement panels (Plate 10). This section had a pitched roof of corrugated asbestos sheets. Beyond this, the walls and roof were clad in corrugated iron sheets.

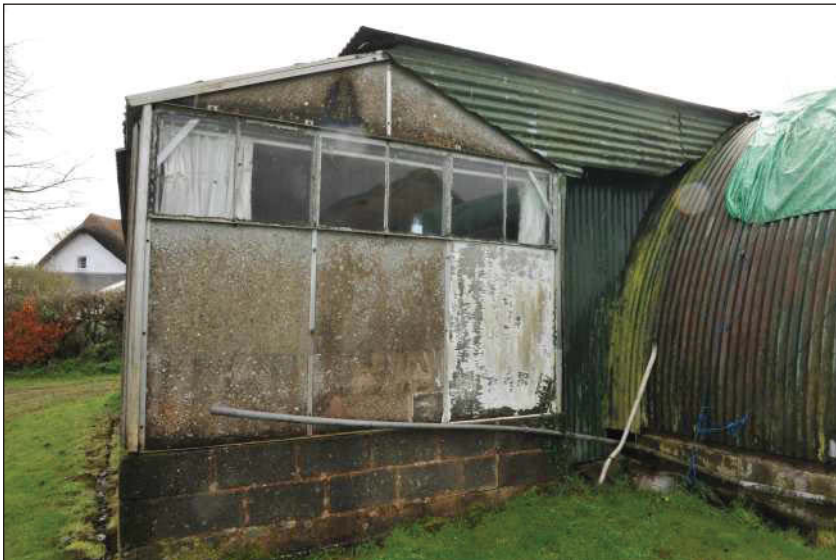
Plate 10: The west elevation of the bar/store extension, viewed from the northwest.

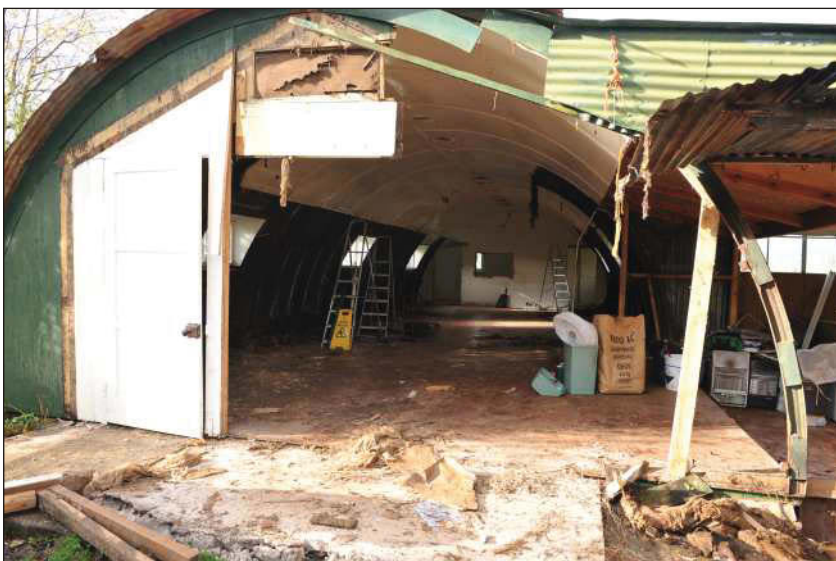
Plate 11: The hall during demolition following removal of the lobby, viewed from the east.

- 4.7** Most of the interior fittings are modern. As noted above, the floor of the main hall is wooden. In the lobby a carpet had been laid over a concrete surface. The extension to the lobby had a tiled lino floor. The partition between the hall and lobby was a wooden frame (Plate 11).
