12 BILLETFIELD, TAUNTON, SOMERSET

Results of an archaeological watching brief

Planning reference: Taunton Deane Borough Council
38/13/0286, condition 5

Document No: ACD961/2/0

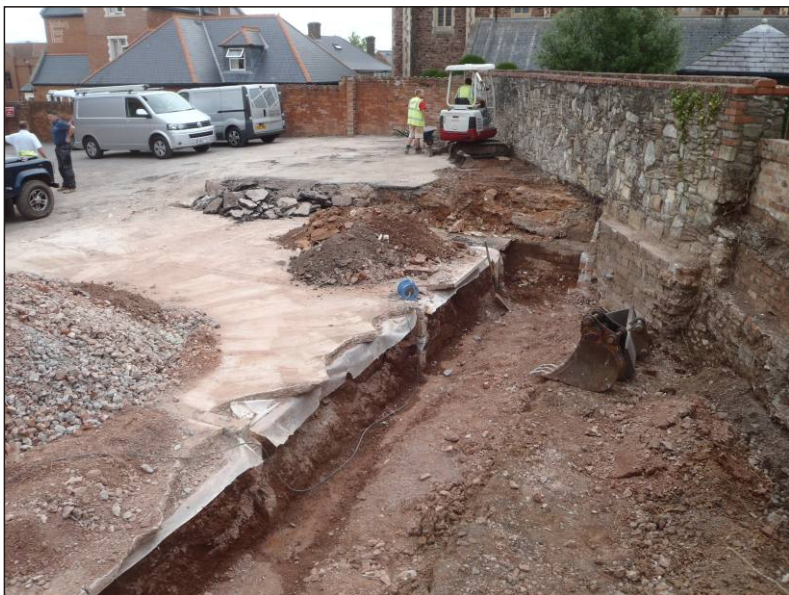
Plate 1: General view of the site, looking east

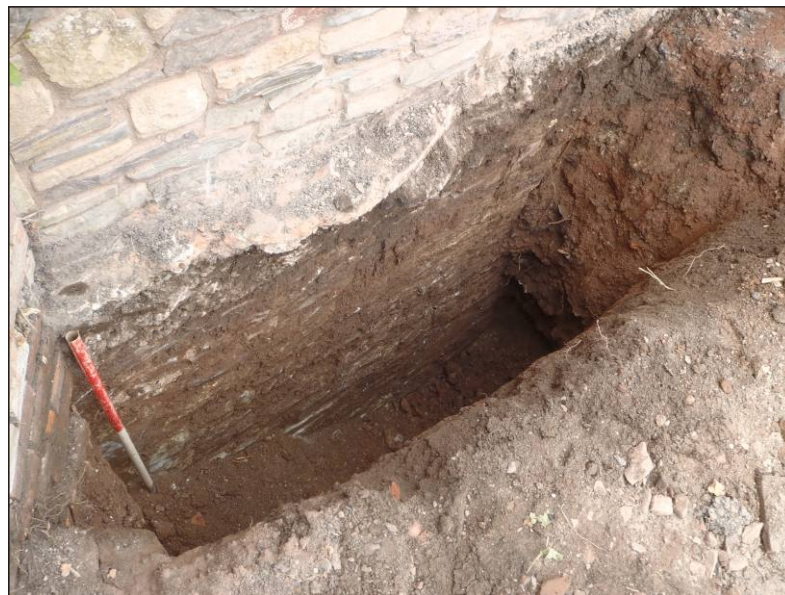
Test pit 1 was located in the south-east corner of the site. It measured 2.6m long by 0.60m wide and was positioned to investigate the foundations at the corner of the boundary wall of the plot. The long side was placed against the rear wall of the plot which is regarded as following the line of Taunton's medieval defences. The rear (south) wall foundation continued to the base of the test pit, giving a total height of the stone-built wall of some 4m; this wall appears to be late 19th or early 20th century in date. The side (east) boundary wall was brick-built with foundations continuing only 0.40m below ground surface; it was not keyed into the rear wall. The sequence of deposits exposed within the plot consisted of the following:

Context no.	Description	Interpretation	Depth	Finds
100	Tarmac and hardcore	Modern car park	0-0.10m	-
101	Blackish-brown silty clay	Garden soil	0.10-0.50m	19th-20th century pottery
102	Dumps of reddish-brown silty clay	Made ground	0.50-2.50m+	Common 19th-20th century pottery, china, glass, CBM, slate, oyster shell and animal bone

Plate 2: Test pit 1, looking south (scale 1m)

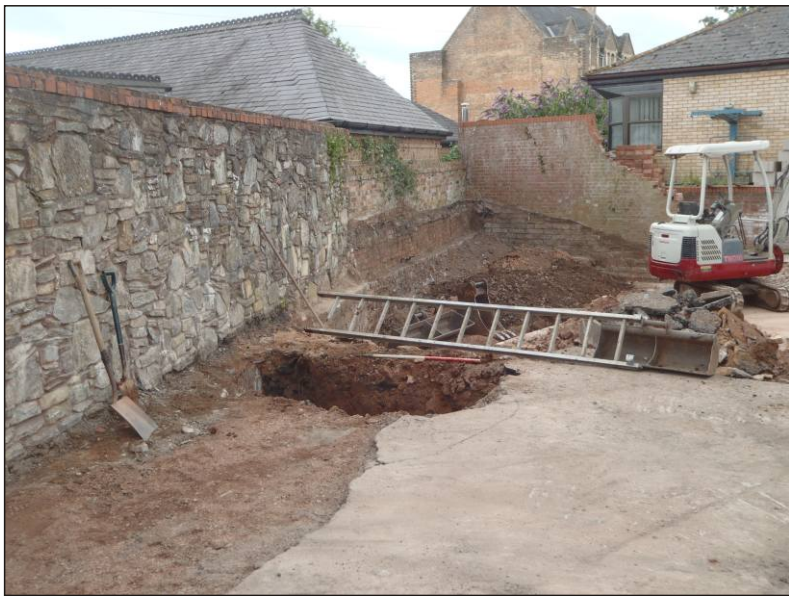
Test pit 2 was located against the rear wall, 4.5m to the south-west of Test pit 1. It measured 2m long by 1.5m wide with the short axis against the wall. The rear stone wall had been underpinned by modern blockwork to a depth of at least 1.80m; its full depth was not exposed. The sequence of deposits against the wall consisted of the following:

Plate 3: Location of test pit 2, looking south-west (scale 1m)

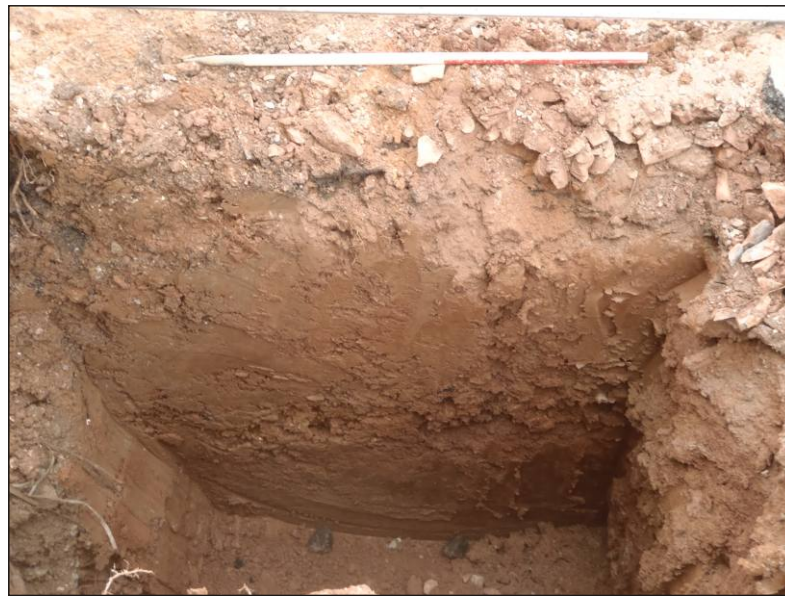
Context no.	Description	Interpretation	Depth	Finds
200	Tarmac and hardcore	Modern car park	0-0.10m	-
201	Reddish-brown clay	Made ground	0.10-1.10m	19th-20th century pottery
202	Reddish-brown clay	Natural	1.10-1.80m+	-

6.3 No archaeological deposits or features were exposed, and therefore no evidence for the medieval defences of Taunton, or for the earthwork feature The Mount, was uncovered. In view of its occurrence across the site, and its exposed depth within the test pit, the clean reddish-brown clay (202) is considered to be a natural deposit, rather than part of the bank associated with the town's defences.

Plate 4: Test pit 2, north-east facing section (scale 1m)
