# WATERDITCH SOLAR FARM, LOWER WATERDITCH, CHRISTCHURCH, DORSET

## Results of an archaeological watching brief

Planning ref. Christchurch Borough Council 8/14/0226,  
condition 5

Document No: ACD1066/2/1

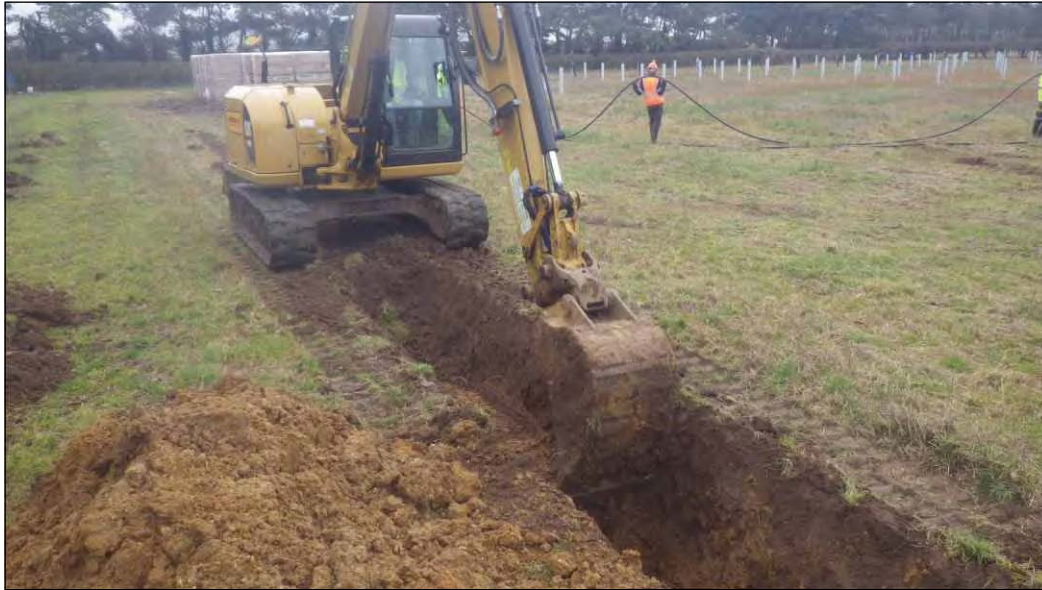
Plate 1: General view of the cable trench excavations, looking southwest

- 5.1** The cable trenches formed the deepest excavations, generally being a maximum of 1.25m below existing levels (Plates 1-2). These were excavated into natural orange-brown gravelly-sand containing natural flint inclusions (1002), which occurred at a depth of between 0.35m to 0.7m below ground level. The geology was overlain by up to 0.35m of subsoil consisting of friable mid grey-brown silty-clay with occasional natural flint inclusions (1001). This was under 0.15-0.30m of friable light-mid grey-brown silty-clay topsoil containing occasional natural flint inclusions (1000).

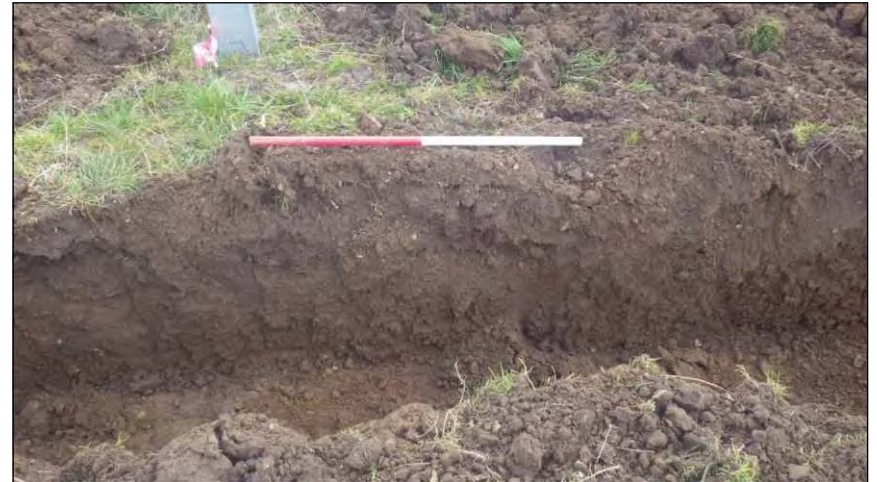
Plate 2: Southeast-facing section of a cable trench. 1m scale

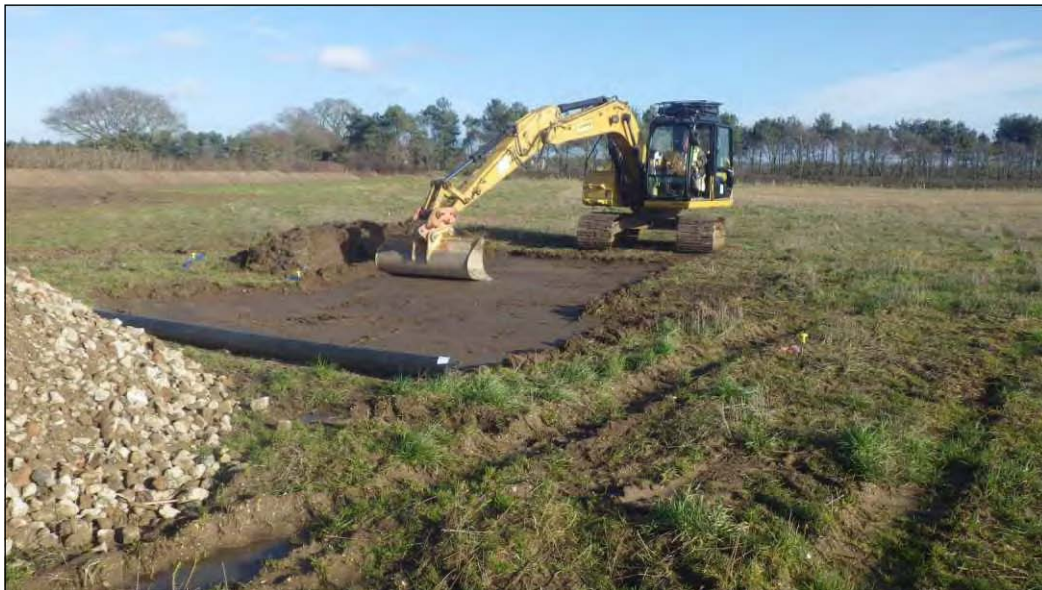
Plate 3: General view of topsoil stripping for a haul road, looking northeast

- 5.2** Shallow excavations for the route of the haul road and temporary compound were excavated to a maximum depth of 0.1m below existing levels (Plate 3). This level was maintained within the ploughsoil and did not extend into the subsoil or indeed the natural geology beneath, i.e. the level of potential archaeological features.
