THE KING OF PRUSSIA, 83 FORE STREET, BOVEY
TRACEY, DEVON

Results of an historic building appraisal

Teignbridge District Council planning references
14/03189/FUL and 14/03190/LBC

Document No: ACD1047/1/1

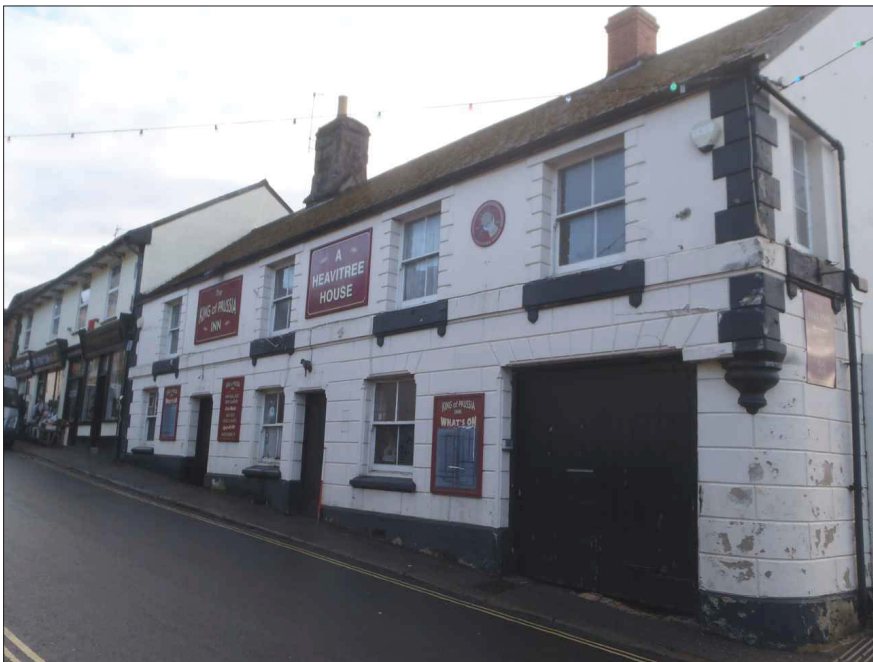
Plate 1: The north elevation showing the street façade, viewed from the northwest. 1m scale

- 5.2** The north elevation fronting Fore Street is probably a 19th-century remodelling with a plastered cream-yellow brick façade, retaining earlier masonry within its core. There are three entrances on the ground floor – a set of double wooden doors on the western side lead through to the rear courtyard, whilst the two other single wooden doors lead into rooms either side of the bar. There are three horned four-pane sash windows on the ground floor, two of which have stained glass lower panes. One of the latter has small leaded panes in the upper panels. All of the openings on the ground floor have rusticated voussoirs and slender flanking columns. The remainder of the wall at this level is finished in rusticated stonework. There are four four-pane sash windows on the first floor that have simple flat lintels, and sills supported on decorative brackets. There is a projecting plat band between the two floors incorporating the cills. The window surrounds have rusticated stonework with the remainder of the wall being painted plaster. This elevation displays various pub signs.

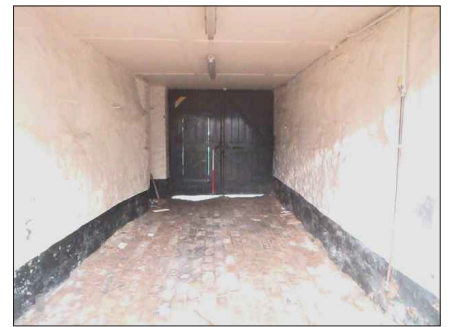
Plate 2: The interior of the passage showing the brick rebuild at the front of the property, viewed from the south. 1m scale

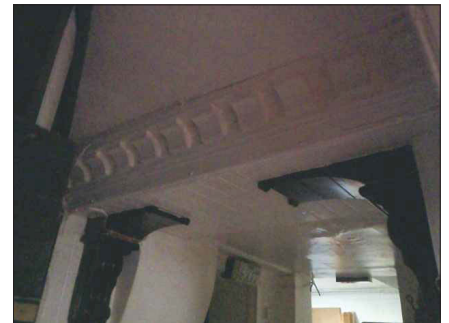
Plate 3: The cornice in the bar, viewed from the southwest

- 5.5** The ground floor is a large open space with a near central bar located against the north elevation. There are two smaller rooms at the east end, one of which is accessed via a corridor that also serves a rear kitchen. The building is entered via lobbies inside the front doors. The ceiling of the right hand area incorporates some chamfered battens, which are probably reused or fake. The main beams are also chamfered and are probably historic. In the west elevation is a cast-iron fireplace set within a wooden surround, and a brick blocked fireplace. This wall is has been largely rebuilt or faced in brick, incorporating displayed examples of local bricks during the 20th-century. Within the central bar area, none of the ceiling timber are early fittings, although one appears to have been reused; the west timber, for example, abuts the front lobby associated with the public house. Above the opening from the east lobby into the bar area is a length of Georgian dentil block moulded cornice.

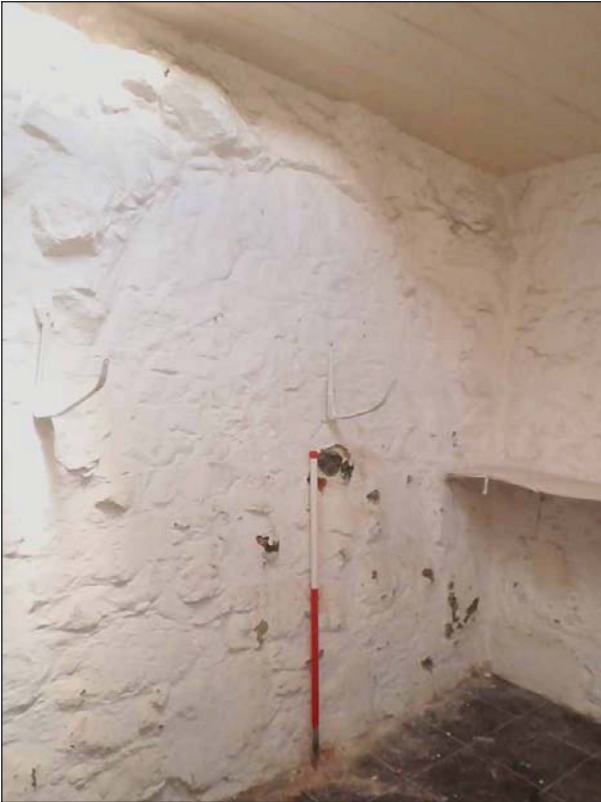
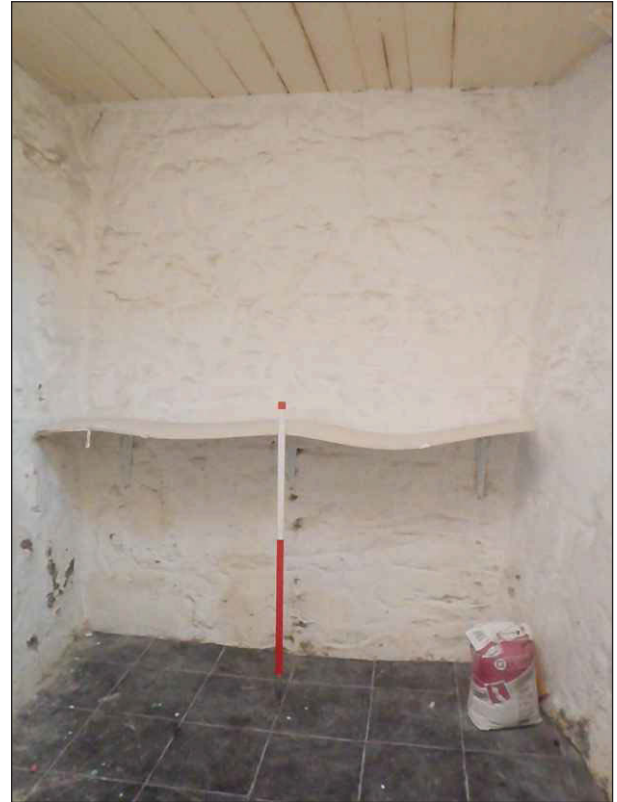
Plate 4: The south elevation of the store showing the remains of the vaulted ceiling, viewed from the southwest. 1m scale

Plate 5: The east elevation of the store showing the remains of the vaulted ceiling, viewed from the west. 1m scale

- 5.8** The store room to the south of the games room has painted stone walls. The north, east and south walls contain blocked tall, arched openings. Above the northern opening the masonry is ragged and projects out into the room; it appears to have formed part of an original vaulted ceiling. The masonry above the southern opening has been rebuilt in brick. The room currently has a modern wooden ceiling incorporating a skylight.

- 6.2** The store to the rear of the games room appears to be part of the original house. Its function is unclear as it does not seem to be domestic in nature but more industrial. The evidence for a former domed or vaulted ceiling may indicate some form of kiln or oven.

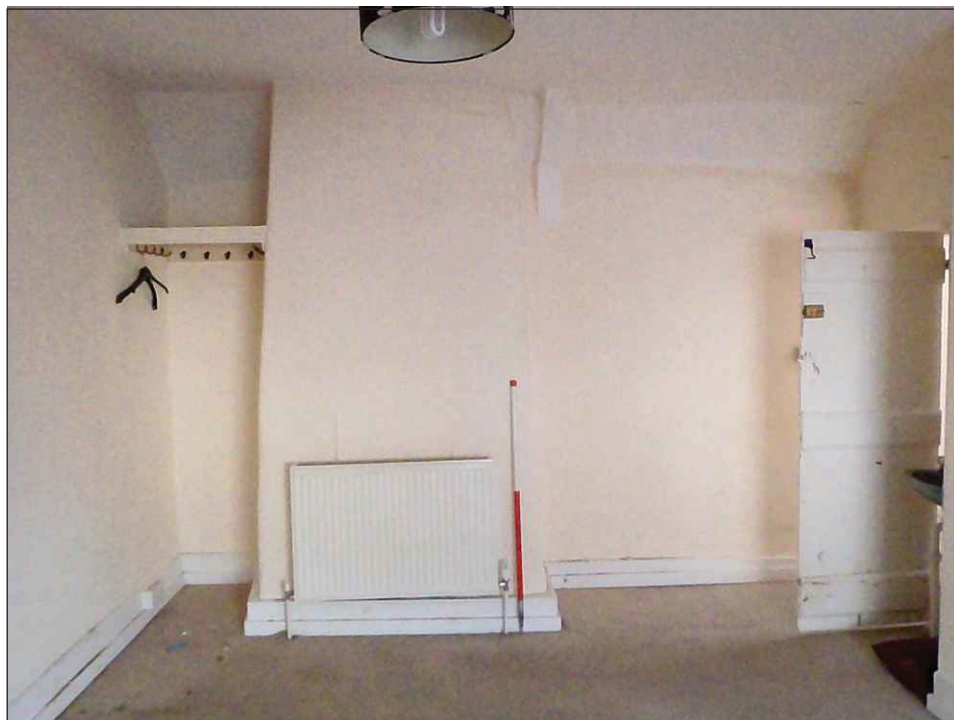
Plate 6: The west wall of bedroom 2 showing the fireplace and adjacent cupboard, and general low-quality finish, viewed from the west. 1m scale

- 5.11** In bedroom 1 there is a projecting chimney breast in the south elevation. The feet of a truss are visible to the west of this fireplace.
- 5.12** In bedroom 2 there is a large blocked fireplace with a wooden surround in the west wall. To the north of the fireplace is a small cupboard. The feet of two trusses are visible in the north elevation. Along the line of the partition with bedroom 3 the truss is curved and may be of a cruck construction. No joint can be discerned, and it is possible that the truss is of true cruck construction rather than jointed cruck construction. The corresponding feet are visible in the corridor. In bedroom 4 there is a projecting chimney stack in the west elevation, adjacent to which is a cupboard.

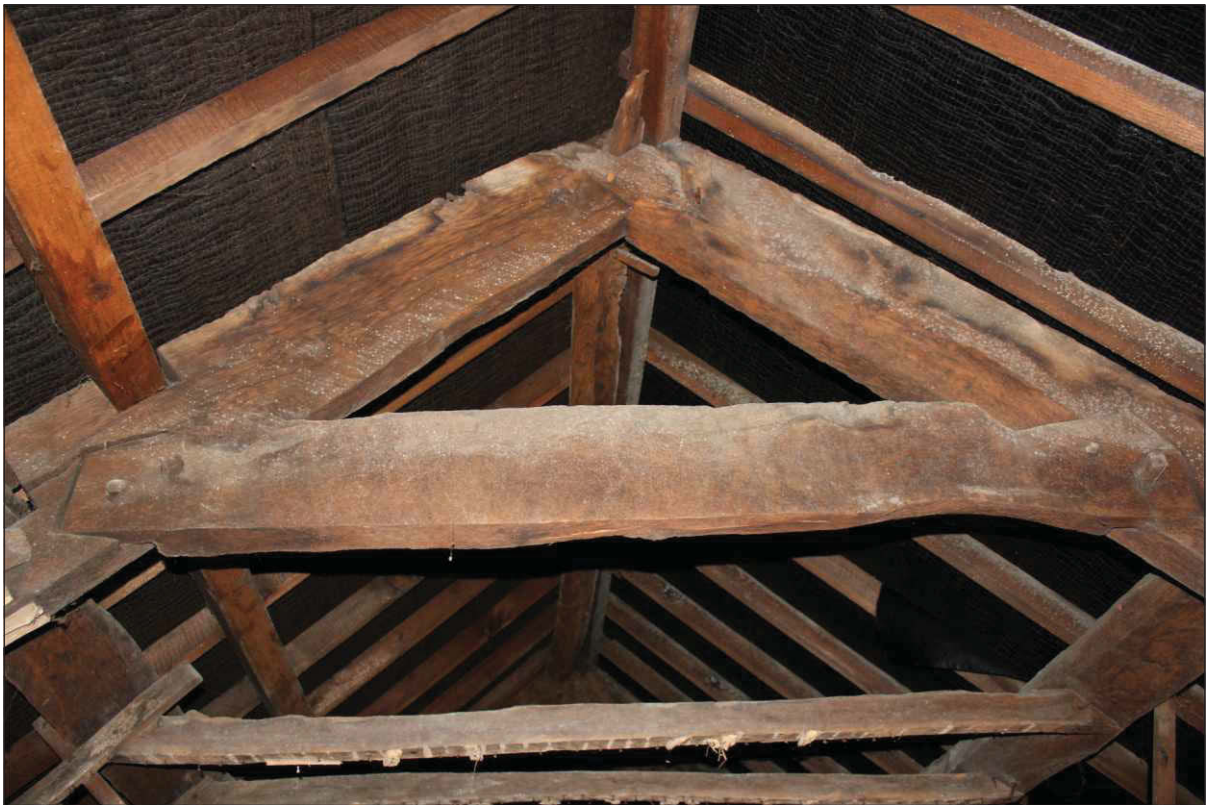
Plate 7: The roof structure showing a typical original truss, viewed from the east

- 5.14** The roof structure is continuous from the east elevation through the chimney stack at the west end of the bar/bedroom 3. Beyond there are no historic timbers. The roof structure is divided into four bays by three trusses, and additional timbers on the line of the eastern chimney stack. The principal rafters have lapped, pegged apex joints and lapped, notched, pegged high level collars. The original two rows of side purlins, along with the ridge purlin, pass through the principal rafters and abut within the trusses using angled (rather than straight) tenons. The side purlins display peg holes for the attachment of secondary rafters; most of the latter have been removed, although some survive at the southwest corner of the structure. None of these timbers are smoke blackened. The present slate roof covering is supported on modern battens attached to replacement notched purlins.

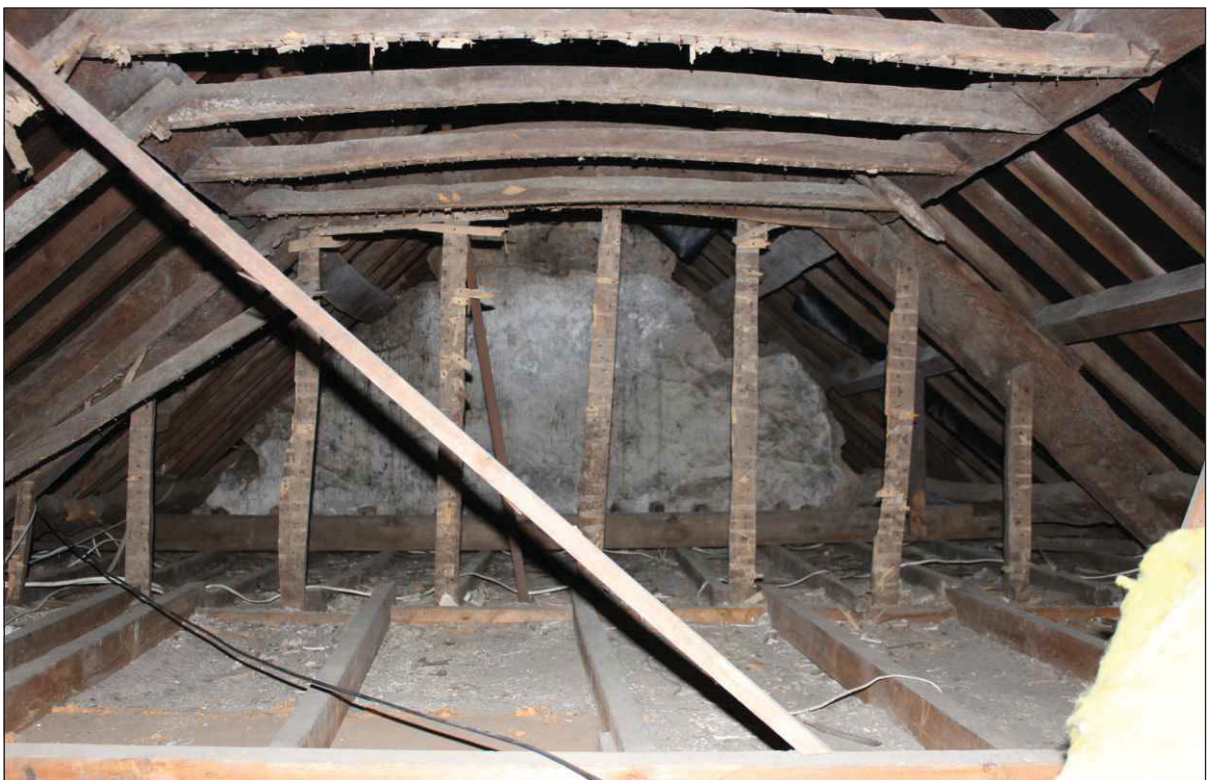
Plate 8: Battens associated with the former partitions in the loft, viewed from the east

- 5.15** The lath and plaster ceiling of the first floor rooms is supported on rows of thin battens. In the western chimney stack there are disused sockets for other battens, and the present structure may there relate to the 1840s conversion to a public house. The ceiling above bedroom 1 is higher than elsewhere, reflecting the raised floor levels in this part of the building. On the west side of the east chimney stack two flues can be discerned, formerly serving the fireplace on the first floor, and the removed fireplace on the ground floor. The west side of this chimney breast is plastered, and in the next two bays to the west the remains of an earlier higher ceiling are present, consisting of horizontal and transverse battens with nails that formerly supported lath and plaster partitions.
