# ROBINSWOOD HILL FARM, GLOUCESTER, GLOUCESTERSHIRE

Results of a archaeological watching brief

Gloucester City Council planning reference 13/01018/FUL

Document No: ACD1149/1/1

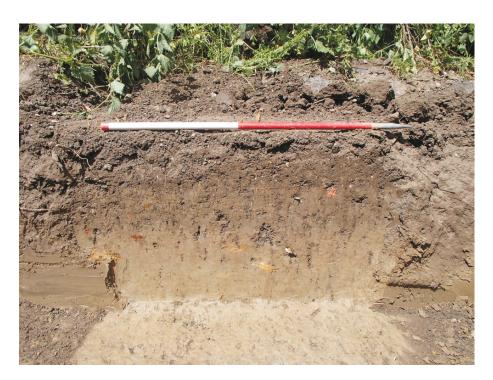
Test pit 1		Length 2.7m	Width Alignment 1.9m NE-SW
Context	Description	Average Depth	Interpretation
100	Friable dark greyish-brown humic silty clay-loam containing sparse well-sorted, sub-angular to sub-rounded mixed stone up to 40mm long, ceramic building material, charcoal and plaster fragments.	0-0.25m	Modern topsoil that has formed over deposit 101
101	Moderately friable dark grey humic silty clay- loam containing sparse well-sorted sub-angular to rounded stone up to 40mm long and charcoal, ceramic building material (including whole bricks), as well as plastic and modern pottery. Similar to 100 but with fewer inclusions	0.25-0.44m	Modern levelling deposit
102	Compact pale brownish-grey, clay-loam, with yellow hues, containing rare well-sorted coarse stone, common ceramic building material and charcoal fragments.	0.44-0.63m	Modern levelling deposit
103	Compact pale yellowish-grey clay, with brown hues, containing sparse poorly sorted, rounded ironstone up to 110mm long and three fragments of a mammal long bone (species unidentified)	0.63-0.97m	Subsoil

104	Very compact pale grey-blue clay with occasional yellow and brown hues.	0.97m +	Natural

Plate 2: Section of test pit 1, looking northwest (1m scale)

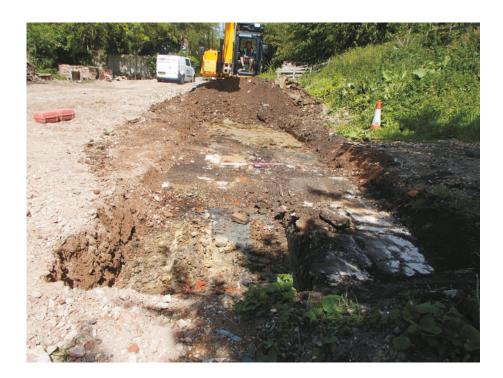
5.2 At the southeast edge of site a small area (Trench 1) was stripped to investigate the extent of disturbance in this part of the development site. This was targeted to pick up the footprints of the now demolished barns along with the undeveloped ground between them. The upper deposits comprised up to 0.40m of crushed building material from the demolition of the barns (106), the former yard surface, down onto an older hardstanding consisting of tarmac, gravel and concrete at the southwest end of the excavation. At this depth modern deposits were exposed in the centre of the trench with disturbed subsoil present at the northeast end of the trench. A test pit (2) was then excavated through the exposed deposits at this level. The results are summarised in table 4 below.

- 6.2 The investigations in the southeast half of the site have demonstrated that modern activity (relating to the construction of the recently demolished farm buildings) had completely removed any soils pre-dating the 19th century; the character of the natural indicates that the hillside has been terraced into, probably for the construction of the farmhouse and associated farm buildings.

Plate 3: Trench 1, looking northeast (1m scale)

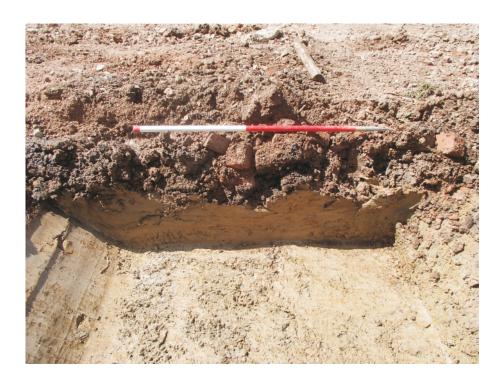
Test pit 2		Length 2.2m	Width Alignment 1.9m NW-SE
Context	Description	Average Depth	Interpretation
106	Crushed demolition debris	0-0.09	Debris from modern demolition of the former farm buildings
105	Sticky dark brown clay-loam containing a mix of inclusions, including metal, whole bricks and sparse sub-rounded stone up to 150mm long.	0.09-0.30m	Modern dumped deposit, possibly a levelling deposit for farmyard surfaces
110	Soft and sticky pale yellowish-grey clay-loam with brown hues containing post-medieval brick as well as a large unabraded sherd from a 19th-century chamber pot	0.30-0.53m	Subsoil
104	Hard compact pale grey-blue clay with occasional yellow and brown hues.	0.53m +	Natural

Plate 4: Section of test pit 2, looking northwest (1m scale)
