# EXETER CATHEDRAL SCHOOL, NEW NURSERY, CATHEDRAL CLOSE, EXETER, DEVON

Results of an archaeological watching brief

Exeter City Council Planning Ref: 13/5118/03

Document No: ACD909/2/1

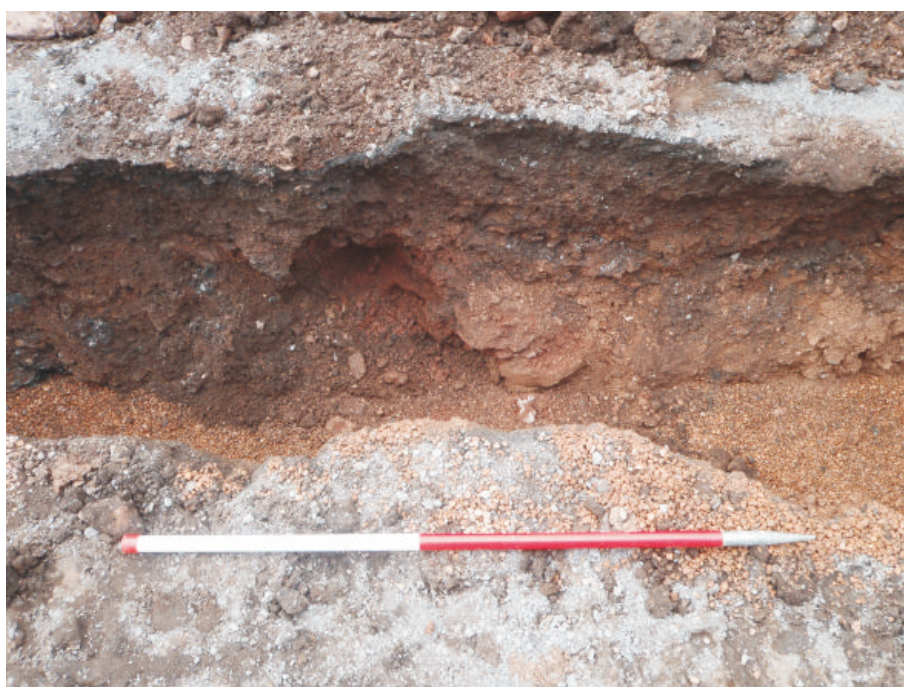
Plate 6: Drainage trench, wall 122 and deposit 123, viewed from the northeast (scale 1m)

Running parallel to the northeast of the groundworks for the storm water attenuation tank a narrower shallower trench measuring 15m by 0.5m and 1m deep was excavated for internal drainage from the new nursery. This also exited at the original pit for the attenuation tanks works in a SE direction and after approximately 0.5m from the original pit the deposits became less complex and very unstable, being dominated beneath the garden soil (113) by a deposit (123) rich in demolition-related material including breccia stone blocks, fragments of mortar and slate, along with animal bone and three sherds of post-medieval pottery. The continuation of wall 122 was exposed although wall 125 and drain F212 was not.

**7.2** The date and function of the wall foundations 122 and 125 could not be established, but their NE-SW orientation matches with the expected orientation of the medieval gatehouse, and any associated outer courtyard structures, and indicate the possibility that they may relate to structures in place prior to the demolition of the gatehouse prior to c. 1744 (Allen and Dyer 2005).
