BELMONT HOSPITAL LODGE, TIVERTON, DEVON

Results of historic building recording

Mid Devon District Council planning reference 13/1354/LBC, condition 3

> > Document No: ACD1145/2/0

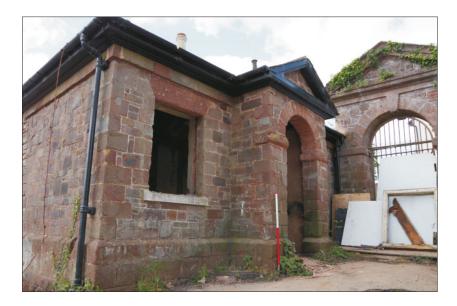
Plate 1: North elevation of the lodge, with the gateway in the background, looking from the northeast (1m scale)

The lodge is constructed of light reddish-grey sandsone and bonded in a pinkish-white lime mortar. In the north and east external elevations – the principal elevations within the former workhouse grounds – the masonry is squared blocks laid in neat courses; elsewhere the stonework is rubble masonry laid in rough courses. There are projecting bands of stonework at the base of the walls and at eaves level; neither extend around to the rear (south) elevation. The principal north elevation is of three-bays, and symmetrical with a projecting pedimented porch with an outer tall, breccia round-headed opening. There is a window opening either side of the porch, each with flat breccia lintels, and white limestone sills. The windows have been removed.

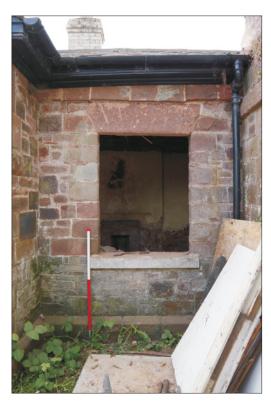
Plate 2: West window in the north elevation of the lodge, looking from the north (1m scale)

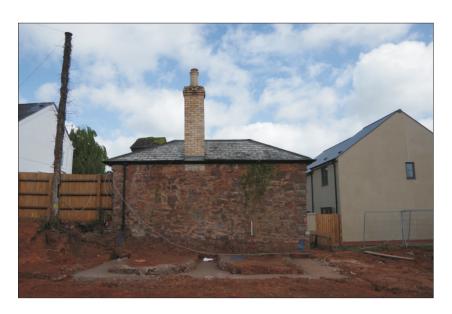
Plate 3: South elevation of the lodge, looking from the south (1m scale)

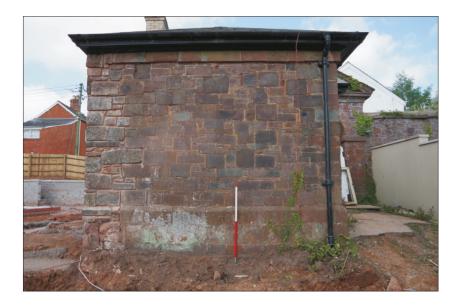
Plate 4: East elevation of the lodge, looking from the east (1m scale)

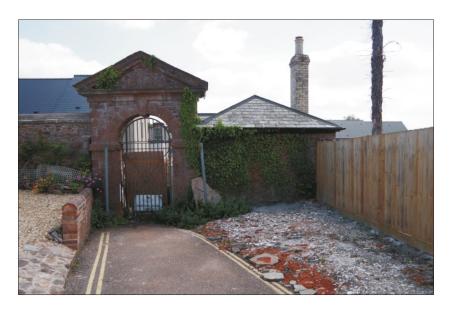
Plate 5: West elevation of the gateway, looking from the west (1m scale)

The gateway is integral to the northwest corner of the lodge, as well as to the south end of the western boundary wall of the former workhouse. It has been designed is in a classical style with a round-headed archway, incorporating a projecting keystone, under a pediment. A fine-grained breccia has been used for some of the detailing. The gate is iron and has diagonal cross-bracing with a central roundel. The arch above is filled with a fixed panel of iron bars.

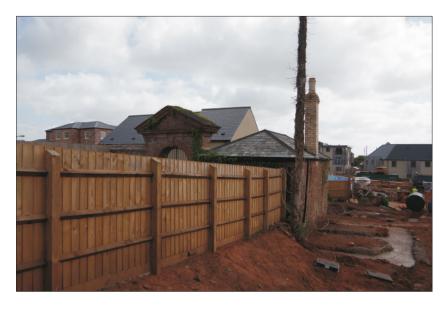
Plate 6: View of the lodge and gateway with the hospital and new development in the background, looking from the southwest

The lodge is located at the former original entrance to the workhouse. The gate, lodge and boundary wall would have formed a physical and visual barrier to those visiting or confined to the workhouse. A further gateway would have been present at the (now-demolished) main entrance to the workhouse building itself. More recently, when the site was the Belmont Hospital, the gate used as part of an access route though the complex.

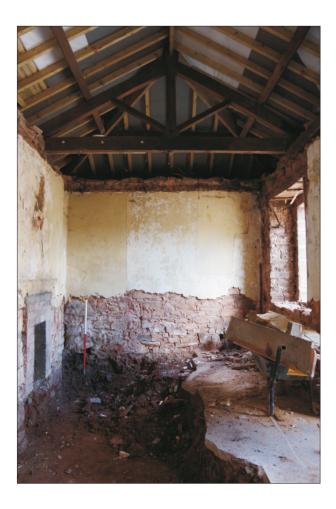
Plate 7: Interior of the lodge, looking from the east (1m scale)

Internally the lodge originally had a two room plan though the partitions had been removed prior to the survey. The front door originally opened into a larger western room, with a smaller room to the east. The walls are finished in a pinkish-white lime plaster painted cream, with occasional patches of cement repair visible. During the course of the survey, the lower portion of the walls and the area in the south elevation where a new opening will be created the plaster was removed. No blocked openings or historic features are present here beneath the plaster. The western room was heated by a fireplace in the south wall. This is set within a slightly projecting chimney breast and has a brick and stone hearth. A black-painted wooden surround had been removed from the opening.

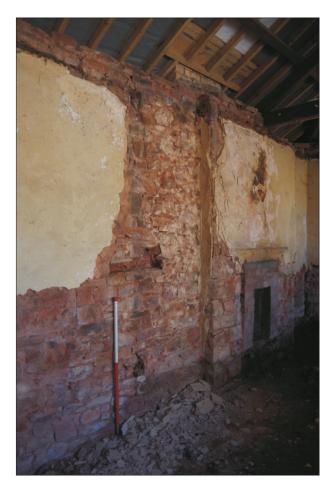
Plate 8: Interior of the lodge, showing the area in which the new opening will be created, looking from the northeast (1m scale)

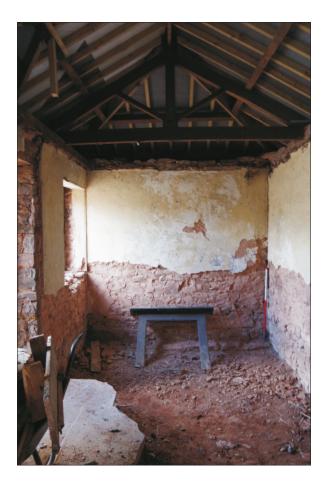
Plate 9: Interior of the lodge, looking from the west, showing the removed fire surround (1m scale)

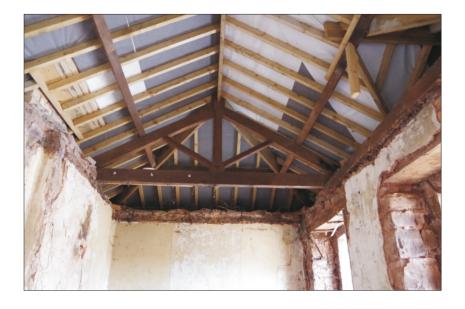
Plate 10: Roof truss in the lodge, looking from the east

The building has a fully hipped slate roof above which a yellow brick chimney projects. The brickwork extends from the top of the rear wall. The top four courses project outwards forming a decorative chimney cap, and are finished with a yellow chimney pot which has a red terracotta cap. The roof structure is formed of king post trusses, with diagonal struts, that support back purlins. These are original timbers, whilst the ridge purlin and common rafters are modern replacements.
