HILL BARTON, EXETER, DEVON

Results of historic building recording

Document No: ACD992/3/1

Date: June 2015

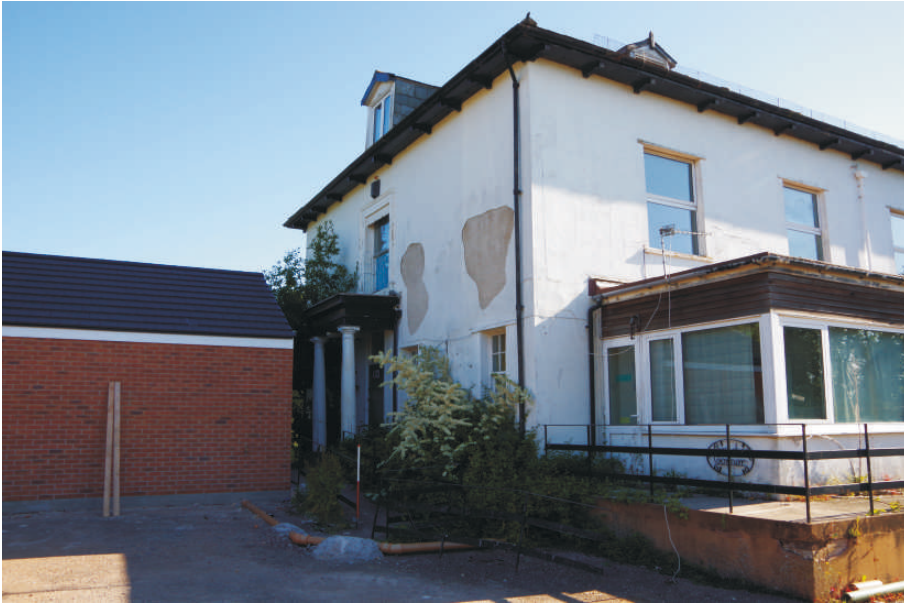
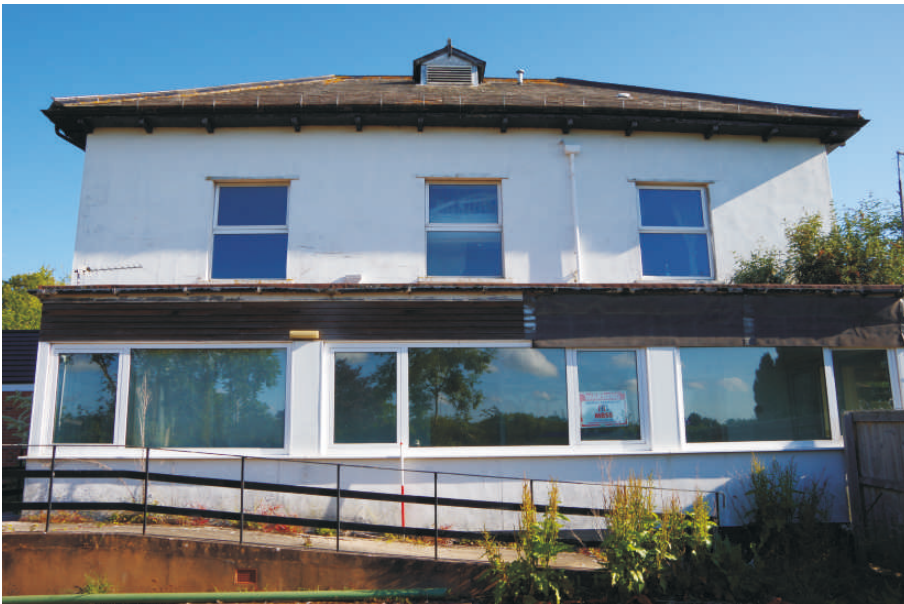
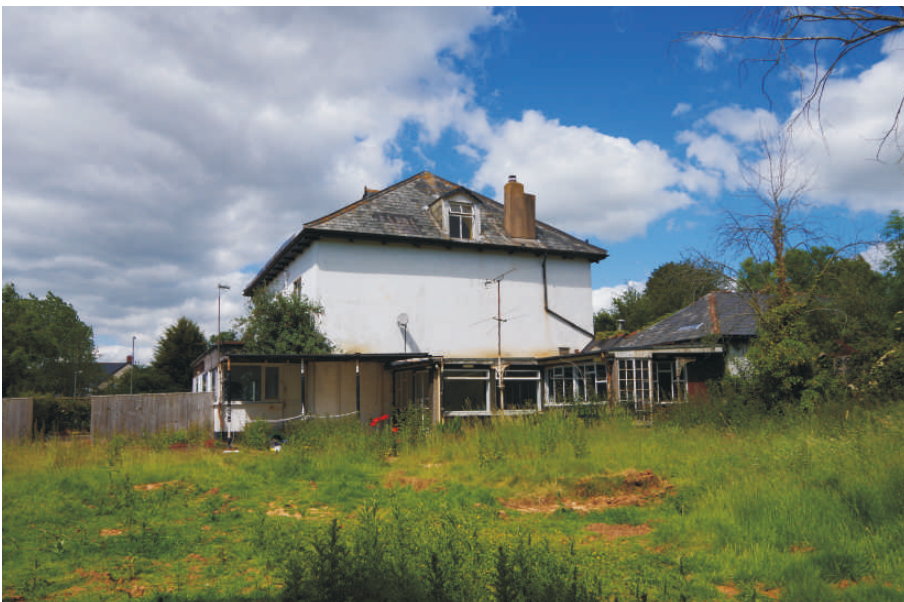
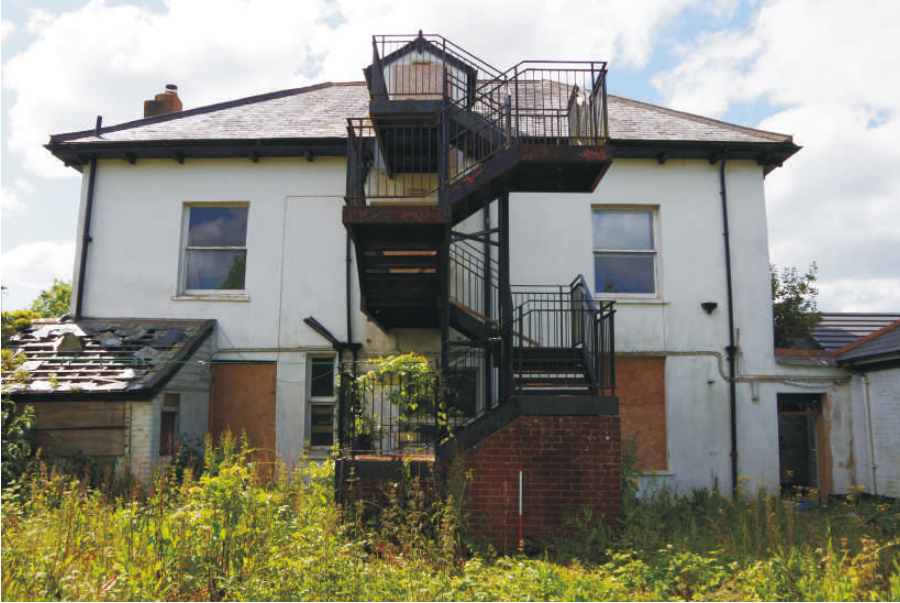
The house has a hipped slate roof with single dormer windows in all pitches; these have wooden barge boards and slate pitches (Plates 1-4). The dormer in the north elevation has been converted into a fire escape (see below). The external walls are all rendered, and there are modern extensions attached to the north, south and east

The west elevation forms the front of the house facing Hill Barton Road. It has a modern central door beneath a porch supported on pillars. On the ground floor are two windows containing 12-pane sash windows, and on the first floor above the doorway is a single window with a two-pane sash. This has a moulded surround and a narrow piece of board with a decorative scalloped tail at the top. On the first floor of the south elevation there are three modern UPVC windows. The ground floor openings are obscured by the modern extension but originally comprised two doorways and a window. The ground floor of the east elevation is also obscured by the modern extension; there are no openings on the first floor. The north elevation incorporates three windows and a door on the ground floor. Those that have not been boarded up have wooden frames. On the first floor are two windows, both with two-pane sashes and a door that gives access to a fire escape. The fire escape consists of a large brick and metal tower with access and stairs from each floor. The dormer window in the roof has been converted into a door giving access to the fire escape from the loft accommodation.

Plate 1: The west elevation of the house, looking northeast (1m scale)

Plate 2: The south elevation of the house, looking north (1m scale)

Plate 3: The east elevation of the house, looking northwest

Plate 4: The north elevation of the house, looking south (1m scale)

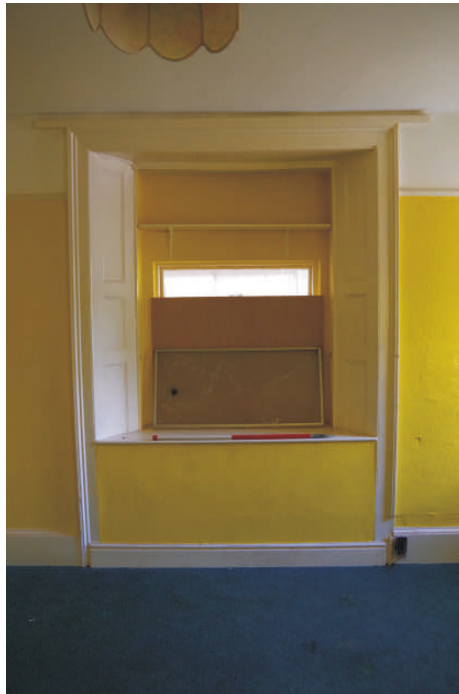
The house has a modern finish throughout and very few original fixtures or fittings have been retained. Some essence of its original finish can be however discerned in the three ground-floor domestic rooms on the ground floor which retain some of the wooden skirting boards, dado rails and wooden panelled surrounds to the windows (Plate 5). There are also wooden skirting boards and door surrounds to the domestic rooms in the corridor. The stairs have a dog leg design with a simple handrail and stick balusters. In the kitchen there is a large breccia fireplace with a wooden surround in the east elevation (Plate 6). The surround has had decorative wooden pieces added to it. The surround has been cut off on the north side indicating that the room has been subdivided. This was probably a recent alteration when the adjacent lift was inserted. In the northwest bedroom on the first floor there is a fireplace in the west elevation. This has a wooden surround onto which a radiator has been attached (Plate 7). On the second floor the side of the room are formed by lath and plaster partitions. Behind these partitions are two cupboards on the north side of the house.

Plate 5: An example of the decorative detailing in the rooms on the ground floor of the house, looking south (1m scale)

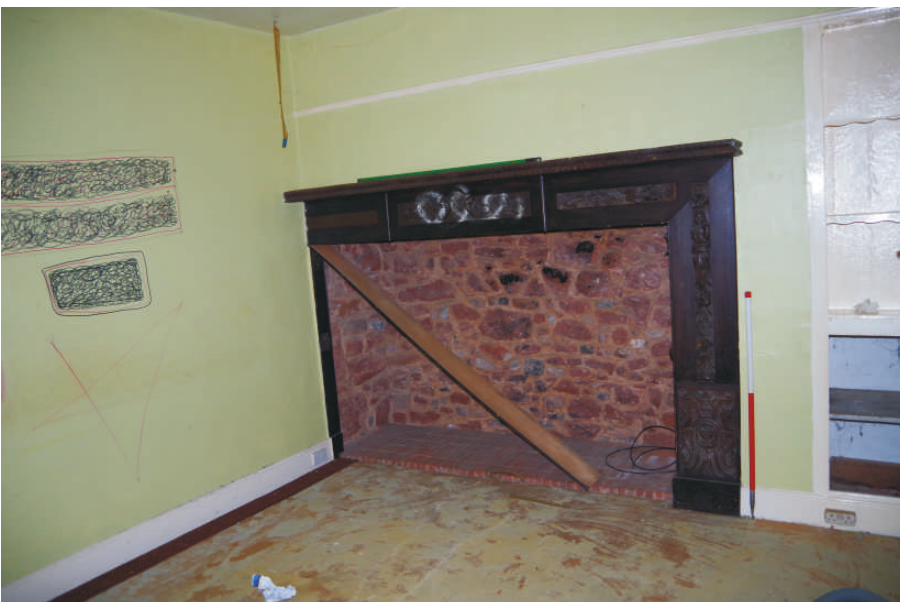
Plate 6: The fireplace on the ground floor of the house, looking northeast (1m scale)

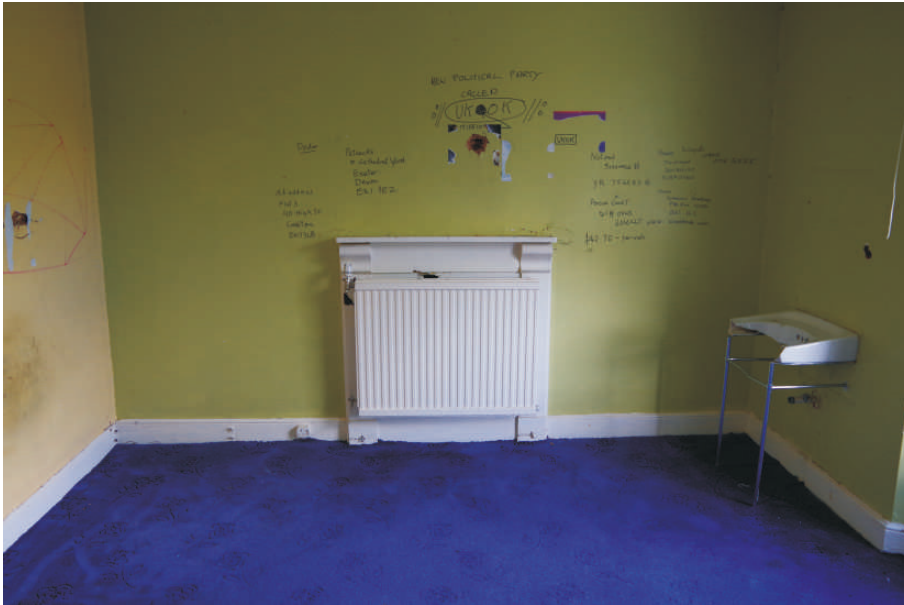
Plate 7: The fireplace on the first floor of the house, looking west (1m scale)

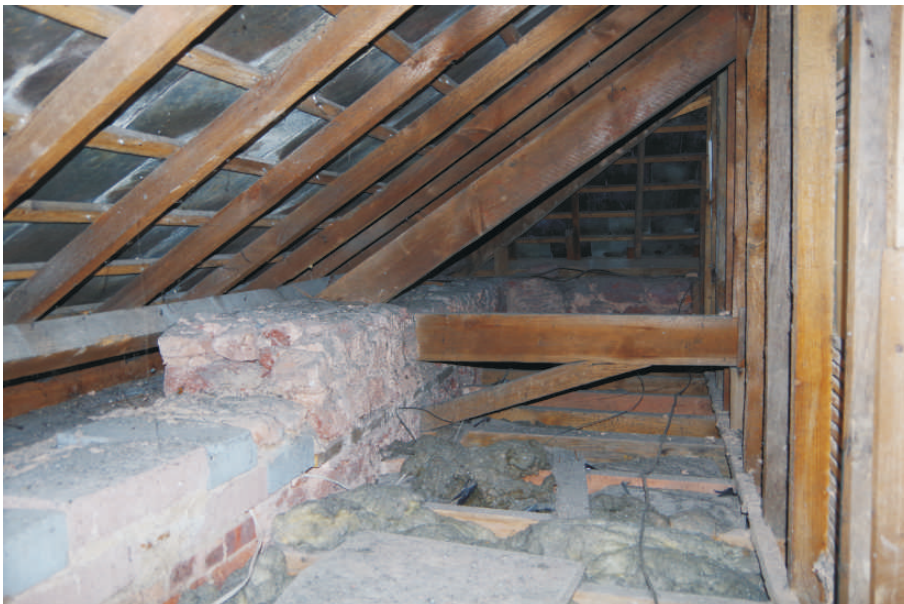
Here the top of the north elevation and the ends of the roof trusses are visible (Plate 8). The wall is constructed of small sub-angular stones with areas of brickwork and modern blockwork repairs. The ends of the trusses terminate in the top of the wall, along with short lengths of collars just above the floor level. The slate roof and associated battens are set onto closely-set secondary rafters that are laid onto back purlins.

Plate 8: The top of the wall and roof trusses in the house, looking northeast

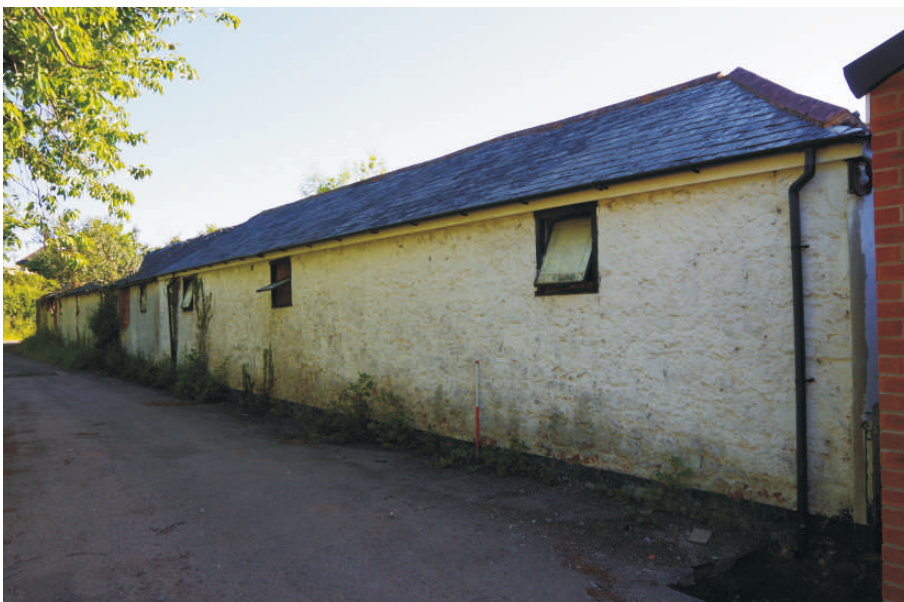
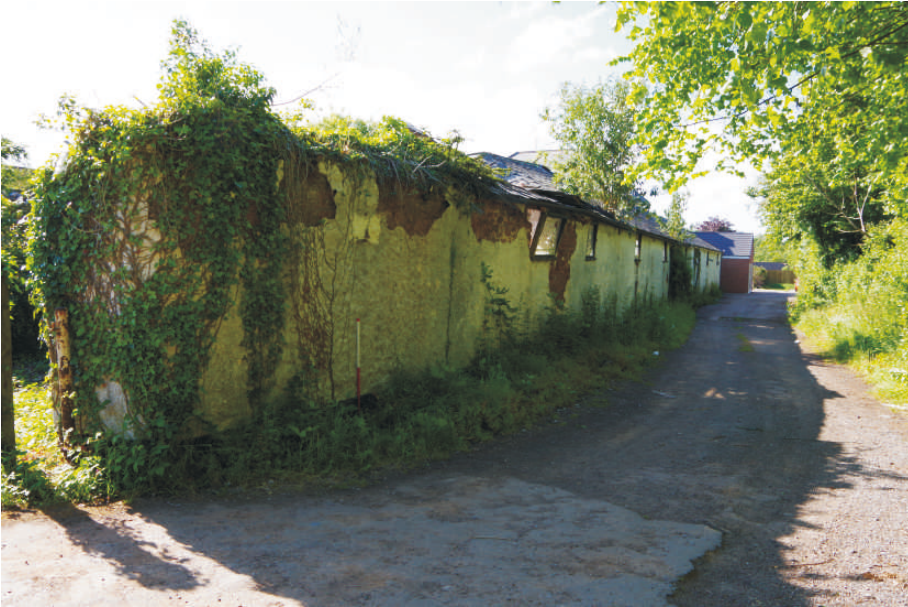
Apart from its east elevation, the western building is entirely constructed of sub-rectangular breccia blocks bonded in a reddish-white lime mortar with frequent inclusions; these walls have been rendered (Plates 9-10). In the west elevation there are eight square metal-framed windows. The wall of this elevation projects northwards past its junction with the north elevation, reflecting the position of a former building. The north elevation contains no openings but some of the breccia blocks are very large, measuring up to 60 x 50 cm, larger than those on the other walls of the range. The east elevation is constructed using red bricks (Plates 11-12). There are four doors and four windows in the elevation. Three of the openings have flattened arches, with the jambs utilising bullnose bricks. One of the openings at the north end is a double door and the window to the south is identical to those in the west elevation. The south elevation has been rendered and is mostly occupied by an inserted garage door. The roof is in a very poor condition and has partially collapsed at the north end and is missing many slates. It is supported on king post trusses with diagonal struts, which have their ends set into the walls (Plates 13 and 14). The back purlins and rafters have are nailed joints. Many of the roof timbers have been replaced.

Plate 9: The west elevation of the western building in the U range, looking northeast (1m scale)

Plate 10: The west elevation of the western building in the U range, looking southeast (1m scale)

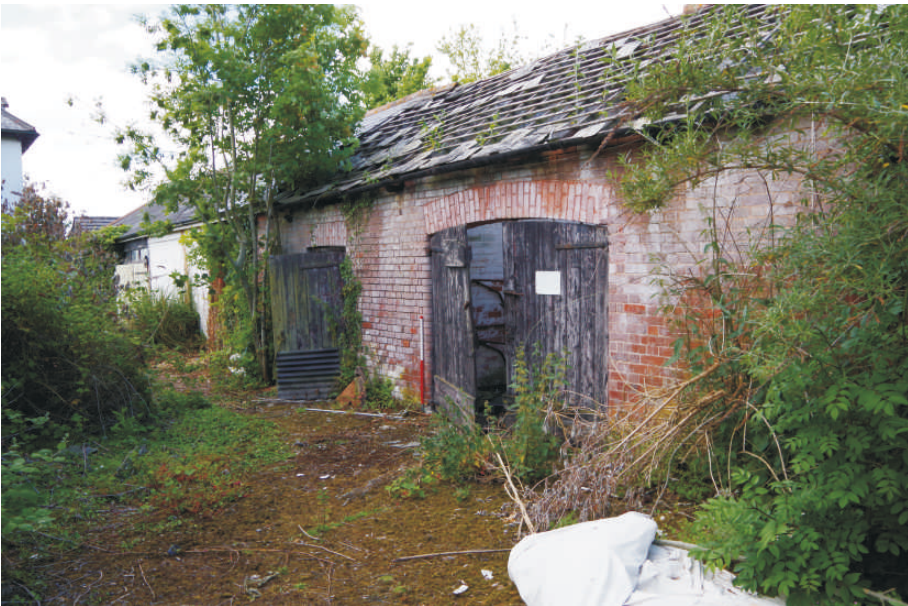
Plate 11: The east elevation of the western building in the U range, looking southwest (1m scale)

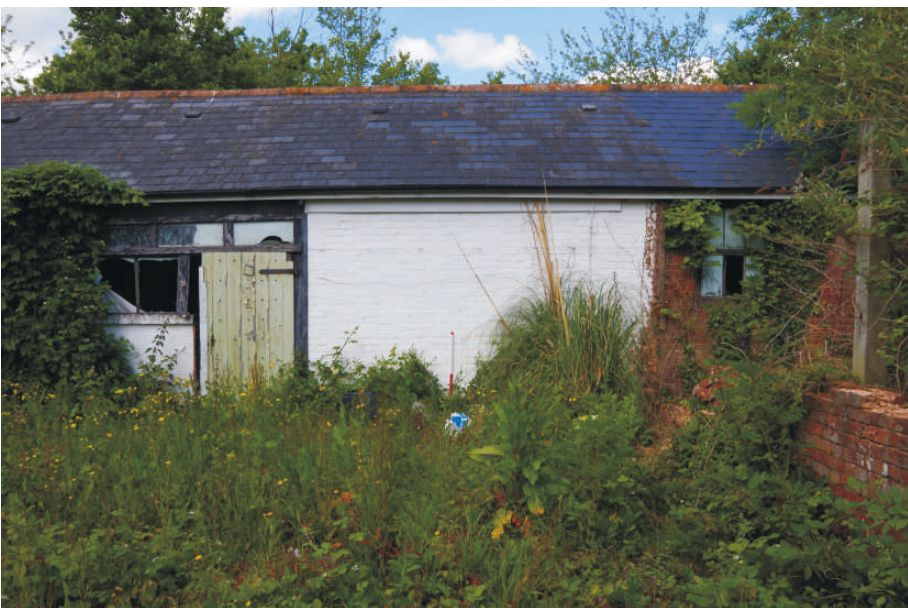
Plate 12: The east elevation of the western building in the U range, looking west (1m scale)

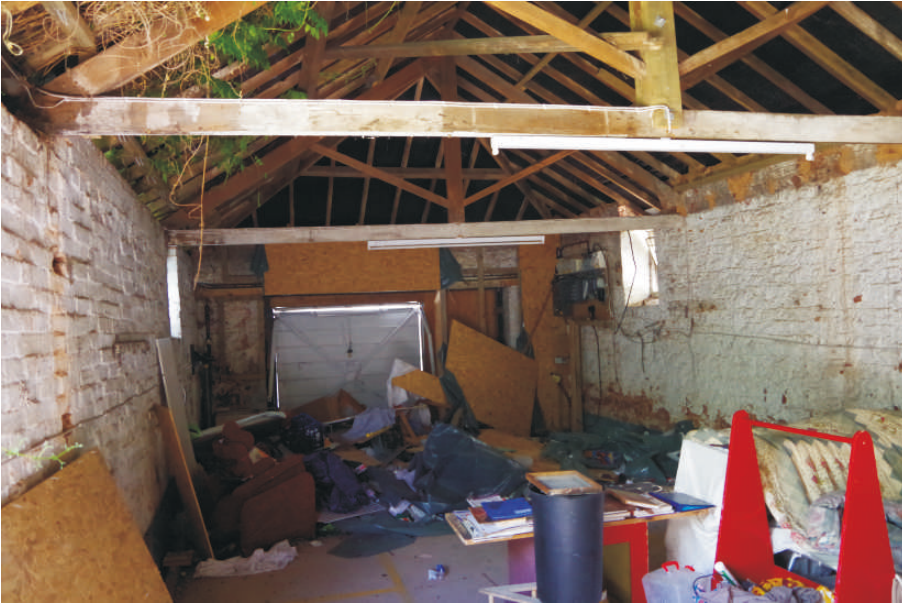
Internally the western building has been divided into four rooms with brick partitions and timber panelling in the gables. The south room has been converted from agricultural use to a garage and store (Plate 13). It has a concrete floor which steps down to the south; the walls have been painted. The three rooms to the north all retain evidence for their original use of housing livestock (Plate 14). The northern room is twice the size of the other two rooms. There is a feeding passage that runs along the west side of the building, adjacent to which are feeding troughs, mangers and water bowls. Doors in the western side of the partition walls provide continuous access to the feeding passage. In the central room shelving has been inserted, with the earlier fittings retained.

Plate 13: The southern end of the western building in the U range, looking southwest

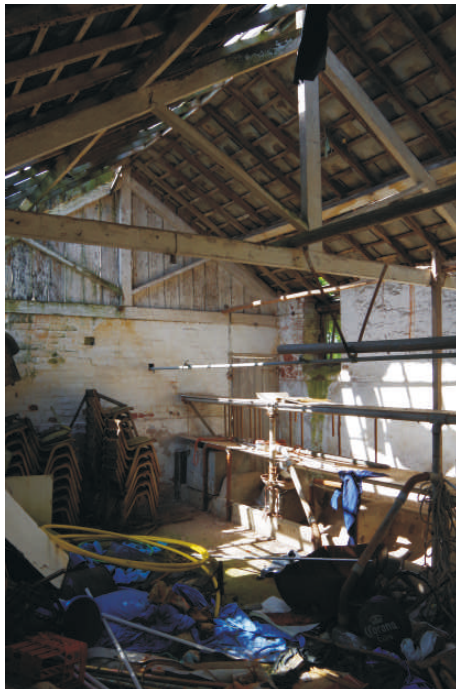
Plate 14: The northern end of the western building in the U range, looking southwest

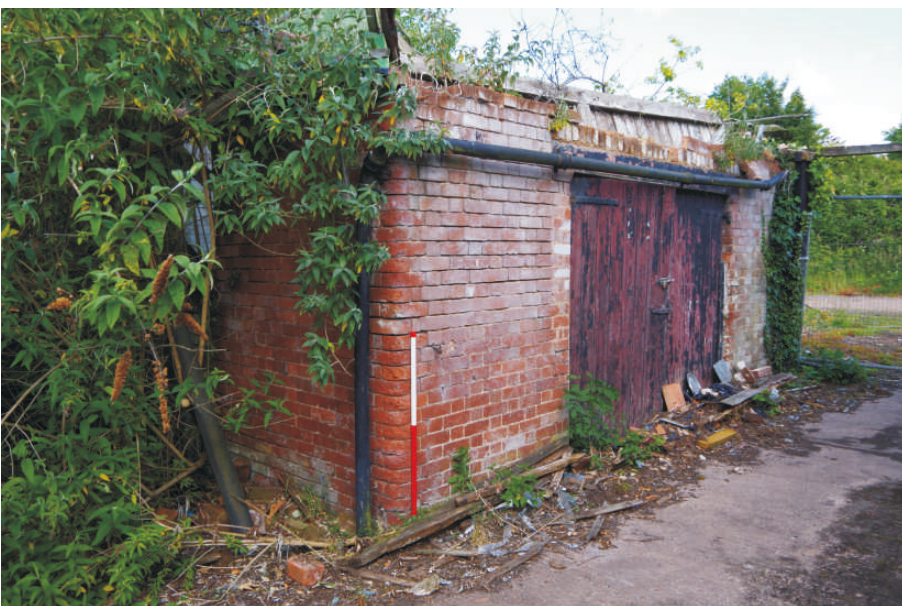
The building at the north end of the west range is constructed of red brick laid in Flemish bond with dark grey cement. The corners of the east elevation are curved using bullnose bricks, with the northeast corner forming one side of the gateway (Plate 15). There is a double door opening in the east elevation, and a window opening in the south elevation.

Plate 15: The building at the north end of the western building in the U range, looking northwest (1m scale)

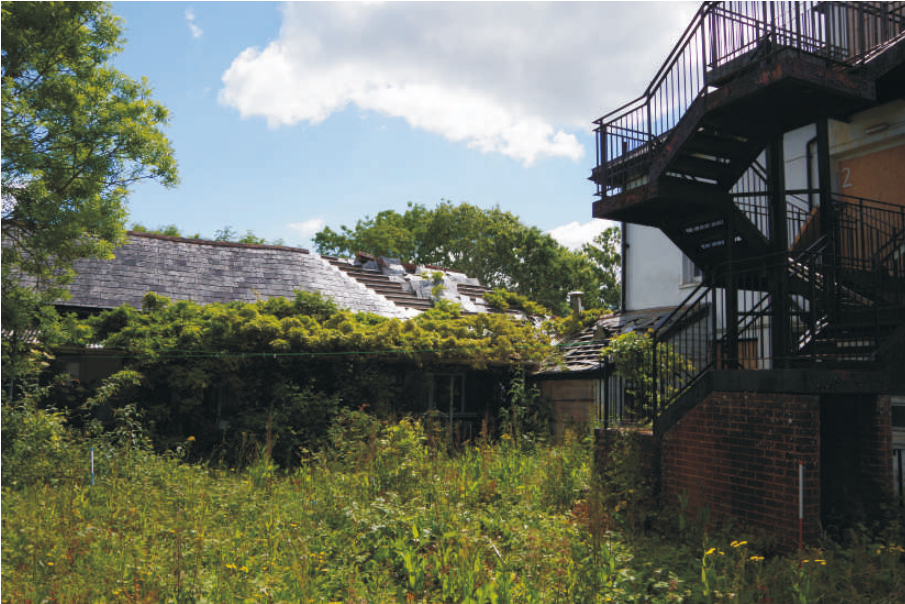
The north and east elevations of the eastern building are constructed of sub-rectangular breccia blocks bonded in a reddish-white lime mortar with frequent inclusions; the external faces have been rendered. The majority of the western elevation was obscured by vegetation, although at the south end a modern veranda projects out into the yard from the building (Plate 16).

Plate 16: The southern end of the eastern building in the U range, looking southeast (1m scale)

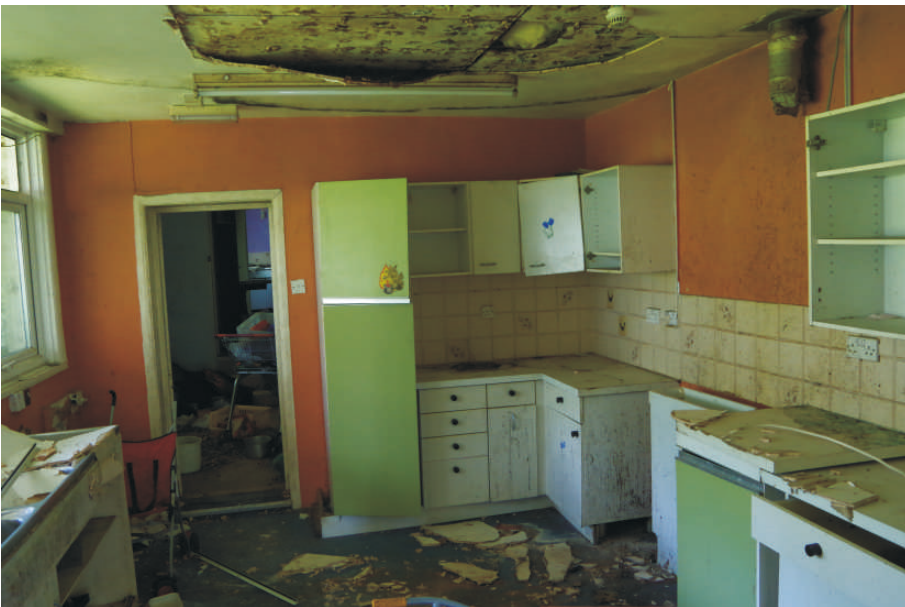
been converted into residential accommodation and is divided into many rooms including a bathroom, kitchen, sitting room and three bedrooms (plate 17). The finishes throughout are all modern and no original fixtures or fittings survive. In a few areas where the wall plaster has come off the walls behind have been painted with what appears to be tar, presumably to prevent damp.

Plate 17: The kitchen in the southern end of the eastern building in the U range, looking north

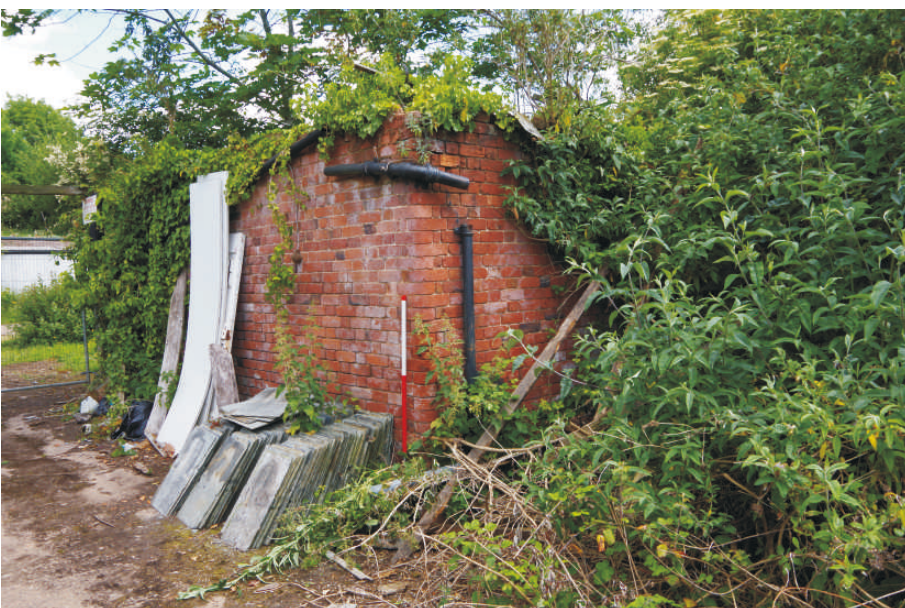
At the north end of the east range is a brick building mirroring the position, general size and construction techniques, of the similar structure on the west side of the range. Due to vegetation no openings could be observed, although there do not appear to be any large external openings (Plate 18).

Plate 18: The building at the north end of the eastern building in the U range, looking northeast (1m scale)

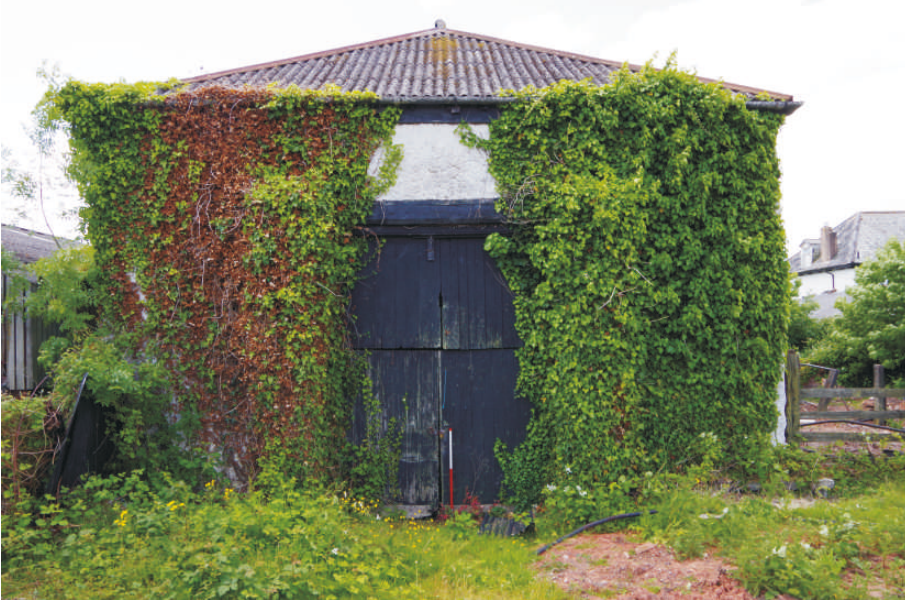
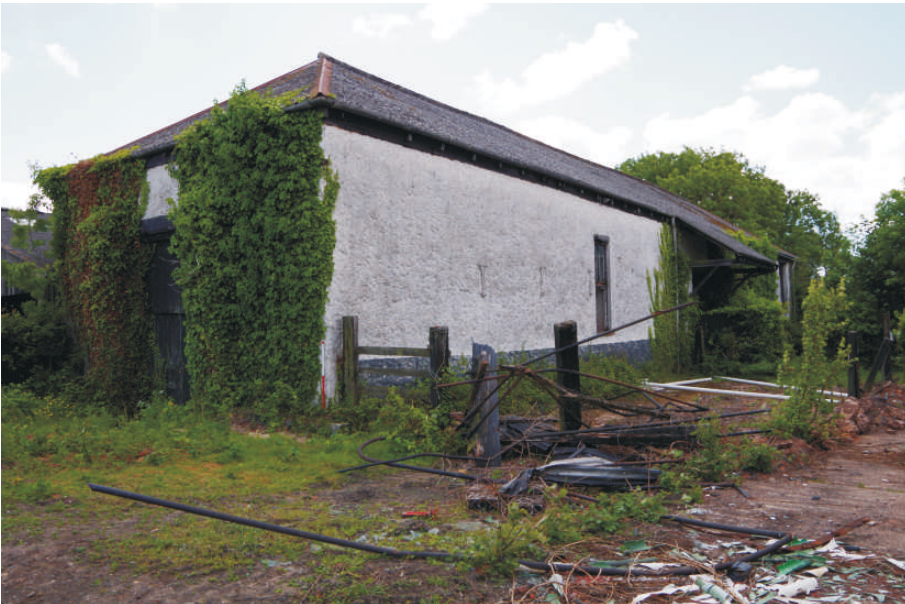
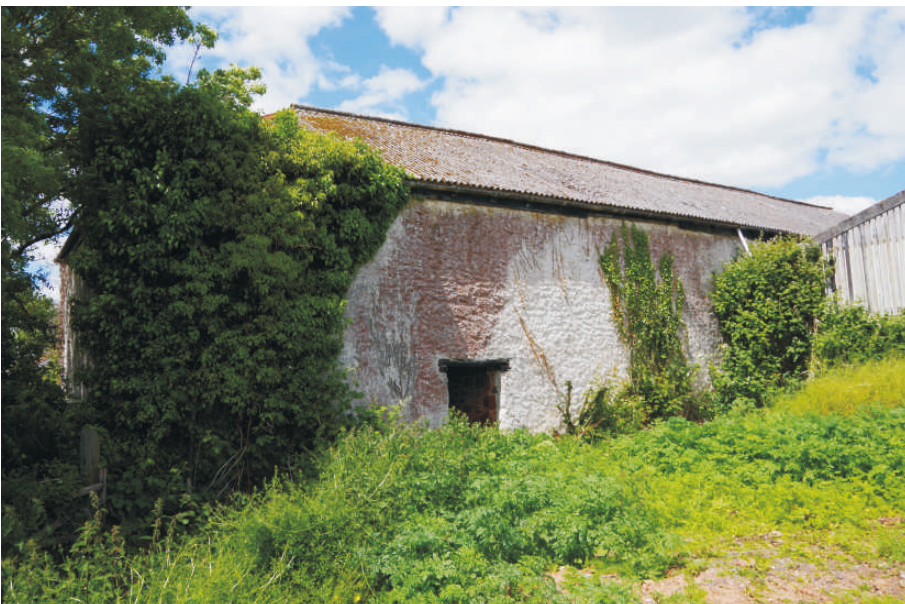
The walls of the building are rendered but internally sub-rectangular breccia blocks are visible (plates 19-21), with small areas of brick repairs, mainly around the openings. There are opposing, roughly central, double wooden doors in the east and west elevations, which are flanked by buttresses with wooden lintels. On the east elevation the roof extends down over the doorway forming a porch. In the north elevation there is a tall, wide opening with double wooden doors; this is also flanked by buttresses, again with a wooden lintel. At the southern end of the barn, in the east elevation there is a ground-floor doorway and window, with a first-floor window over, and in the east elevation a ground floor double door with two windows on the first floor. There is a further tall window or loading door in the north end of the east elevation.

Plate 19: The north elevation of the old barn, looking south (1m scale)

Plate 20: The west elevation of the old barn, looking southeast (1m scale)

Plate 21: The east elevation of the old barn, looking northwest (1m scale)

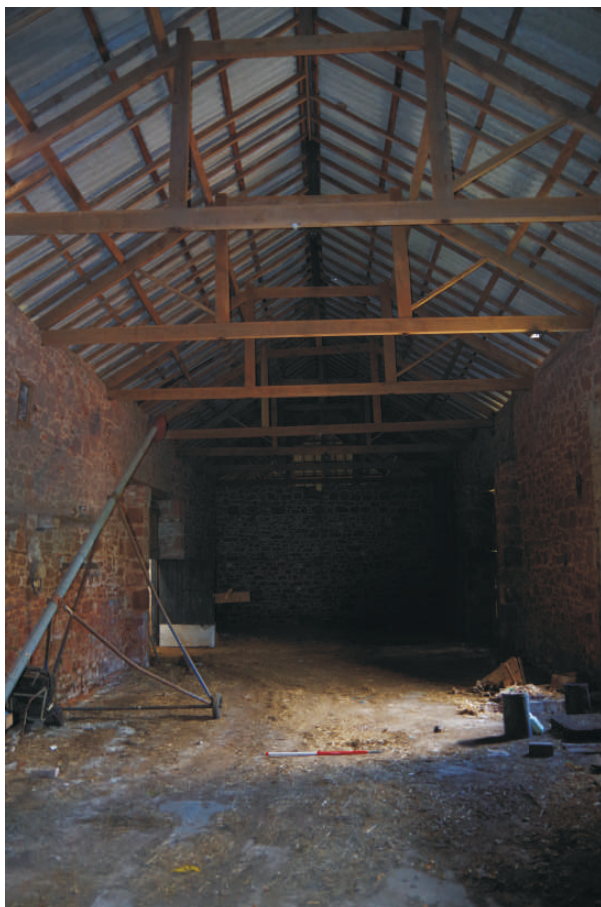
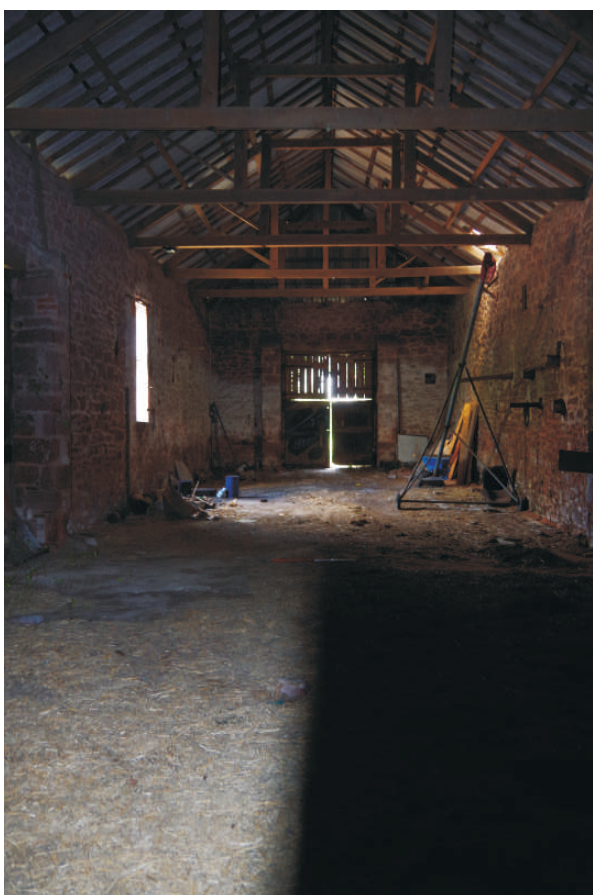
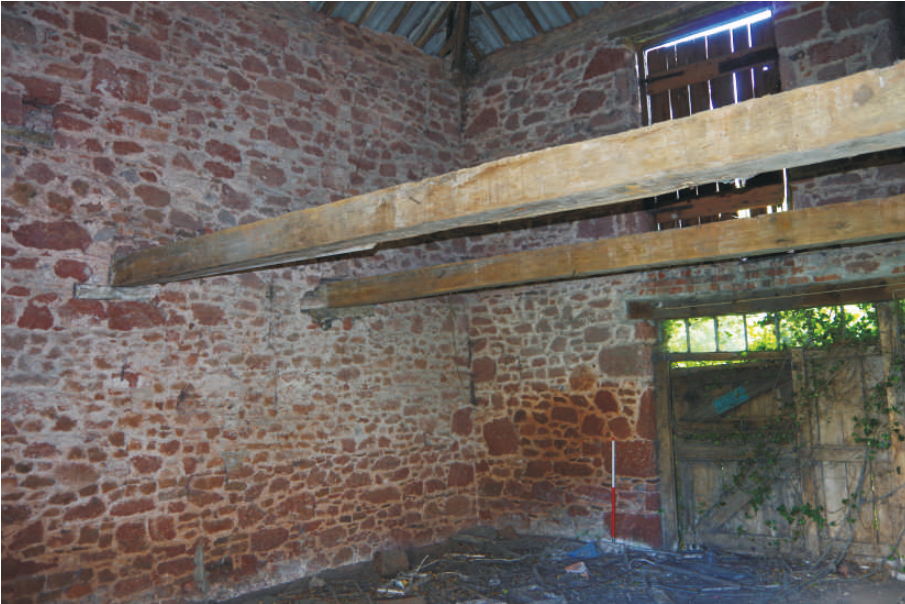
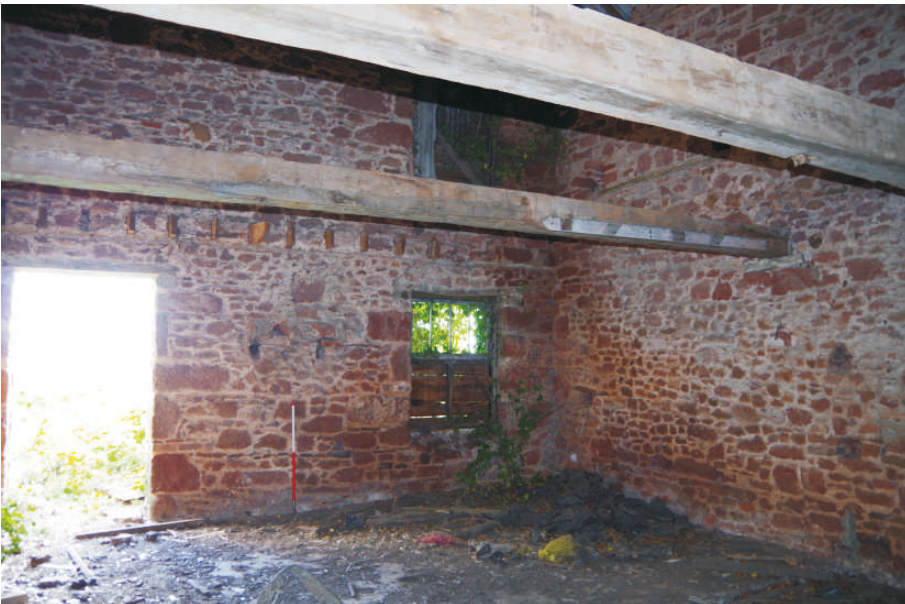
The barn is divided into two rooms by a wall of sub-angular breccia blocks; the northern room is larger than the southern room. There is no access internally between these spaces (Plates 22-25). Some parts of the walls in both rooms have been lime washed. The northern room has a concrete floor, and against the west wall concrete bases for machinery have been set into this floor. In the east wall are many holes for former beams, some still containing the studs of beams (Plates 26-27). Some of these may represent evidence for a partial first floor. Other, lower holes and areas of altered masonry are probably associated with a former building attached to the east side of the barn, which may have been a horse-engine house.

Plate 22: The northern end of the old barn, looking south (1m scale)

Plate 23: The northern end of the old barn, looking north (1m scale)

Plate 24: The southern end of the old barn, looking southwest (1m scale)

Plate 25: The southern end of the old barn, looking southeast (1m scale)

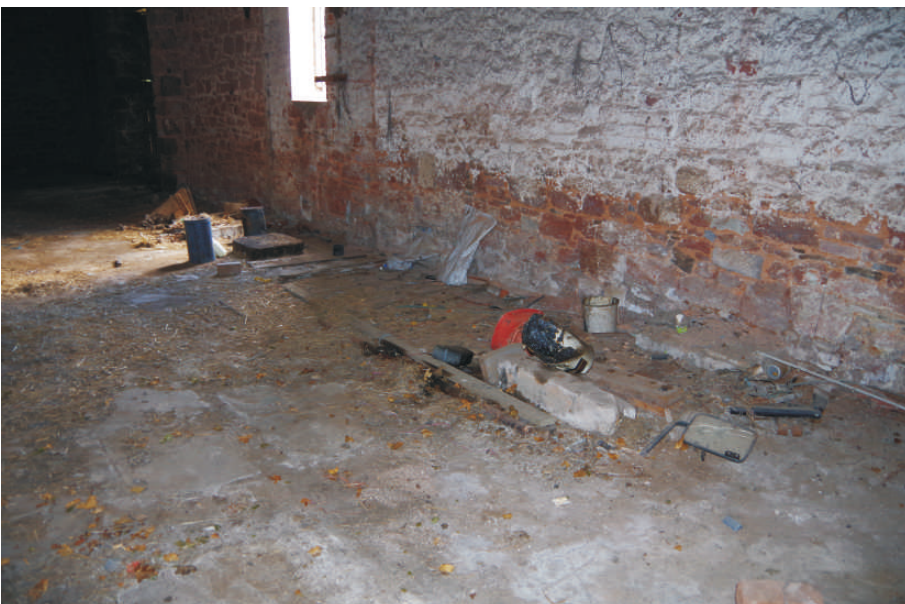
Plate 26: Concrete bases for machines in the northern end of the old barn, looking southwest

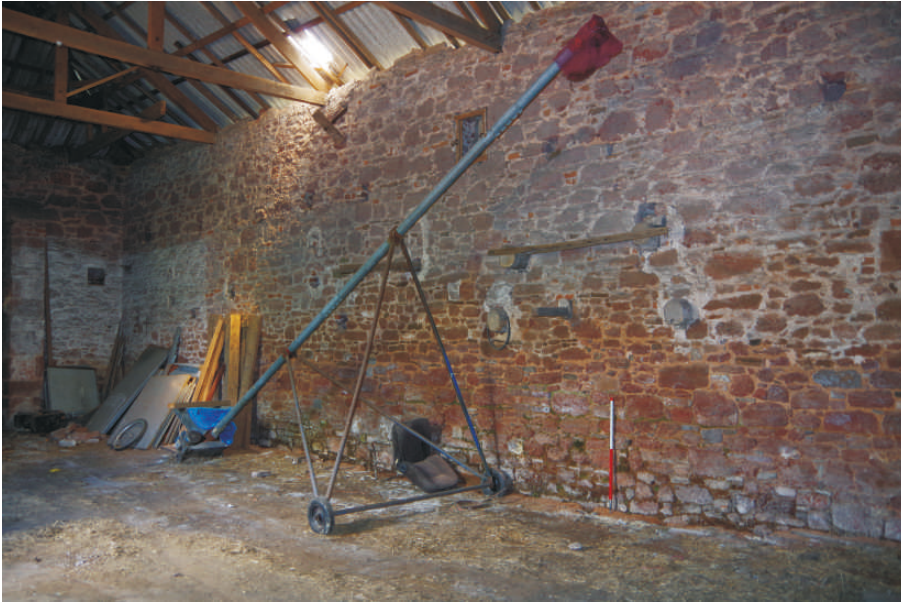
Plate 27: Holes for beams in the northern end of the old barn, looking northeast (1m scale)

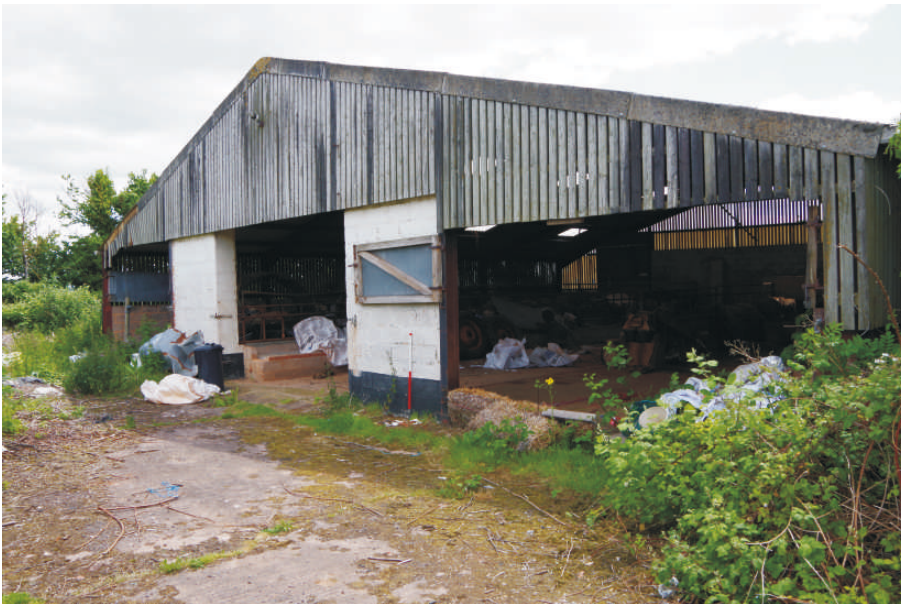
This barn has been added to the west side of the old barn. The lower portions of the walls are constructed using concrete blocks laid between steel posts that support the roof and wooden slats (providing ventilation) that form the upper parts of the walls (Plate 28). There are three large doors in the north elevation and a single door in the south elevation. The barn has a pitched roof with corrugated sheeting and plastic skylights.

Plate 28: The north elevation of the new barn, looking southeast (1m scale)

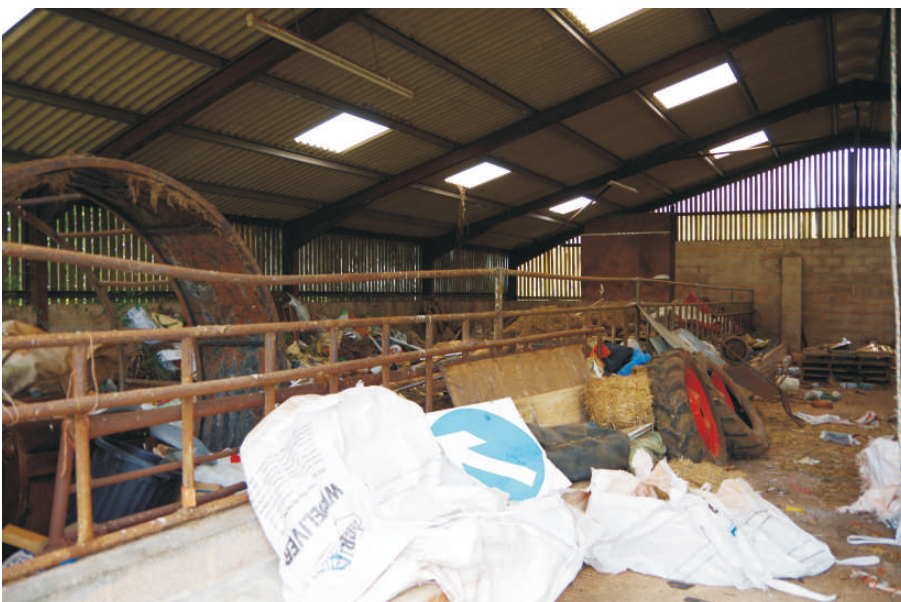
The building was used for housing livestock with large open pens for the animals, and with feeding troughs running north-south dividing the pens (Plate 29). There is a separate area to the west which does not contain troughs; this may therefore have been used for storage rather than as a separate animal pen. A concrete ramp in the southwest corner of the barn leads into the old barn. There is no evidence for the structure on the east side of the old barn depicted on historic mapping.

Plate 29: The new barn, looking south east
