FORMER CAR PARK OF THE SEVEN STARS INN,  
KENNFORD, KENN, DEVON

Results of an archaeological watching brief

Planning reference: Teignbridge District Council  
14/02407/FUL, condition 5

Document No: ACD1045/2/1

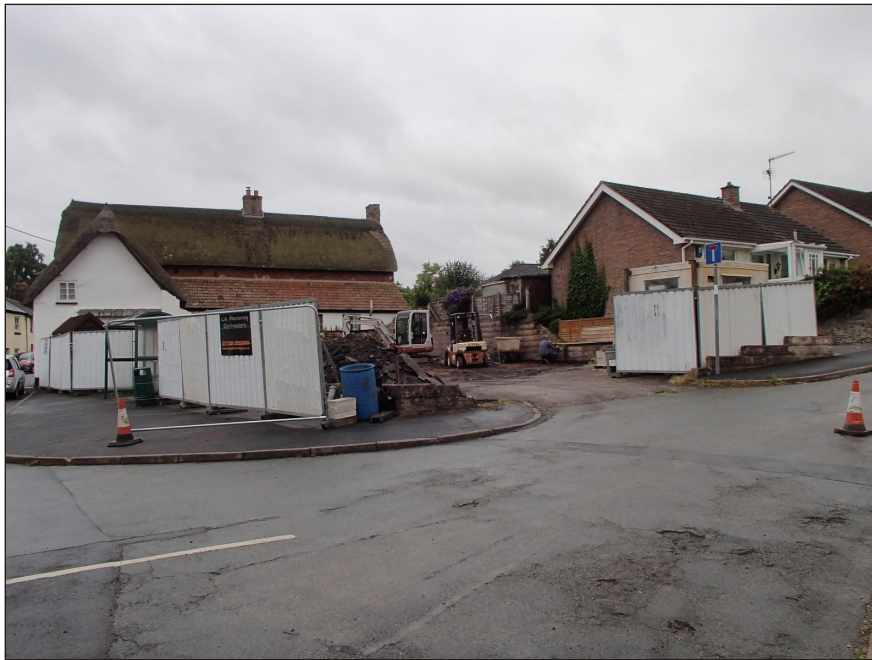
Plate 1: General view of the site, viewed from the northeast

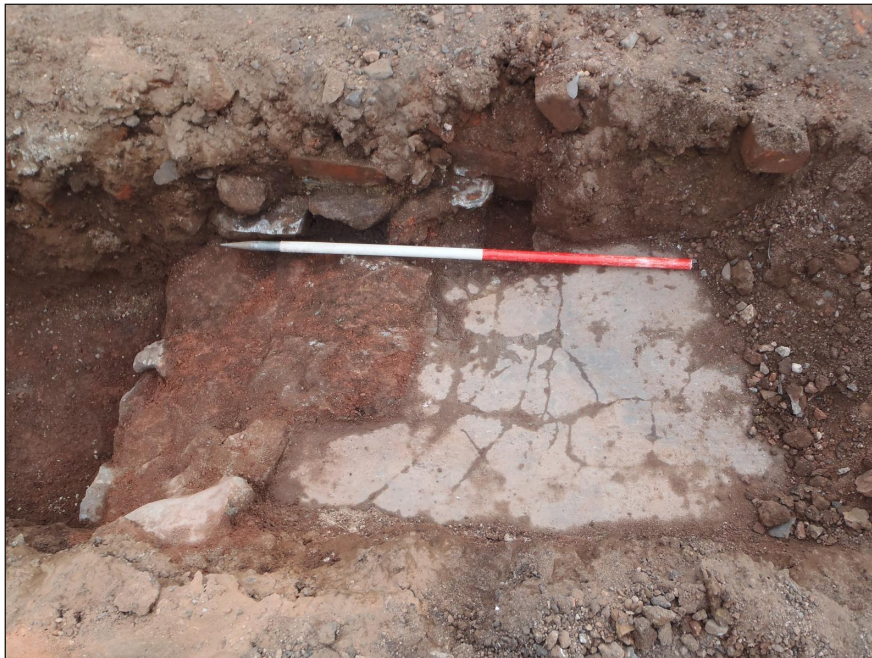
Wall 005 was aligned N-S and exposed over a length of 0.80m. It was generally 0.40m wide with an extension to 0.70m wide on the east side where a cement floor (004) was exposed. It was constructed of grey sandstone blocks measuring up to 0.25 by 0.20 by 0.10m, with only a single course surviving that was bonded using red sandy clay.

Plate 2: Wall 005, viewed from the south (scale 1m)

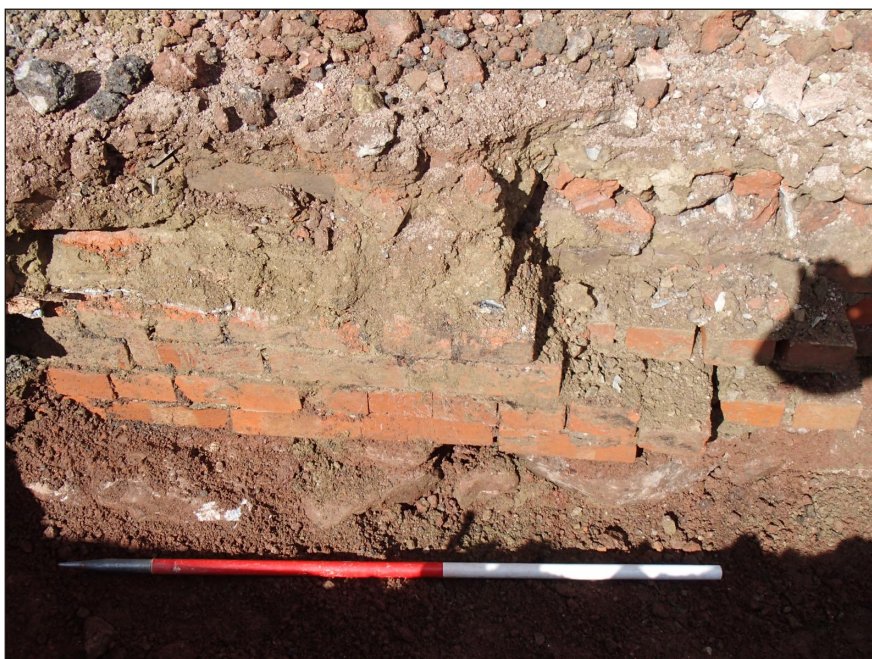
Wall 014 was exposed for a length of 1.65m as an elevation in the west side of a north-south aligned foundation trench. It was up to two courses and 0.20m high constructed of grey sandstone blocks measuring up to 0.15 by 0.10m and poorly bonded with red clay and patches of white lime mortar. It appeared to have been used as the footings for a modern brick wall (015).

Plate 3: Wall 014 beneath brick wall 015, viewed from the west (scale 1m)

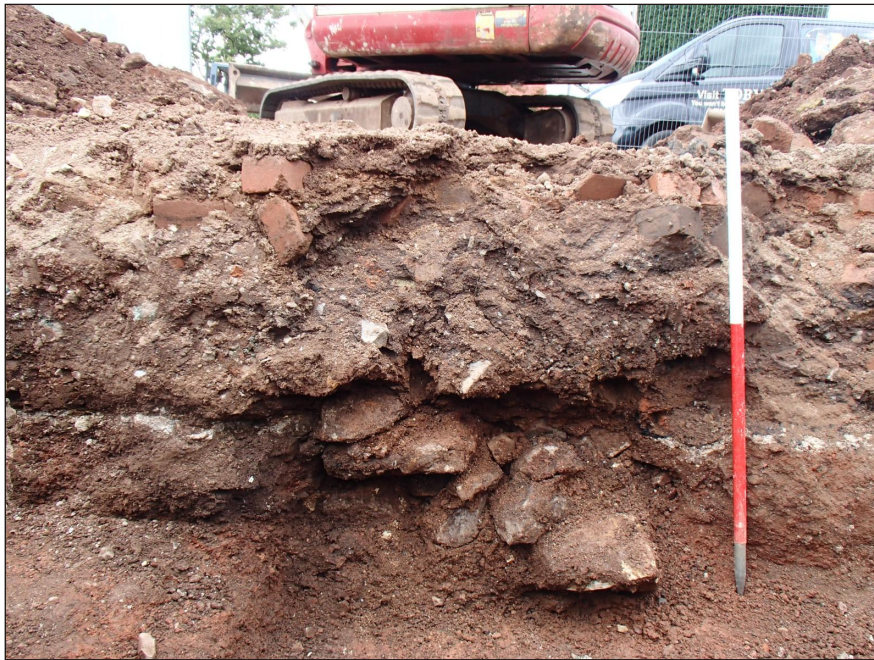
Wall 016 was exposed for a length of 3.20m and measured 0.80m wide and survived to a maximum height of 0.50m in up to six courses. It was constructed of (often large) grey sandstone blocks, some measuring at least 0.50 by 0.35 by 0.30m, in rubble coursing and bonded in a soft light yellow lime mortar with flint/chert inclusions. It formed the southwest corner of a building. The wall had been constructed within a foundation trench (F017). It appears that the wall was still standing, although as a boundary rather than a house wall, when a concrete layer (019) was laid, abutting it on either side and sealing on the external west side a garden deposit (018). The top of the concrete layer was covered with evidence of burning presumably related to the patches of evidence for conflagration on the building to the south.

Plate 4: South-facing section of wall 016 (scale 1m)

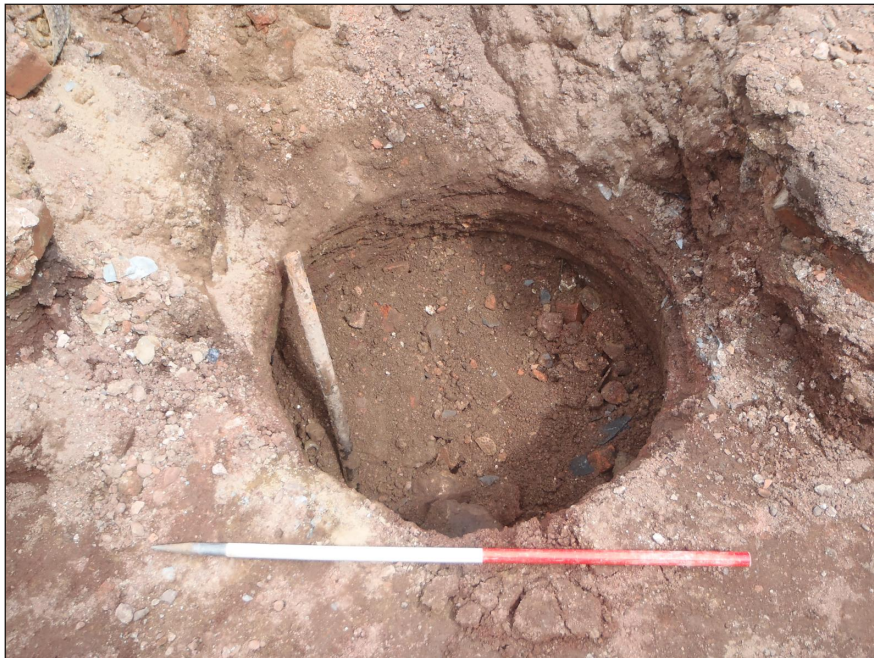
Well F010 was located in the southwest of the site and measured 1m in diameter. The well had a modern capping of slate slabs and brick bonded with cement. Although there was a void beneath the capping this was probably due to the settling of a backfill (009) consisting of greyish brown clayey silt.

Plate 5: Well F010, viewed from the west (scale 1m)

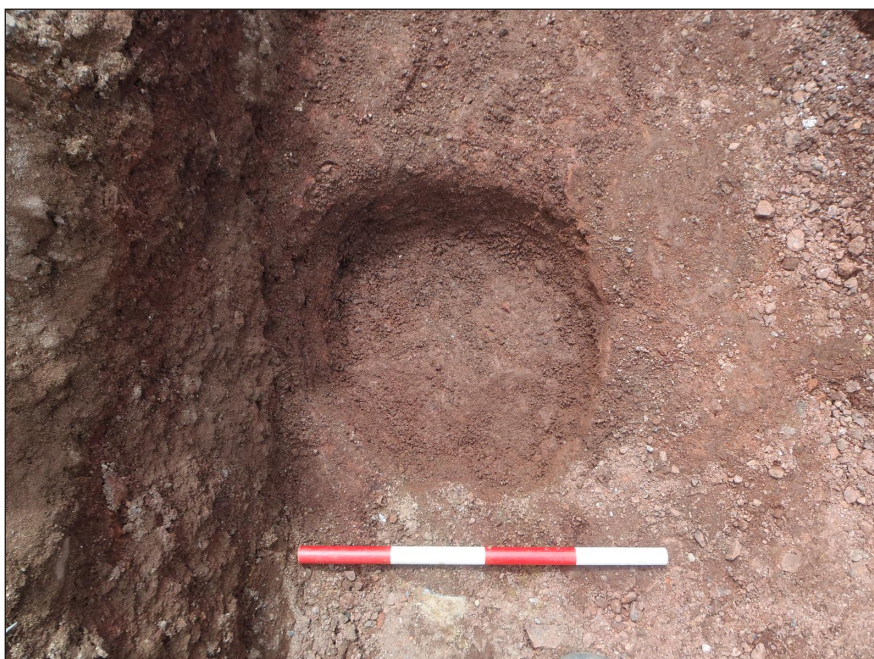
Probable posthole F012 was located 0.95m northwest of well F010. It measured 0.45m long, 0.30m wide and 0.11m deep. It contained a single fill (011) consisting of greyish brown silty clay from which there were no finds.

Plate 6: Posthole F012, viewed from the north (scale 0.40m)
