PAIGNTON PARISH VILLAGE HALL, CHURCH PATH, PAIGNTON, DEVON

Results of an archaeological excavation

Torbay Council planning ref. P/2014/0544, condition 1

The Bishop's Palace: Scheduled Monument (National Heritage List no. 1020764)

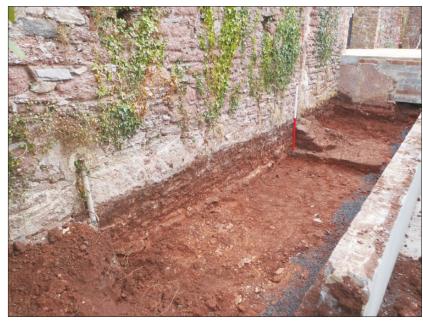
Plate 2: Post-excavation view of the trench, looking northeast (scale 1m)

The excavation comprised the removal of made ground and garden soils to a depth of 0.50m on to a deposit of soft red silty clay (1001). Very slighting projecting footings of the main curtain wall (303) were exposed just above the base of the excavation. The footings for the north-south wall (304) were exposed along with an early demolition deposit (1000). Where possible the context numbers have been retained from the 2012 recording (Passmore 2013), with 1000+ numbers allocated for newly exposed contexts; Figures 2 and 3 are also updated from the earlier report.

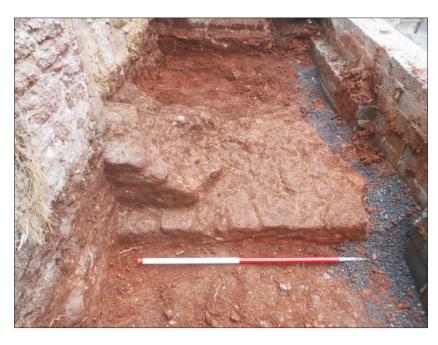
Plate 3: Wall 304, looking east (scale 1m)

Wall 304 was aligned N-S and exposed over a length of 1.35m. It was generally 1.0m wide with a step out on the west side. It was constructed of well-laid blocks of breccia and limestone. Wall 304 is the same build as curtain wall F303. Its base was not exposed.

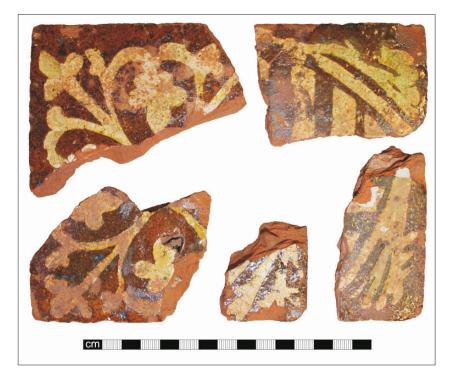
Plate 4: Medieval floor tiles; *left* foliate design, *right* Arms of de Clare

All of the tiles appear to have originally been square with the exception of the most complete tile, which was triangular. The triangular tile is a quarter of a square tile (of extrapolated original dimensions 133mm by 90mm by 90mm), which appears to have been scored to a depth of 6-8mm along the diagonals prior to firing and broken along these lines once fired. None of the square tile fragments has an original length preserved and none join together. Tile thickness varies between 17.5mm and 21mm. The base of one fragment has mortar adhering to it.

The designs, which are inlaid with white slip, are summarised in Table 1. All of the identifiable designs come from the 'stock repertoire' seen on Wessex tiles. Comparable tiles from Exeter date from the late 13th and early 14th centuries (Allan 1984, 232-3).

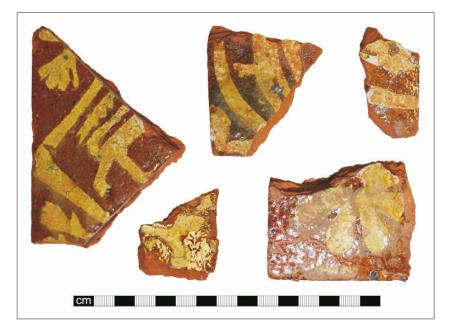
Plate 5: Medieval floor tiles; *left* Arms of England, *middle top* two birds, *bottom right* flower, *remainder* unidentified
