# COCKWOOD HARBOUR TEST PITS, COCKWOOD, DEVON

Results of an archaeological watching brief

Document No: ACD1197/1/0

Date: August 2015

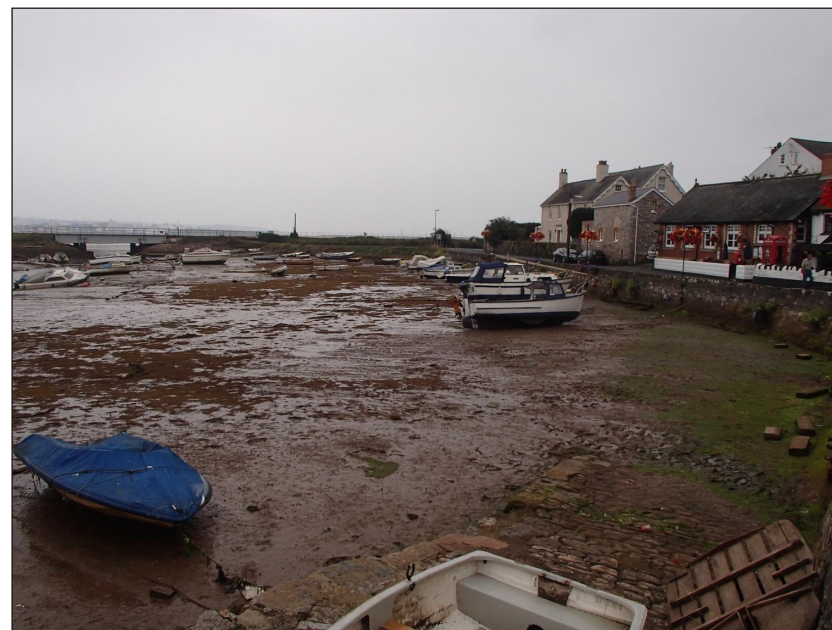
Plate 2: General view of area of test pits 2-4, looking southeast

- 5.1 Test Pit 1 was not excavated, but a stone was removed close to its location to assess the structure of the embankment wall. Test Pits 4-10 were located adjacent to the existing harbour wall (Plates 2-3). Test pits 2-3 were excavated approximately 0.40-0.50m from the harbour wall in the harbour sediments. A number of test pits contained deposits with modern ceramics, ceramic building material and glass. These materials were not retained and no finds of earlier date were observed.

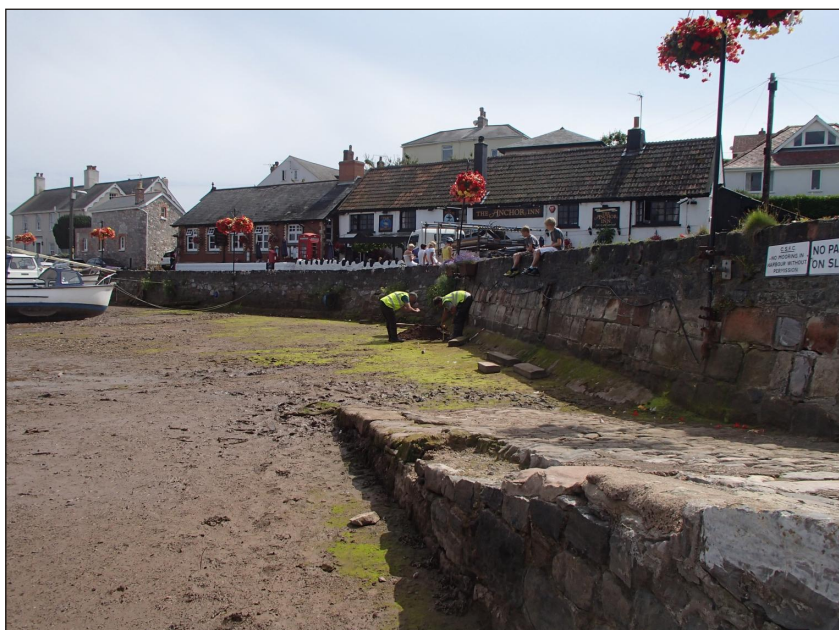
Plate 3: Excavation of test pit 4 in progress, looking south

Test Pit 4 measured 0.60m long by 0.40m wide and was excavated to a maximum depth of 0.75m below the current foreshore level. Deposits encountered comprised 0.25m of blackish

grey sandy silt loam overlain by reddish brown sand containing mixed stone inclusions and fragments of modern ceramics. The same cement footing as recorded in Test Pit 3 was present. Beneath this the harbour wall was projected out in a northeast direction before becoming vertical again at the base of the intervention.

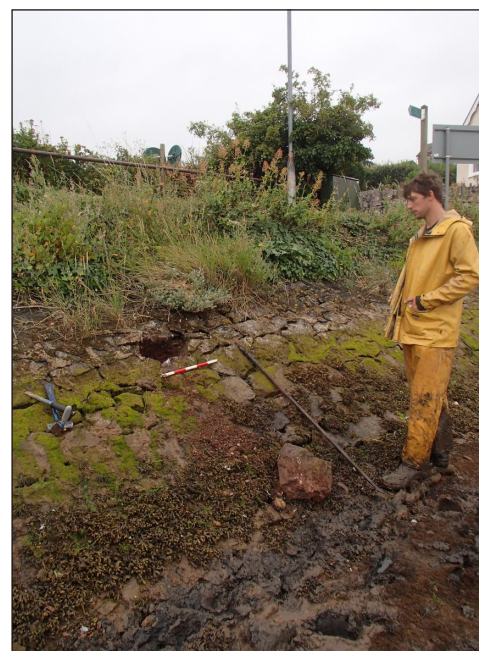
Plate 4: Stone removed from embankment wall adjacent to proposed location of test pit 1, view to southwest

Works in the area of proposed Test Pit 1 comprised the removal of a stone block from the upper course of the lower section of the harbour wall. The wall here is battered at approximately 45° to the foreshore. The removal of the stone showed that the lower part of the harbour wall is formed from a single layer of mortar bonded masonry constructed over an earthen bank.

**6.2** The earthen core of the causeway carrying the Exeter to Dawlish Warren road was exposed adjacent to the proposed location of Test Pit 1. This appears to be encased in a single layer of mortar-bonded masonry. It was not possible to establish whether the masonry cladding is a later addition or whether it is contemporary with the initial construction of the causeway. This probably post-dates 1848 and this area is not embanked in Dawson's watercolour. It is,

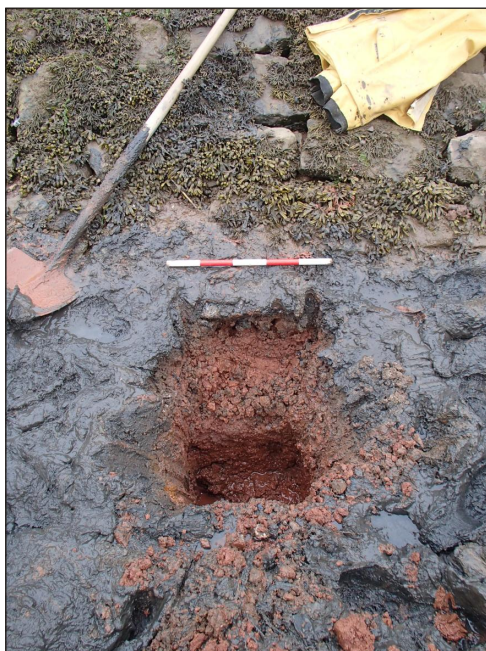
Plate 5: Test pit 2, looking southwest (scale 0.5m)

Test Pit 2 measured 0.50m long by 0.40m wide and was excavated to a depth of 0.70m below the current foreshore level. Deposits encountered comprised 0.55m of orange sandy gravel aggregate overlain by 0.15m of greyish brown sandy loam.

A further small section of the upper course of the lower harbour wall was removed. This revealed the same method of construction as outlined in Test Pit 1 (see 5.2 above).

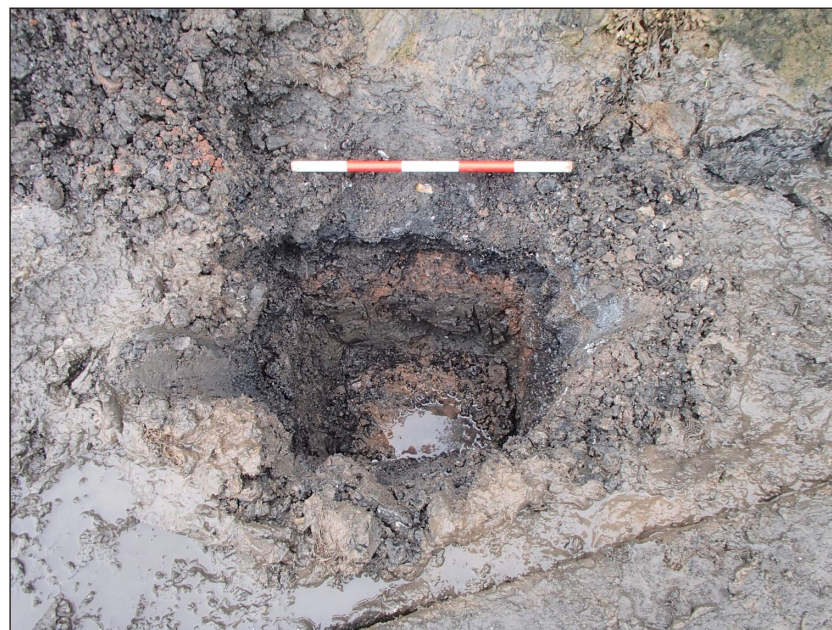
Plate 6: Test pit 3, looking southwest (scale 0.5m)

Test Pit 3 measured 0.55m long by 0.40m wide and was excavated to a depth of 0.60m below the current foreshore level. Deposits encountered comprised 0.30m of grey estuarine silty clay overlain by up to 0.30m of sandy gravel aggregate. At a depth of 0.20m below ground level a stepped cement footing was recorded protruding from the lower section of the harbour wall. A layer of highly organic silty clay with abundant ceramic fragments was recorded overlying the cement footing and abutting the sandy aggregate.

- 6.4 The presence of a cement footing, modern aggregates, and deposits containing modern materials adjacent to a number of sections of harbour wall are indicative of 20th-century interventions, possibly representing strengthening works, associated with the harbour wall structure.

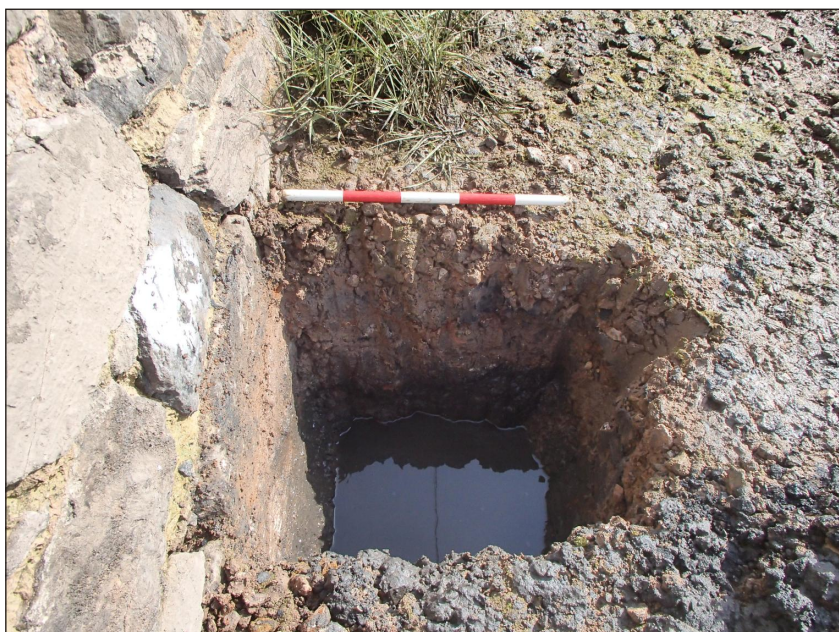
Plate 7: Test pit 9, looking northeast (scale 0.5m)

Test pit 9 measured 0.55m long by 0.40m wide and was excavated to a maximum depth of 0.60m below the current foreshore level. Deposits encountered consisted of 0.35m of dark blackish grey sandy silt loam overlain by 0.25m of mid brown sandy loam.

Two cores were drilled, located above Test Pits 9 and 10. These established that the wall was between approximately 0.72m (above Pit 9) and 0.80-0.85m thick (above Pit 10), and was constructed largely of solid stone blocks possibly with some looser core material.

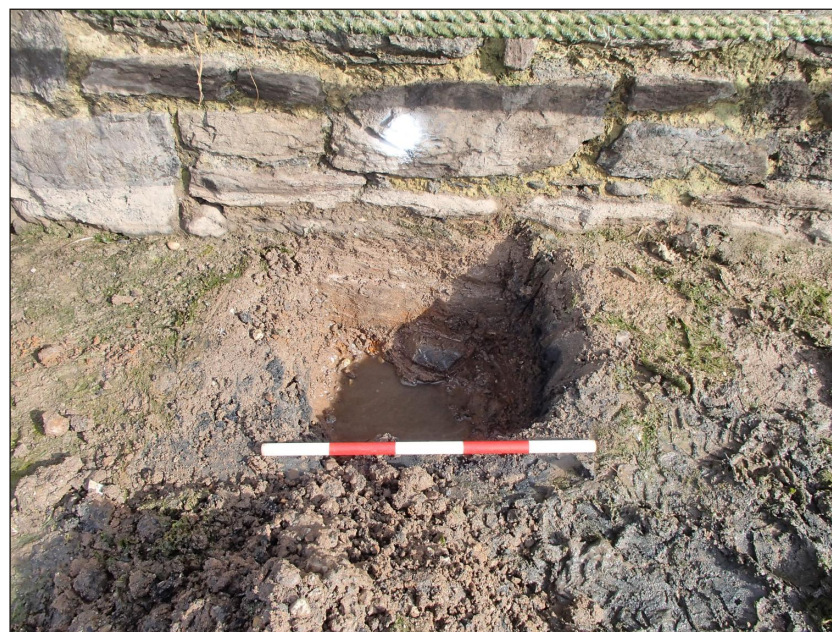
Plate 8: Test pit 10, looking north (scale 0.5m)

Test pit 10 measured 0.45m long by 0.40m wide and was excavated to a maximum depth of 0.30m below the current foreshore level. At the base of the intervention a layer of very compacted mixed stones were present overlain by a layer of mid brown sandy loam.
