LAND AT CASTLE HOUSE, LYDFORD, DEVON

Results of archaeological investigations

Dartmoor National Park Authority planning reference:
0422/14 (Condition 3)

Report No: ACD1284/2/1

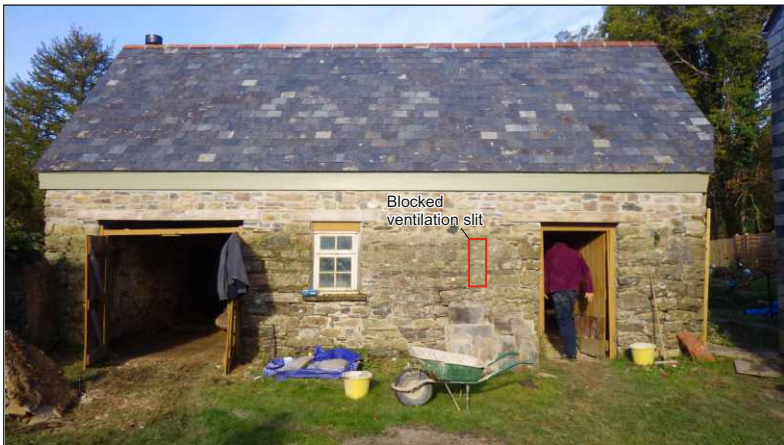
The interior of the outbuilding measured approximately 8.5m in length and 4.2m wide. Removal of an existing concrete surface exposed earlier floor surfaces. These consisted of a cobble surface in the northeast portion and a slightly elevated random slab slate to the southwest (110), which were separated by granite kerb stones (109). This kerbing consisted of two granite blocks measuring 0.1m wide. Separately, they measured 2.40m and 1.30m in length. The surfaces were set into a mid grey silty-sand bedding layer. No finds were recovered.

Plate 2: Showing front elevation of outbuilding. View to northwest

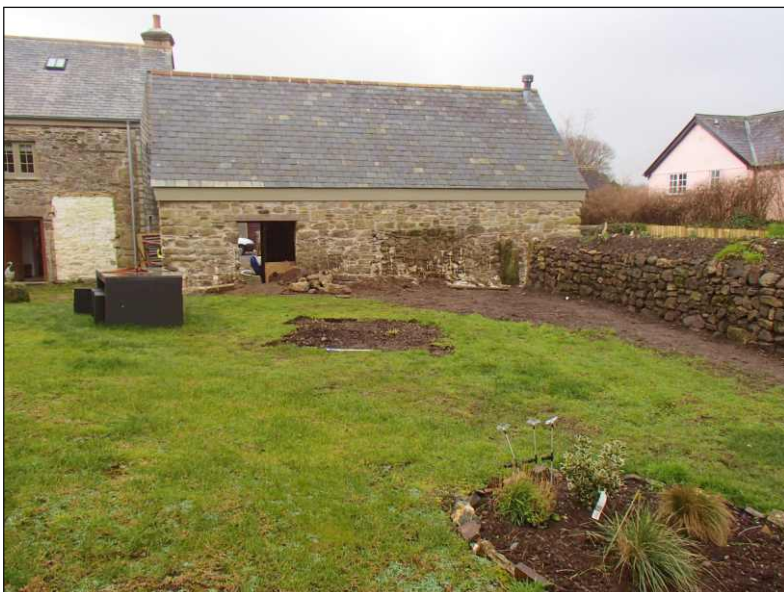
Plate 3: Showing rear elevation of outbuilding. View to southeast

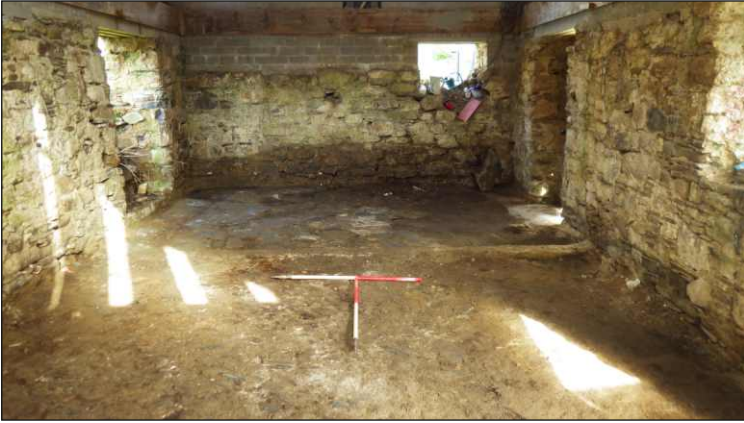
Plate 4: Showing interior of outbuilding with cobble surface 108 and slate surface 110 visible. View to northeast (scales 2 x 1m)

6.1 The monitoring of groundworks during the conversion of the outbuilding, which was of probable 18th to early 19th century date, exposed surfaces beneath an existing concrete floor. These show that the internal area was subdivided by granite kerb 111. The area to the northeast of this, which was covered with slate flooring 110, was more level and slightly elevated above cobbles 108 to the southwest. Its position between two opposing doors, the rear of which had associated granite threshold 112, suggests that it represented a walkway through the building linking the yard to the southeast with the plot to the rear. The remaining area of the outbuilding covered by the cobbled surface may have functioned as a store or possible shippon (animal shed). Indeed, evidence for a blocked ventilation slit present on the front elevation is consistent with this interpretation (see Plate 2). It also suggests that the window openings were a later addition. No evidence for the building having been previously larger, as suggested on the 1846 parish tithe map, was exposed.

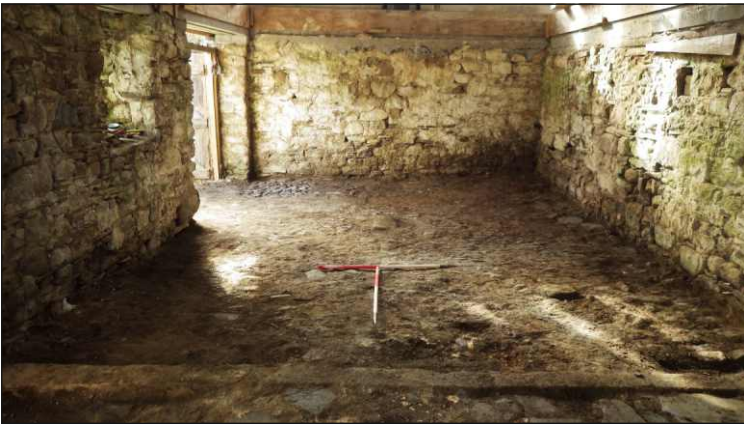
Plate 5: Showing interior of outbuilding with cobble surface 108 and granite kerb 111 exposed. View to southwest (scales 2 x 1m)

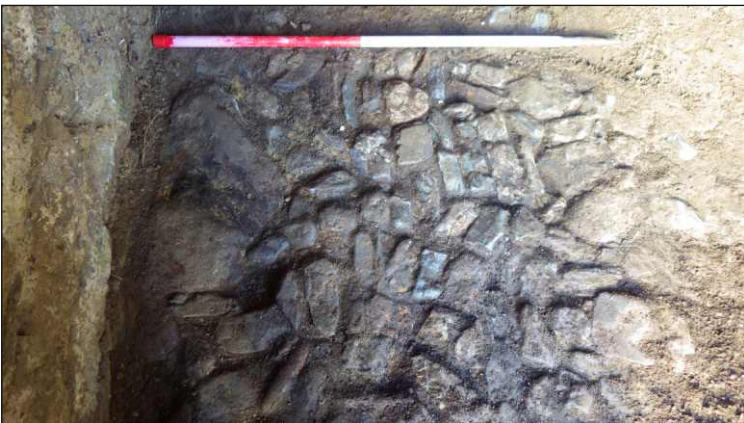
Plate 6: Detailed view of cobble surface 108. Looking northwest (scale 1m)

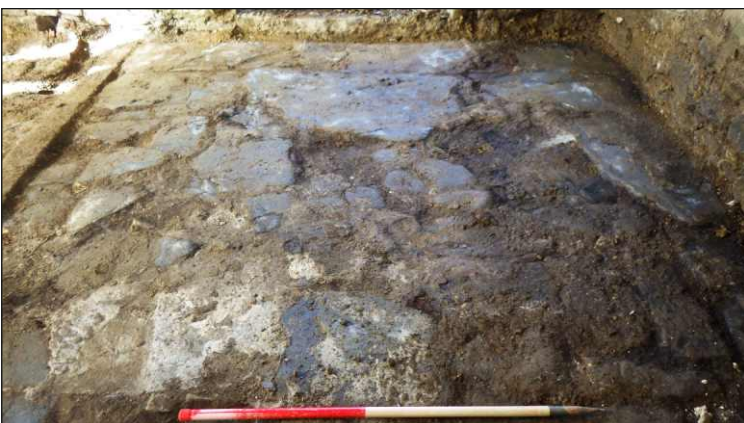
Plate 7: Detailed view of slate surface 110. View to southeast (scale 1m)

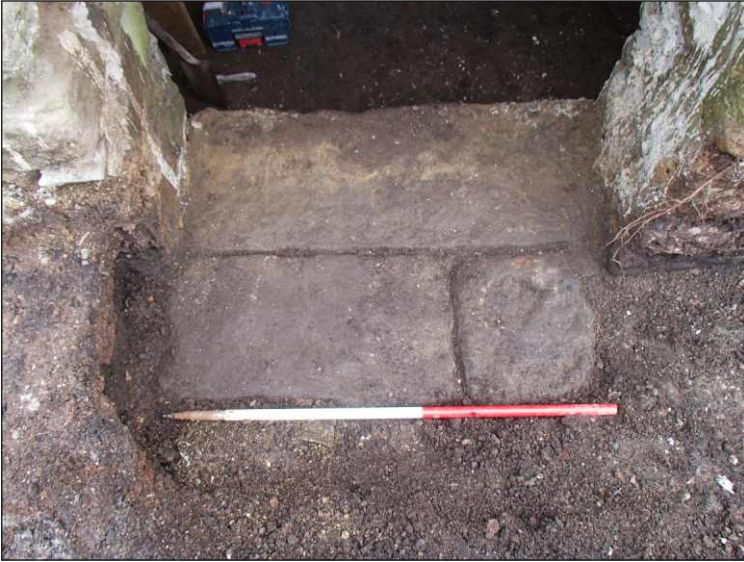
An area excavated on the northwest side of the outbuilding around an existing doorway exposed a threshold (112). This measured 1.10m long, 0.5m wide and was comprised of two granite blocks.

Plate 8: Showing granite threshold 112.
View to southeast (scale 1m)

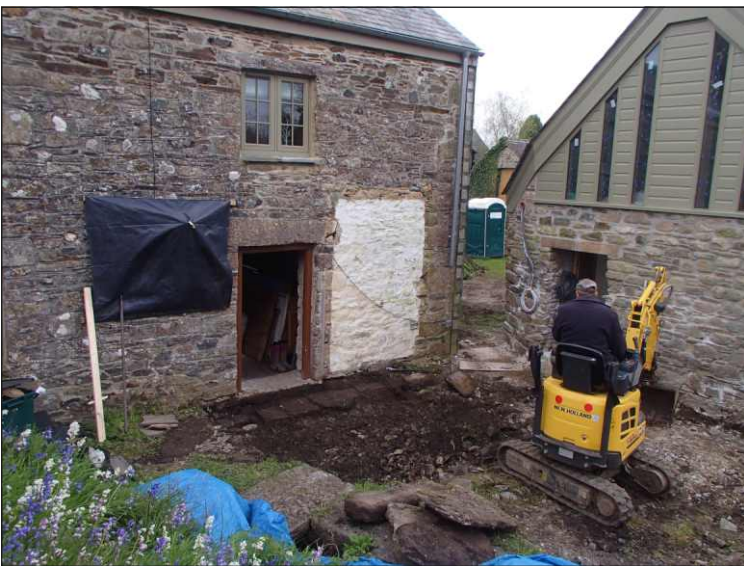
Natural subsoil (101) was exposed in the area for the new link at a depth of 0.12m below existing levels. The excavations exposed a stone drain (F113) that extended along the rear wall of Castle House. It measured 0.5m wide, 0.34m deep and was constructed from c.0.2m long granite vertically placed blocks, capped with slate slabs of up to 0.35m long (S111). Drain trench F113 was backfilled with a dark brownish-grey silty-loam (115) and the drain was silted up with a mid brownish-grey silty-loam (116). No finds were recovered.

Plate 9: General working view of
groundworks for new link. View to south

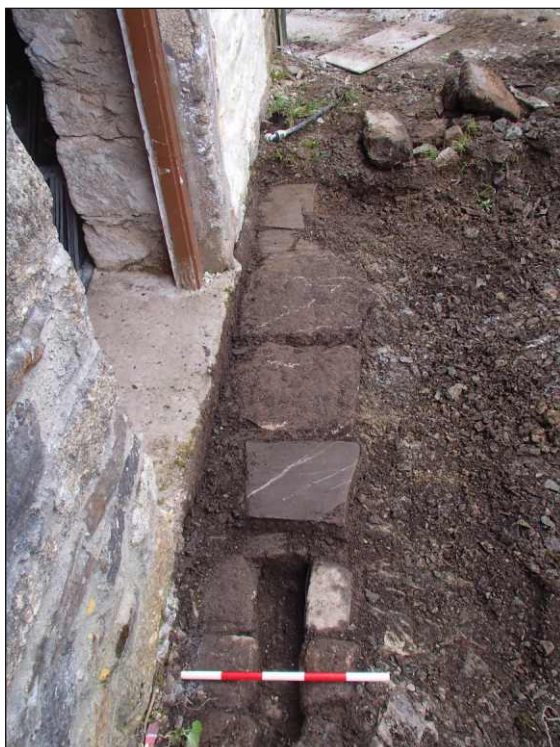
Plate 10: Showing stone drain F113.
View to southwest (scale 0.5m)

6.2 The stone drain (F113), which was exposed to the rear of Castle House, was of probable 19th century date and clearly associated with the existing house.

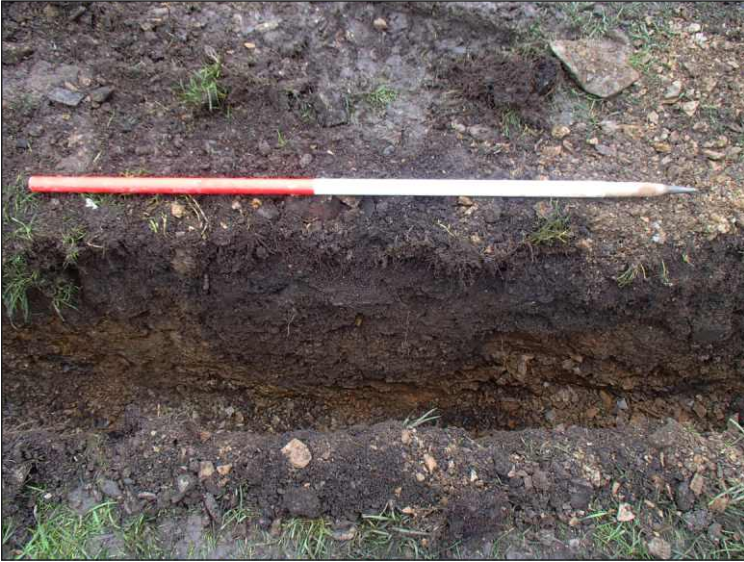
Possible ditch F104 was aligned northeast to southwest. It measured 0.62m wide and 0.36m deep with steeply-sloping sides and a concave base. The possible ditch contained a dark brown silty-clay fill (103) with rare charcoal fleck inclusions. No finds were recovered.

Plate 11: Possible ditch F104. View to southwest (scale 1m)

6.3 The two possible ditches exposed to the rear of the outbuilding were undated. Based on their dimensions, they may have represented simple plot divisions or drains. No boundaries in these locations are depicted on the Lydford parish tithe map or the Ordnance Survey editions. Their alignments, which respect those established by the Saxon village and subsequently maintained, therefore have the potential to have represent earlier origins than the existing Castle House property..

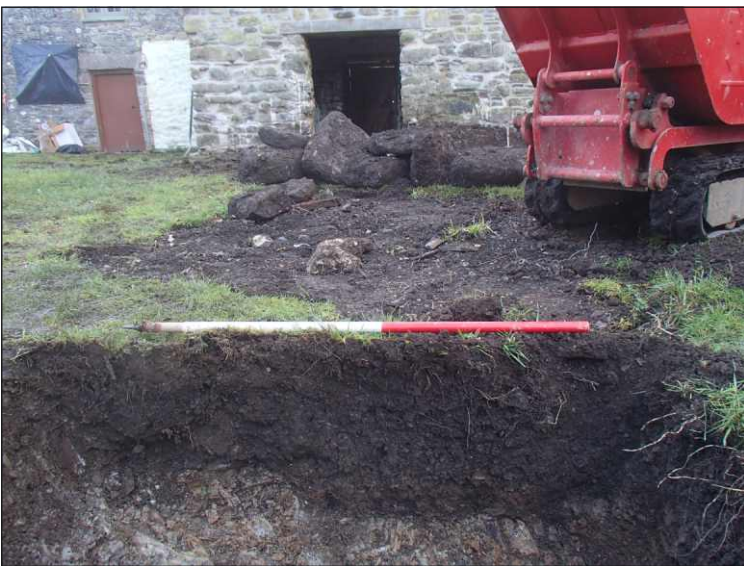
Possible ditch F107 was aligned northwest to southeast and measured 0.88m wide and 0.3m deep. It had steeply-sloping sides and a concave base. The possible ditch contained a dark brown silty-clay fill (108) with occasional charcoal fleck inclusions. No finds were recovered.

Plate 12: Possible ditch F107. View to southeast (scale 1m)
