BROOK COTTAGE, PRESTON, TORBAY

Results of historic building recording

Torbay Council planning reference P/2015/0342, condition 4

Document No: ACD1261/2/1

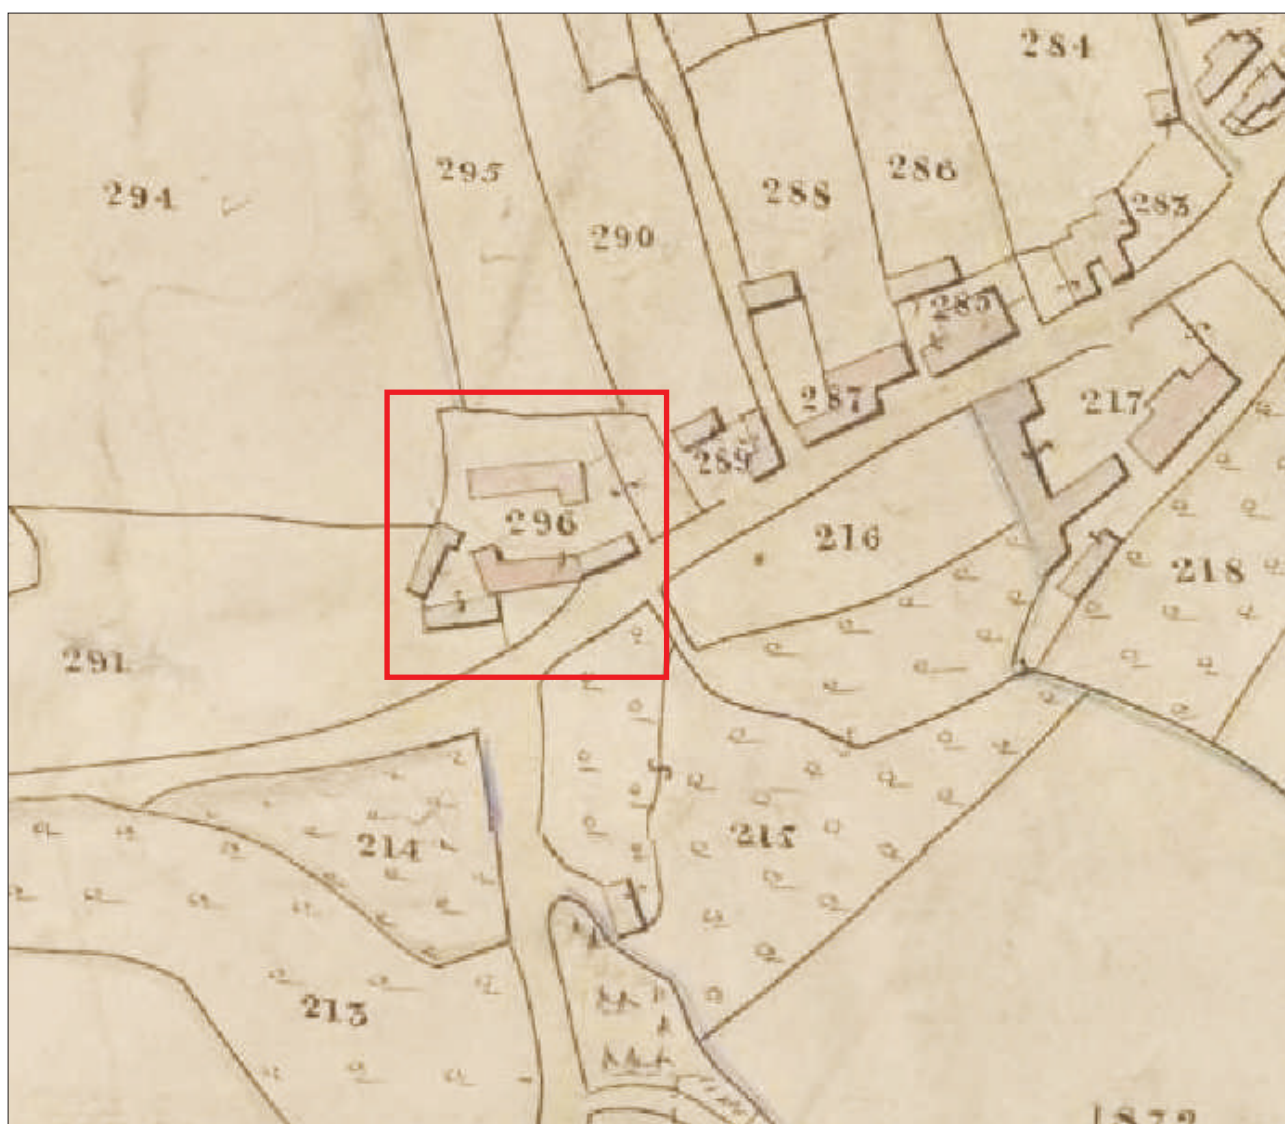
Fig. 2: Extract from the Paignton
tithe map of 1840

- 2.2 The 1840 Paignton tithe map (Fig. 2) depicts the area prior to the residential expansions of the later 19th and early 20th centuries. Brook Cottage is located within plot 296 situated at the west end of the hamlet of Preston, to the north of Old Torbay Road, which then passed to the north of the present A3022 Torquay Road. The property sits opposite the junction with another road running south towards, and east of, the historic core of Paignton. Plots with shapes characteristic of medieval strip fields are aligned onto both these roads. Plot 296 appears to have been taken out of several of these plots, implying a late medieval or early post-medieval foundation date for the property. The map depicts the site as two ranges of roughly east-west aligned buildings, coloured as houses, along with a further three structures probably representing outbuildings. The accompanying apportionment describes the plots as a

- 6.1** The early origins of the building now known as Brook Cottage are unknown. However, the northern range represents the western end of a large house depicted on the 1840 Paighton tithe map. Given the length of this building, it is possible that it was a traditional, vernacular cross passage house. The present northern, flat-roofed section would appear to be a later rear extension, but there is currently no architectural evidence for this. It is possible that the west elevation of this range has been rebuilt.

- 6.2** In 1840 the southern range was depicted in non-domestic use, presumably an agricultural outbuilding. The western extension had been added by this date. There is no architectural evidence for its function.

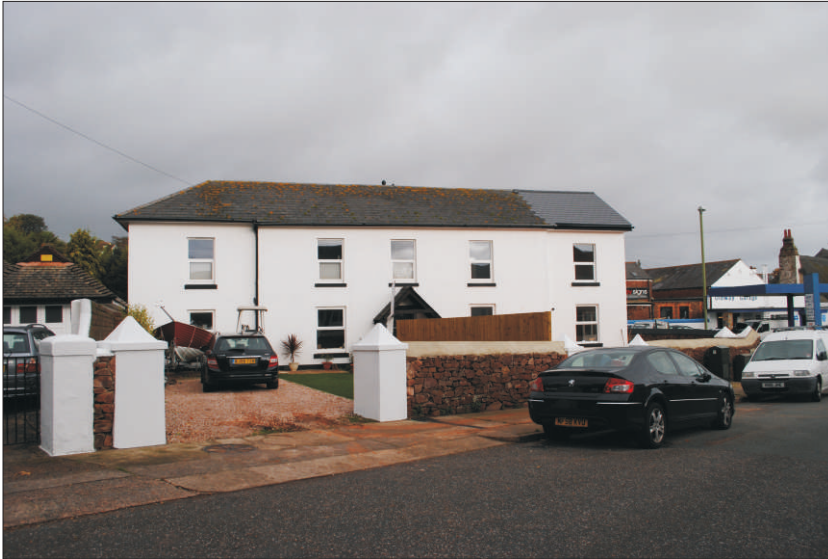
The main elevation (on the southern range) fronts onto Manor Crescent (Plate 1). It is rendered, with asymmetric fenestration. However, the central core of the building is symmetrical, with a pair of windows flanking a central doorway. This has six panels with the top two being stained glass with flower decoration. It is covered by a wooden porch with a pitched slate roof. There is a further window in the west room, and there was a large curving window in the modern east extension. There are four windows on the first floor, located directly over the ground-floor openings. All of the windows are modern replacements. The modern eastern extension was single storeyed with a flat felt roof. It projected out slightly from the main elevation, and in addition to the window in the south elevation featured an external door in the west elevation.

Plate 1: General view of the main elevation, looking north

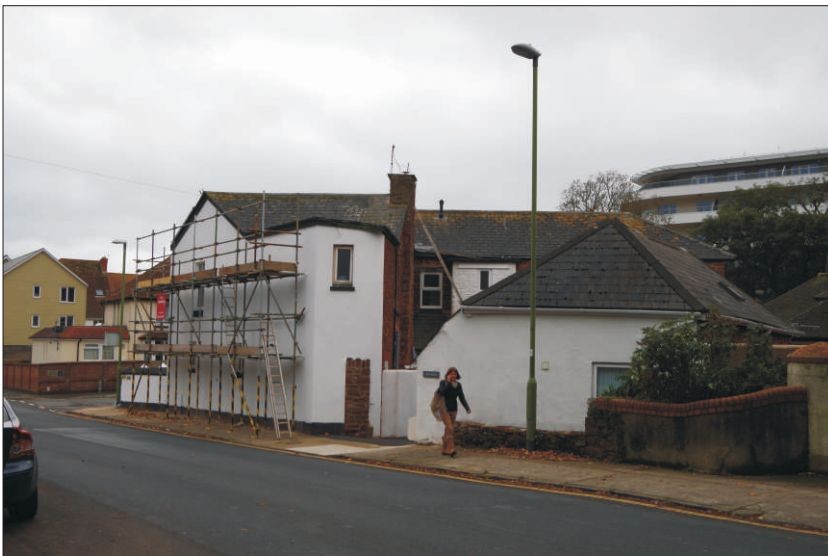
The west elevation of the southern range, along with the east elevations of the southern and northern ranges are also rendered, although the finish on the former is a recent addition and the breccia stonework was formerly exposed. There are no openings or features in this elevation. In the east elevation there is a single first-floor window in the southern range along with two windows on the ground floor of the northern range (Plate 2).

Plate 2: General view of the cottage, showing the east elevation, looking south

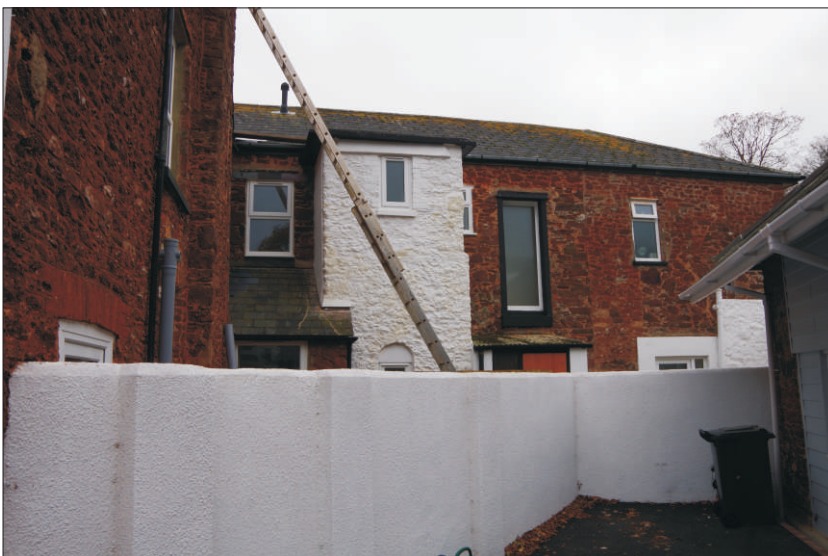
In the north elevation of the southern range (Plate 3) and the west elevation of the north range (Plate 4) the stonework is exposed, although some areas have been painted white. Two phases of masonry are visible in the main fabric of the north elevation, with the block to the west being an addition. Both builds are constructed in local breccia laid in rough courses with a pinkish white cement mortar. In the western masonry is a vertical break that does not extend the full height of the building. A possible horizontal break is also visible and these may be evidence that much of this elevation has been rebuilt. The whole elevation contains five modern windows of varying shapes and sizes, along with modern double doors on the ground floor of the west block. There are two extensions and a lean-to store. The eastern extension is a single storey and contains a window in what was previously a doorway opening. This is modern, and was a 20th-century porch. The western extension is earlier, two storeyed, constructed of painted stonework, and contains windows on each floor. Prior to conversion, this extension contained toilets on both floors, and it was probably constructed for this function. The store is modern, and is attached to the west of side of this extension. It is single storeyed and contains a window and a wooden door.

Plate 3: The north elevation of the southern range, looking south

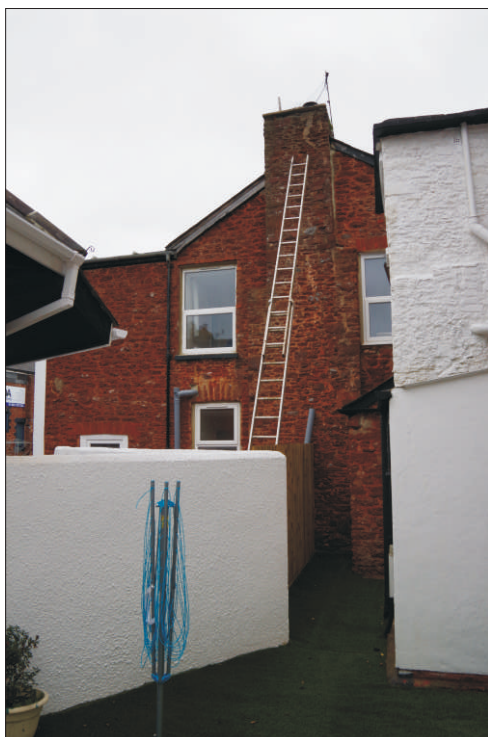
The west elevation of the north elevation incorporates a projecting chimney stack, with openings (all with modern fittings) to either side. On the ground floor there is a doorway into the former porch along with two windows; one has arched breccia voussoirs, whilst the other has an arched brick head. On the first floor there is a pair of windows, one with a flat brick head and the other with an arched brick head.

Plate 4: The west elevation of the northern range, looking east

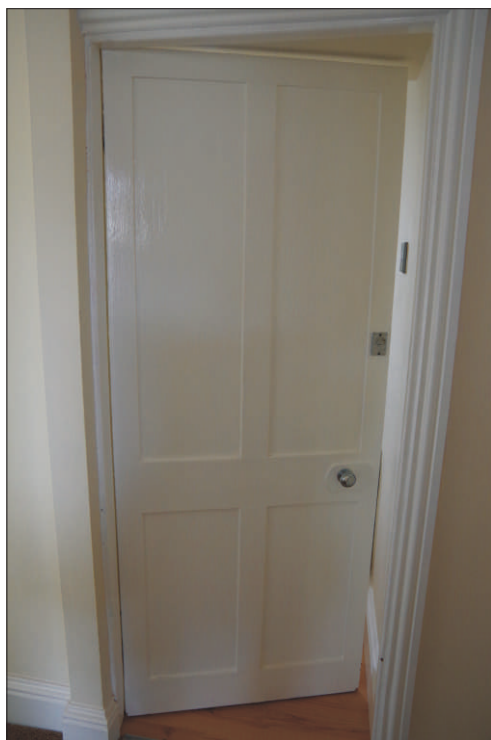
On the ground floor the southern range contained two principal rooms either side of a central corridor that incorporated the staircase to the first floor. Early 20th-century doors survive, and will be retained. Two of these are four- and six-panel doors, whilst the other three have additional simple moulding around the four or six panels (Plates 5 and 6). There are two large fireplaces on the ground floor. The eastern fireplace is wide, and has been heavily repointed, with a new wooden lintel added (Plate 7). The western fireplace is grander and retains its original polished dark blue marble surround and mantelpiece, along with a slate hearth defined by a brass rail (Plate 8). Either side of this fireplace there were formerly two arched recesses, probably originally for display cabinets. The southern recess has been converted into a doorway providing access into the western extension.

Plate 5: An example of one of the simple panelled doors

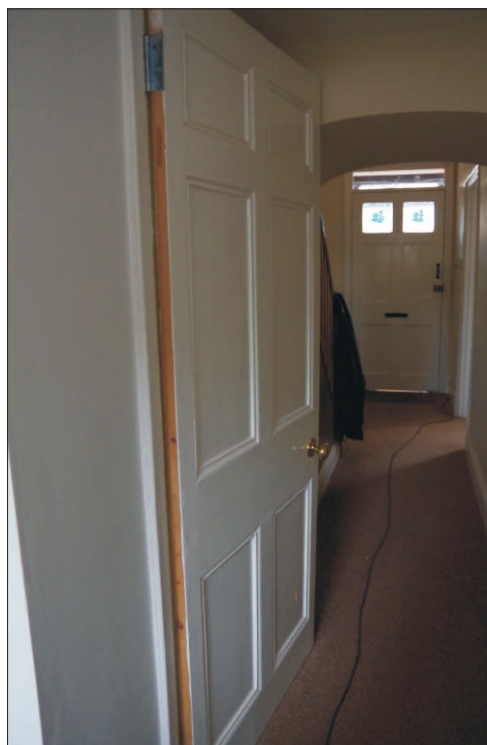
Plate 6: An example of one of the panelled doors with simple moulding

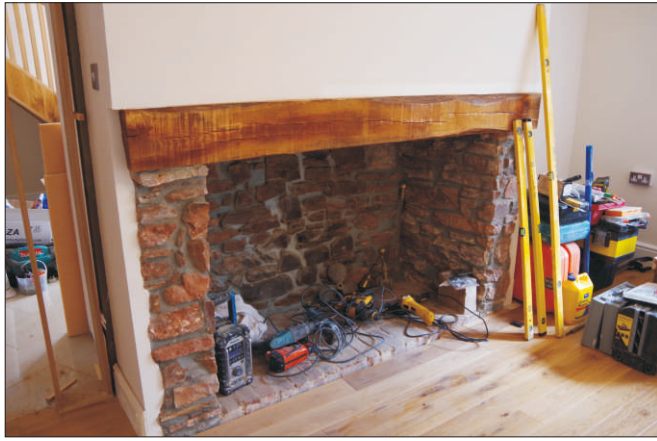
Plate 7: The fireplace in the former kitchen, looking southeast

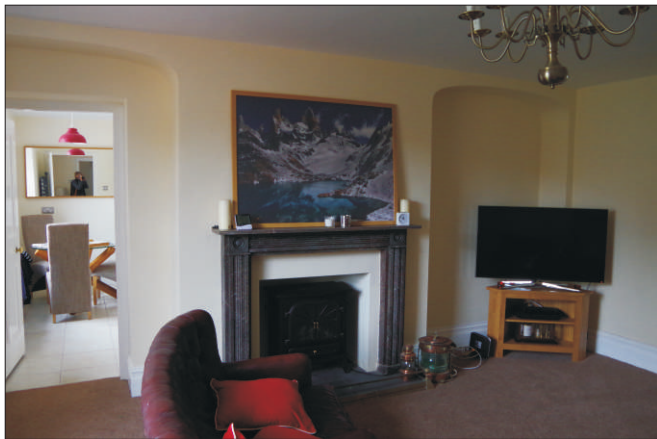
Plate 8: The fireplace and recesses in the former parlour, looking northwest

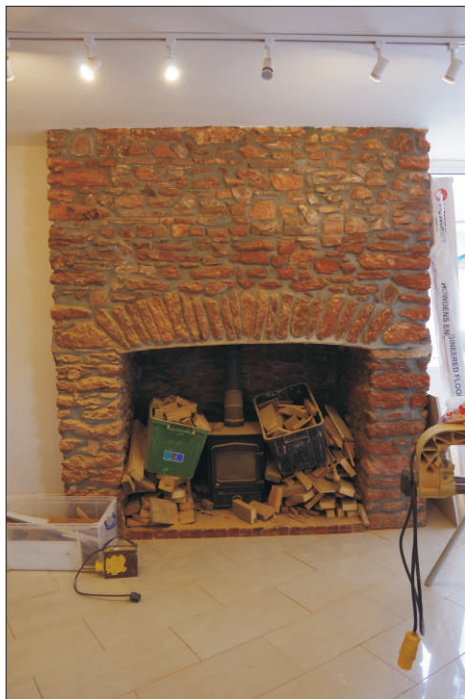
In the northern range there is an exposed fireplace in the west elevation. This has a slightly curved breccia head laid onto a cast-iron support plate (Plate 9).

Plate 9: The fireplace in the northern range, looking west
