CASTLE GREEN, TAUNTON, SOMERSET

Results of an archaeological watching brief

Scheduled Monument: Shell keep castle, part of the associated outer bailey, ninth century cemetery and a Civil War siegework at Taunton Castle (National Heritage List no. 1013541)

Document No: ACD1245/2/0

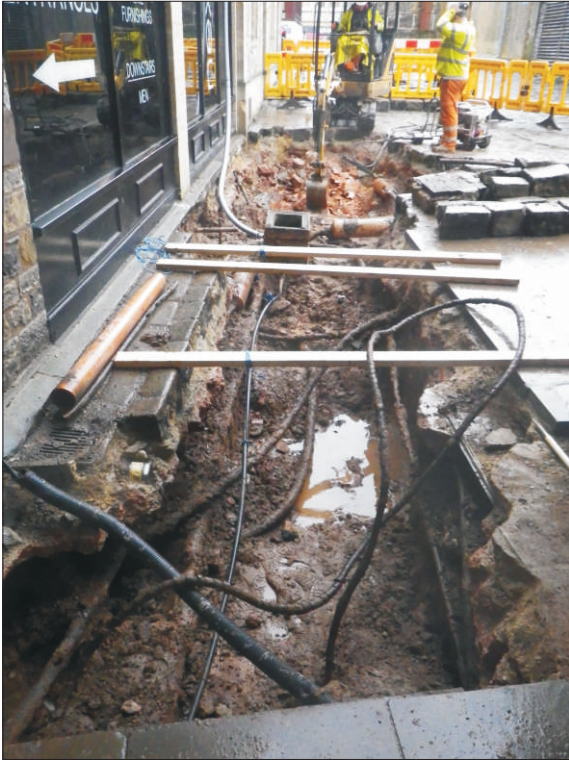
Plate 1: Castle Bow trench, Castle Walk, with work in progress, view from the north

A trench was excavated in Castle Walk which passed through the southern arch of Castle Bow and turned 90 degrees to continue within the south side of Castle Bow. The Castle Walk trench was north-south aligned and irregular in plan but in its final form measured approximately 10.5m long by 3.0m wide and was excavated to a maximum depth of 1.2m, but more commonly 0.9m (Plate 1). The Castle Walk and Castle Bow trenches were joined by a breach 0.15m wide. The Castle Bow trench was east-west aligned and measured approximately 5m long by 1.2m wide and up to 0.80m deep. Chunks of tarmac were present in deposits to at least 0.63m deep in this trench and in all areas it was clear that the deposits had been disturbed by buried services.

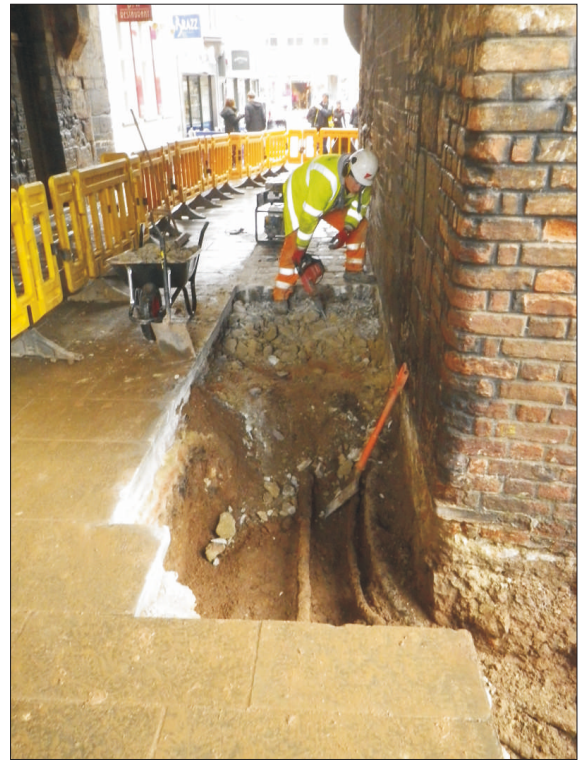
Plate 2: Castle Bow trench, Castle Bow, with work in progress, view from the west

Castle Bow is the former East Gate of the castle. It was substantially modified in the 19th century and incorporated within the building now occupied by the Castle Hotel. The watching brief trench passed in a narrow slot through the southern doorway (Door 452 in Webster 2016, fig. 15.1). This is a brick-arched doorway and Webster (*ibid.*, p. 244) states that it was probably inserted in 1822 when the meat market was built taking up the majority of the block to the south of Castle Bow, which covers an area previously occupied by the castle defences and the outer moat. The area to the south of the doorway forms a sub-square area with the Castle Green Inn to the west and 20th buildings to the east (replacements for the market building) which formed a pound area for the market (*ibid.*, fig. 6.1). Brick culvert or relieving arch S109 may also date to the period of the construction of the meat market. The trench had the potential to reveal remains of the foundation for Castle Bow where the doorway had been inserted, but these had been completely removed. No historic flooring was seen in Castle Walk or the passage of Castle Bow.

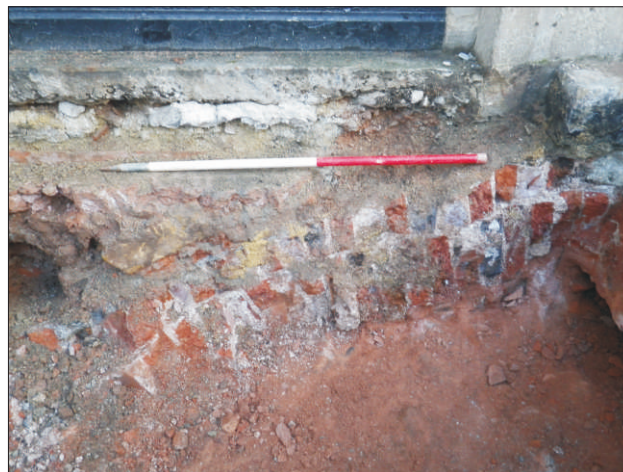
The remains of part of a brick culvert or relieving arch (S109) was recorded in the at the southern end of the Castle Walk trench; the structure continued beyond the limits of the trench to the south and west. It was aligned east-west with the head of the arch situated immediately beyond the limit of the trench to the south. The bricks were red, hard-fired and unfroged bonded by a hard light grey mortar containing charcoal flecking. No finds were recovered from this trench.

Plate 3: Castle Bow trench, Castle Walk, brick culvert S109, view from the west (scale 1m)

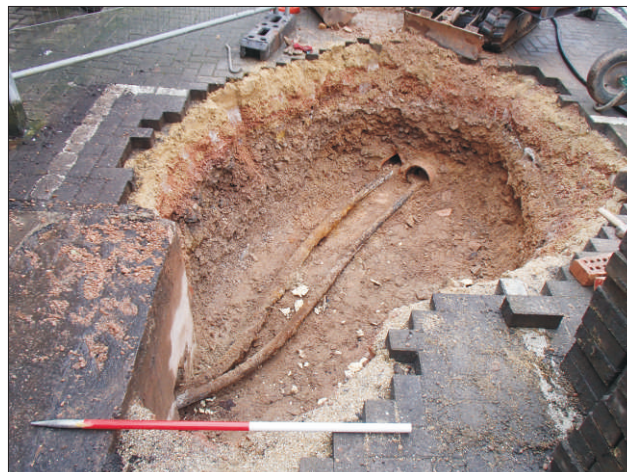
In the service yard to the east of Castle Walk an area of 2.40m long by 2.20m wide was excavated to a depth of 0.90m below the ground surface. The excavation revealed that the area was formed of backfilled material over a variety of modern services. No archaeological features were recorded in plan or section and no finds were recovered.

Plate 4: Castle Walk service area trench, view from the east (scale 1m)

The trench excavated in the Castle Walk service area had the potential to locate archaeological features and deposits related to the castle defences within the line of the outer moat at this location (*ibid.*). However, no features or deposits related to the castle defences were observed. In addition the trench was located in a position which would have been internal to the market constructed in 1822 and there was potential for the survival of features and deposits related to this structure. There were no features or deposits related to the meat market observed. The whole block within which the Castle Walk service area trench was located has been subject to re-development during the 20th century which appears to have destroyed the evidence for the historic use of the site.
