FORMER NEWTON ABBOT ISOLATION HOSPITAL, DEVON

Results of historic building recording

Teignbridge District council planning reference 13/01497/MAJ,
condition 8

Document No: ACD1329/2/1

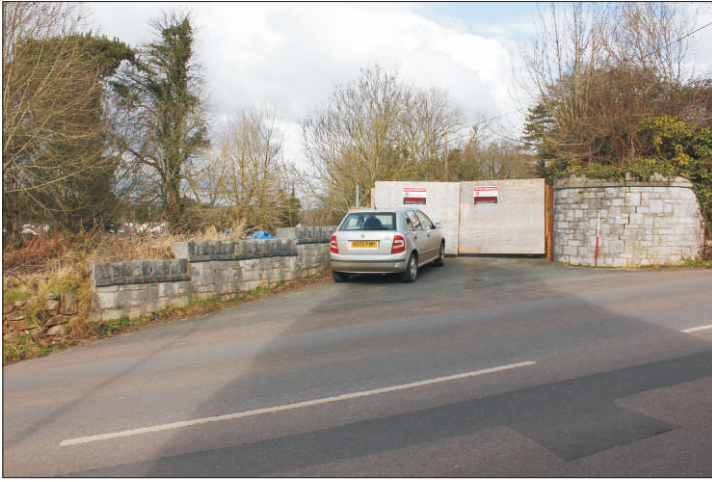
Plate 1: Main entrance, looking northwest (1m scale)

The main entrance is located on the north side of Old Totnes Road. The entrance walls are constructed of limestone blocks in a random bond with a crenelated top (Plate 1). To the east of the entrance the wall is rounded and is much taller than the wall to the west. There is a brick gate pier on each side of the entrance although the western one appears to have been reduced in height. The current gates are modern.

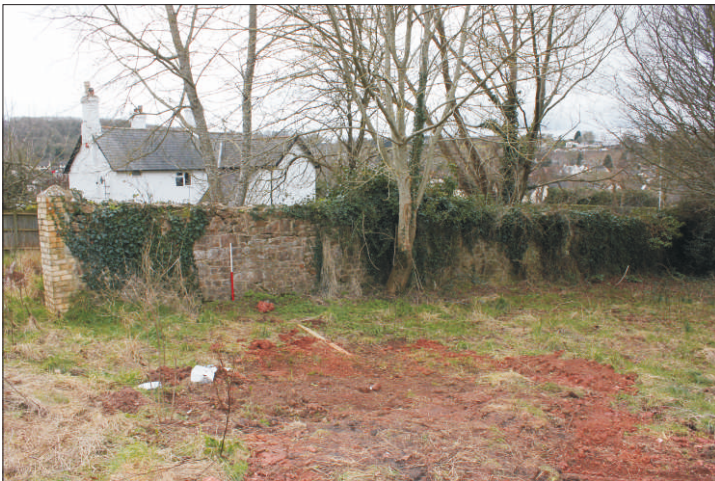
Plate 2: Southern boundary wall, looking southwest (1m scale)

The southern boundary of the site to the west of the entrance, along the north side of Old Totnes Road, consists of a small rubble stone retaining wall. Beyond, within the site, there is a wall constructed of limestone blocks in a random bond (Plate 2). It seems likely that this would have run from the west side of the entrance to the western boundary; however its eastern part has been removed and it now starts within the centre of the plot. Here it is now finished with a yellow brick pier and concrete capstone. The southern boundary of the site to the east of the entrance is formed by a hedge bank with mature trees. Mature trees and shrubs are also found along the west and east boundaries, however here there are no banks. In the northern part of the east boundary there are coal shutes associated with a former coal store. The northern boundary is a wall constructed of limestone blocks laid in a random bond (Plate 3).

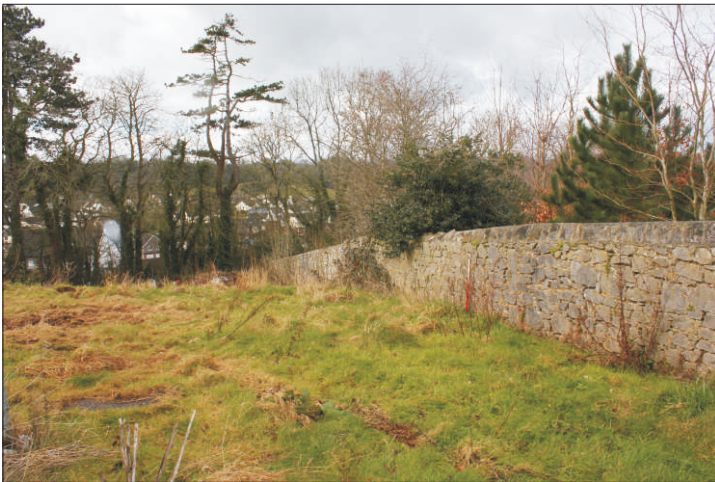
Plate 3: Northern boundary wall, looking west-northwest (1m scale)

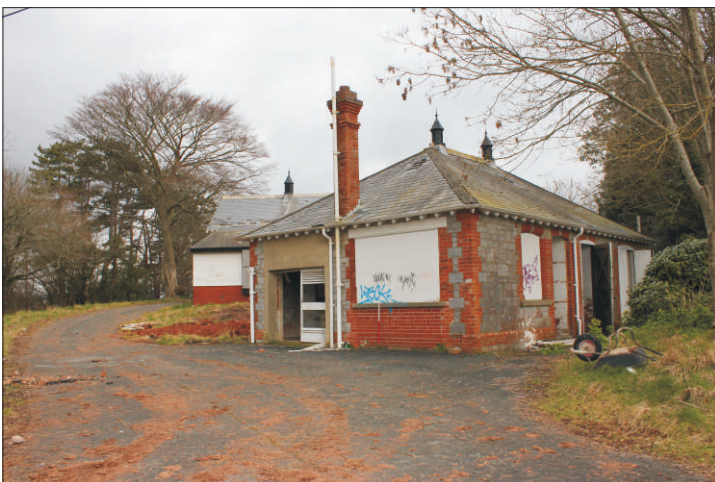
Plate 4: West and south elevations of The Morgue, with Ivycroft in the background, looking northeast (1m scale)

In the west elevation there are two large vehicle doors (Plate 4). The north opening contains one of two louvered doors. The south opening is a later insertion since the brickwork around it is different to the other openings and there is no string course. It has been partially blocked and being converted to a window. In the south elevation there is a window and three doors; the latter are later insertions with concrete over the brickwork to mimic earlier limestone details. In the north elevation there are three windows and three doors (Plate 5). The doors are planks with cross bracing on the inside and cast-iron handles and hatches; the frames have lights above. The windows are sashes of two panes. In the east elevation there is a pair of windows flanking a projecting bay. The window is in the east elevation of the bay, and is a sash with horns. The bay has a catslide roof. The room could not be accessed due to dense vegetation, but probably housed a W/C.

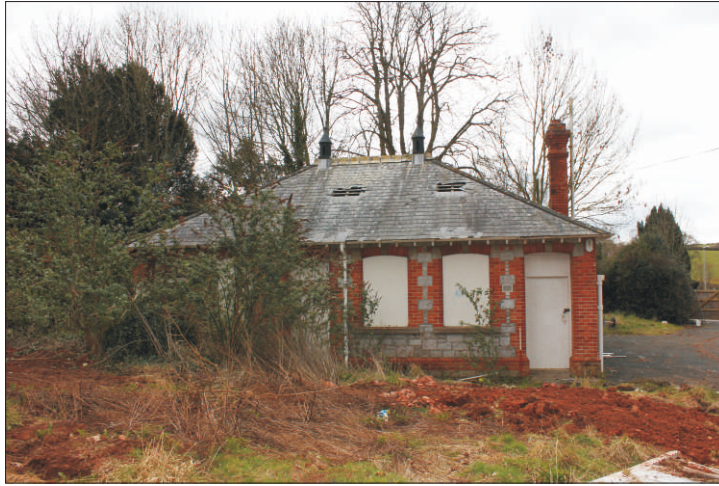
Plate 5: North elevation of The Morgue, looking south (1m scale)

The building is constructed of limestone blocks laid in a random bond with red brick detailing around the windows, as quoins and for a chamfered string course. It is set within a terrace on its east side. The window and door openings have rebated chamfered bricks and limestone keystones and springing stones and concrete sills. The roof is fully hipped with slate tiles, decorative ceramic ridge tiles, a brick chimney at the west end and two central decorative ventilation cowls. The ends of the rafters, which project below the eaves, are moulded. The building retains its cast-iron drain and down pipes.

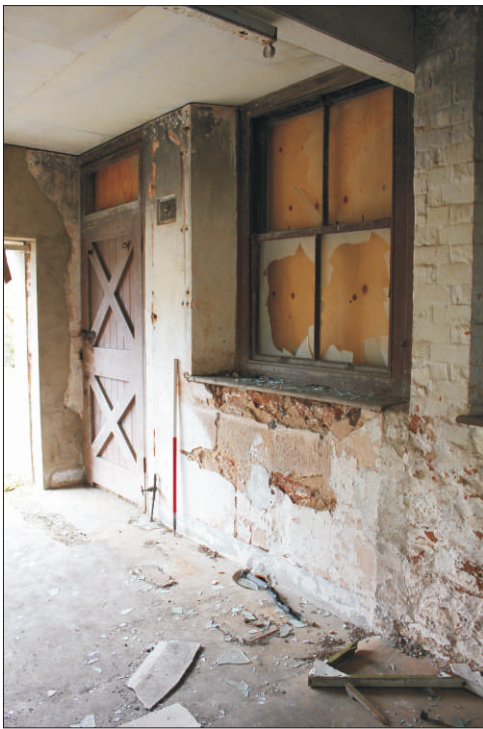
Plate 6: North wall of the north garage in The Morgue, looking northwest (1m scale)

Internally there are asbestos board or lath and plaster ceilings and concrete floors throughout. The external walls are formed from rubble red sandstone, with the internal partitions constructed of red bricks. The north garage room is mostly plastered (Plate 6). There is an angled return to the partition with the south garage for a fireplace or stove (Plate 7), which has a vent just below the ceiling. This room was formerly divided into two areas, and a scar of the partition is visible on the floor and

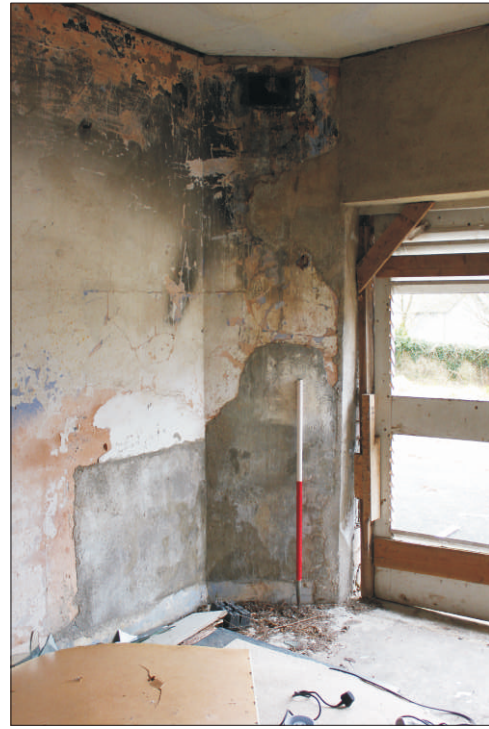
Plate 7: Blocked fireplace in north garage in The Morgue, looking southwest (1m scale)

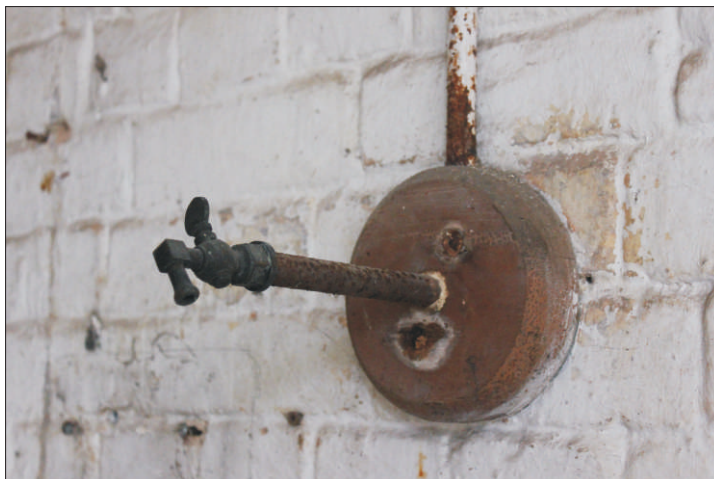
Plate 8: Gas fitting in south garage in The Morgue, looking northwest

north wall. There is a four-panel door to the south garage in which there is a modern sink and old gas light fitting attached to the partition wall (Plate 8).

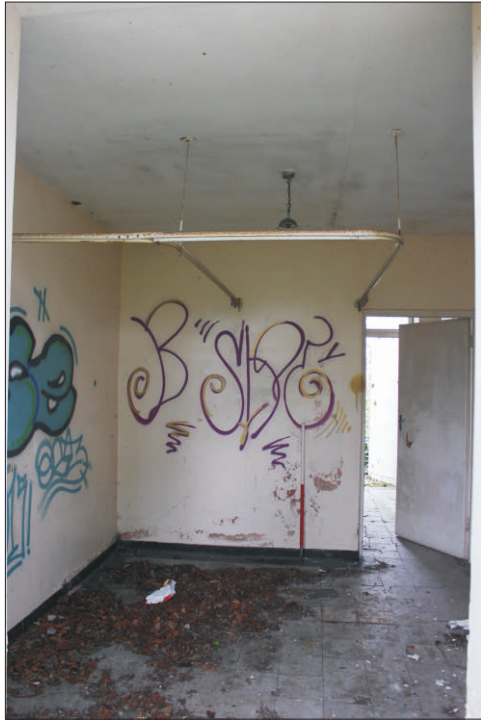
Plate 9: General view of morgue room, looking north (1m scale)

In the central south store, the doorway in a later insertion but has a limestone threshold perhaps indicating it is an early feature. There is a blocked door to the room to the east. northwest corner of partition with the north garage there is a small grate with the associated stack visible above. There are no historic fittings. The southeast room is lit by a sash window in the east elevation. Fittings comprise curtain rails attached to the ceiling, probably indicating use as a mortuary (Plate 9). The northeast room is lit by windows in the east and north elevations; the door in the latter elevation is a modern replacement. The room has a blocked flue in the southeast corner, but no other historic fittings

6.5 The other original building is The Garage or Morgue. The mortuary may have been located in the southwest corner of the building. This building also contained steam disinfecting equipment associated with the laundry. There is no evidence for a boiler

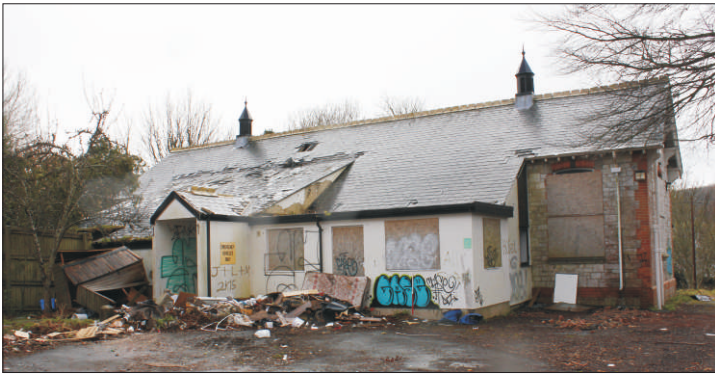
Plate 10: North elevation of Ivycroft, looking southeast (1m scale)

In the north elevation two of the primary window openings can be seen either side of the extensions (Plate 10). In the east and west elevations there are central windows and fake timber framing in the upper part of the gables (Plate 11). There are simple bargeboards supported on projecting wooden corbels with double corbels at the ends of the boards. In the south elevation there are three narrow and two wide windows (Plate 12), one of which has been converted into doorway and which is accessed via an external concrete ramp.

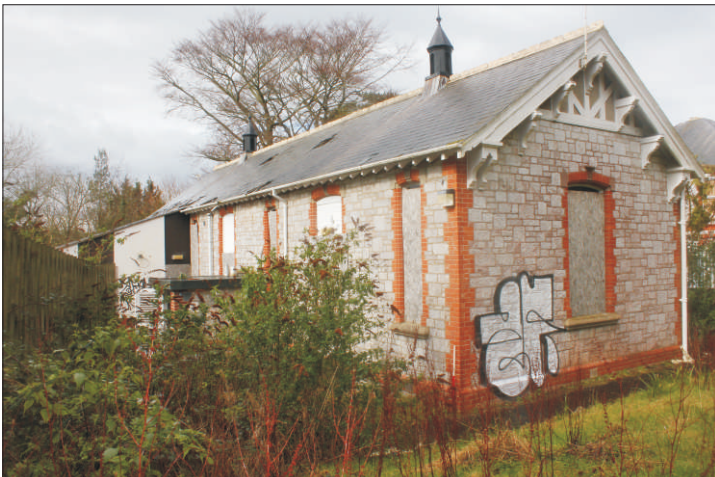
Plate 12: South and east elevations of Ivycroft, looking northwest (1m scale)

The building is constructed of limestone blocks laid in a random bond with red brick detailing around the windows and for quoins. The windows have rebated chamfered bricks, rusticated limestone keystones and springing stones and concrete sills. The roof is gabled with slate tiles, decorative ceramic ridge tiles and two decorative ventilation cowls. It has cast-iron drain and down pipes. All of the windows have been externally blocked. There are late 20th-century extensions on the north and south sides, which have rendered walls and are under cat slide and pitched roofs. There is also a boiler room extension on the south side constructed in the same style as the main building but with a flat roof. The main entrance is in the north elevation through a gabled porch. Between this doorway and an entrance in the south elevation of The Willows there is the remains of a (former covered) walkway with low brick side walls.

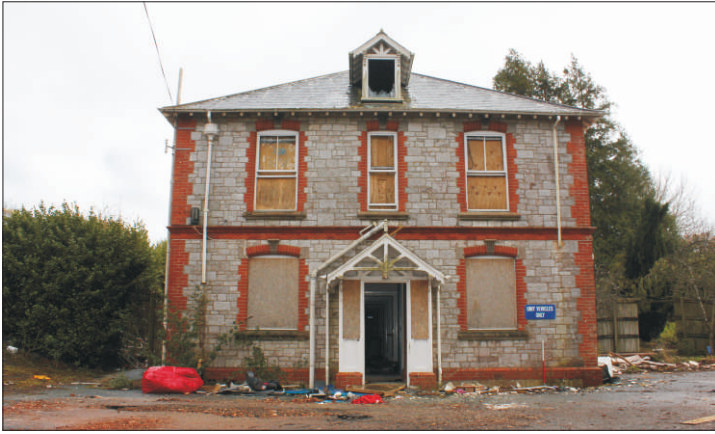
Plate 13: West elevation of The Willows, looking east (1m scale)

The main entrance is in the west elevation and is under a decorative wooden porch (Plate 13). There are two windows on the ground floor, three windows on the first floor and a central dormer window. In the north elevation there are two windows and a door on the ground floor and three windows on the first floor (Plate 14). There is an off-centre projecting chimney breast towards the western part of the elevation. In the south elevation there is a door and window on the ground floor and two windows on the first floor, with the one above the door being taller than the other (Plate 15). The doorway formerly led into an enclosed linking corridor to Ivycroft. There is an off-centre projecting chimney breast to the west incorporating an engraved date stone (Plate 16). The inscription reads 'This hospital was built by the Newton Abbott Joint Hospital Committee August 1902. William Vicary. J.P: G.C Chairman. John Underhill Clerk'. In the east elevation of the east range there are two doors on the ground floor, one of which has been converted into a window. On the first floor there is a window and an inserted fire door leading on to a metal staircase (Plate 17). On the first floor of the south elevation there are two windows. In the south range there is a window in the east elevation, and another in the south elevation that has been converted into a door.

The west porch is wood and glazed panels set on to a brick base, and has a tiled floor. This leads into a short lobby. There is a six-panel outer door (with chamfered details) to the lobby. This space leads into a central corridor that serves all the ground-floor rooms. These spaces retain their skirting boards, dado rails and door frames, but the doors themselves have been replaced. There are suspended ceilings below the original height of the rooms. There are two large rooms to the front (west), and in the southwest room a deep moulded cornice is partially exposed – the only evidence for historic detailing of the ceilings. Despite the external chimney stacks evidence, there is no evidence for fireplaces in these western rooms. The central corridor has a return to the south to the six-panel door in the south elevation. Here there is the staircase to the first floor. This has a thick square newel post and slender balustrades all with deep chamfers (Plate 18); the underside is enclosed with chamfered panelling. To the north is a small room. Towards the rear of the building there are two further large rooms. The large northern room has an angled return to the northeast corner, which may represent a chimney stack. To the east, the corridor ends in a lobby from which there are doors to two much smaller rooms, one of which has been created out of the east end of the corridor/lobby, and a wide doorless opening into a larger southern room within the south range. This room has been formed from several smaller spaces and rolled steel joists have been used to support the floor above. All the detailing such as the dado rails are contemporary with the modern refurbishment.

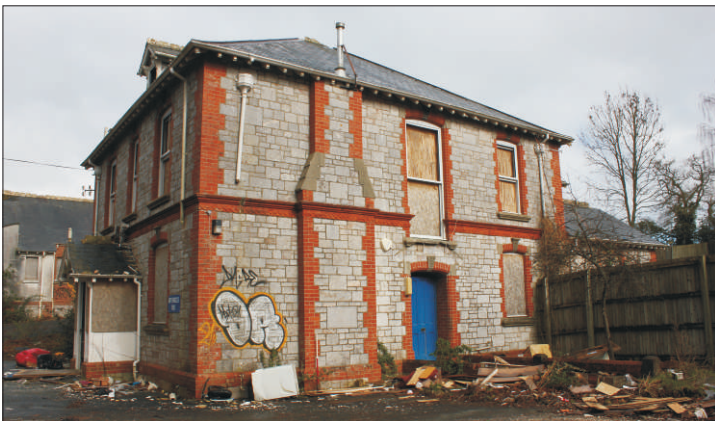
Plate 15: South elevation of The Willows, looking northeast (1m scale)

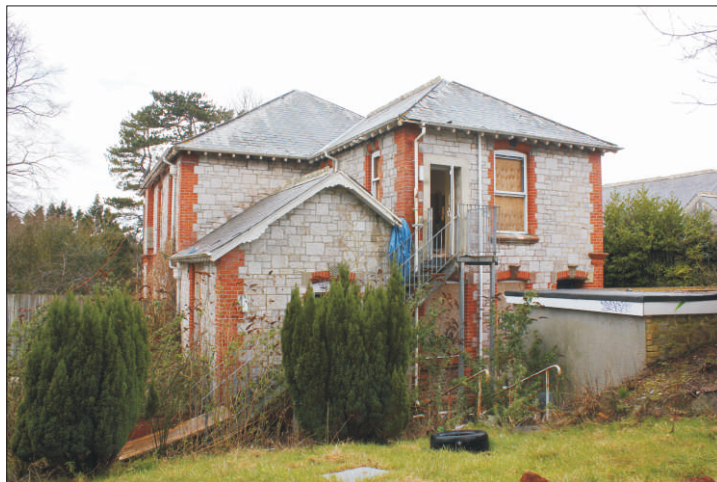
Plate 17: East elevation of The Willows, looking west-northwest

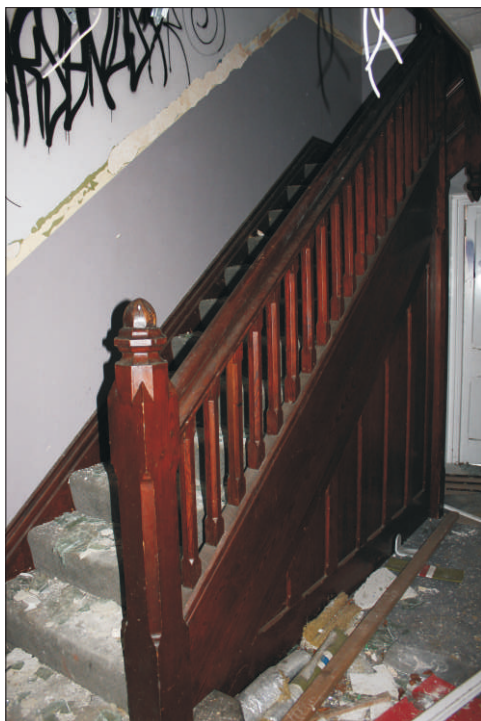
Plate 18: General view of the stairs in The Willows, looking southeast

The stairs are in two flights separated by a half landing. Here there is a wooden rail against the window opening. An arched opening leads into a central east-west aligned corridor situated over the ground-floor corridor. There are various sized rooms on either side of the corridor, separated by timber-framed partitions with lath and plaster finish and modern plasterboard (Plate 19). This floor retains its skirting boards and door frames, however the dado rails have been removed and there are no other architectural features.

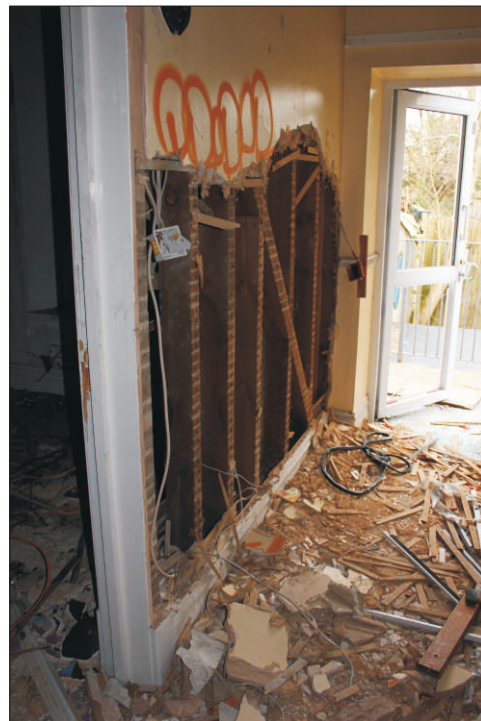
Plate 19: General view of timber-frame partition in The Willows, looking northeast

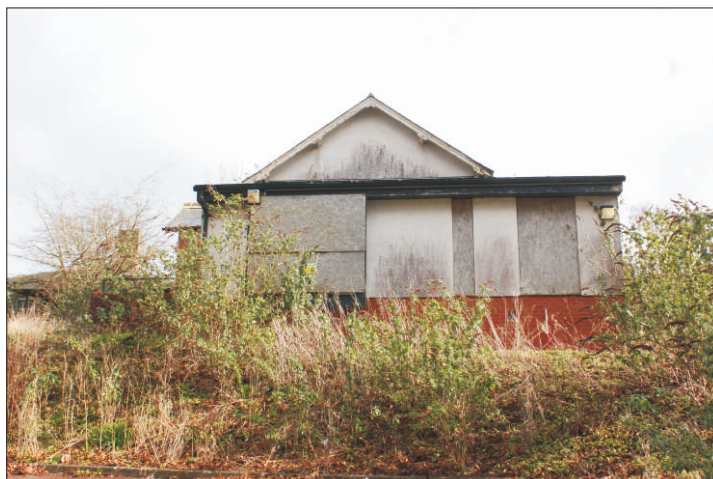
Plate 20: West elevation of the Day Care Unit, looking east (1m scale)

The building is single storeyed and constructed of brick laid in stretcher bond, with a double skin of bricks separated by a cavity, under a gabled slate roof with decorative ceramic ridge tiles. There is a large modern extension on the west side that is constructed of brick; the upper parts of its walls are rendered (Plate 20).

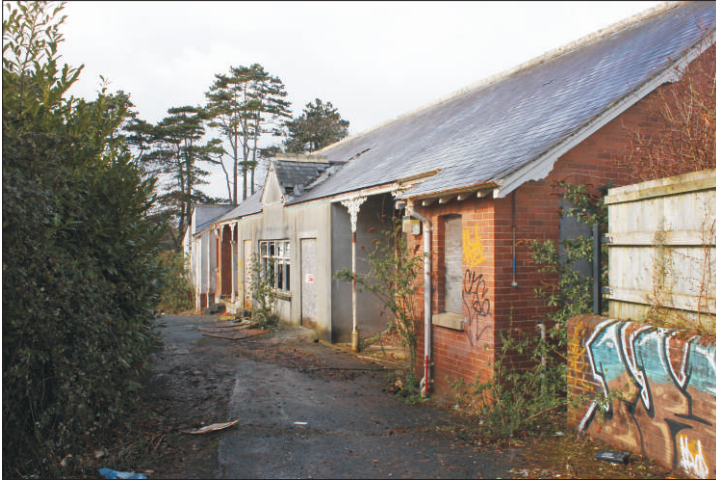
Plate 21: South elevation of the Day Care Unit, looking west-northwest (1m scale)

On the south elevation there is a decorative iron framed veranda which has been partially infilled in the centre (Plate 21). The walls of this infilling are rendered, and the feature includes two doorways flanking a long rectangular window under a pediment. The decorative iron work was made by R.L Harding and Sons of Torquay. Within the surviving verandas there are two windows and doors in the side walls leading to small entrance lobbies (Plate 22). The lobbies provide access to small W/Cs at the south corners of the building, and both the lobbies and W/Cs are lit by windows in this elevation. The western W/C was altered when the west extension was added. All the primary windows are under bricked-arched heads.

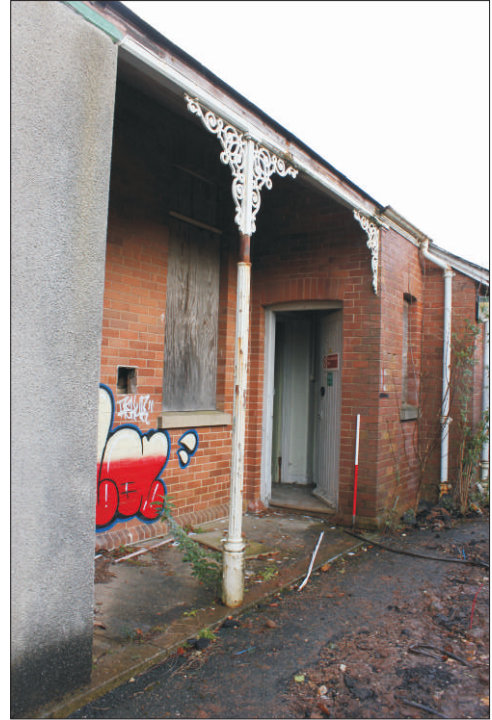
Plate 22: Veranda with decorative iron frame, looking northeast (1m scale)

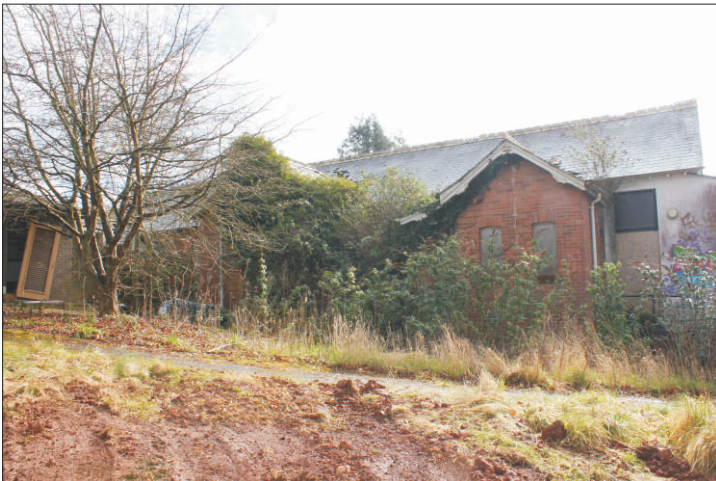
Plate 23: North elevation of the Day Care Unit, looking southeast

On the north elevation the ends and the central part of the elevation project forward reflecting the position of further W/Cs (Plate 23). There is a window in the central projection, there are two windows in the end projections. There is also a single window in each of the areas of masonry between these projections. There are three 2- and 4-pane sash windows with fixed lights over, and a projecting chimney stack in the east elevation.

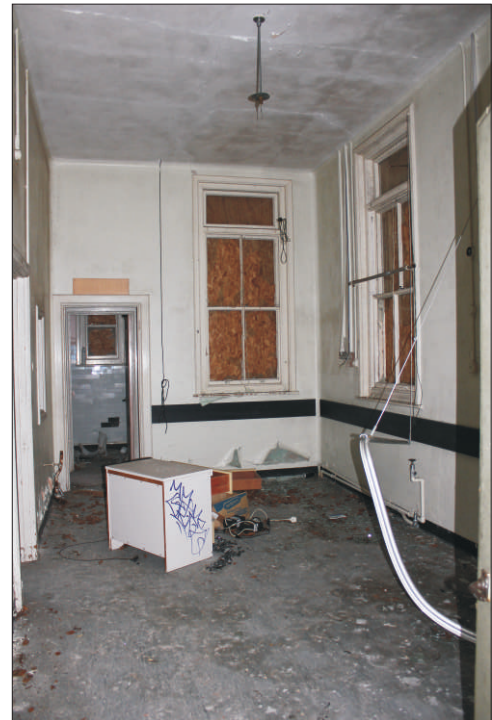
Plate 24: East ward room in the Day Care Unit, looking north

The surviving southeast W/C is half finished with ceramic tiles. Both the W/C and adjacent lobby have parquet floors. The lobby leads into a long ward along the east side of the building (Plate 24). A doorway in the north elevation leads into the north W/C and a doorway in the west elevation leads into another large ward (Plate 25). This room has floor channels for heating pipes. A door in the southeast corner leads into the former veranda, which is now the covered corridor. A further door leads to a central corridor that gives access to the central W/Cs on the north side of the building. The current fittings are entirely modern, and it is possible that this area originally had a different purpose. The covered corridor gives access to a pair of small rooms with interconnecting hatches to each other and the adjacent wards. Like the wards the ceilings of these rooms are tall, and are finished with lath and plaster. To the west is another ward, and beyond, the former west ward has been incorporated into late 20th century extension. Here all the walls are either heavily altered or rebuilt. A door in the north elevation gives access to the northwest W/Cs. All these W/Cs are half tiled. The other rooms have architectural details including thick moulding to the doors and windows and thin skirting boards.

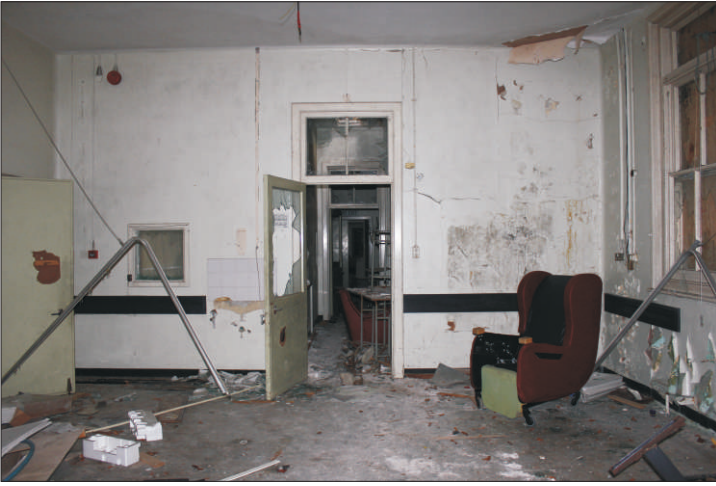
Plate 25: East central ward in the Day Care Unit, looking west

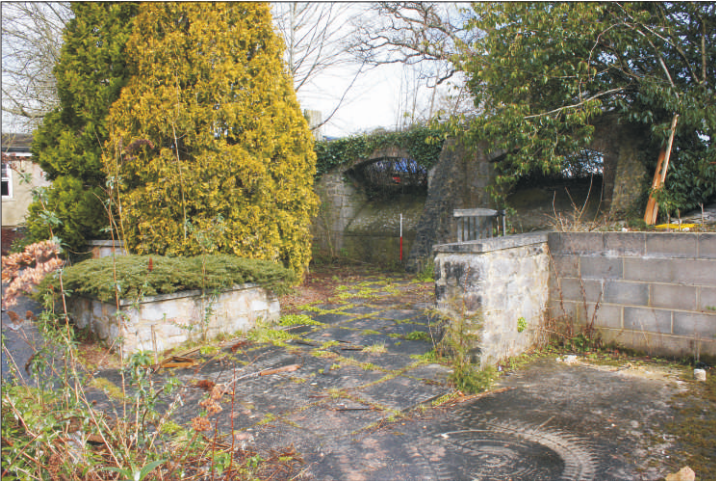
Plate 26: Remains of the Coal Store, looking northeast (1m scale)

On the northeastern edge of the site there are the remains of a coal store (Plate 26). The lower parts of the limestone walls remain along with a taller eastern section containing delivery chutes that have brick arches above and buttresses on the east side. The area of the store is currently used a patio.

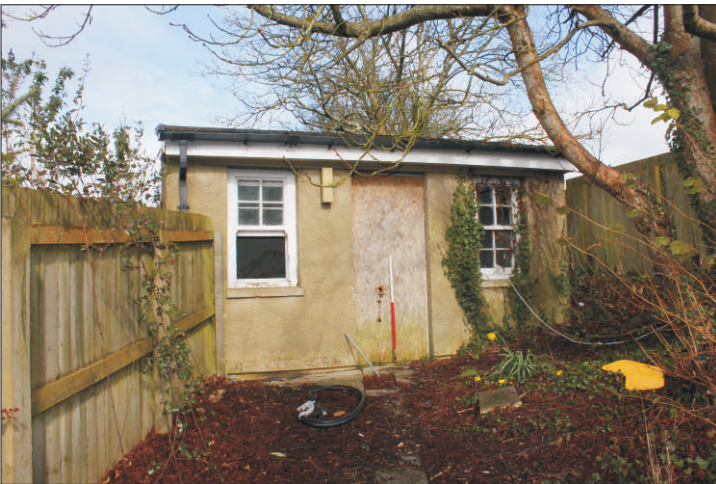
Plate 27: General view of the Gardener's Shed, looking north (1m scale)

On the north eastern side of the site there is a small gardeners shed (Plate 27). The walls are rendered and it has a sloping tiled roof. In the south elevation there is a central door and two eight-pane horned sash windows.

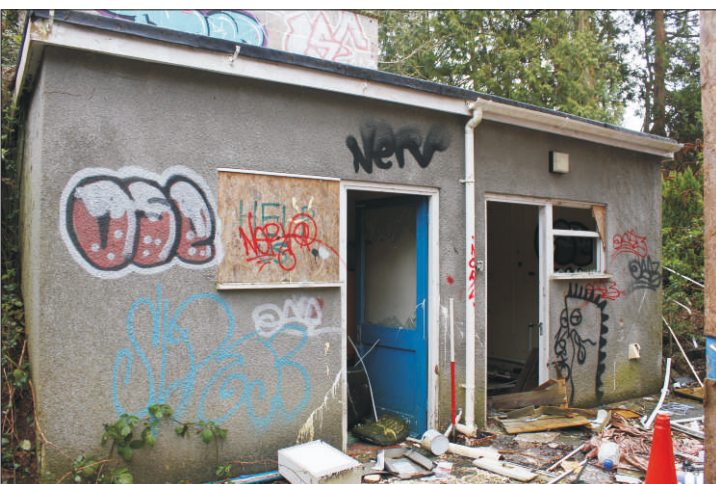
Plate 28: General view of plant building, looking east-southeast (1m scale)

This small rectangular building is located just to the east of the Willows (Plate 28). The walls are rendered and it has a flat felt roof. The building is divided into two rooms, each with a door and window in the west elevation. These are modern replacements.
