WINDMILL HILL CAVE, BRIXHAM, TORBAY

Results of an archaeological watching brief

On behalf of
South West Water Ltd

Document No: ACD1347/1/1

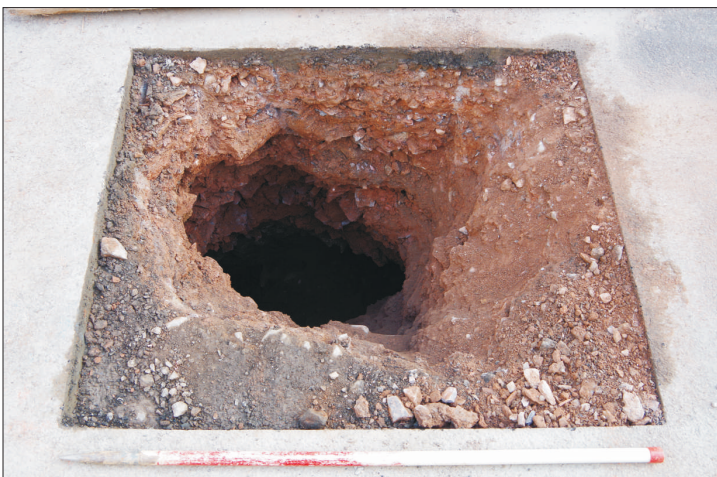
Plate 4: View to the east showing the void within Tp2 (1m scale)

The southern test pit (Tp2) was located 1.90m to the south of Tp1 and measured 1m wide by 1.20m long. This test pit also exposed part of the void beneath two sewer pipes which were situated adjacent to the northern and western edges of the pit.

The deposit sequence within the pit consisted of the tarmac road surface with modern made ground beneath overlying a dark reddish brown sandy clay with abundant large fragments of limestone. The solid natural geology was exposed from a depth of 1.30m from the road surface and was visible on both the east and west sides of the void. The base of the void was visible from the road surface to the southwest of the pit but it was not possible to identify any *in-situ* soil deposits due to the presence of collapsed material at the base of the void. As the top of the void within this test pit was so narrow it was difficult to determine whether the void continued further to the south beyond the pit.

The two test pits have shown the void to extend on a north-south alignment for approximately 4.60m+. Historic maps of the area show the presence of a former quarry immediately to the southeast of No. 89 Mount Pleasant Road, with which the void may be associated. However, the exposure of natural geology within the slanting sides of the void, and the presence of a narrow base indicate that it is more likely to represent a chamber or fissure associated with the cave system immediately to the northeast.
