BARNS AT HARESTON FARM, BRIXTON, DEVON

Heritage Statement

Document No: ACD1207/1/0

Date: September 2015

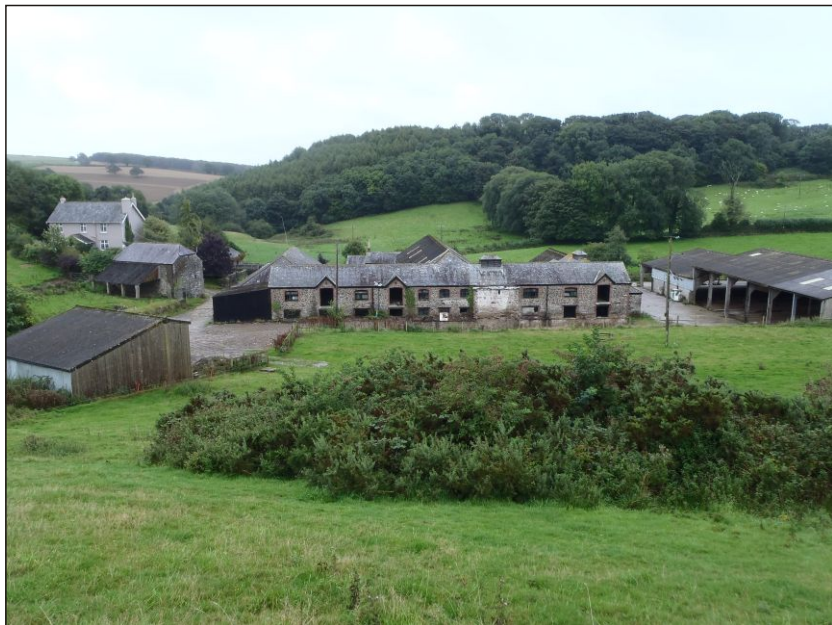
Plate 1: The farm complex, viewed from the northwest.

The northwest elevation has ten openings at first-floor level (Plate 1); seven are windows and three are double doors beneath dormers. The windows and doors all have wooden frames. The roof is slated. The land slopes down to the southwest along this elevation. At ground level are 10 openings. The four to the northeast are for hatches with double doors; the remainder appear to be for windows.

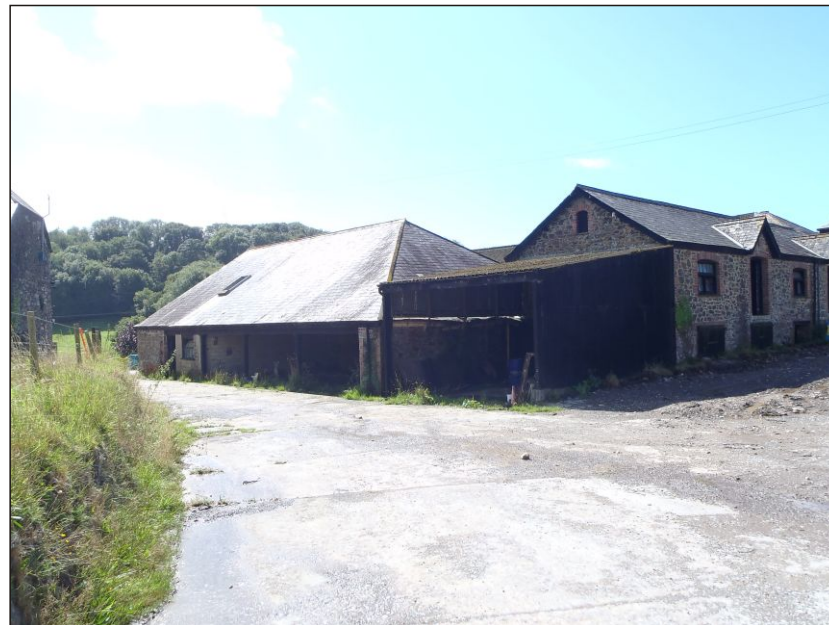
Plate 2: The northeast elevation, viewed from the north.

The northeast elevation has a corrugated metal lean-to garage against the northwest range (Plate 2). Beside this, to the northeast is an open-fronted structure, supported on the northeast side on three cast-iron pillars. This has a mud floor and slate roof. At its southeast end one bay of the barn has been infilled by a modern concrete block construction creating extra internal space (Rooms 2 and 4, see below). The external concrete block wall has a window and door (for Room 2) with a skylight inserted above.

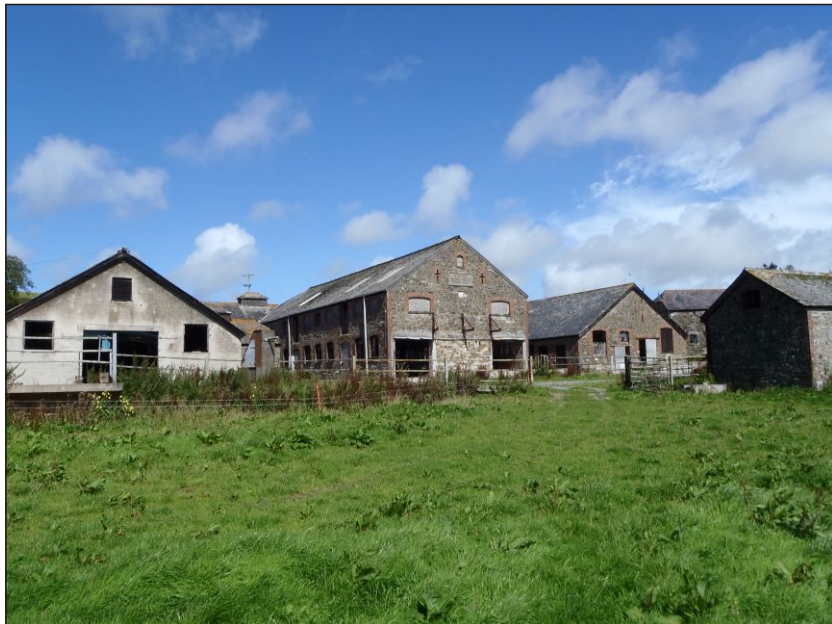
Plate 3: The southeast elevation, viewed from the south.

The southeast elevation incorporates the three gable ends of the wings (Plate 3). The most easterly gable end is single storey and has two steel sliding doors, a clerestory window above one of these, an off-centre slit vent and a pair of windows, the most easterly with wooden louver shutters and the westerly is part-blocked to approximately half of its original height. The central gable is the most interesting and is two storeys tall (Plates 4 and 5). It has two large, modern, openings at ground floor level. At first storey level there is a pair of low arched windows, infilled with breeze blocks, and two cross slit vents above which is a centrally located rectangular arched vent. Between the cross slit vents are two plaques. The largest, in cement, reads "THE PLYMOUTH/ CO-OPERATIVE SOCIETY LTD/ ERECTED 1908". Beneath this is a smaller plaque, possibly in marble, which reads "There is nothing/ permanent [?- here even]/ the woods bide/ but their time". The gable end of westerly wing is single story, and of modern concrete block construction with a single large opening.

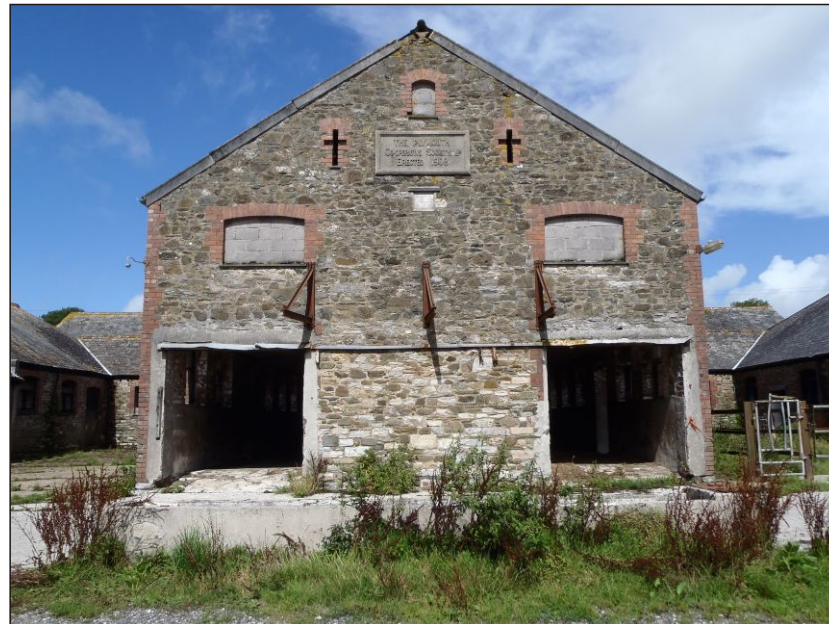
Plate 4: The southeast elevation of the central wing.

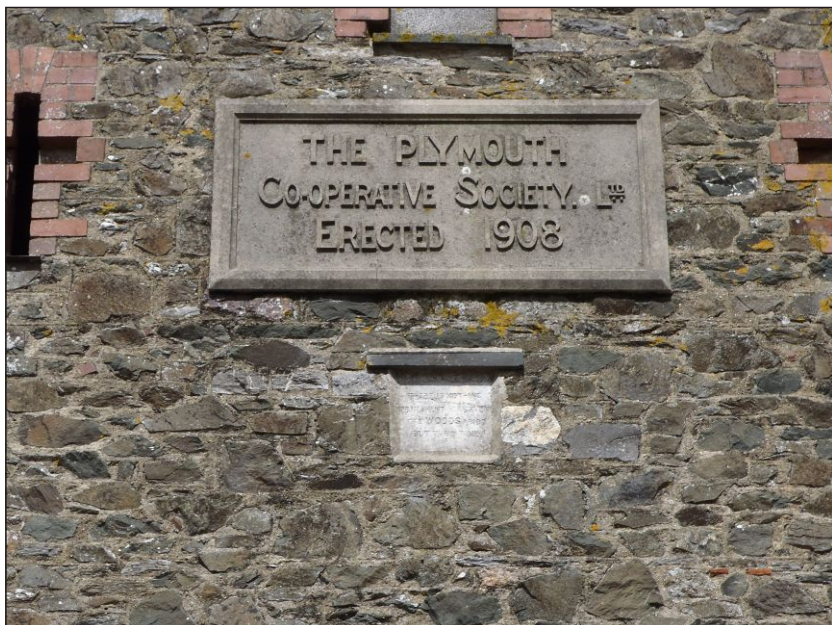
Plate 5: Central wing plaques, detail.

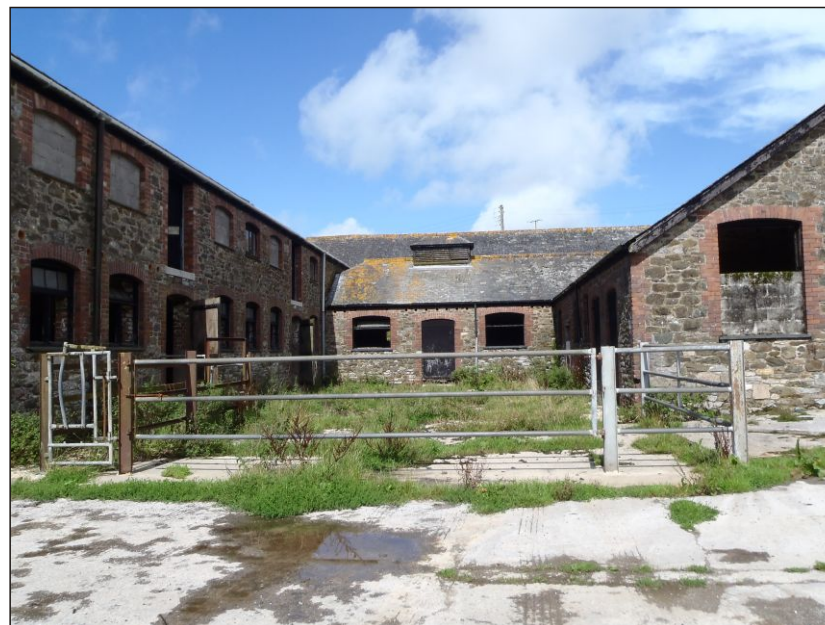
Plate 6: Foldyard 1, viewed from the northeast.

Foldyard 1 has doors providing access to four rooms (originally five, see below) at ground level (Plate 6). Each of these rooms is provided with windows. Only the central wing has an upper floor visible from this foldyard and is provided with six windows and two doors matching the positions of those below them. Many of the upper windows have been blocked and the roof of this wing has been replaced with corrugated sheeting. Here, and elsewhere, an original feature is the provision of granite threshold stones for the upper doors. Granite is also used for external doors at ground level to provide the mortice block for sliding latches. A distinctive architectural feature that is present throughout the old build to the rear of the northwest range is particularly apparent in Foldyard 1 is the provision of clay pipe venting at eaves level (or beam level in the case of the central wing). This is a feature of some 19th- and 20th-century Westcountry agricultural buildings.

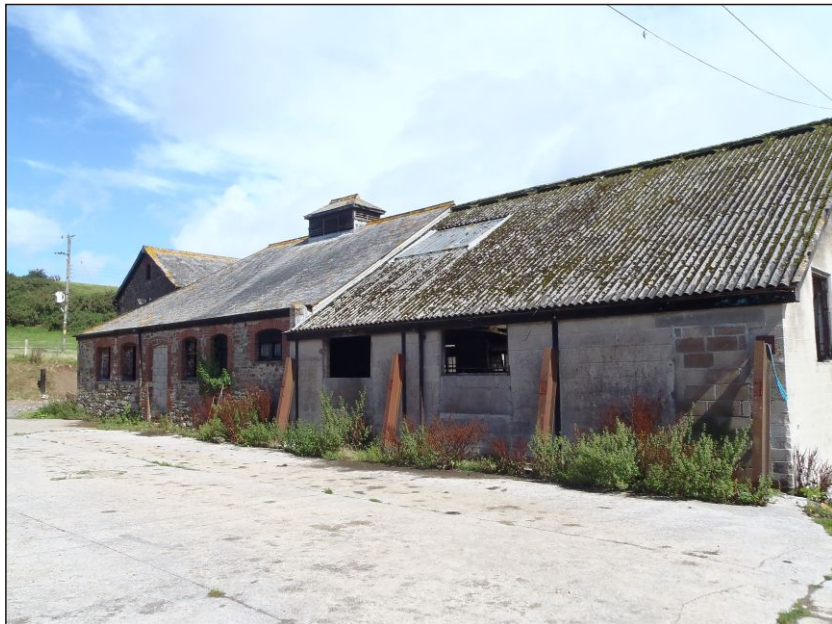
Plate 7: The southwest wing, viewed from the south.

The southwest elevation reveals two builds (Plate 7). An extension towards the gable end is constructed of concrete blocks, and beyond is the original build, including the southwest end of the northwest range with many modifications to the original openings.

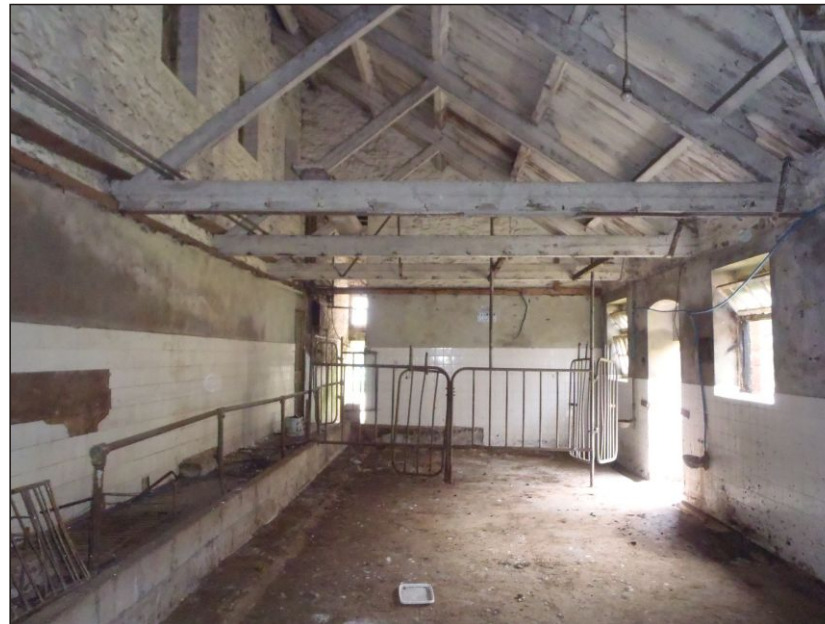
Plate 8: Building A, Room 7, viewed from the northwest.

Room 7 is an L-shaped former milking parlour with cement and steel troughs (Plate 8). The current configuration has been achieved by the removal of a northwest-southeast aligned wall and its replacement with a steel joist. The total area comprises eight bays with half A-frames sharing the opposite pitch of the roof with the open-fronted room (1) to the northeast and two A-frame structures in the southwest part of the room. The four hatches noted in the room 1 are revealed high up in the northeast wall; the ceiling is formed by the roof and there is no evidence that a loft was once positioned above this area making the location of the hatches difficult to explain. A pair of brick-arched doors provide access from Foldyard 1 and four windows face onto the foldyard. There are access points via a corridor in the southeast and through a pair of brick-arched doors to Room 11 in the southwest. There were formerly two doors in the northwest wall providing a link with Room 8, with the northeasterly completely and the southwesterly partly blocked up.

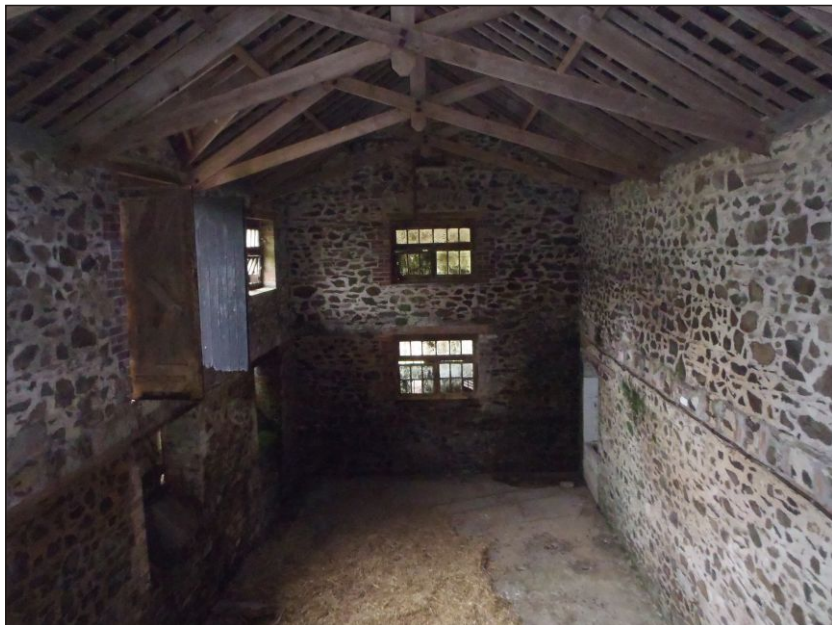
Plate 9: Building A, Room 8, viewed from the mezzanine, looking northeast.

Room 8 is a large room at the northeastern end of the northwest range (Plate 9). It formerly had a full first floor but this has been removed, leaving the beam slots visible, although blocked. A small part of this floor has been left as a mezzanine/balcony at the southwest end of the room with the reminder open to the roof revealing three cross-braced frame structures. The northwest wall contains two brick-arched windows and two doors with dormers above at the level of the first floor. One door matched the surviving portion of upper floor. At ground-floor level

are four hatches, the bases of which are at the level of the ground externally, but are significantly above floor level internally. These are all provided with steel and cement lintels and double wooden doors. The northeast wall is provided with two large centrally placed rectangular windows above which is a small rectangular louvred vent within the gable. Formerly there were two doors to Room 7 and a pair of doors linking with Room 9 below and an upper room above within the northwest range. This southwestern wall is brick-built in English bond, as are the other two dividing walls in the northwest range.

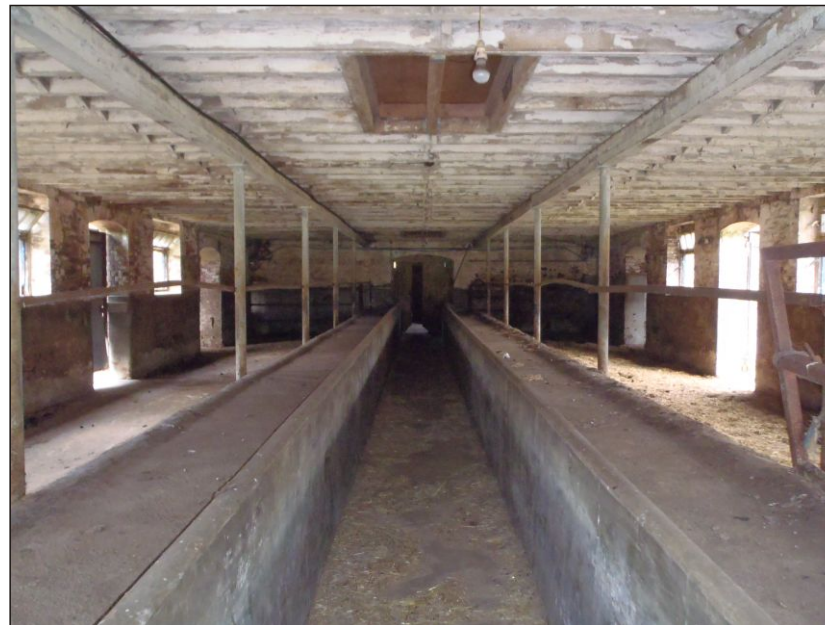
Plate 10: Building A, Room 11, looking northwest.

Room 11 is formed by the central wing and was formerly a large cattle byre (Plate 10). It has two cement and steel troughs, with a narrow feeding passage in between, placed longitudinally along the length of the building. Access externally is through both foldyards and the southeast gable end. There is also a pair of doors each side connecting to rooms 7 and 12 and the large centrally placed door to Room 9. The feeding passage between the troughs allowed the dairy hand to fill the troughs with fodder, either from Room 9 or through a pair of hatches over the feeding passage in the ceiling above. The ceiling appears to retain the beams and cross-braces of the original build, but the floorboards are modern replacements.

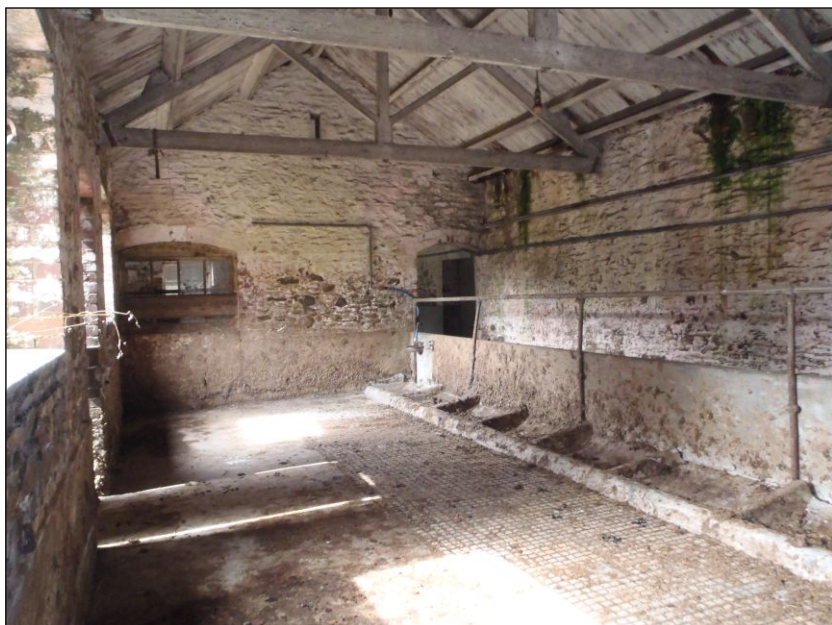
Plate 11: Building A, Room 12, looking west.

Room 12 is a small cattle byre with a cement and steel trough dividing the room from a corridor/feeding passage in the northwest (Plate 11). The size and layout of this room would have originally mirrored that of the southwest part of Room 7 before that was knocked through to make a larger milking parlour. The ceiling is formed by the roof with two wooden A-frame structures. A pair of brick-arched doors in the northeast wall gives access to Room 11, and there may have been the same in the southwest wall although the southernmost of these is now a window (of original type). The southeast wall has a centrally placed door giving access to Foldyard 2 and windows either side.

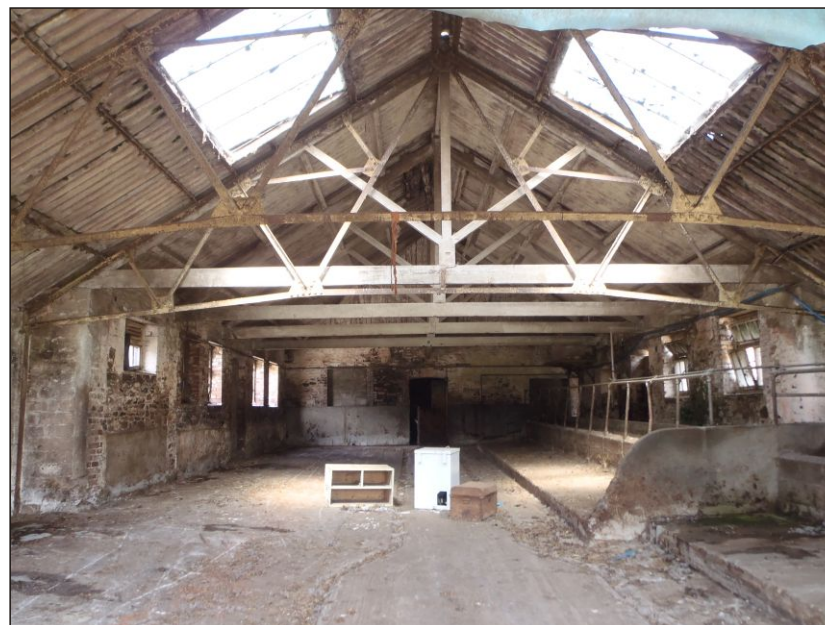
Plate 12: Building A, Room 13, looking northwest.

Room 13 forms the southwest wing and was a large cattle byre with a cement and steel trough along the length of one side (Plate 12). This room has been extended using concrete blocks and a corrugated sheet roof supported on steel trusses; it is slightly wider than the original build. The 2nd edition revised 25-inch Ordnance Survey map shows this area was a walled yard prior to the extension. The northeast wall of the original build has a door and two windows opening on to Foldyard 2. The southwest wall has five windows and a blocked door. There is a blocked window in the northwest wall and a brick-arched door providing access to Room 14, along with

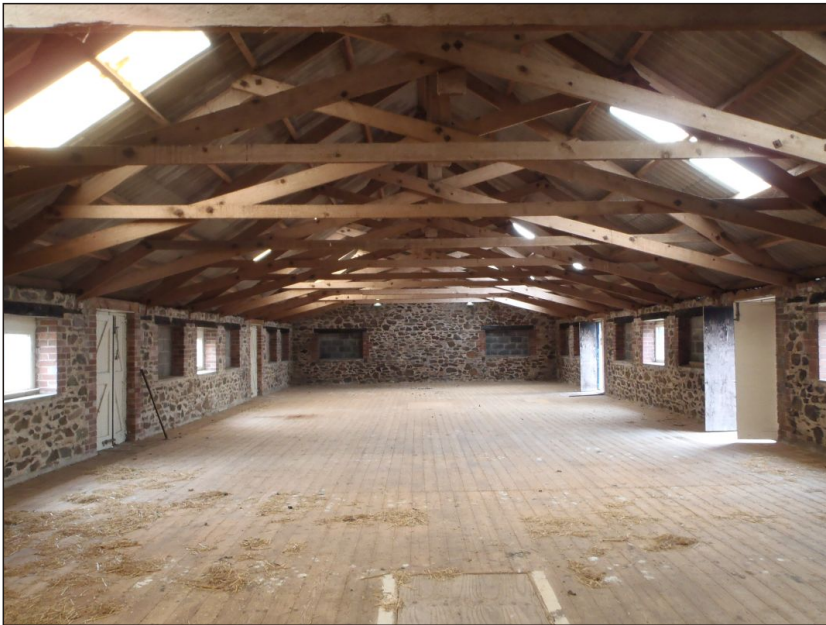
Plate 13: Building A, loft above Room 11, looking southeast.

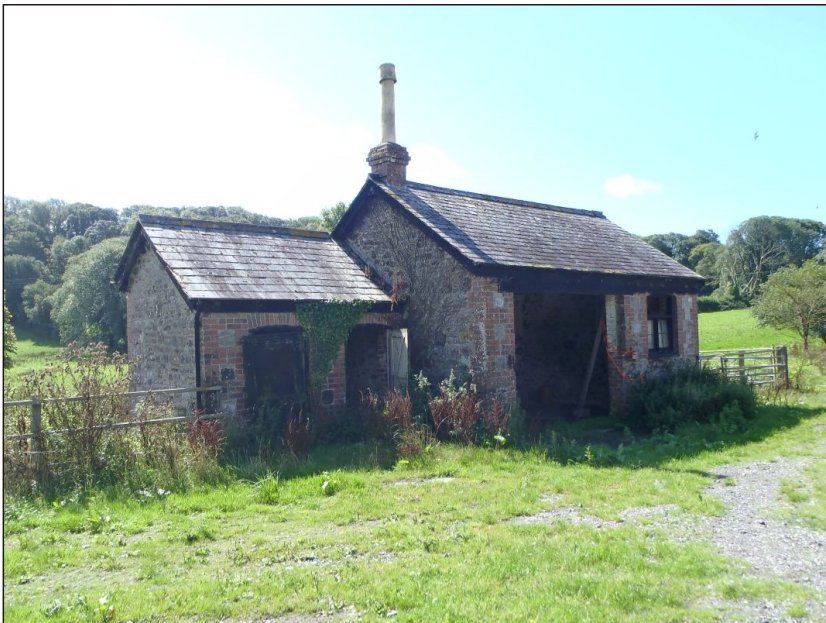
Plate 14: Building B, viewed from the north.

This is located to the southeast of Building A. It is constructed using the same materials and in the same style as Building A and has a pitched slate roof with a brick chimney stack on the northeast end of the ridge which is topped by a tall yellow ceramic chimney pot. It comprises one large double height room with a clerestory window in the southwest gable and a large door and window in the northwest wall. The ceiling is open to the roof with two wooden A-frame structures exposed. This room may have been used as a garage, although the chimney along with an ash hatch, an adjacent blocked opening and pipe in the southeast corner may indicate that a boiler or free-standing hearth had been located in this area. To the southeast are two adjoining contemporary small rooms with a different ridge line that is lower in height. Each of these has a door facing northwest. The room in the middle has a large brick-built pedestal at the rear holding a concrete shelf. The functions of these small rooms are unclear.

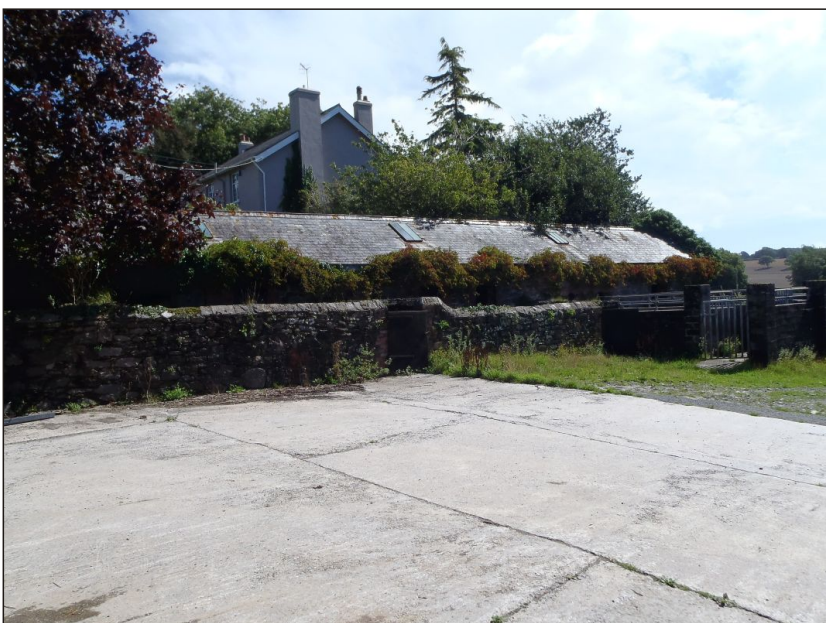
Plate 15: Building C, viewed from the northwest.

This is located to the southeast of Building A, and is narrow and long on a northwest-southeast alignment. It is constructed of the same materials and in the same style as buildings A and B and has a pitched slate roof. It comprises two rooms; a small room at the southeast end accessed externally by a southwest facing door and the remainder divided by pens internally and formerly accessed by seven (one now blocked) small doors in the southwest wall opening from external pens. The pair of external pens matching the northwest end appear to have their original stone walls, but the pair southeast of these have been replaced in concrete and steel; these are matched internally by pens constructed with modern materials. This building was undoubtedly constructed as a piggery with a feed preparation area at the southeast end. Oddly, the only window is at the northwest end.
