WHEAL MARTYN 'UPPER PROCESSING PLANT', CARTHEW, NEAR ST AUSTELL, CORNWALL

Results of archaeological recording

Cornwall Council planning reference NR/02/00134/ROMPS -
OA17 Greensplat

Document No: ACD1359/2/0

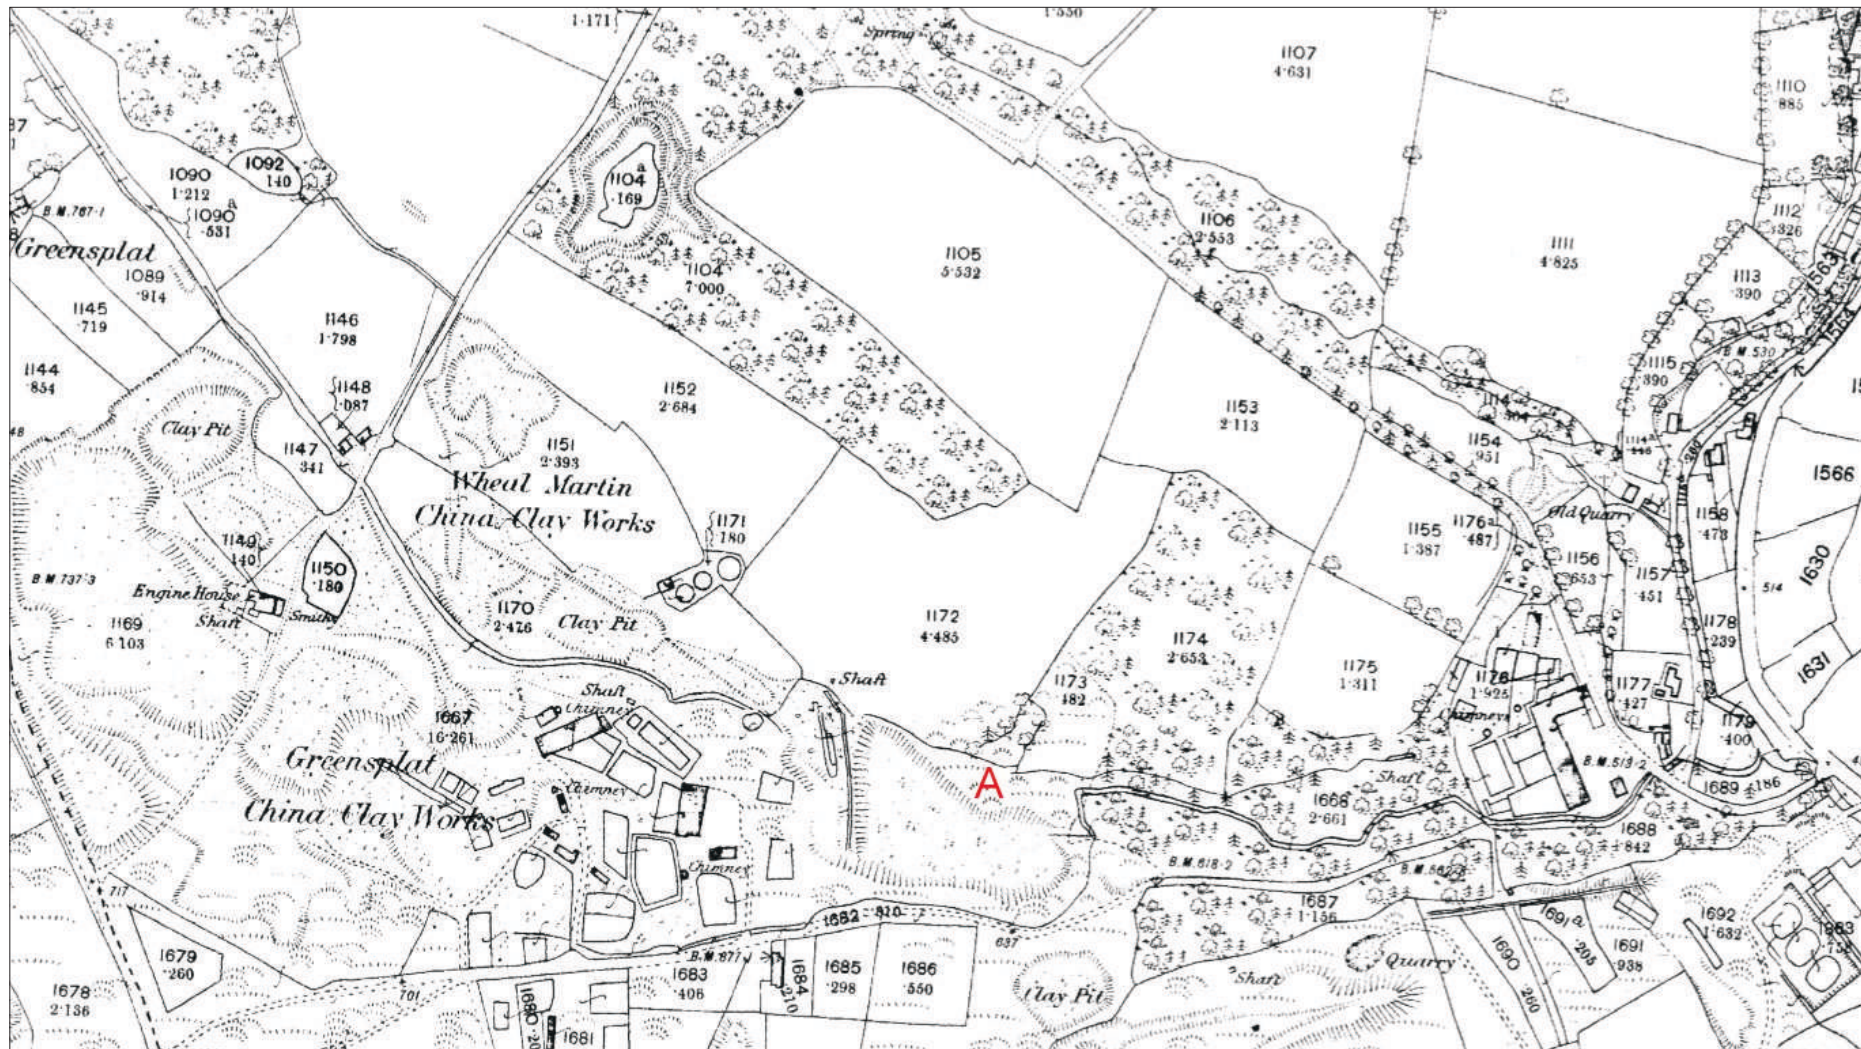
Fig. 3: Wheal Martyn in 1879, extract
from the OS 25-inch map published
1880. 'A' marks the future site of the
Upper Processing Plant.

The future site of the Upper Processing Plant ('A' on Fig. 3) is shown as scrubland on the north side of a shallow but extensive extraction pit. The earlier Town Place has gone, and its area is shown as scrub in the corner of an enlarged field. Only one small enclosure on its east side is retained, also as scrub.

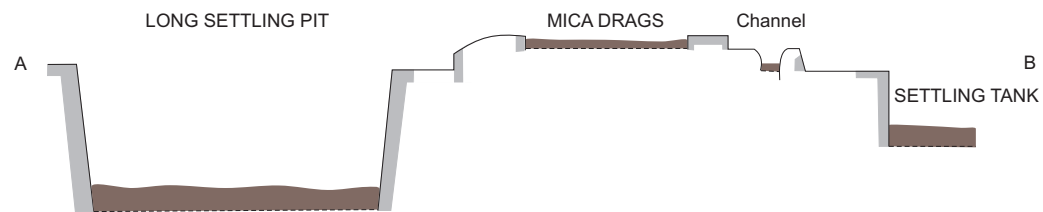
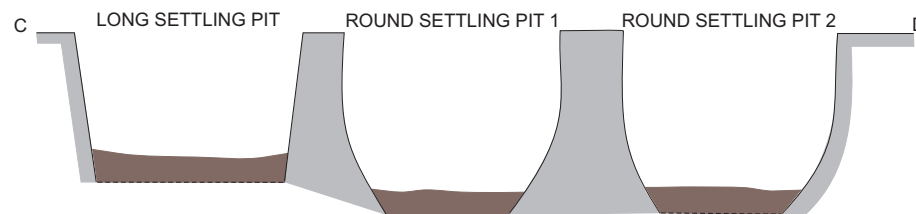
TITLE
Fig. 7: Sections A-B and C-D of the
Upper Processing Plant

a) Section A-B

b) Section C-D

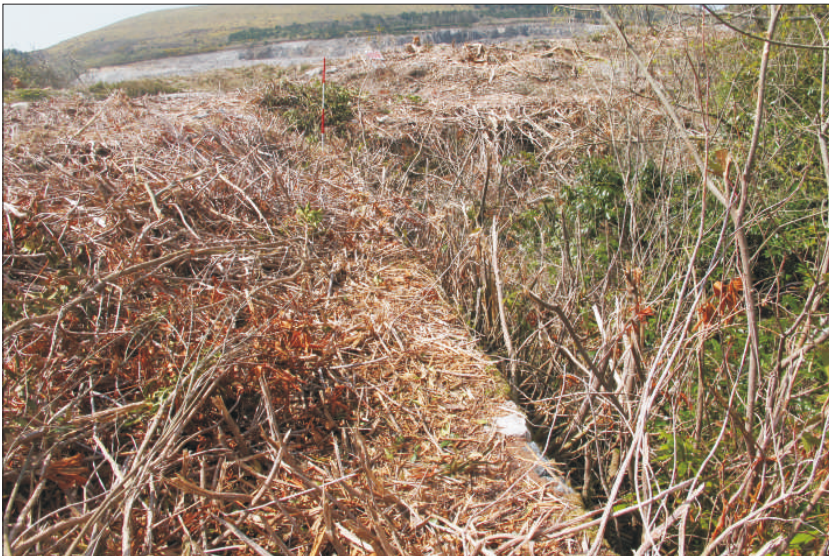
This major feature of the site was a long, sunken pit with rubble stone walls. In plan it was rectangular at the west end but tapered towards a rounded east end. The rough coping stones along the south edge were broken by three features. At the west end was a gap in the coping, either constructed or where damaged coping had fallen away (LSP.1), but towards the east end was an opening 800mm wide and c. 350mm deep which tapered towards a buried earthenware pipe, interpreted as an inflow to fill the pit with clay slurry (LSP.2). Almost at the

Plate 2: Long Settling Pit from east-southeast, showing stone edge along the south side (2m scale)

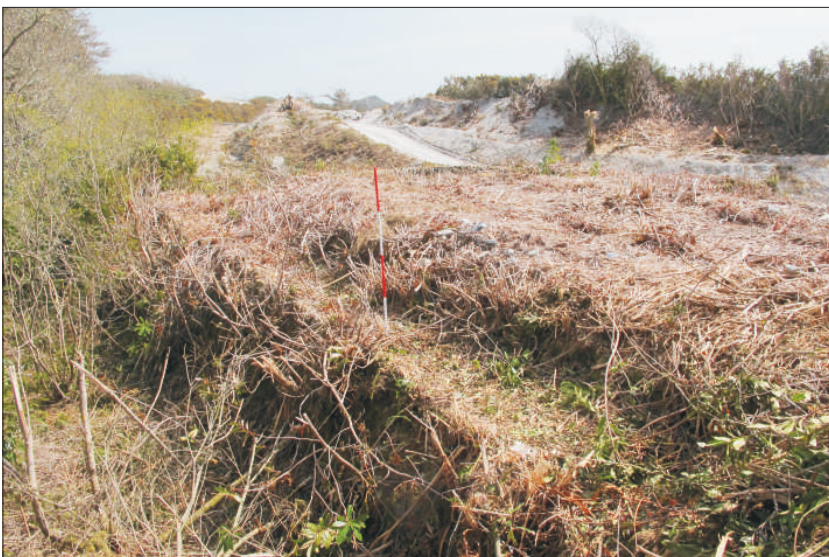
Plate 3: Long Settling Pit from northwest, showing the south wall, shelf and the raised mica drags area behind (2m scale)

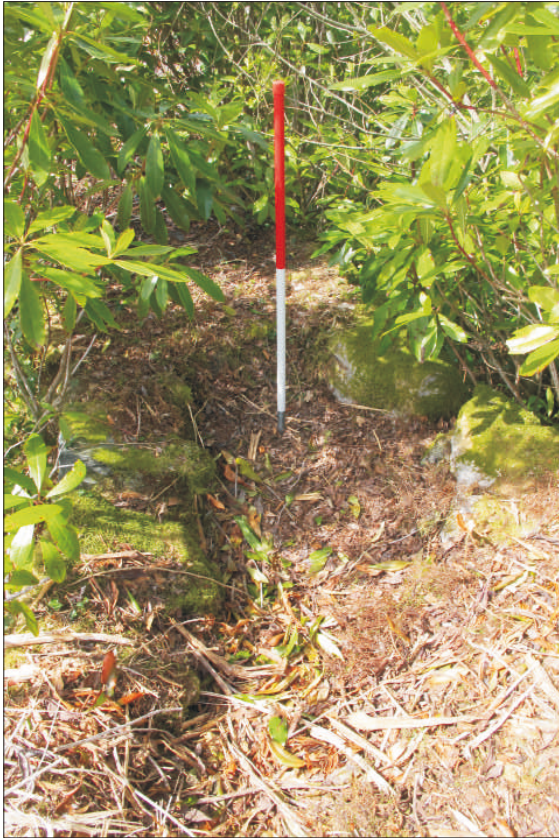
east end, a very narrow (100mm) slot gave access to a shaped basin filled with earth to 200mm but which perhaps measured 350mm deep (LSP.3). A channel 150mm wide connected with the top of Round Settling Pit 1.

Plate 4: Basin feature between Long Settling Pit (R) and Round Settling Pit 1 (L), from east-southeast (1m scale)

- 7.7** The function of the basin connecting the Long Settling Pit and Round Settling Pit 1 is unclear but could have regulated levels in the two pits; the narrow grooved channel between the two Round Settling Pits could have done the same.

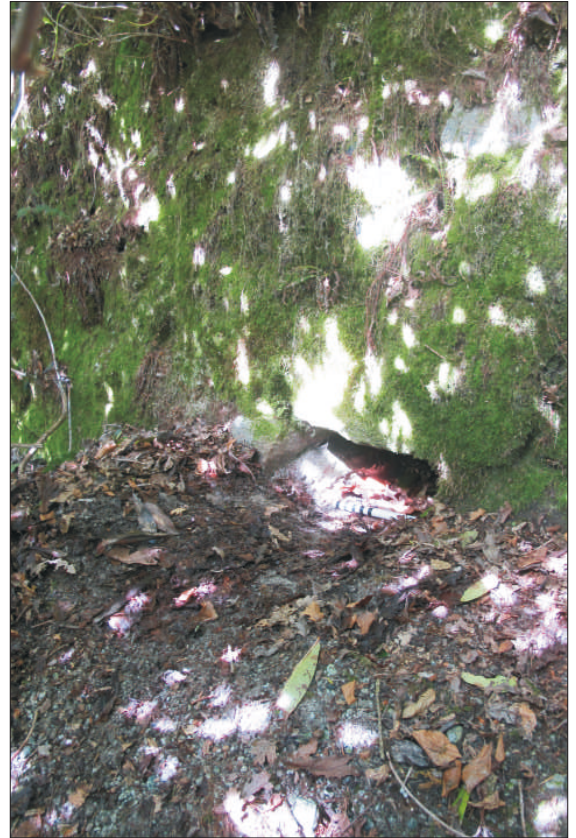
Inside the pit, the moss-covered walls were slightly battered to a depth of c. 3m before its base was buried with silt, rubble and vegetation including trees. Near the base at the northeast end a small rectangular opening was perhaps one of several places for draining the pit (LSP.4).

Plate 5: Long Settling Pit interior, squared drain(?) hole (LSP.4) in north stone wall at the east end (0.20m scale)

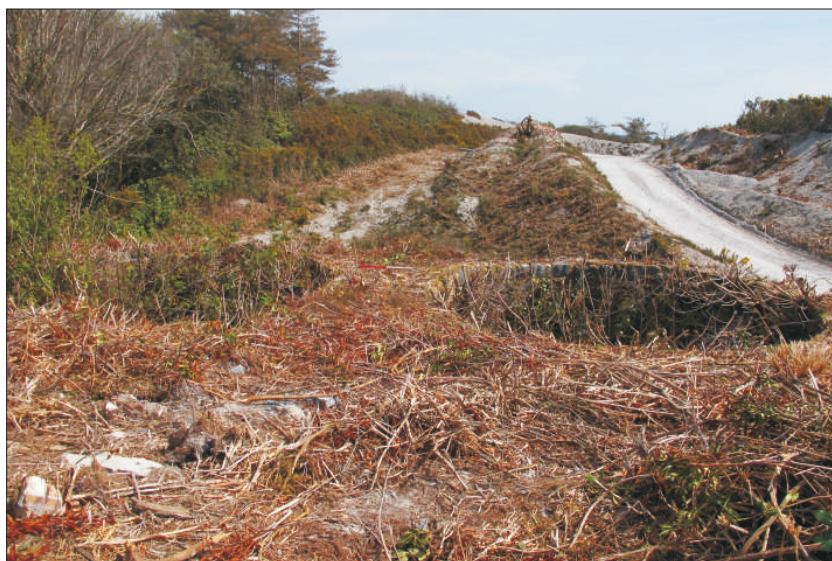
This was the north pit of a pair and measured c. 5.5m in diameter. It was built of rough stone, some of which formed a coping around the top. The coping was slightly distorted on the east side, perhaps where the supporting ground had been excavated away. At the top on the north side was the narrow channel and feature described above (LSP.3), while on the southwest side a small recess (RSP1.1) served as an inflow point for a buried earthenware pipe of 230mm (9ins) internal diameter, leading from the demolished area. Flat ground separated this pit from Round Settling Pit 2, and a narrow groove, 200mm wide and c. 250mm deep, connected the tops of both pits (RSP1.2). Internally, the sides of the stone-lined pit began to taper sharply inwards at a depth of c. 2.8m, creating an inverted cone shape. The lower part was silted but the full depth of the pit must exceed c. 4m. Trees still grew within the pit, making it difficult to record.

Plate 6: Round Settling Pits 1 and 2, from west (1m scale)

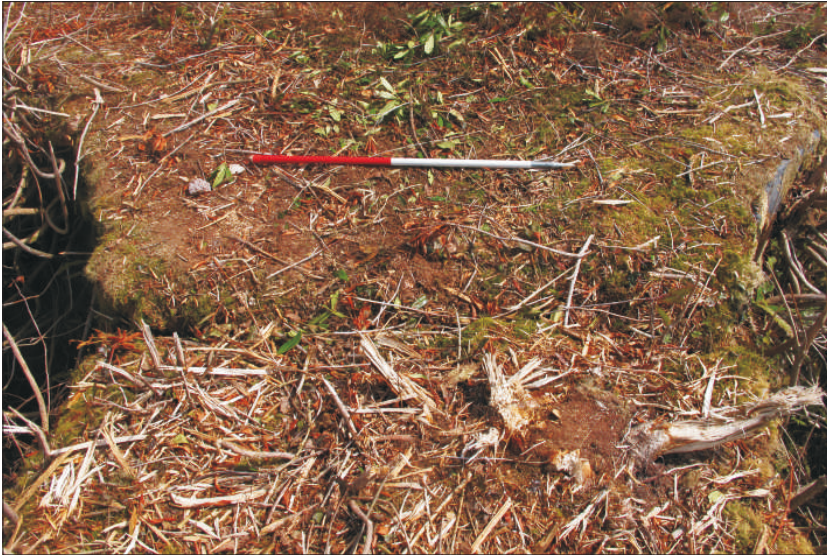
Plate 7: Narrow groove (RSP1.2) connecting the two round settling pits, from west (1m scale)

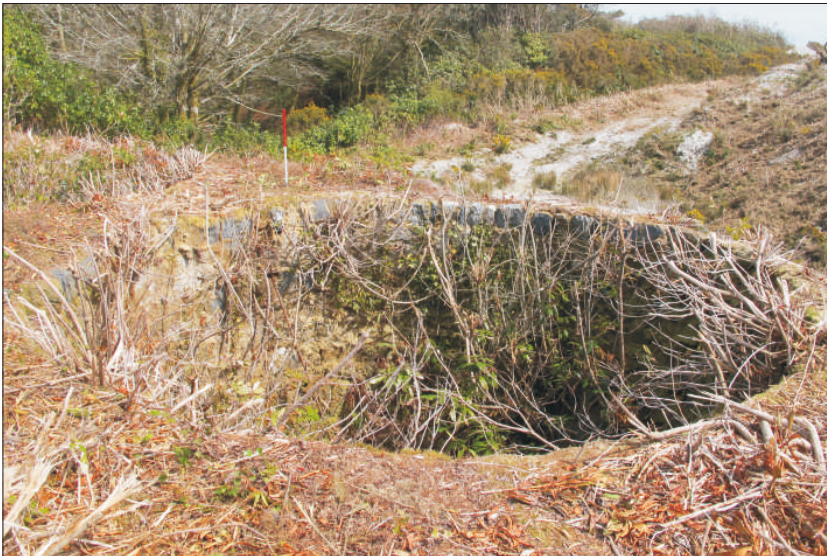
The south pit matched its twin, with similar construction materials and dimensions, and likewise still filled with growing trees. The ground had been excavated very close to the coping on the east side, although there was no evidence of collapse. At the top on the northwest side was a small recess (RSP2.1) serving as an inflow point for an earthenware pipe of 230mm (9ins) internal diameter, leading from the demolished area. In front of the pipe were two small upright timbers 200mm apart, which could have held hatch boards for controlling the flow of clay slurry. A pipe of unknown diameter was observed half-way down the moss-covered wall on the southwest side (RSP2.2). Of greater interest, a long iron rod with a mechanism attached (RSP2.3) lay in the pit, leaning against the wall immediately below the narrow groove which connected the two pits, described above. This may have been part of a mechanism connecting both pits, lying in the groove, or a mechanism for discharging the pit from an opening now buried at the base.

Plate 8: Round Settling Pit 2, overgrown internally, from southwest (1m scale)

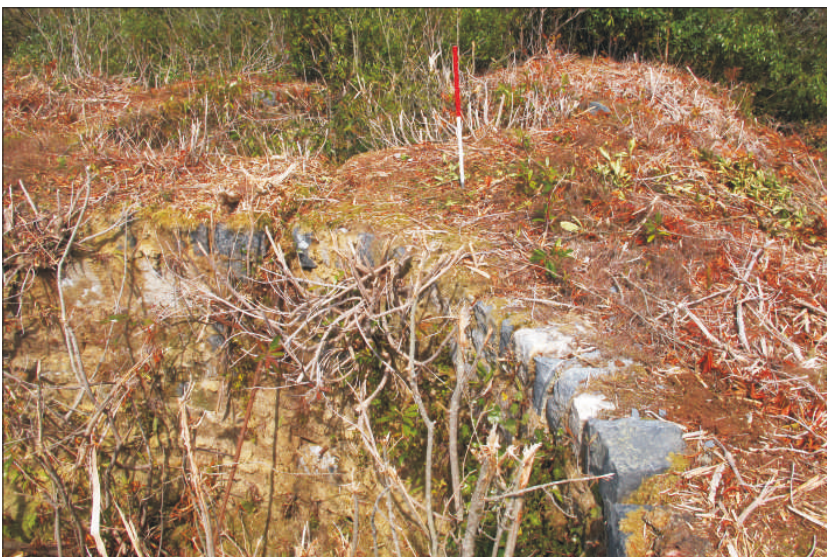
Plate 9: Round Settling Pit 2, stone coping, iron rod inside and narrow groove between the two pits, from south (1m scale)

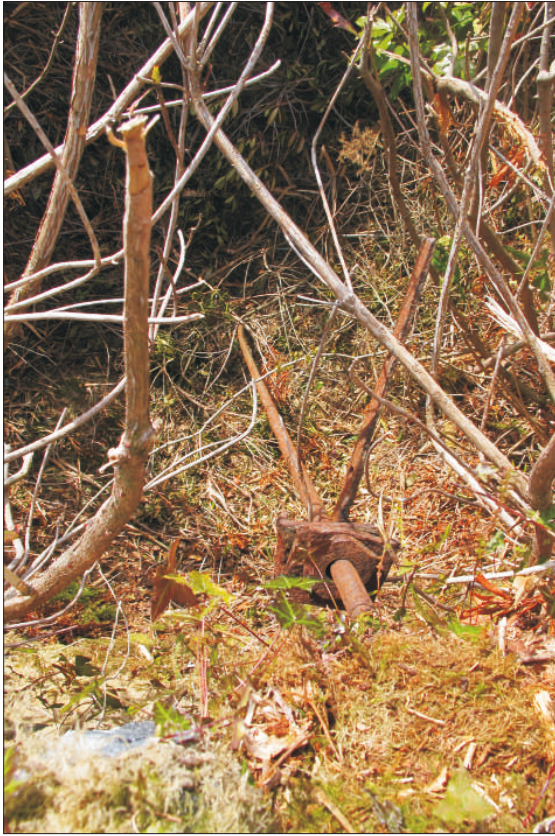
Plate 10: Round Settling Pit 2, interior on northeast side with long iron rod (RSP2.3), looking down from south-southwest

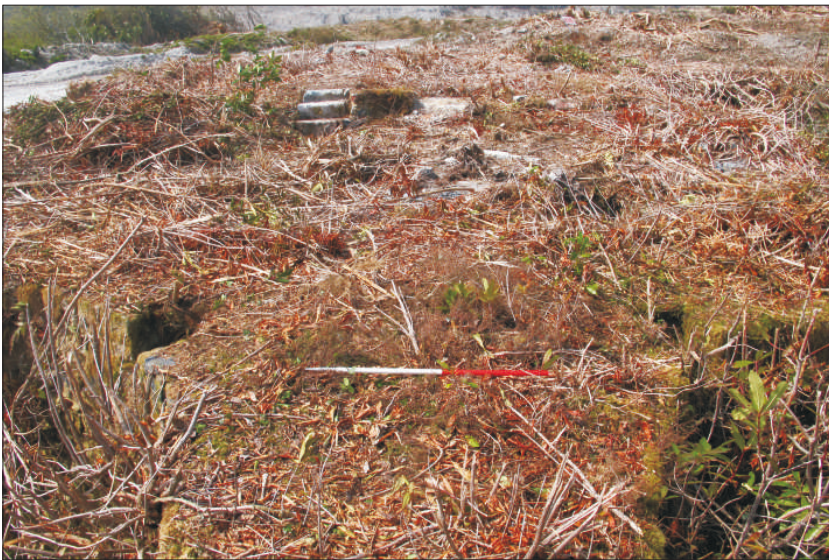
Plate 11: Two inflow recesses for pipes to Round Settling Pit 1 (R) and Round Settling Pit 2 (L), with demolished area and mica drags behind, from east (1m scale)

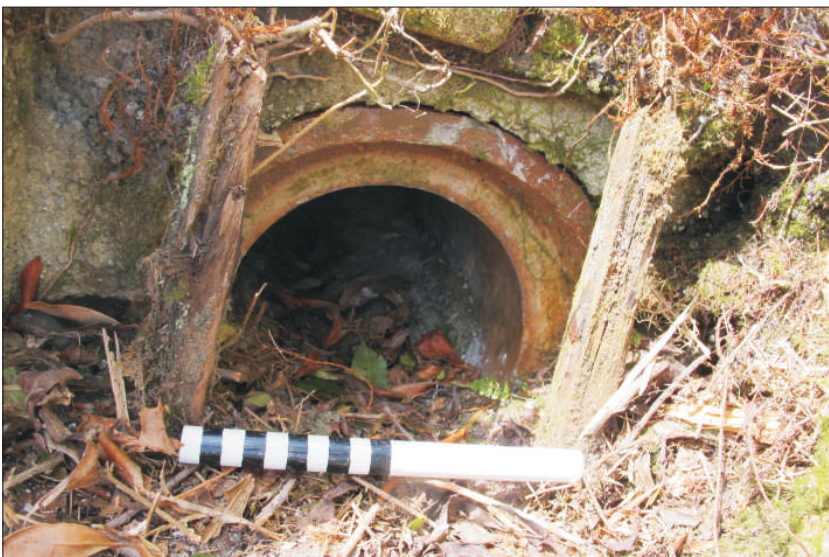
Plate 12: Inflow (RSP2.1) earthenware pipe and wood posts for control hatch, from southeast (0.20m scale)

- 7.5** Earthenware ('cloam') pipes were commonly used for distributing clay slurry at china clay works and all those seen at the Upper Processing Plant were of 230mm (9ins) internal diameter. Flanges on the pipes should indicate the flow direction although this was not always consistent with the interpretation, unless pipe joints were less critical if they became sealed with clay.

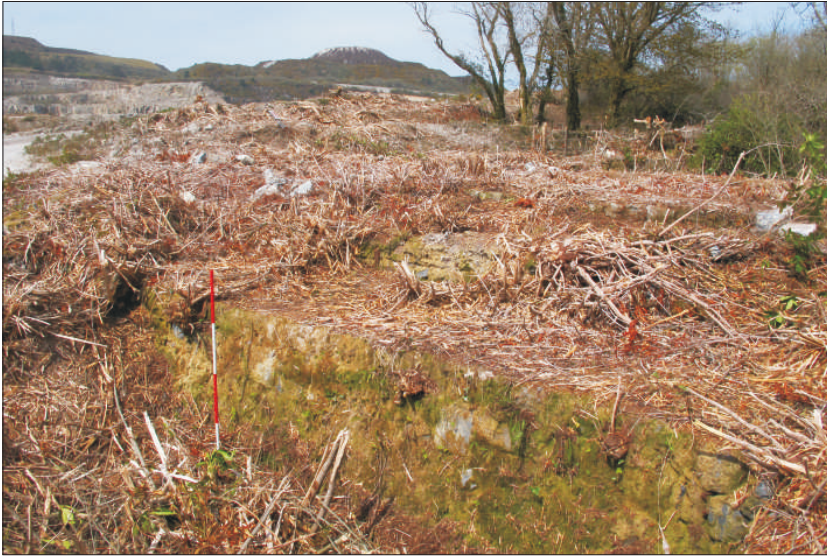
This rectangular stone-walled tank was incomplete. The south and west walls were demolished, and boulders placed across this area gave some protection from traffic on the clay pit track. Most of the north and east walls of rubble stone survived for a length of c. 7.5m each. The depth of this tank was only 1.4m to 1.7m down to the fill and the base was considered to be not far beneath. The east wall was truncated by the modern clay pit roadway at a point where its construction included dressed stones, perhaps indicating the location of a hatch for discharging the pit (ST.1). This destruction also provided a cross-section showing the wall to be 700mm wide at the top and 1m at the base. The ground behind the wall was of quartz sand material derived from previous waste tips. The face of the north wall was slightly battered, above which was a flat area c. 2.2m wide. The two walls were poorly joined at the corner. Here, on the north wall were two small iron spikes of unknown function (ST.2).

Plate 13: Settling Tank interior north wall, with low walls of the Channel and Mica Drags stepped up behind, from southeast (2m scale)

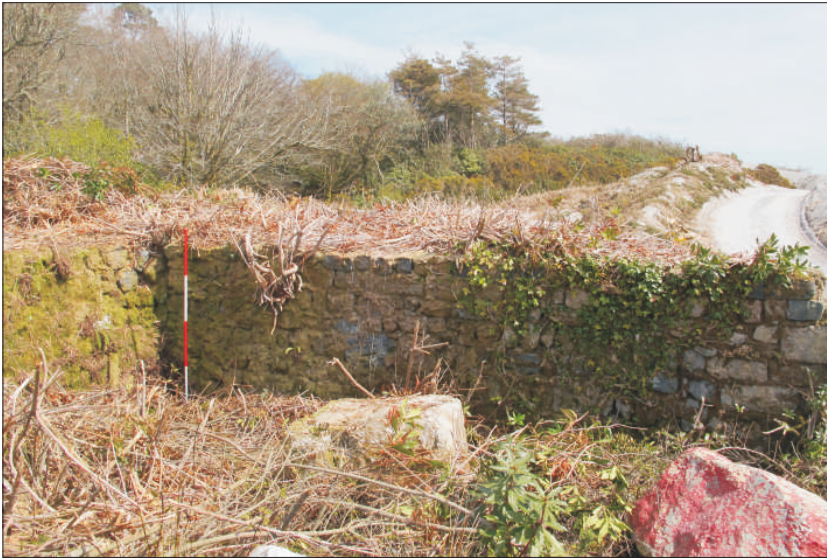
Plate 14: Settling Tank interior east wall, with corner on left and dressed stones to the right, from west-southwest (2m scale)

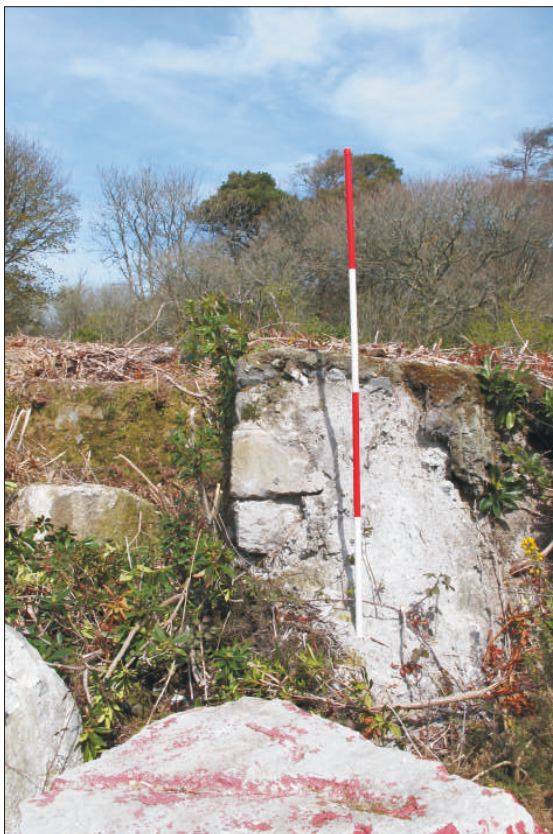
Plate 15: Settling Tank, truncated south end of east wall, providing a cross-section to show construction and dressed stones (2m scale)

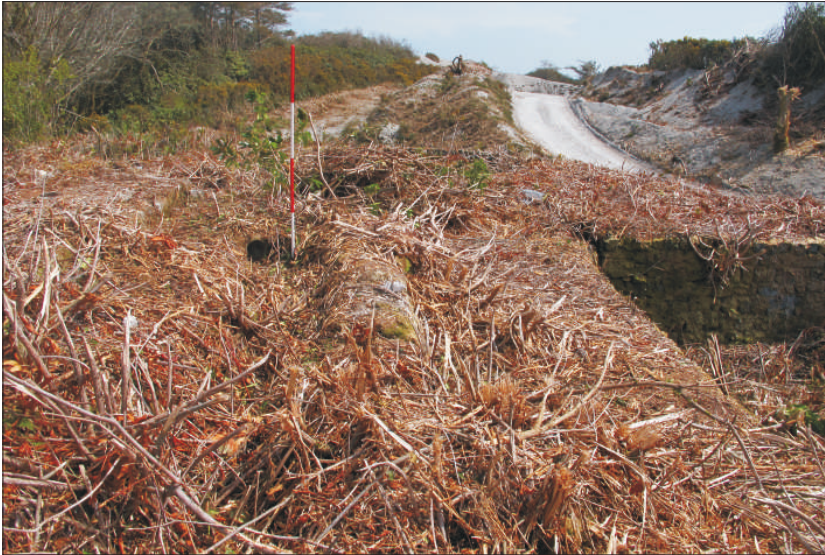
A channel aligned west-east ran between the parallel Settling Tank and the Mica Drags Platform. It disappeared beneath debris towards the west, but it turned slightly at the east end into a buried earthenware pipe of 230mm (9ins) internal diameter (C.1). The channel was c. 550mm wide and 350mm deep to the fill material. A small overflow outlet 250mm wide and 200mm deep was observed cut into the south bank which was encrusted with clay (C.2).

Plate 16: View from west of the Channel (or launder), with scale next to earthenware pipe. The Settling Tank is seen on the right and the mica drag platform on left (2m scale)

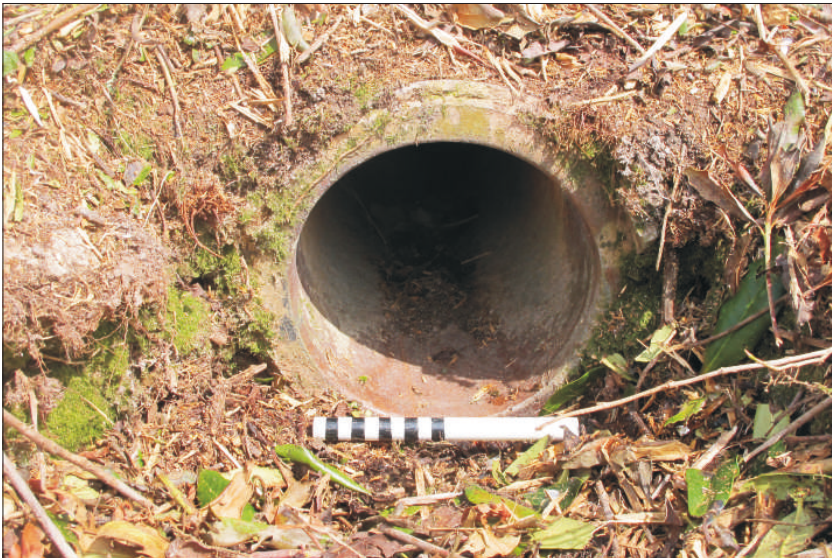
Plate 17: Earthenware pipe (C.1) detail at end of the Channel, from southwest. The pipe is aligned towards the demolished area (0.20m scale)

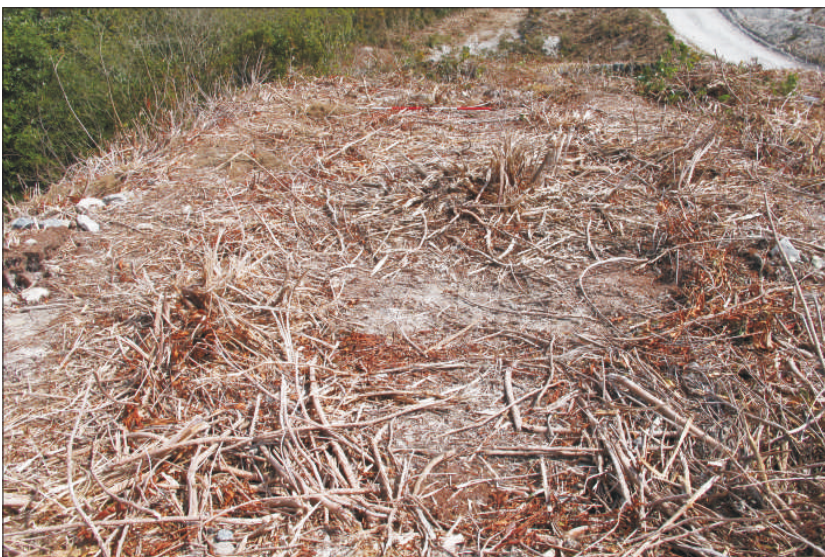
Only a short length of the east end survived of the original mica drags which were recorded as 40m long on the historic Ordnance Survey maps. The rest had been either demolished, buried under rubble or vanished in the void of the modern china clay pit. What survived was a platform measuring c. 13.5m long and 900mm high, partially buried and damaged. The position of the drags was indicated by a very shallow depression c. 4.2m wide between two broad platforms. Within, the trace of two cross channels (MDP.1 and MDP.2) were probably the sites of drain channels under the drag for discharging waste fine silt and mica. Damage to the south wall was probably caused by the passing of machinery and stones had become loosened or fallen away. Most of the raised east end wall had been damaged but the moss-covered south part survived (MDP.3), with a set of three stone or concrete steps alongside (MDP.4). These steps would have given access to the top of the mica drags.

Plate 18: View from the west along the top of the mica drag platform towards the east wall (2m scale)

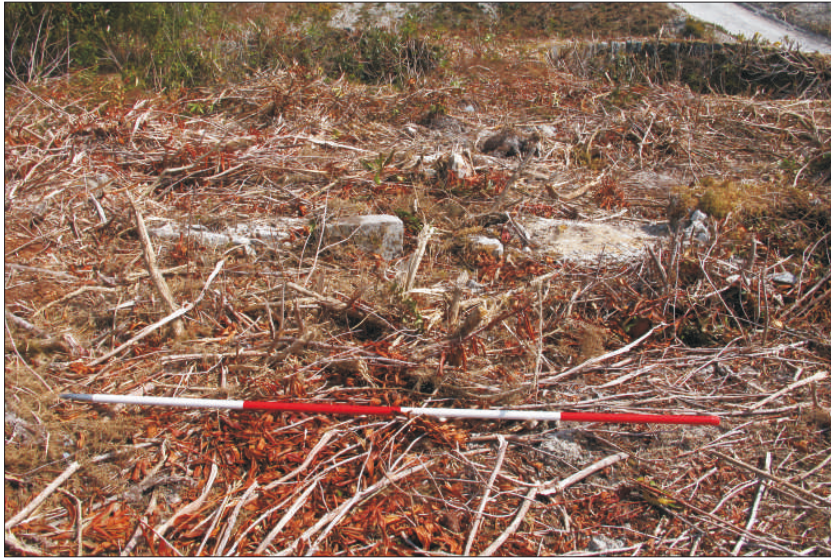
Plate 19: Broken east wall of the mica drag, from west. A possible cross-drain is in the shadow behind the scale. The demolished area and two round settling pits are beyond (2m scale)

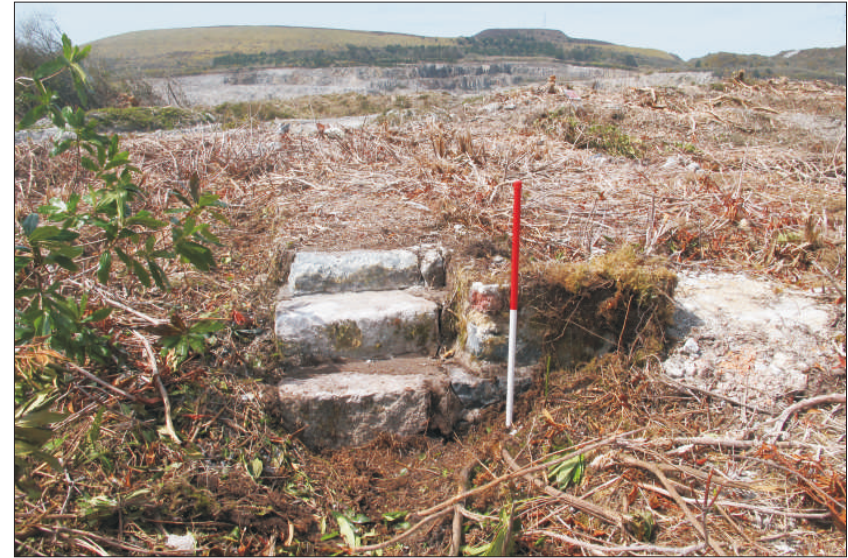
Plate 20: Steps (MDP.4) and end of the mica drag platform east wall (damaged to right), from the east (1m scale)

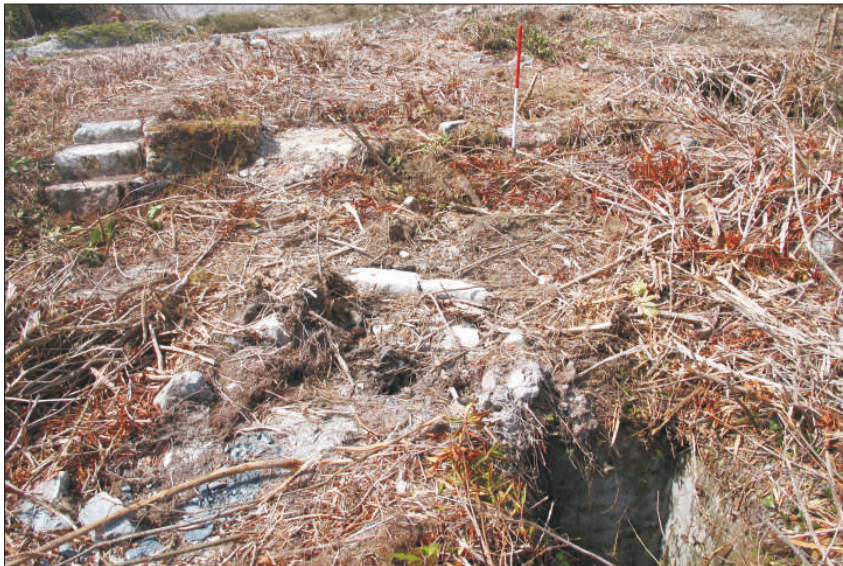
A small square building was marked between the mica drags and north round pit on the Ordnance Survey maps of 1906 and 1933. This area was the scene of recent damage by machinery, leaving it strewn with broken stone, brick and concrete block rubble. A buried depression near the east wall of the mica drags may have been the position of the final drain for the refined clay slurry (DA.1). The most notable feature was an almost square pit (measuring 800mm x 900mm) constructed of concrete blocks and rendered inside with cement (DA.2). It was open to a depth of 900mm after which it was filled with debris. A complete brick from the demolition debris, which had fallen into the pit, was stamped 'CARBIS'. The brick measured 230mm x 110mm x 63mm (9ins x 4 ½ ins x 2 ½ ins) and was a product of the Carbis Brickworks which operated in 1883-1942 just a few miles away near Roche (Ferguson and Thurlow 2005, 76-79).

Plate 21: Demolished area, strewn with debris, from east. The cement-lined pit (DA.2) is in the foreground (1m scale)

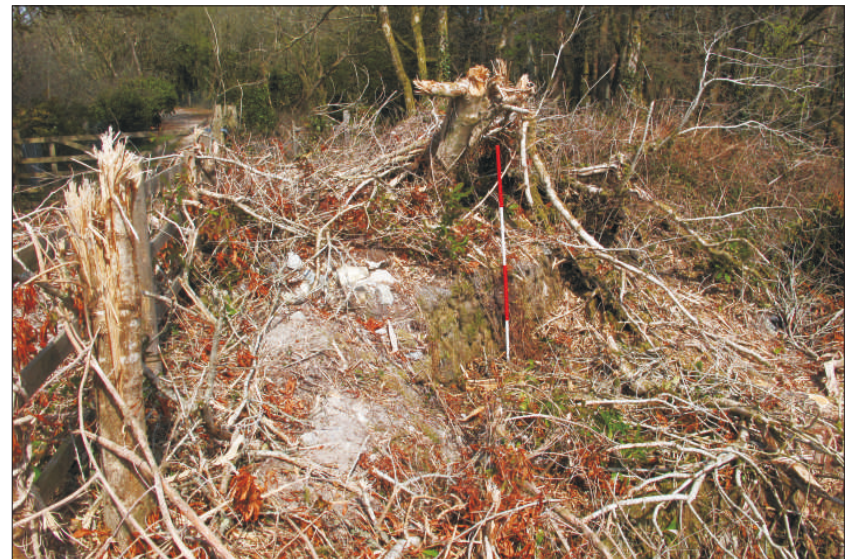
A dry-stone wall on a slight angle near the northwest corner of the Long Settling Pit may have been one of the earlier small field walls at Town Place recorded on the Tithe Map of 1839 and remaining on the 1879 Ordnance Survey map. If so, it had become incorporated into a retaining wall shown in 1906 (Fig. 4).

Plate 22: A possible early dry-stone boundary wall, near the partially hidden Long Settling Tank on bottom right. This view, from southwest, shows the proximity of the Wheal Martyn Museum woodland area beyond the gate on the left (2m scale)
