CHURCH OF ST ANDREW, STOKE DAMEREL, PLYMOUTH

Results of an archaeological watching brief

Document No: ACD1187/2/0

Date: July 2016

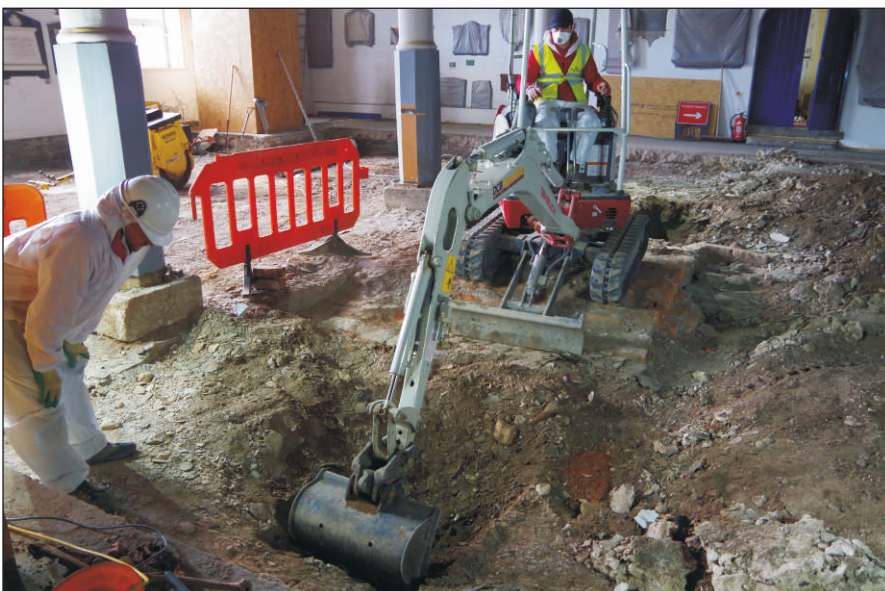
Plate 3: Groundworks in progress, looking southwest

The initial phase of work comprised the monitoring of two access holes cut through the modern board floor within the chancel. The main phase of work comprised the ground reduction of the floor level within the nave and aisles of the church (Plate 3). During this ground reduction nine brick-built tombs (T1-T9), three graves and a further four ill-defined voids which may have been the locations for graves were exposed. The tombs, graves and voids are discussed below in greater detail. A plan showing the location of all features exposed is included as Fig. 2. No finds were collected.

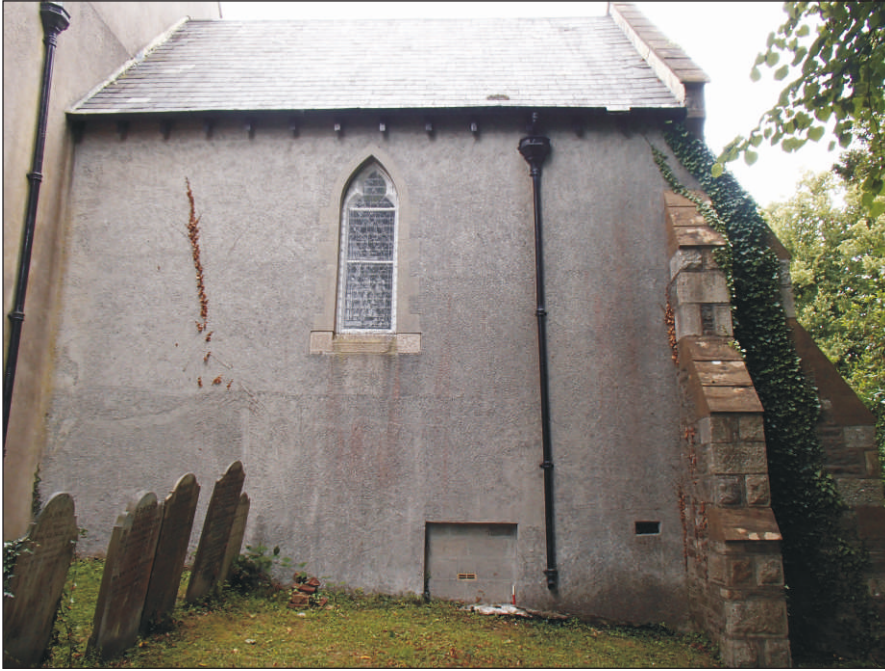
Plate 4: Chancel wall showing blocked access to cellar, looking north (scale 0.2m)

- 5.5** The chancel, which is of 19th century date, was provided with a cellar which is now largely filled with rubble and inaccessible. Access to the cellar appears to have been either through a blocked door in the exterior of the south wall or from beneath a lintel in the north wall.

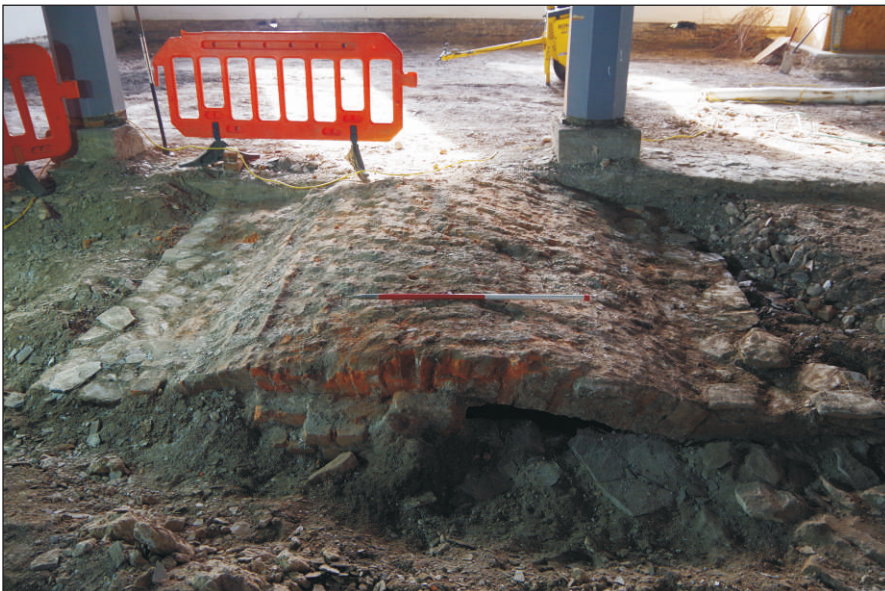
Tomb 1 was a large structure with an arched brick and mortar roof and was exposed beneath up to 0.30m of concrete forming the current floor. The structure measured 2.50m long by 2m wide and was aligned north-south. A small void showed that the tomb was filled with rubble material almost to the roof and could not be explored further. The vault was built of handmade bricks (measuring 0.25m x 0.12m x 0.08m) with a lime mortar bond. Slate walls measuring 0.50m wide were exposed on the east and west sides of the vault and appeared to cap the side walls of the tomb. An additional north-south aligned brick structure was partially exposed to the north of the western line of slates. As exposed it was two courses high, measuring 0.64m long (N-S) comprised of five bricks width. This may represent the beginning of steps leading to the tomb, but this could not be confirmed as no further or deeper excavation was necessary.

Plate 5: Tomb 1, looking south (scale 1m)

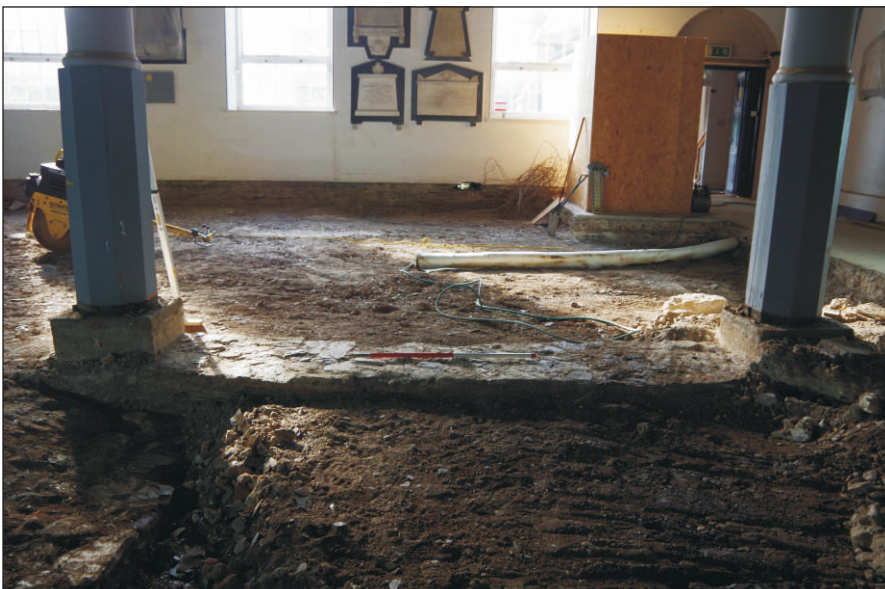
During the careful hand cleaning of the area to the south of T1 part of a slate wall foundation measuring 0.8m wide was exposed between the westernmost and central pillar separating the nave and the south aisle (Plate 6). Later observations showed that the robbed remains of this wall had probably continued to the east.

Plate 6: Wall foundation adjacent to Tomb 1, looking south (scale 1m)

- 5.4** A wall foundation exposed supporting the pillars marking the boundary between the nave and south aisle is located too far to the south to be related to the earlier church. It is probable that the foundation marks the extent of the earliest 18th century rebuild of the church, which, according to documentary evidence, was soon extended again with the addition of the south aisle. No structural remains of the south wall of the earlier church were exposed and the foundations appear to have been completely removed when the wall they supported was demolished.

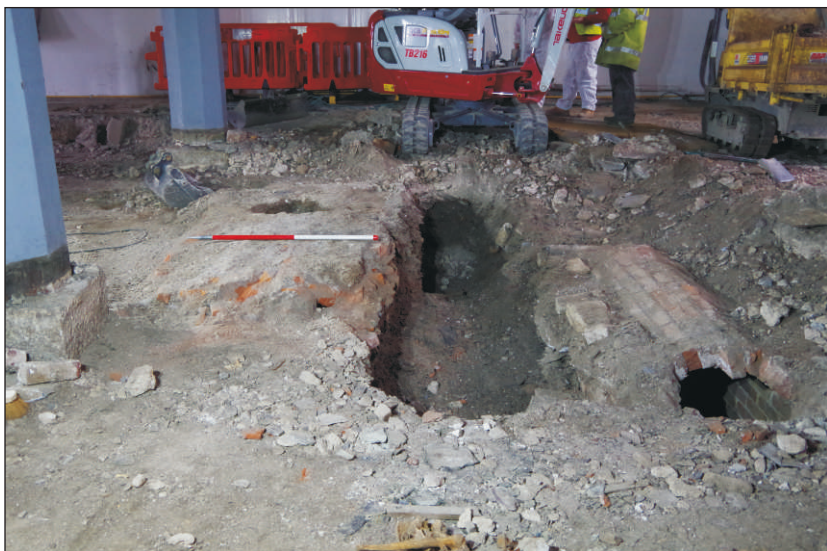
This tomb appeared to be a single grave measuring approximately 2.10m long by 0.35m wide (Plate 7). The vaulted roof and side walls were constructed of handmade

bricks. The tomb was surrounded by a rubble packing composed of abundant shale, lime mortar, stone (possibly original structural fragments) and a silty sandy material. It contained a single wooden coffin that had largely collapsed, although at the west end a coffin handle was still attached and a skull was exposed.

Tomb 3 comprised a single brick grave with a vaulted roof. There was evidence that this vault had been damaged at its most westerly end and repaired at a later date. The vault was constructed of machine-made bricks set within a shallow, flat arch and measured 2.40m long by 1.40m wide. The walls were handmade bricks with lime mortar and lime washed on the inside. Following the removal of the roof, the tomb measured 2.10m long by 0.75m wide by 0.90m deep. It contained only a rubble fill at its base.

The location of a grave between in T2 and T3 was indicated by the presence of a small number of *in situ* plastered bricks and some evidence of possible timber lining.

Plate 7: Tomb 2 (R), Void 3 centre foreground and Tomb 3 (L), looking west (scale 1m)

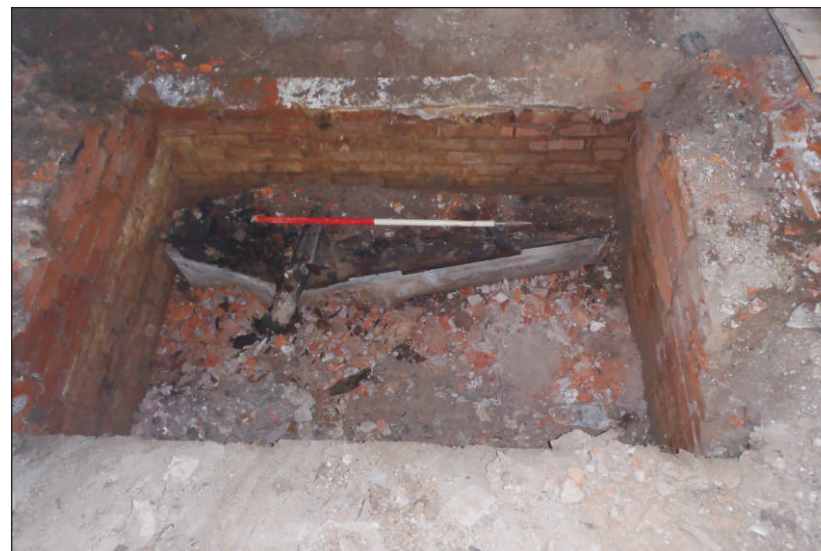
This was a brick-built grave with a vaulted roof. It was located directly in front of the north door of the church. It measured, as exposed, 2.50m long by 1.40m wide. Beneath the brick arch the remains of the wooden arch bracing were still attached to the brick. A single lead-lined coffin with the remains of a wooden coffin within were exposed (Plate 8). The east end appeared to be repaired with larger bricks and may have been the location for access.

Plate 8: Tomb 4, looking north (scale 1m)

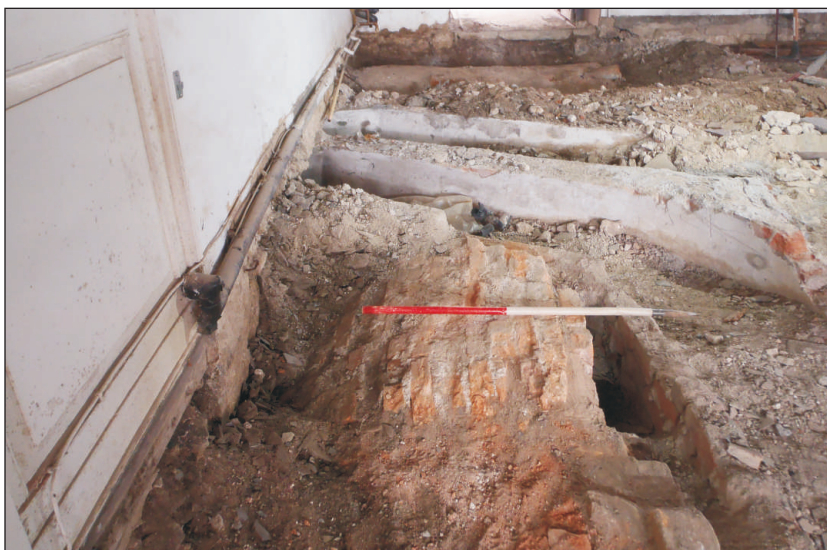
Tomb 6 was situated to the south of T4 and against the west wall (Plate 9). It had been heavily truncated by modern brick lined air/ventilation ducts and the excavated material has been used to fill the void. The tomb had a double thickness vaulted roof (0.22m thick) and appeared to be aligned north-south. The tomb was built of handmade bricks with lime mortar.

Plate 9: Tomb 6, looking north (scale 1m)

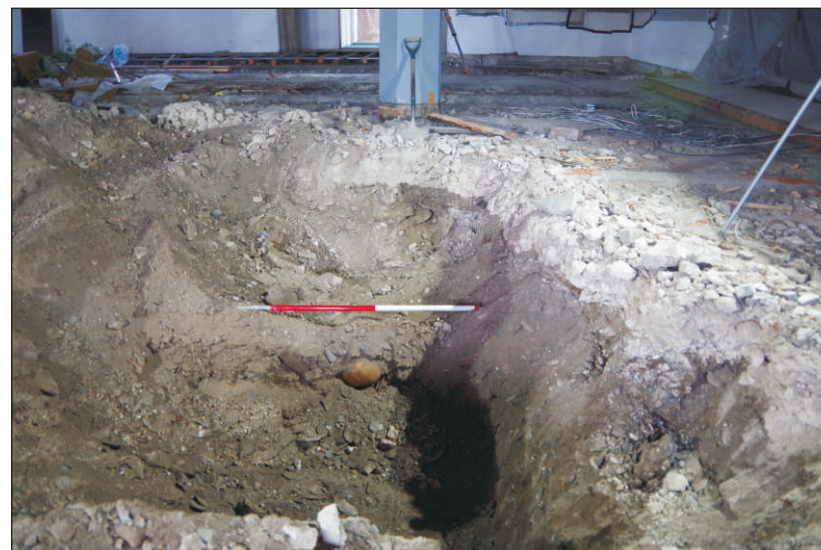
This possible grave was initially discovered through the presence of a void exposed during the ground reduction. The void was too small to determine the size or depth of the grave, but disarticulated bones included a skull, long bone and vertebra were visible along with pieces of wood and what appeared to be part of the metal bracket for a coffin lid. The groundworks continued to a depth of 0.70m below the modern floor level, but no formal grave was exposed.

Plate 10: Void 2, looking north (scale 1m)
