THE FORMER MASONS AND MARINERS PUBLIC HOUSE, PORTLAND, DORSET

Historic Building Survey

Document No: ACD1314/1/0

Date: June 2016

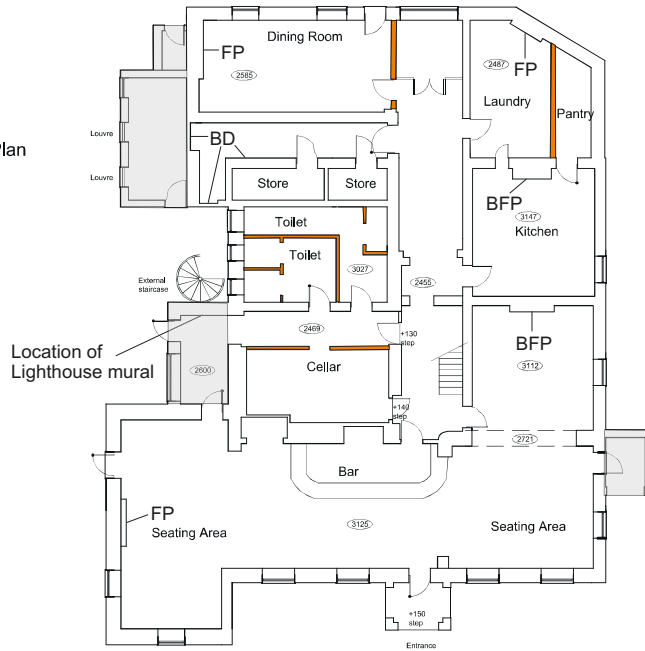
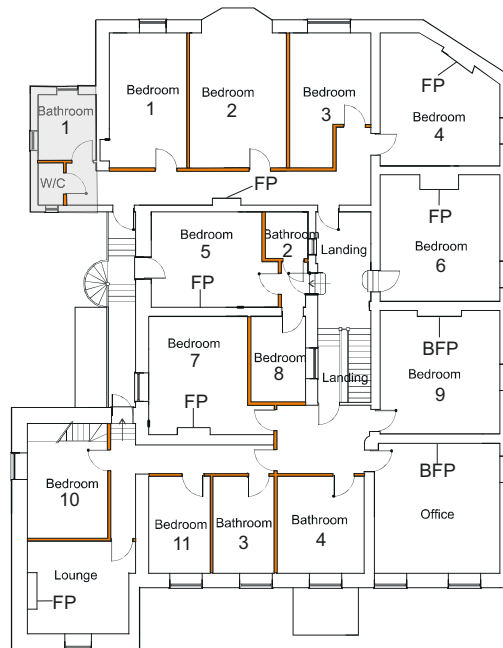
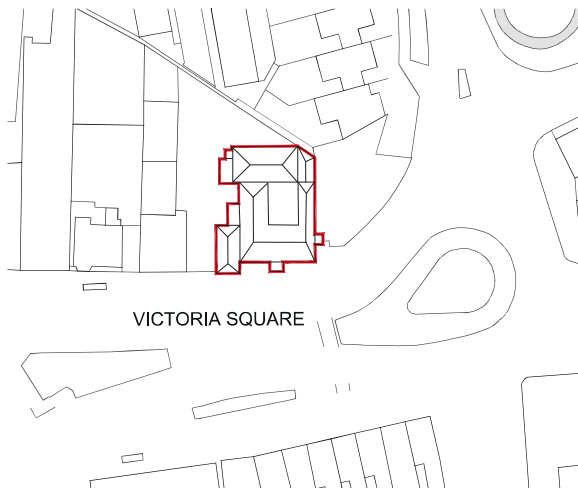
Fig. 3: Floor and roof plans

Ground Floor Plan
Scale 1:100

First Floor Plan
Scale 1:100

Roof Plan
Scale 1:500

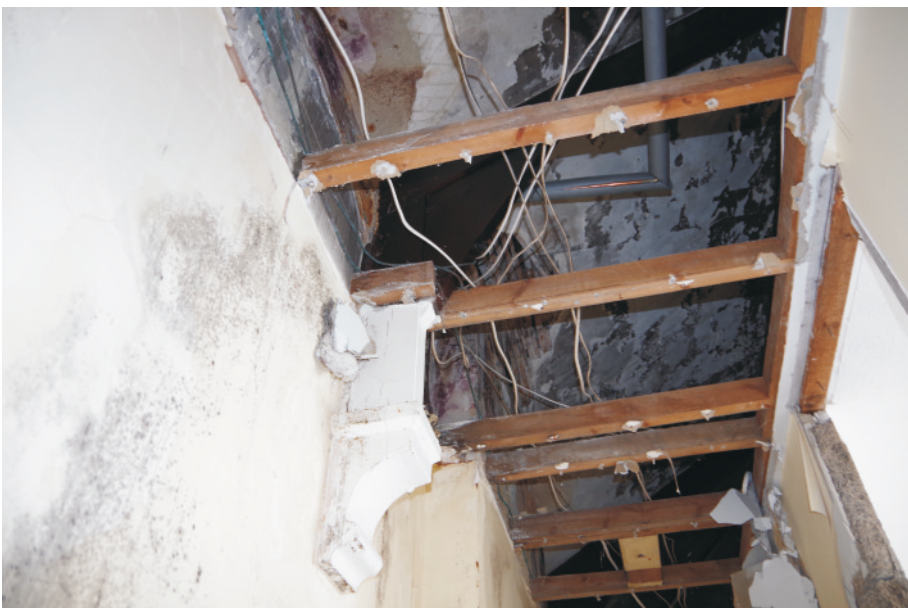
- 5.6** The roof of the eastern block is lower than the main U-shaped roof, and is supported on a modern form of jointed cruck roof. The joints are bolted together and with the lower crucks sitting on decorative corbels (Plate 6). No collars were visible in the exposed lower parts of the roof. The roof between the trusses is finished internally with lath and plaster, obscuring the remainder of the structure.

Plate 6: The jointed cruck roof beams on decorative corbels in the east block, viewed from the south.

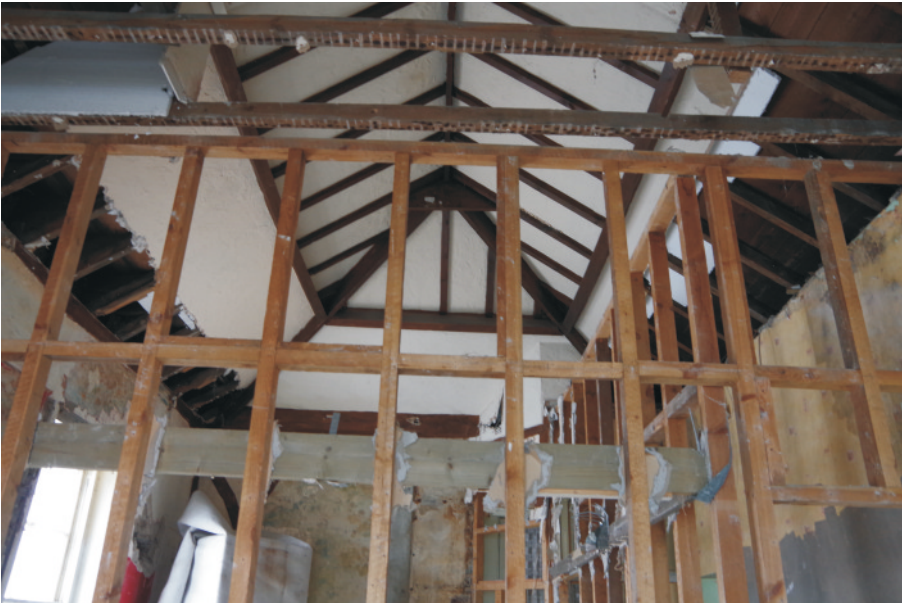
- 5.7** The northwest block is not supported on standard trusses. Instead the ridge and side purlins are solely supported on the hip trusses. Closely-set common rafters are set on the back of the side purlins. Below the central side purlins the roof is ceiled with lath and plaster, covering the rafters, whereas above these purlins the roof is finished with lath and plaster laid between the common rafters giving a covered 'lantern' effect (Plate 7).

Plate 7: The roof of the northwest block, viewed from the west.

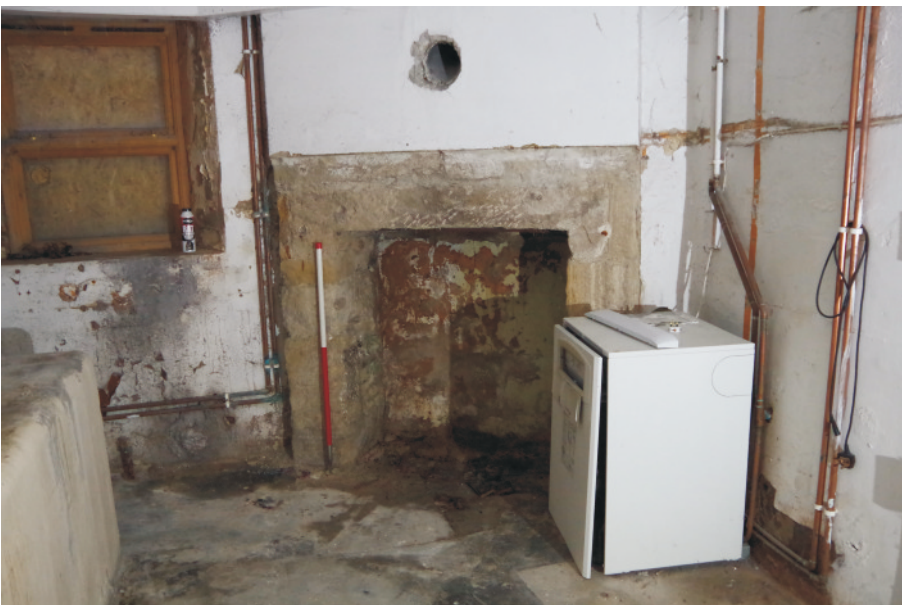
- 5.9** The building has a modern finish throughout including modern fixtures and fittings within the kitchen, bar and bathrooms. Original or early features and fittings of note are discussed below. On the ground floor the fireplace in the dining room has a modern stone surround, a wooden mantel and bricks defining the hearth. It is likely that this obscures or replaces an earlier fireplace. In the laundry room, the fireplace (in the angled southeast wall) has a Portland stone surround displaying rough tool marks as a finish (Plate 8). Also within this room there is also a large, 0.75m high, concrete slab against the north wall, the function of which is unclear (Plate 9). The laundry and the adjacent pantry are divided by a modern wall. Both rooms retain their original flagstone floor, which is also exposed in the corridor to the north of the stores (Plate 10). The west wall of the latter is constructed from rubble stonework with some blocks measuring up to 0.50 x 0.80m long. It has been rendered and scored to imitate ashlar masonry. There are three former doorways in the north and west walls of the corridor and store north wall, all probably blocked when the brick extension was added. In the south store is a modern safe.

Plate 8: Fireplace in the laundry, viewed from the west. 1m scale.

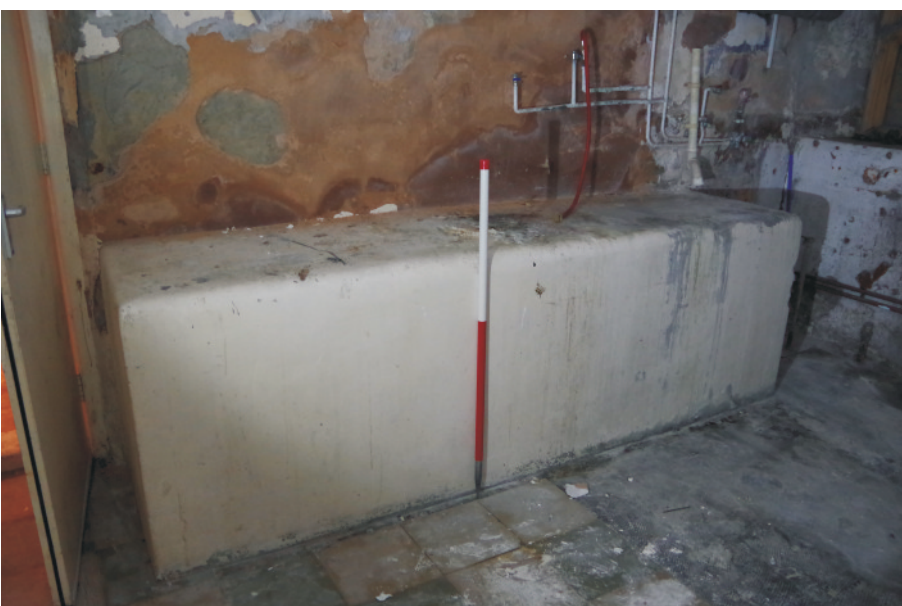
Plate 9: Large concrete slab in the laundry, viewed from the southwest. 1m scale.

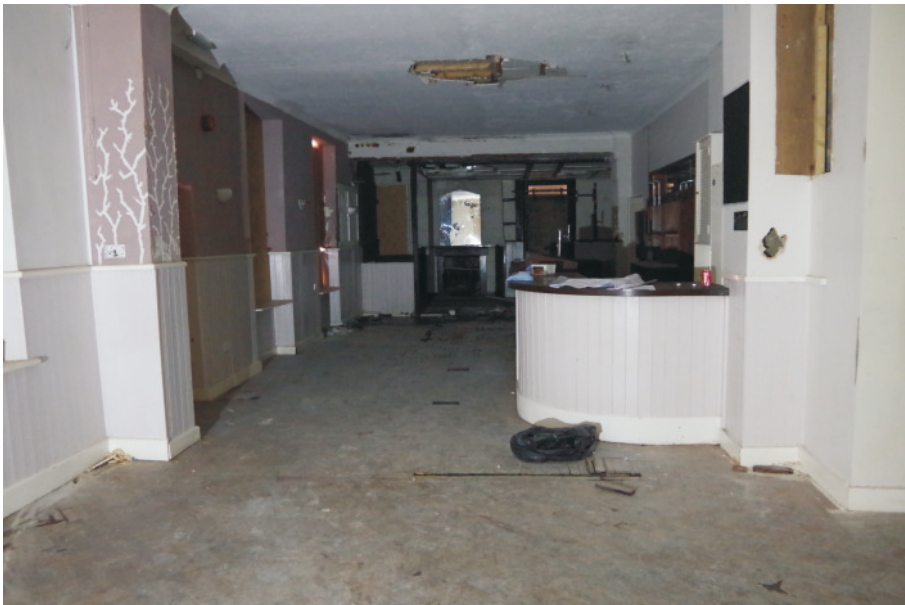
- 5.10** In the majority of the bar area the lower walls have wooden panelling topped with a dado rail; they are finished with wooden skirting boards and coving (Plate 11). At the north end of the bar the seating area has been decorated with very poor-quality

Plate 11: Bar area, viewed from the south.

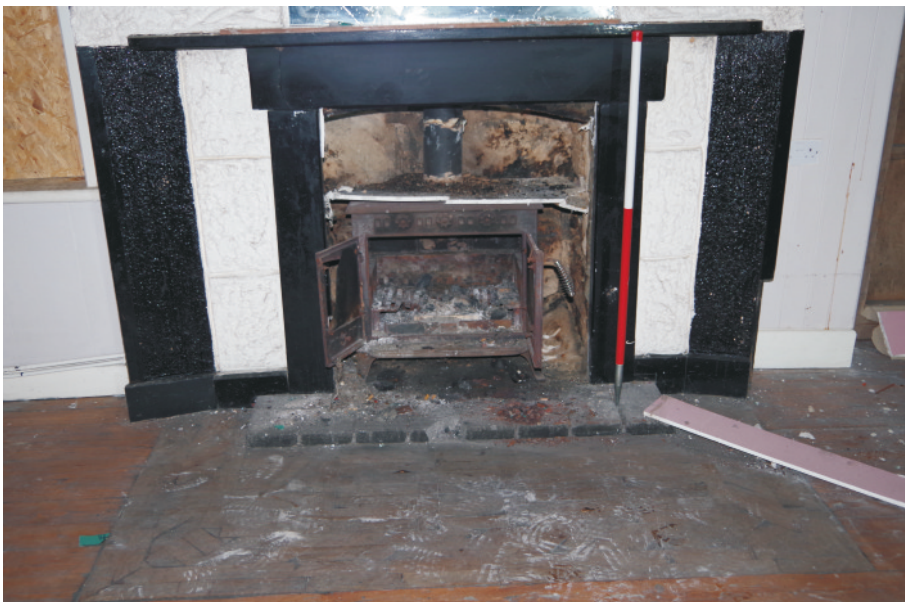
faux panels and beams. Here there is a cast-iron fireplace within a wooden surround and stone hearth in the north wall (Plate 12). In the south east corner of the bar is a disk jockey booth. The finish throughout the bar is modern. There is a 3-dimensional mural of a lighthouse in the corridor to the north of the bar (Plate 13).

Plate 12: Fireplace in the seating area of the bar, viewed from the south. 1m scale.
