BATHING WATER DIRECTIVE WORKS, COMBE MARTIN, DEVON

Results of an archaeological watching brief

On behalf of:
South West Water

Document No: ACD990/1/1

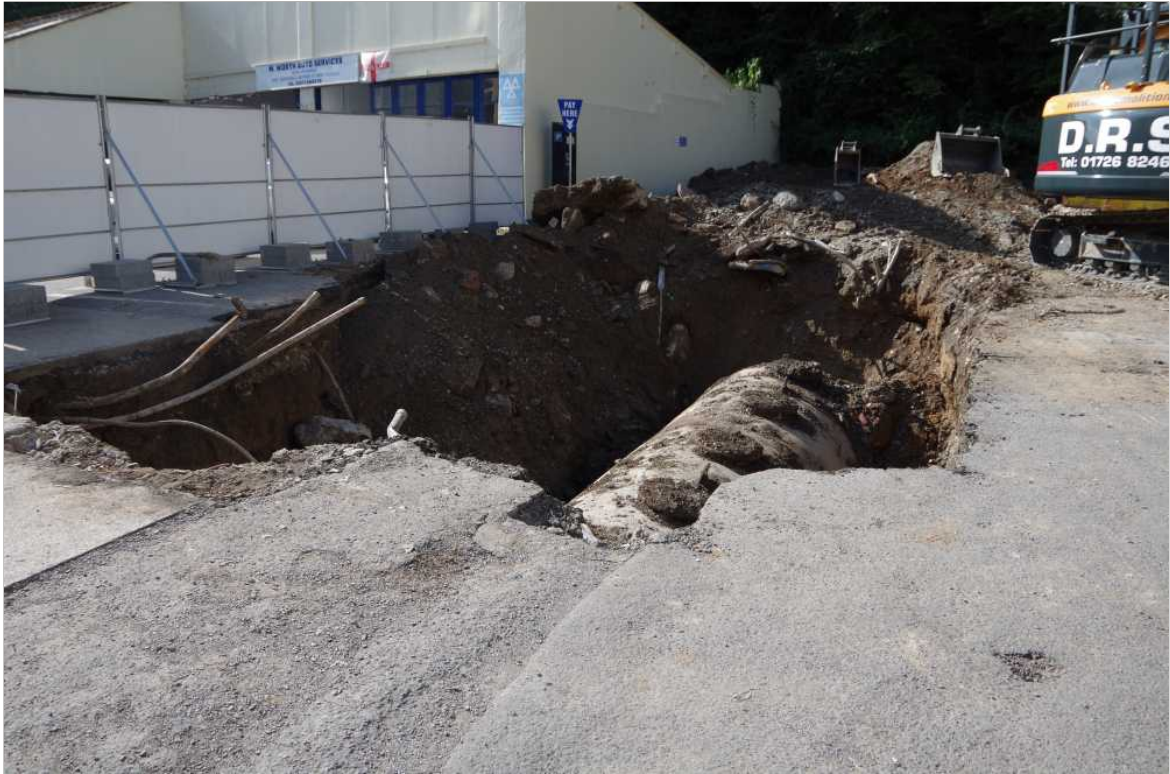
Plate 1: Glen Lyn Car Park (Area 1), general view during initial removal of fuel tanks

The works initially involved the removal of buried fuel tanks and an expansion of the hole for a new drainage tank. Overall the excavated area measured 15m by 10m. Due to the depth of the excavations the trench could not be entered prior to sheet piling been installed. No archaeological features were exposed and the generally stratigraphy comprised 0.45m of tarmac and hard core above up to 1.2m of made ground deposits of mid to dark brown firm silty clay and yellow-brown firm clay directly overlying top of slate natural bedrock. No finds were present.

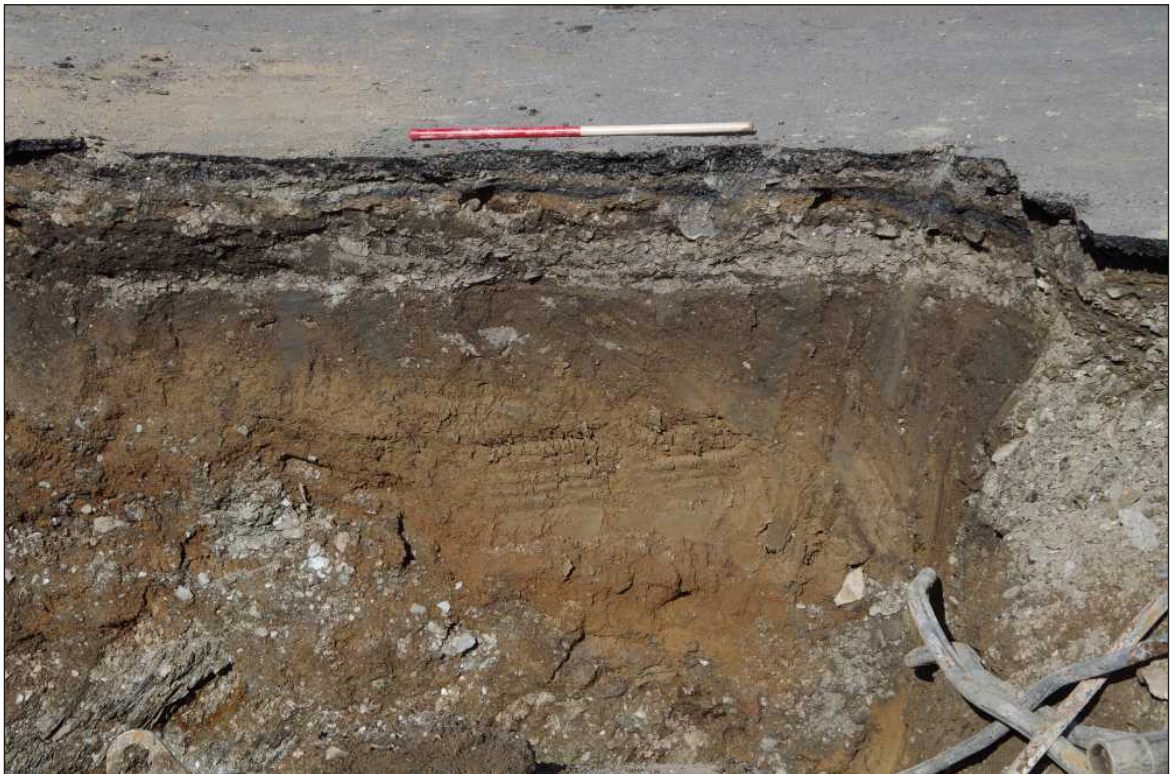
Plate 2: Glen Lyn Car Park (Area 1), typical section revealed during removal of a fuel tank (scale 1m)
