BELL INN, 108 DREW STREET, BRIXHAM

Architectural Assessment

Document No: ACD1345/1/1

Date: April 2016

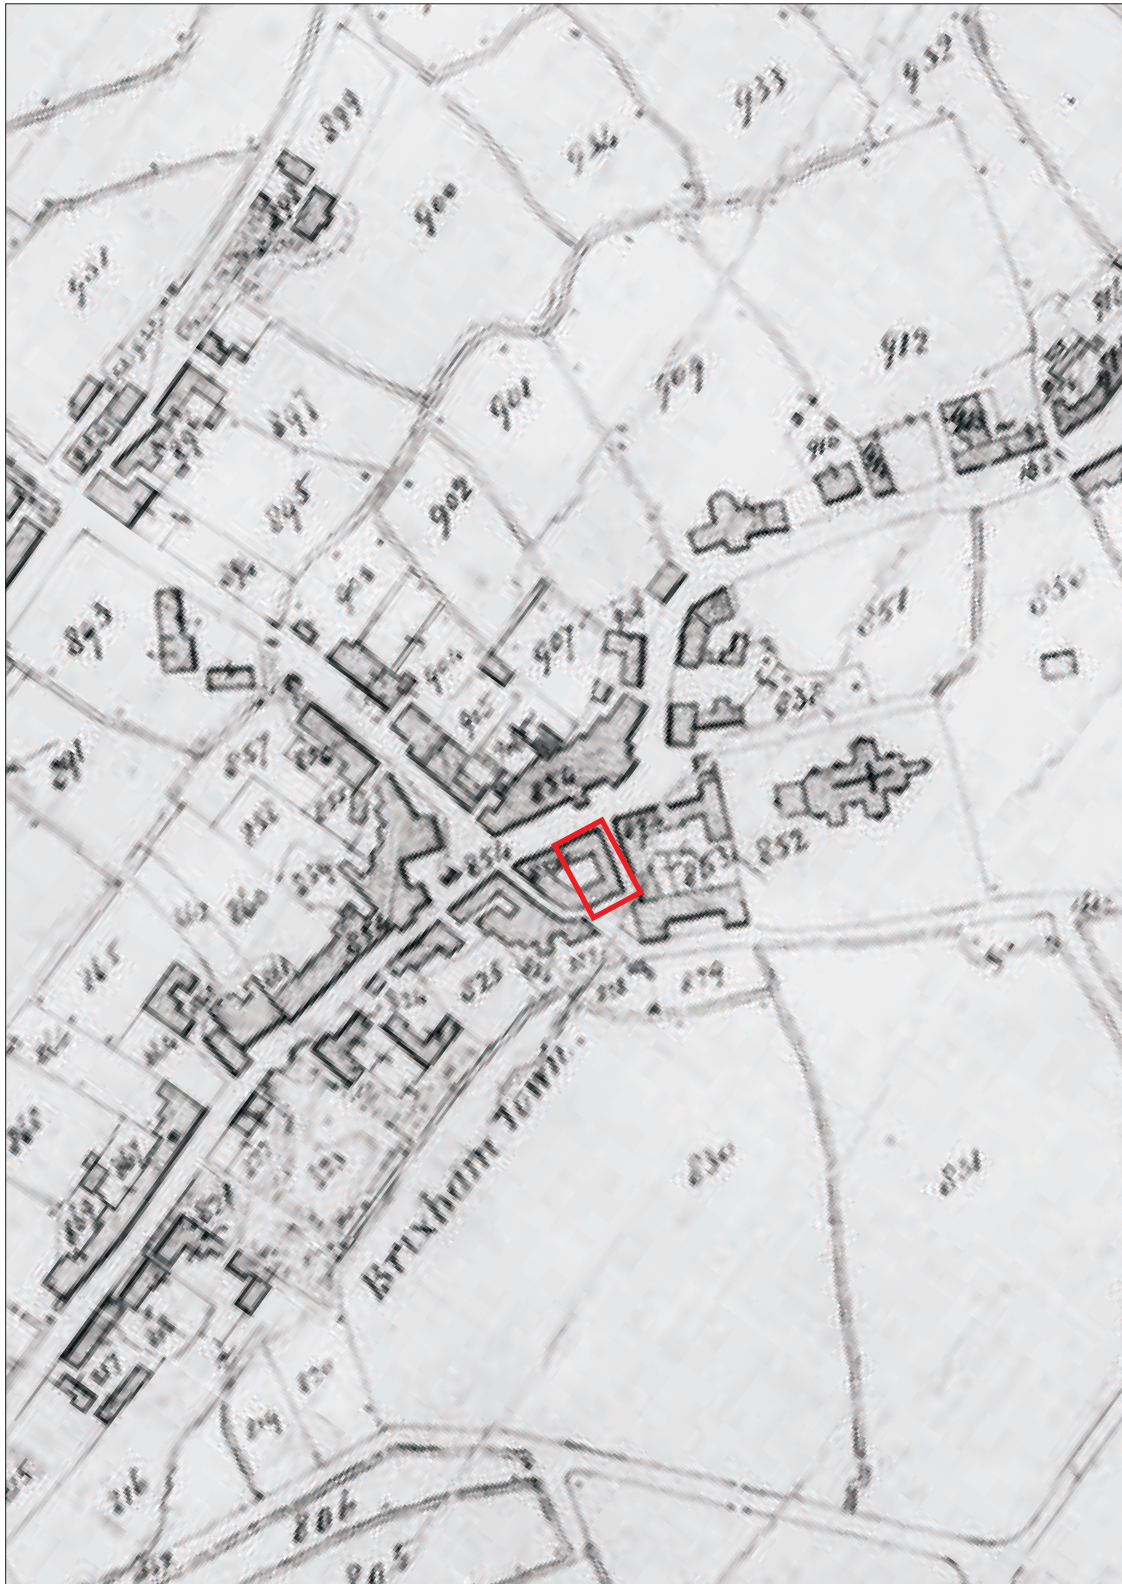
Fig. 3: Extract from the first edition 25-inch Ordnance Survey map, 1864

- 4.3** The building is recorded in detail on the first edition Ordnance Survey 25-inch map of 1864 (Fig. 3). It comprised a deep front range with two buildings (a central and rear range) attached to the rear on the east side, along with a yard to the west with a further rear building at the back of this yard. The property was simply labelled as "Inn". By 1906 when the 25-inch map was revised the southwest rear range had been extended into the yard (Fig. 4). The map also depicts the passage into the yard at the front of the property.

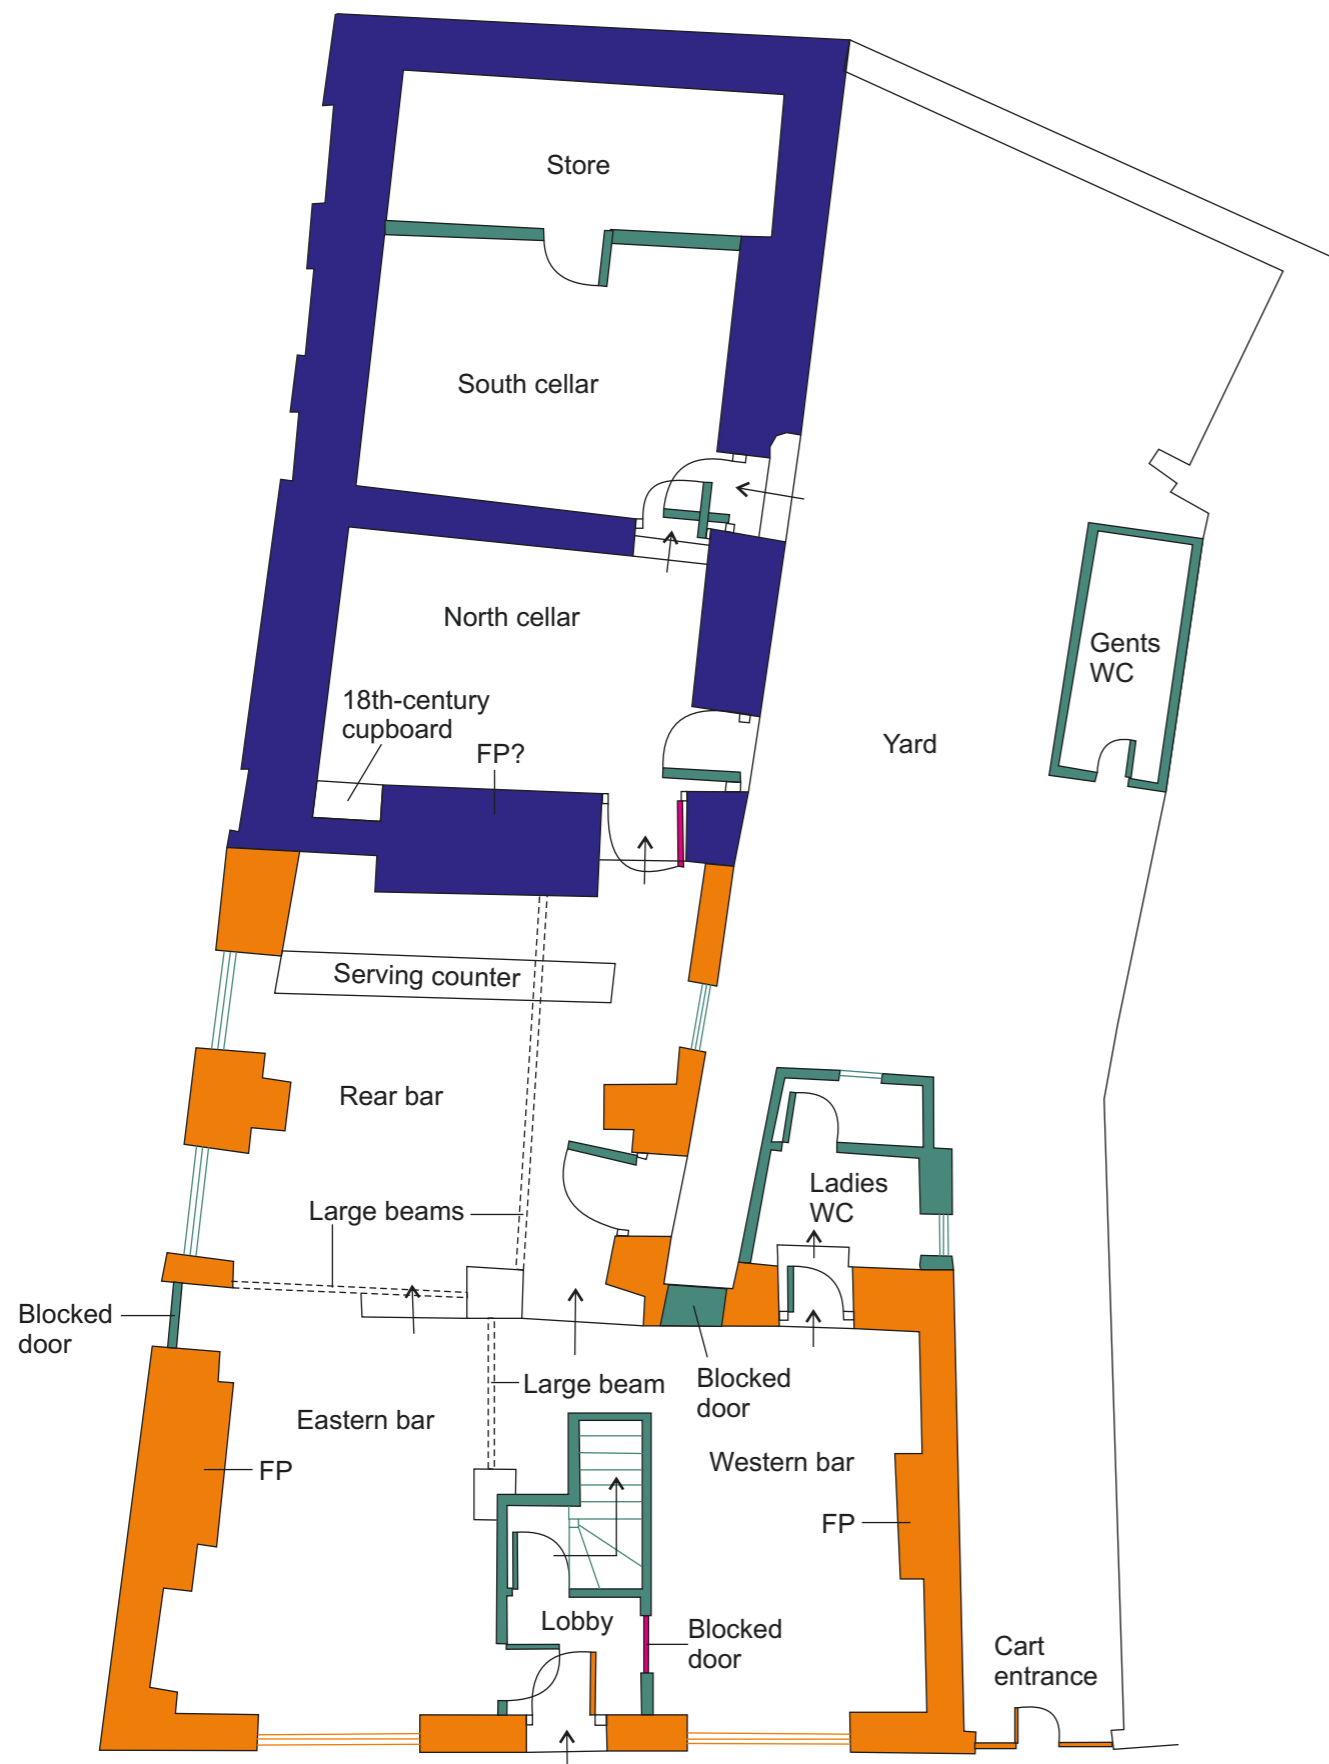
Fig. 5: Phased floor plans

Key

- Late 17th century
- Possibly late 17th century
- c. 1800
- 19th century
- 20th century

- 6.3** In the early 19th century the central and front range were constructed, presumably replacing an earlier structure. There is no visible evidence to suggest whether one range is earlier than the other and it is more likely that they are both contemporary. They appear to have been purpose built as a public house, and utilised the ground floor of the rear range as cellars. It is not clear when the first floor of the rear range falls out of domestic use (assuming this was its function) and became a store. It may have occurred when the other ranges were constructed, or alternatively later, and during the 19th-century may have been occupied by the owners as a private residence whilst the first and second floors of the other ranges housed public guest accommodation. There are a few fittings that survive from this date; namely the doors to the cart entrance and possible the larger beams in the front and central ranges.

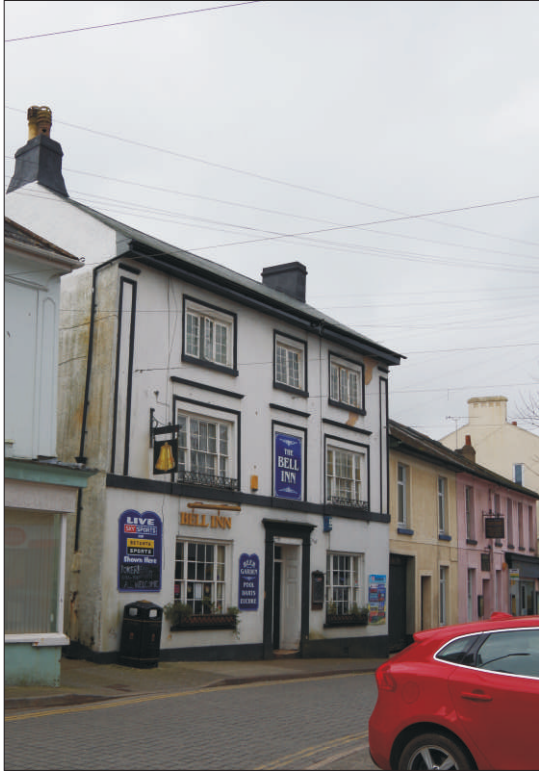
The main, northwest elevation of the front range faces onto Drew Street (Plate 1). It is rendered with string courses along the base of the wall and below the first floor windows. On the ground floor there are two sash windows of 12 panes with four-pane side lights and a central door. The latter is of six panels with panelled reveals and has a simple surround formed of pilasters and an entablature. On the first floor there are a further two sash windows of the same design as those on the ground floor and a central sign for the inn set over a blocked or blind window. On the second floor there are three casement windows. The two outer are of three lights with the central one being of two lights; each of the lights has eight panes. The windows on the first and second floor have moulded architraves and on the second floor they also have friezes and cornices. There are large panelled pilasters flanking the upper two storeys and it has a deep flat eaves cornice.

Plate 1: Northwest elevation of front range, looking southwest

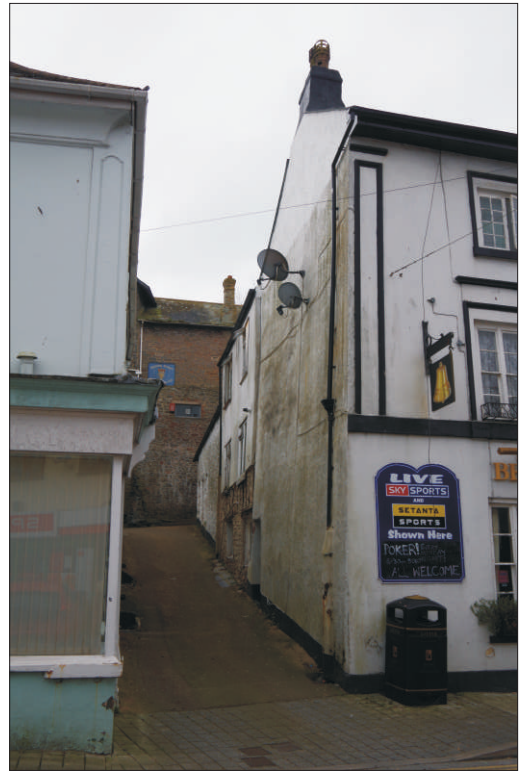
The northeast elevation of the building runs along the side of an alley (Plate 2). The front range is rendered like the northwest elevation and has a ground floor wooden plank door at the south end. This is no longer in use and has been blocked internally. The central range is also rendered but this has been removed for repairs to the ground floor. This has exposed the fabric which is rubble stonework at the base topped with a timber frame with panels of rubble stonework (Plate 3). The timber frame is formed of thin pine studs, measuring 75mm wide and 150mm deep. During previous repair work to the elevation the rest of the timber frame was exposed (Thorpe 2000). There are two windows on each of the three floors all of which are 20th-century replacements but within the position of original window openings. The rear range is constructed of painted rubble stonework and incorporates three windows and a doorway (Plate 4). The door has been partially infilled to convert it into a window. All the openings have wooden lintels and are currently blocked.

Plate 2: Northeast elevation of the building, looking south-southwest

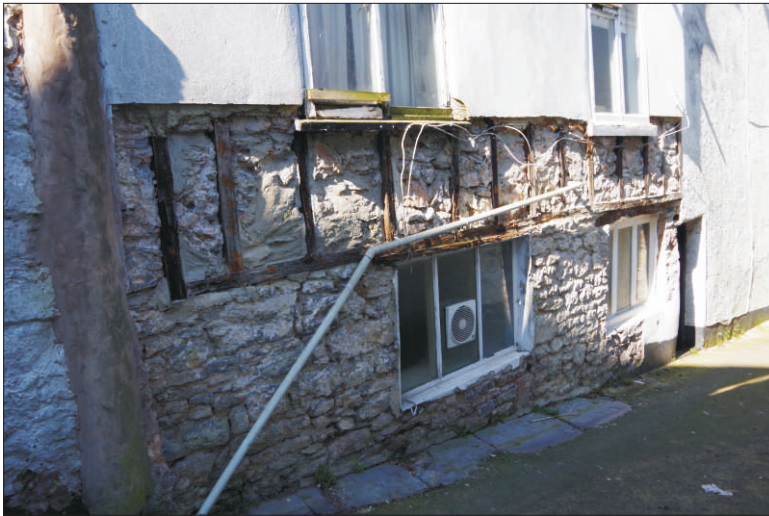
- 4.5** In 2000 timber framing on the east elevation of the east side of the building was investigated by Keystone Historic Building Consultants (Thorpe 2000). This was located within the 3-storey part of the rear range (of c.1800) immediately behind the front range. The timber framing was exposed at first- and second-floor levels and contained two 20th-century windows on each floor, both within original openings.

Plate 3: Ground floor of the northeast elevation of the central range showing the timber framing, looking northwest

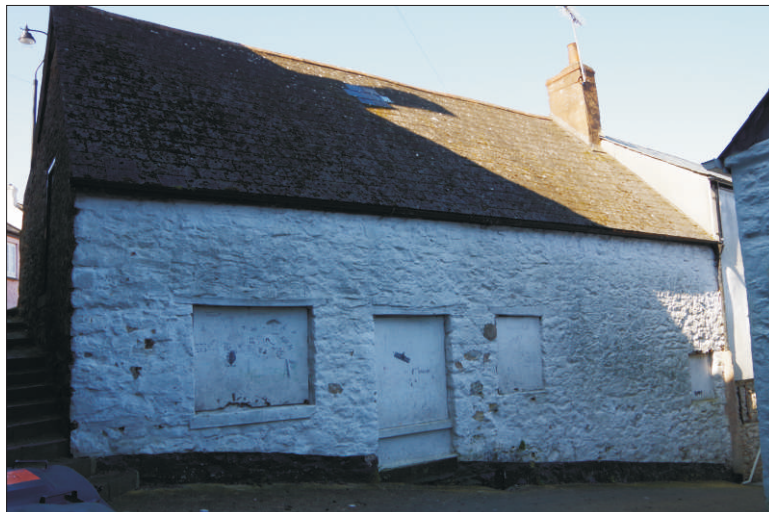
Plate 4: Northeast elevation of the rear range, looking west

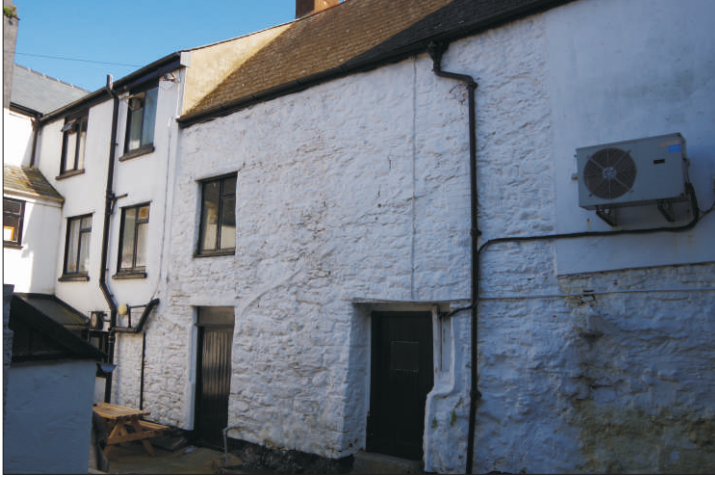
The southwest elevation of the central range is of painted rubble stonework on the ground floor with the upper two storeys being rendered (Plate 5). There is a door and window on the ground floor, with two windows on each of the two upper storeys; all are 20th-century replacements. The rear range is also of painted rubble stonework, except the upper storey at the southeast end which is rendered (Plate 5). Below this the stonework is very uneven which may be because it blocks an opening that once went into the now demolished range at the rear of the plot, and/or is associated with a wall of this former building. There are two doors on the ground floor and a window on the first floor, all of which are 20th-century replacements. The southern doorway has been converted from a wider former window, whose opening retains two metal security bars (Plate 6). At first floor level, above this doorway, are areas of altered masonry. These comprise a small opening infilled with bricks, and below eaves level a wider, deeper area of possibly infill, defined to the south by a

row of jambs. This may represent a former opening, although its position appears to coincide with the first-floor partition.

Plate 5: Southwest elevation of the central and rear ranges, looking north

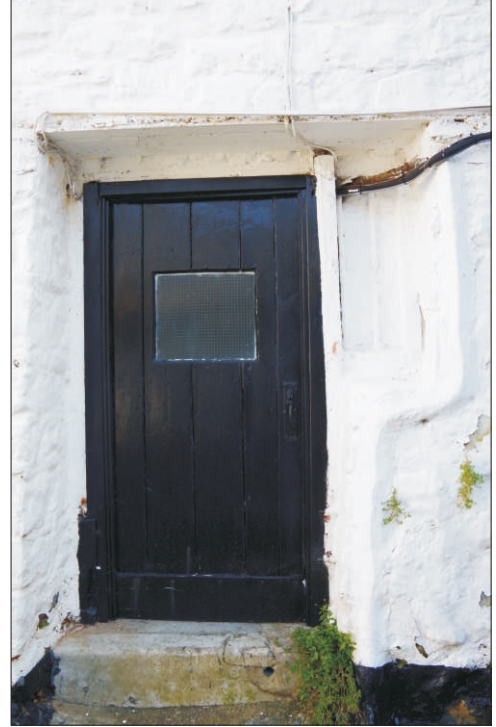
Plate 6: Door and earlier window in the southwest elevation of the rear range, looking northeast

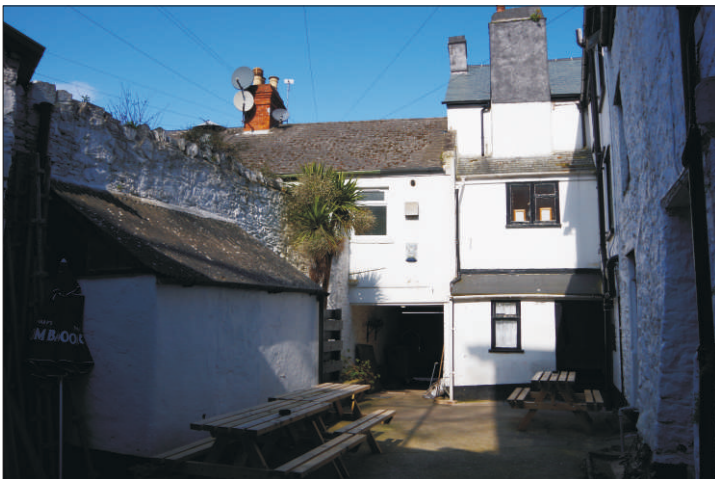
The southeast elevation of the front range is rendered as are the two extensions constructed against this elevation (Plate 7). One extension is single storey with a sloping felt roof, and a 20th-century window and doorway. The other is of two storeys with a sloping tiled roof and a 20-century window at first-floor level. Above this extension is a projecting chimney stack for the front range; this has a single chimney pot. On the ground floor within the extension, the external wall of the front range has been retained. Adjacent to the extension there is a stone step and a drain which indicates that there may have previously been a door opening here.

The rear yard has a concrete floor and the boundary walls are painted rubble stonework with repairs in blockwork and concrete to the rear, southeast wall. The gents WC outbuilding in the yard is rendered and has a sloping corrugated sheet roof (see Plate 7).

Plate 7: Southeast elevation of the rear range showing the 20th-century extensions, cart entrance and 20th-century outbuilding, looking northwest

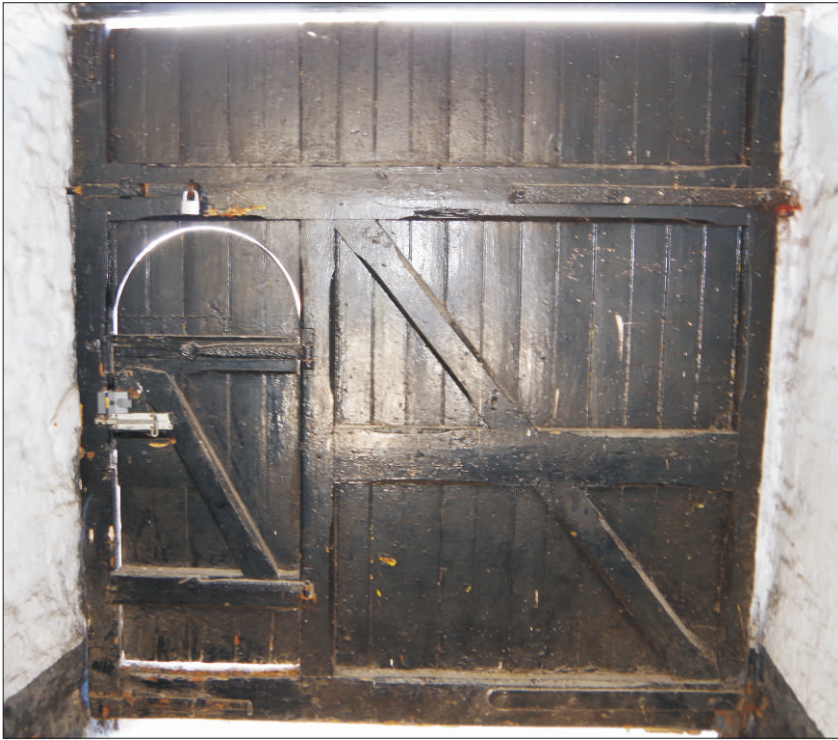
The covered cart entrance has a concrete floor. The southwest wall of the front range, which forms one side of this passage, is constructed of painted rubble stonework whilst the northeast wall of the adjoining property is of painted brick. There are two metal loops for tying horses on to the wall. The doors are large wooden planks with a smaller pedestrian door on the west side. The main doors have large straight strap hinges whilst the pedestrian door has spearhead shaped ends to the strap hinges which date stylistically to the 18th century (Plate 9).

Plate 9: 18th-century cart entrance gates, looking northwest

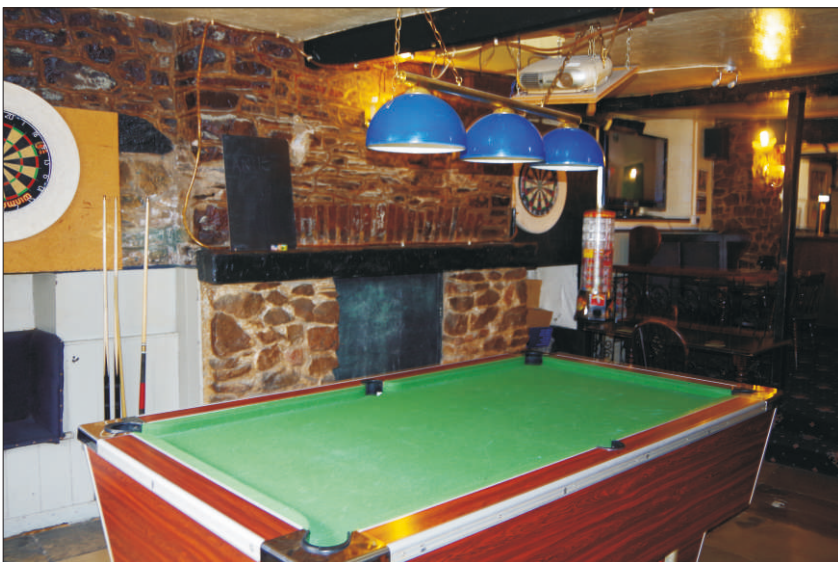
Within the front range there are currently two bar areas, a central lobby and a staircase. The eastern bar has a flagstone floor and the lower part of the walls are covered with timber planks. The upper parts of the walls are either rendered or covered with faux stone walling. There is a blocked fireplace on the east wall that has a stone surround and a brick arch above (Plate 10). To the south of this is a blocked doorway to the side alley. There is a fake beam across the ceiling but also several larger, possibly original beams. The eastern bar is open to the rear bar that is located in the central range. It seems likely that at least one internal wall has been removed to create this larger open-plan space.

Plate 10: General view of eastern bar in the front range, looking southeast

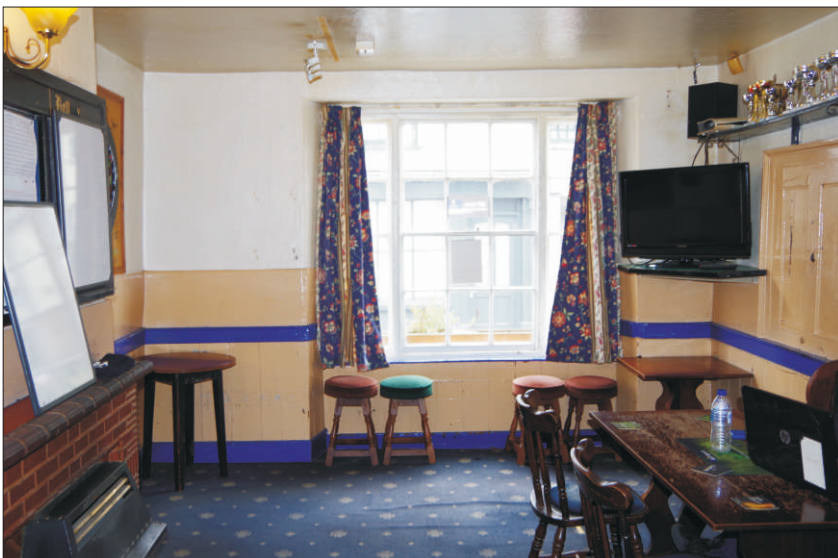
The floor of the western bar is covered with carpets and the lower parts of the walls are covered with timber planks, which continues over a doorway within the partition to the lobby (Plate 11). There is a fireplace in the west elevation with a 20th-century electric fire against a low 20th-century brick surround. In the south wall is a door into the ladies WCs which are within the two extensions to the rear.

Plate 11: General view of western bar in the front range, looking northwest

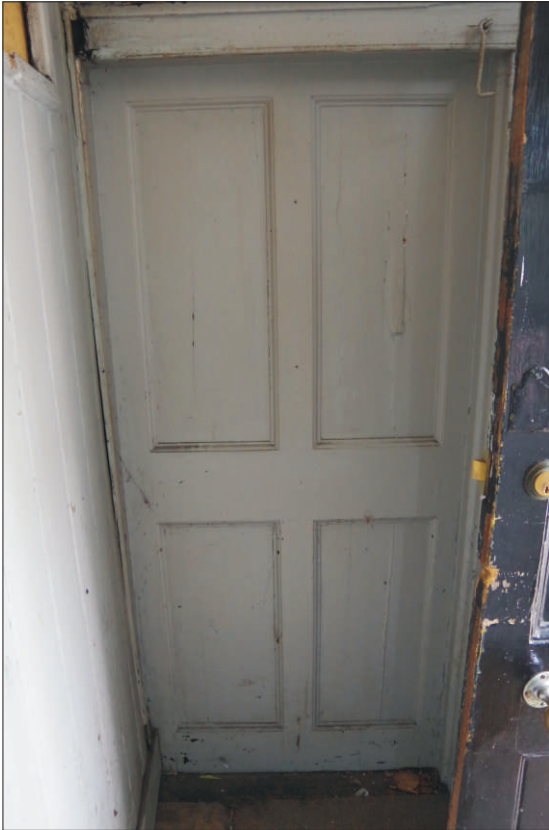
The lobby has a flagstone floor, and there are doors to each of the bars and to the staircase to the first floor. The doors to the eastern bar and first floor are 20th-century replacements whilst the door to the western bar is of 19th-century date (Plate 12). The partition to the east of the door to the first floor is formed from a reused plank door. The stairs are wooden with a simple handrail to the east and a dado rail on the west (Plate 13). The wall to the east is formed by timber planks. The stairs themselves are date to the 20th century but are almost certainly in the position of the original ones.

Plate 12: 19th-century door to the western bar in the front range, looking southwest

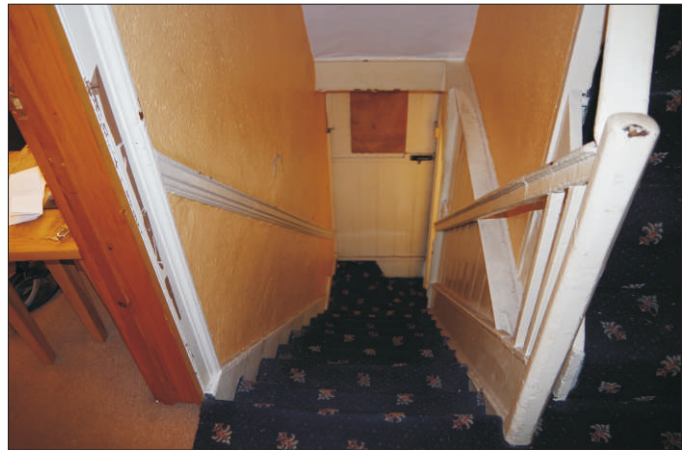
Plate 13: General view of the 20th-century stairs, view from the first floor to the ground floor, looking northwest

Within the front range it is proposed to open up the front range to provide better access by the bars. This will involve the removal of the 20th-century stairs between the ground and first floor along with the surrounding walls. A new staircase will be constructed with the 20th-century extension to the rear of the front range. The extension will be largely rebuilt. The stairs and walls themselves do not have any architectural value, although they do reflect the original layout of the building. This layout is however retained through their positions between the first and second floors.

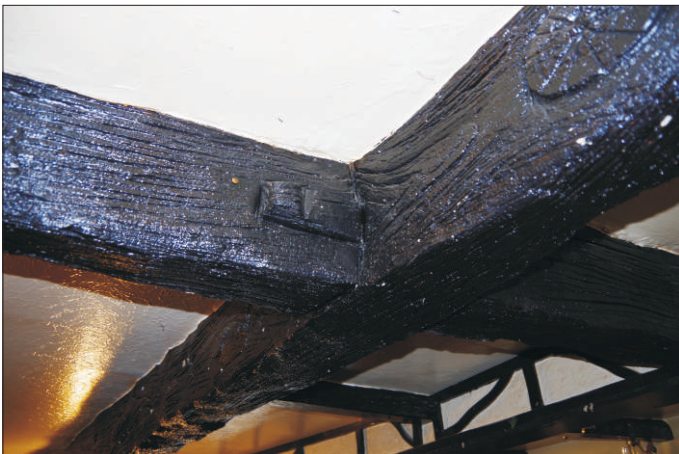
Within the central range there is the rear bar and serving counter. There are two large beams on the ceiling (like those in the adjacent eastern bar) that are probably original; the joint between them is exposed (Plate 14). There are also several smaller fake beams. The lower parts of the walls are covered with timber planks like the other bars and there are pillars finished with faux stone walling.

Plate 14: View of joint between two large beams in the bar in the central range, looking southeast

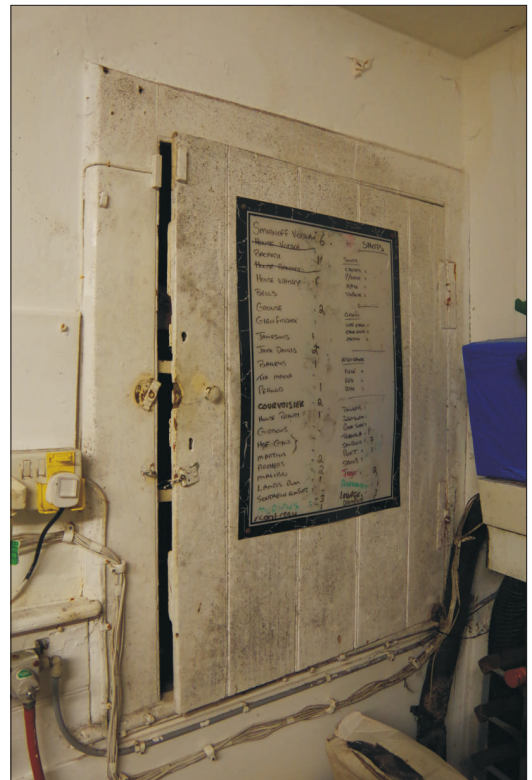
Within the rear range there are two cellar rooms, both of which have concrete floors. In the north cellar the ceiling and internal walls are rendered and there are timber planks on the external walls. There was formerly a fireplace in the northwest wall but this has been blocked. In the alcove to the east of this there is a small wooden cupboard with a plank door fixed with simple rectangular H hinges; stylistically this feature dates to the 18th century. (Plate 15). The door from the bar into the cellar is of four panels with round headed strap hinges, and is of 19th-century date (Plate 16). In the south cellar the ceiling is finished with plasterboard, and there is a door in the south wall to a further small room which was not accessible (Plate 17). This door and the one from the north cellar are both of wooden plank construction.

Plate 15: 18th-century cupboard in the north cellar of the rear range, looking northeast

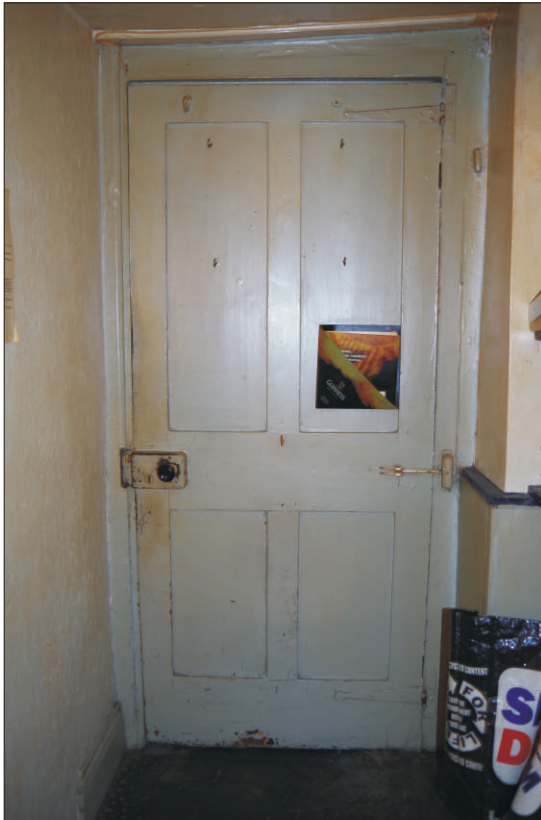
Plate 16: 19th-century door to the north cellar in the rear range, looking southeast

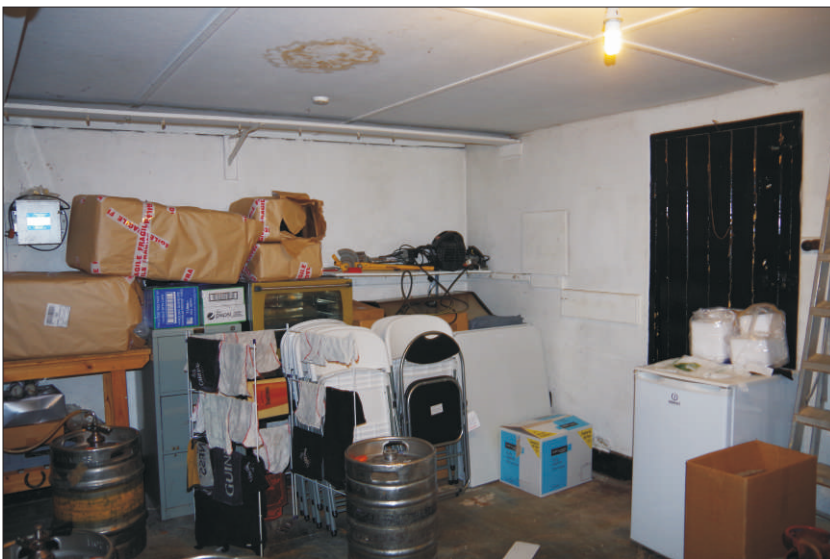
Plate 17: General view of the south cellar in the rear range, looking east

Within the rear range, on the ground floor it is proposed to remove the wall in the southern cellar. Since the wall is rendered it is not clear what architectural value this wall has but is likely to be modern subdivision of an earlier larger cellar. New partitions are to be inserted within this cellar to create a new gents WC replacing those in the existing outbuilding that will be demolished. These will be accessed through a new doorway in the southwest wall. This is an area of what appears to be infilling associated with the demolished range along the rear of the plot.

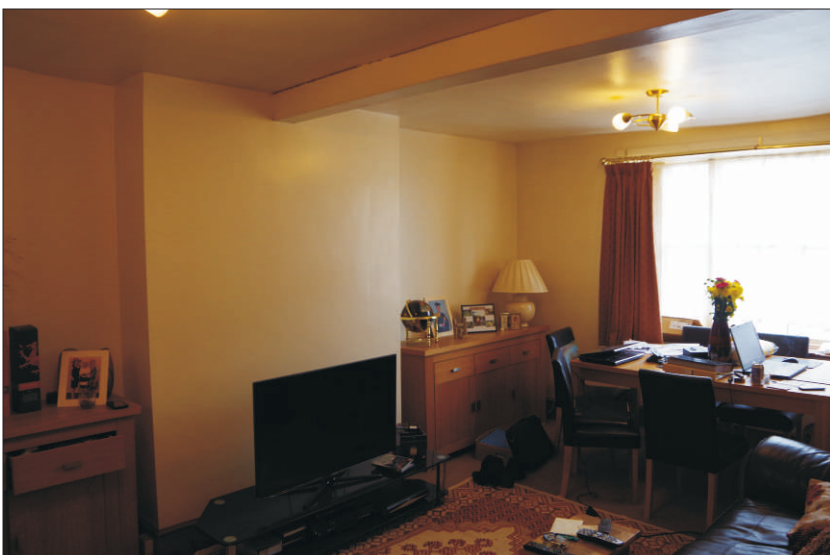
Within the front range there are currently two bedrooms, a lounge and an office, all accessed from a small landing. The two bedrooms have been created by the addition of a stud wall in what was originally a single, larger room. There would have been a fireplace in the east wall but this has been blocked. These rooms along with the lounge and office have a modern finish, fixtures and fittings. There would have been a fireplace in the west wall of the lounge but this has also been blocked (Plate 18). The walls of the office appear to be modern stud walls and there is the end of a RSJ visible in the southeast corner of the room, which appears to indicate that the whole of this floor has been reordered during the 20th century, although an earlier layout generally seems to have been recreated.

Plate 18: General view of the lounge on the first floor of the front range, looking west

On the first floor it is proposed to remove the stud walls forming the two bedrooms and the office, and to create an opening in the wall between the bedroom and kitchen in the central range. All these partitions are of 20th-century date and do not have any architectural value.
