THE FORMER MASONS AND MARINERS PUBLIC HOUSE, PORTLAND, DORSET

Historic Building Survey

Document No: ACD1314/1/0

Date: June 2016

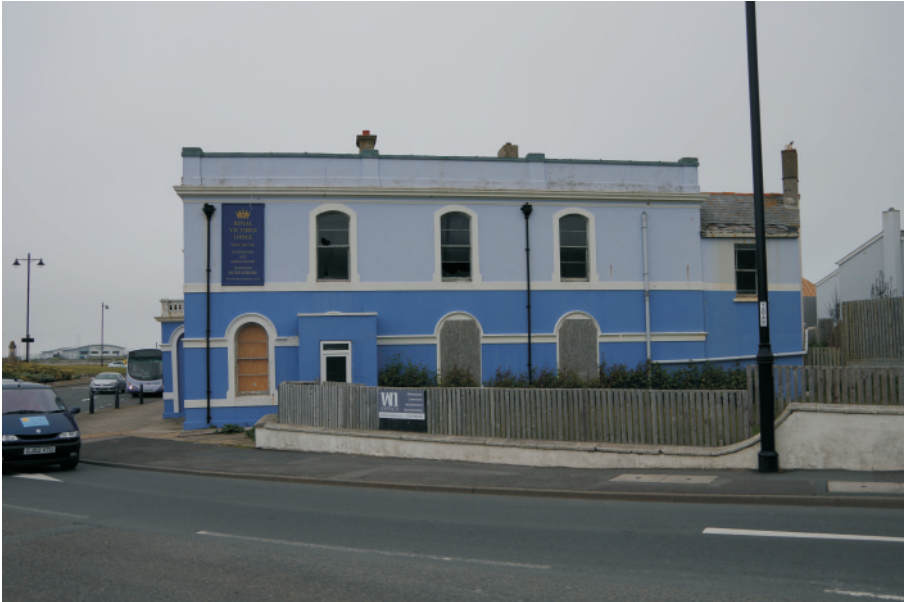
Plate 1: The south elevation, viewed from the south.

5.3 The majority of the building is rendered except the extensions, though internally the external walls were observed to be constructed of Portland stone. The south and west elevations of the main block are the most prominent and attractive (Plates 1 and 2). The ground-floor windows have arched heads surrounded by a raised plat band, and are set between a plain cill band and a moulded band at the level of the base of the arches. The first-floor windows have flat segmental heads with plat band surrounds set onto a plain cill band. The windows themselves are horned sashes of three and four panes. The ground floor cill band does not continue onto the northwest block (unlike the higher bands). The ground floor bands do not extend onto the south elevation of the east block. The first-floor window here is a two-pane rectangular sash divided into smaller panels by thin glazing bars. Near the top of the elevations there are a small plinth and a moulded cornice with a parapet blocking the view of the roof and gutters. The main entrance is located on the west elevation and has a square porch with arched openings on three sides although two are now blocked. This is flat roofed and topped with a cornice and carved stone parapet. There is a secondary entrance attached the south elevation enclosed with a flat-roofed 20th-century porch.

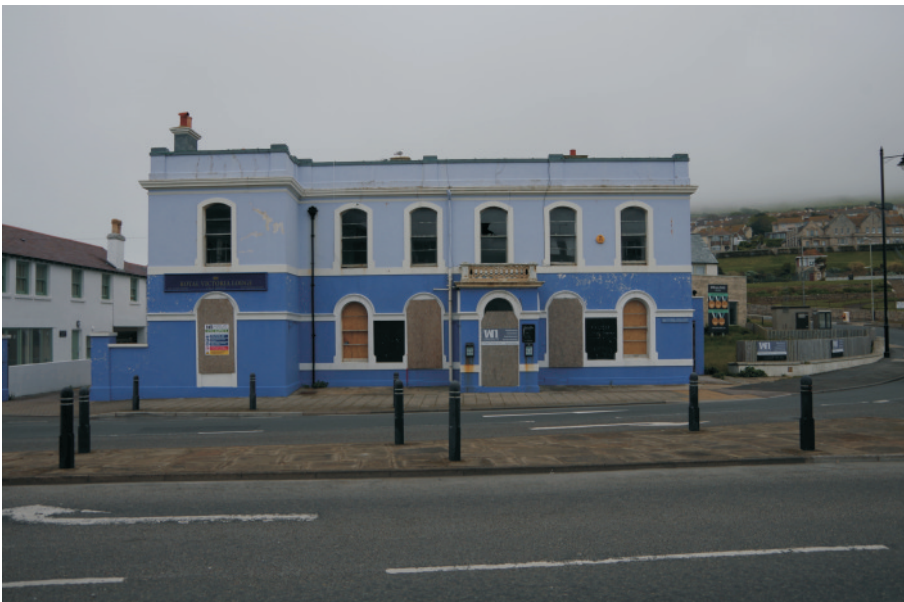
Plate 2: The west elevation, viewed from the west. 1m scale.

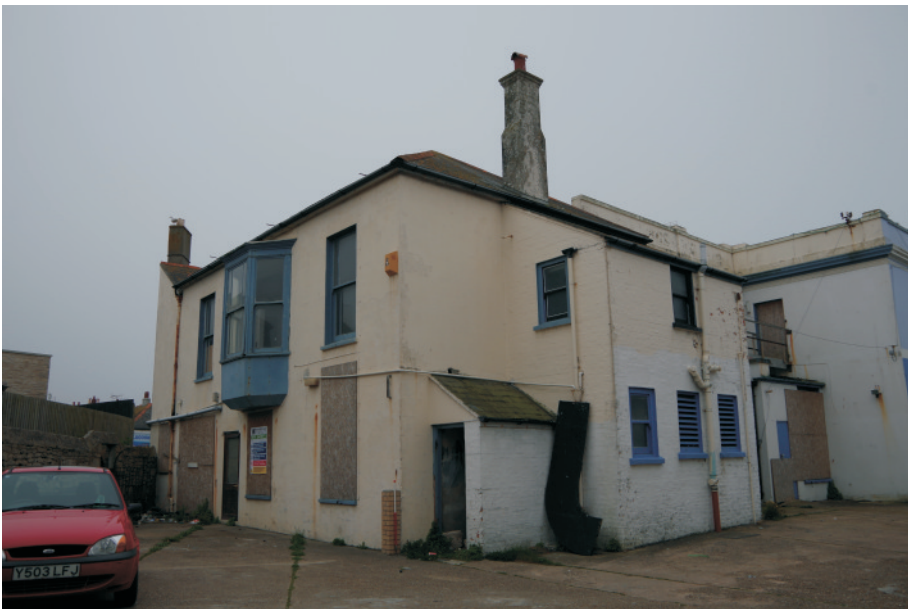
Plate 5: The east elevation of the east block and the north and east elevations of the brick extensions, viewed from the northeast. 1m scale.

5.4 On the north and east elevations there are none of the decorative features present on the other elevations apart from the plinth, moulded cornice and parapet which continue along the northwest block and onto the central part of the north elevation (Plates 3-5). The east elevation is rendered and has been scored to imitate ashlar masonry. On the north elevation there are two eight-pane sash windows; all the other windows and doors are boarded up and not visible. In the central part there is a single-storey extension and a modern metal fire escape with a spiral staircase. On the east side of the elevation is a two-storey brick extension. This contains a ground floor doorway, a two-pane sash window and a fire escape on the first floor of the west elevation, two-pane sash windows and two sets of louvres in its north elevation, and a first-floor two-pane sash window in the east elevation. To the east of this is a single-storey brick store under a pitched slate roof. The windows on the first floor of the main east elevation comprise a pair of rectangular two-pane horned sashes divided into smaller panels by thin glazing bars separated by a central oriel window. Most of the ground-floor openings have been boarded up but a modern UPVC window is visible.

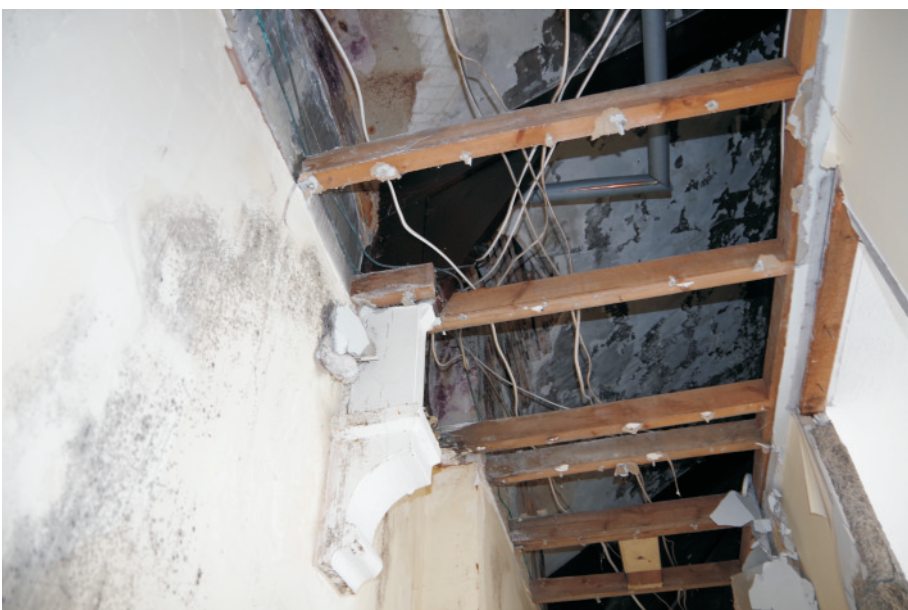
Plate 6: The jointed cruck roof beams on decorative corbels in the east block, viewed from the south.

- 5.6** The roof of the eastern block is lower than the main U-shaped roof, and is supported on a modern form of jointed cruck roof. The joints are bolted together and with the lower crucks sitting on decorative corbels (Plate 6). No collars were visible in the exposed lower parts of the roof. The roof between the trusses is finished internally with lath and plaster, obscuring the remainder of the structure.

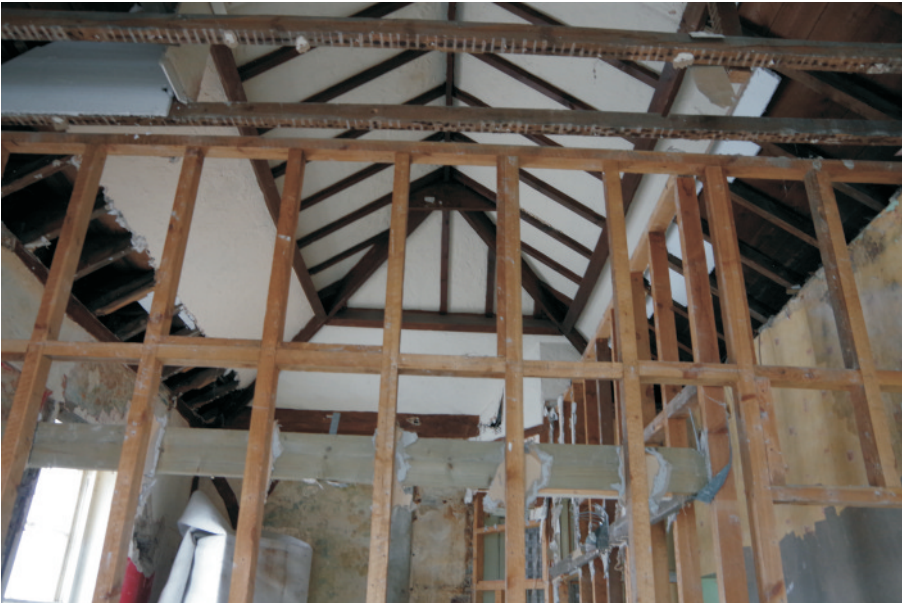
Plate 7: The roof of the northwest block, viewed from the west.

- 5.7** The northwest block is not supported on standard trusses. Instead the ridge and side purlins are solely supported on the hip trusses. Closely-set common rafters are set on the back of the side purlins. Below the central side purlins the roof is ceiled with lath and plaster, covering the rafters, whereas above these purlins the roof is finished with lath and plaster laid between the common rafters giving a covered 'lantern' effect (Plate 7).

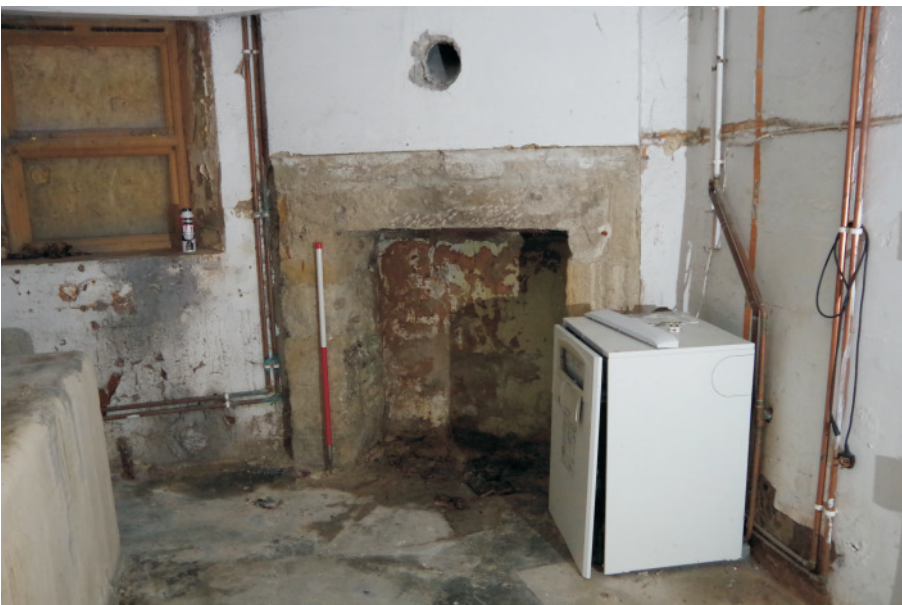
Plate 8: Fireplace in the laundry, viewed from the west. 1m scale.

- 5.9** The building has a modern finish throughout including modern fixtures and fittings within the kitchen, bar and bathrooms. Original or early features and fittings of note are discussed below. On the ground floor the fireplace in the dining room has a modern stone surround, a wooden mantel and bricks defining the hearth. It is likely that this obscures or replaces an earlier fireplace. In the laundry room, the fireplace (in the angled southeast wall) has a Portland stone surround displaying rough tool marks as a finish (Plate 8). Also within this room there is also a large, 0.75m high, concrete slab against the north wall, the function of which is unclear (Plate 9). The laundry and the adjacent pantry are divided by a modern wall. Both rooms retain their original flagstone floor, which is also exposed in the corridor to the north of the stores (Plate 10). The west wall of the latter is constructed from rubble stonework with some blocks measuring up to 0.50 x 0.80m long. It has been rendered and scored to imitate ashlar masonry. There are three former doorways in the north and west walls of the corridor and store north wall, all probably blocked when the brick extension was added. In the south store is a modern safe.

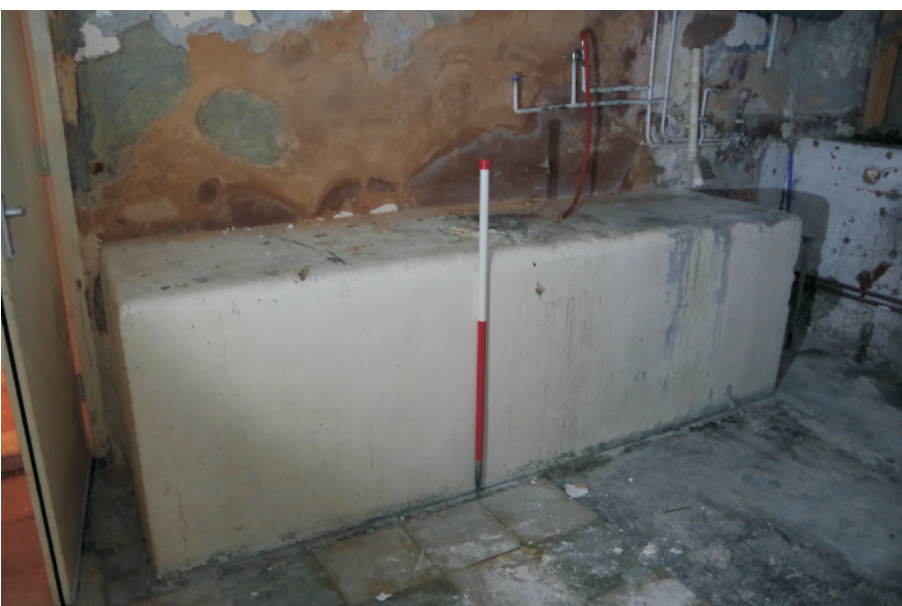
Plate 9: Large concrete slab in the laundry, viewed from the southwest. 1m scale.

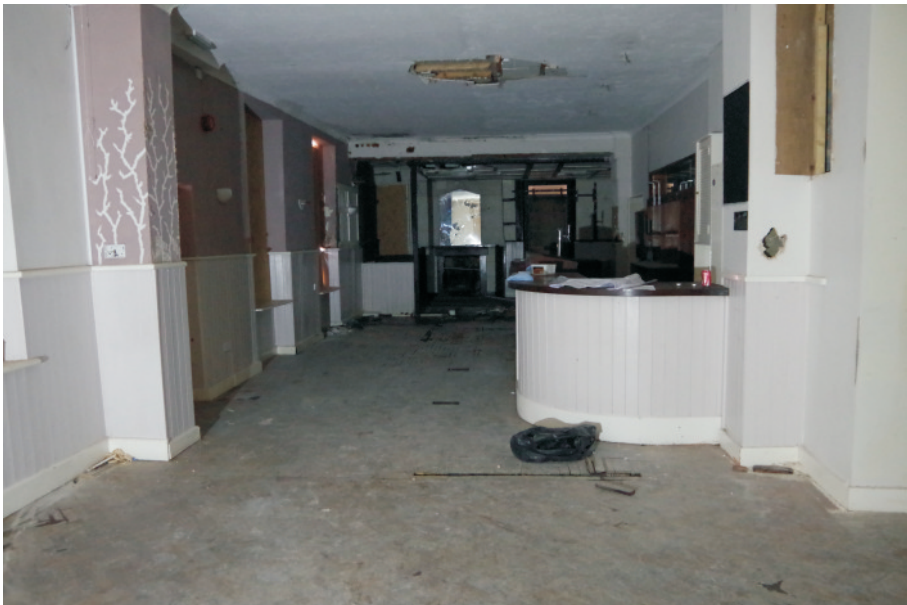
Plate 11: Bar area, viewed from the south.

- 5.10** In the majority of the bar area the lower walls have wooden panelling topped with a dado rail; they are finished with wooden skirting boards and coving (Plate 11). At the north end of the bar the seating area has been decorated with very poor-quality

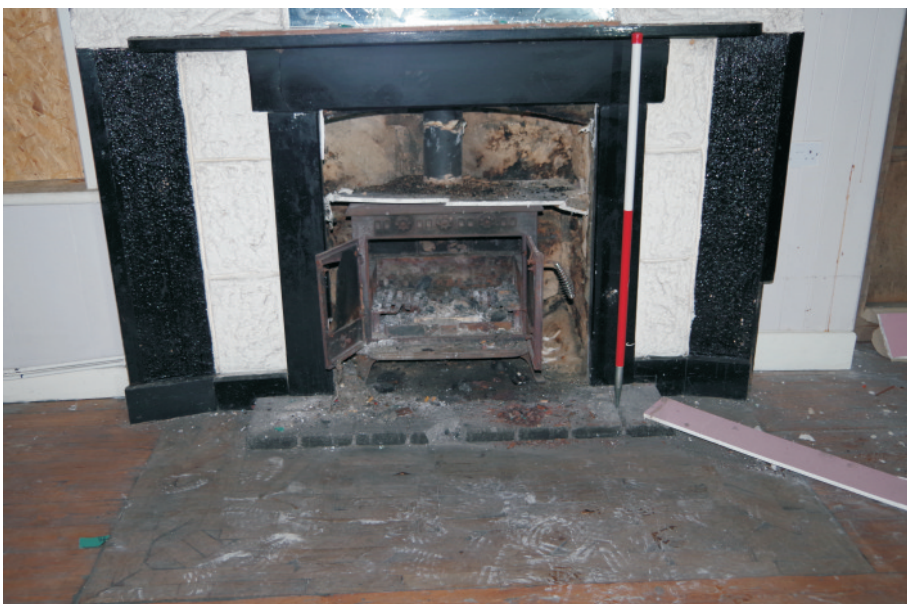
Plate 12: Fireplace in the seating area of the bar, viewed from the south. 1m scale.

faux panels and beams. Here there is a cast-iron fireplace within a wooden surround and stone hearth in the north wall (Plate 12). In the south east corner of the bar is a disk jockey booth. The finish throughout the bar is modern. There is a 3-dimensional mural of a lighthouse in the corridor to the north of the bar (Plate 13).

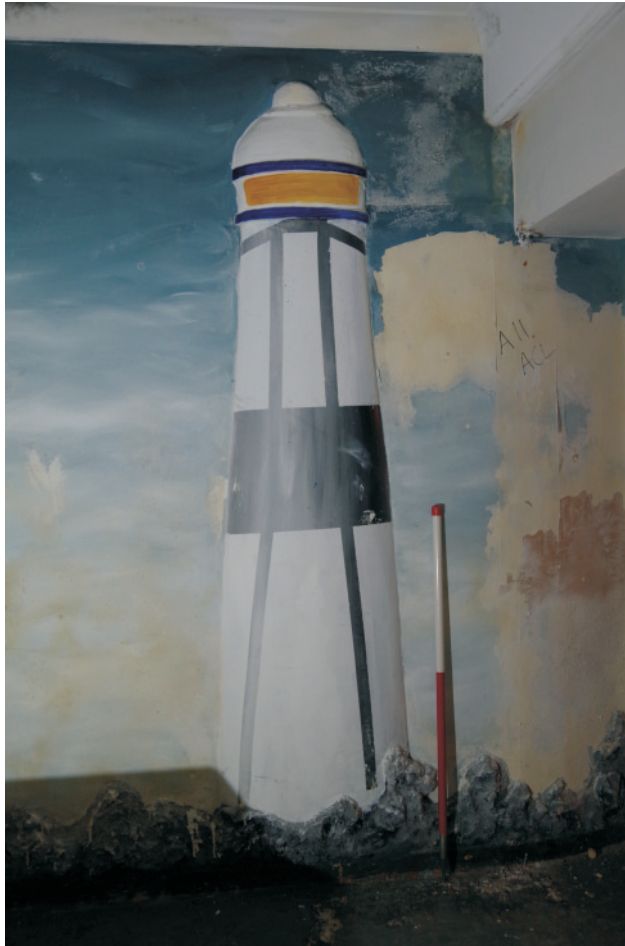
Plate 13: Lighthouse mural, viewed from the west. 1m scale.
