BREALEYS FARM, BEAFORD, DEVON

Heritage Statement

Document No: ACD1383/1/0

Date: May 2016

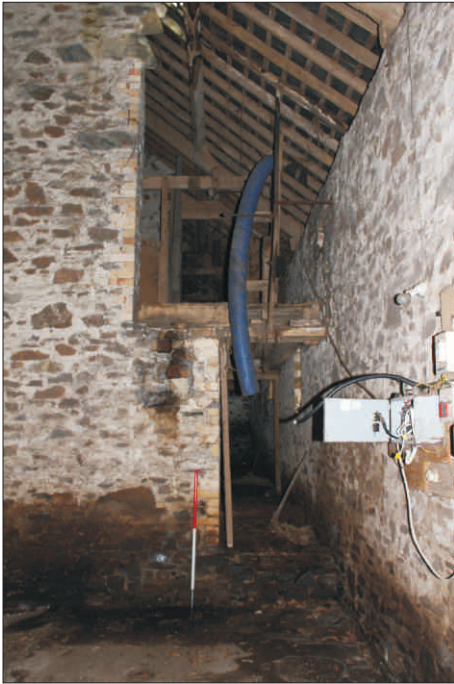
Plate 7: South facing internal elevation of threshing barn, looking north (1m scale)

- 5.8 The interior of the threshing barn (Plate 6) has been rendered above the doorways, and there are a couple of patches of stonework repair, predominately on the west and south walls. All four walls show areas of heavily lime mortared stonework, with additional patches of light rendering. The north wall (Plate 7) has a floor to roof inserted (20th-century) opening providing access to the ground floor (c.1.00m wide) and first floor granaries (c.1.80m wide). The jambs have been faced with yellow Peters Marland brick, whilst the ground-floor threshold shows the core-work of the original wall (Plate 8). Projecting from the east elevation at first floor level is a dog-leg shaped iron rod with a hoop at one end, which was associated

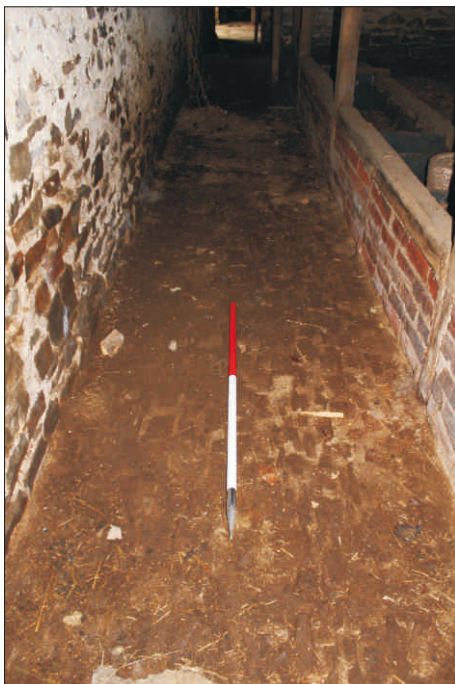
Plate 14: Cobbled floor of feeding passage, view from above, looking south (1m scale)

- 5.13** Along the east elevation of the room is a feeding passage, c.1m wide, with a cobbled surface (Plate 14), which provides access to red brick and concrete feeding troughs, which have internal slate partitions that run parallel to the feeding passage. The floor to the west of the troughs has a raised concrete platform for the cattle stalls, with a north-south aligned drain west. The ceiling joists are supported on five timber posts; the two centrally located posts are set on concrete plinths. The remaining three posts are integral to the construction of the troughs, indicating that the ceiling is contemporary with the early-mid 20th-century feeding troughs.

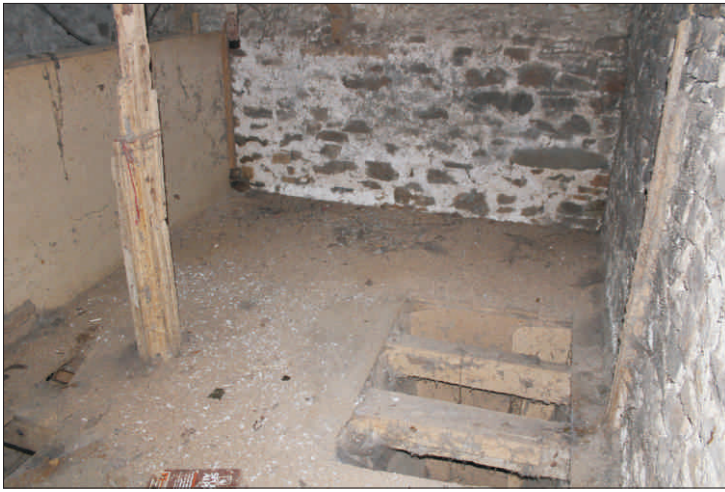
Plate 16: First-floor granary within partitioned corner, showing shaft to grain chute below, looking east

- 5.14** The first floor accessed from the ground floor granary staircase that opens out into an additional granary room (Plate 15). The northwest corner of the room has been partitioned off (Plate 16), with chipboard and tongue and groove panelling. This panelling does not rise to the roof, but stops at chest height. Here there is a shaft through the floor boards that leads to the ground floor grain chute. The walls again have a light rendering. Located at the east end of the north elevation is an entrance into the engine house/hayloft. Here there is a floor-to-rafters timber open-fronted cupboard. The roof over this room has two-bays with a single A-frame truss with collar and king post. Two posts, one of which is part of the partition wall, have been attached to the collar. There is a purlin halfway up each side of the truss, with the secondary rafters resting on the purlins. At the east end, on the south side of the truss a driving spindle (Plate 17) is attached, which relates to the threshing process.
