GREENSLINCH FARMHOUSE, SILVERTON, DEVON

Results of Historic Building Recording

Mid Devon District Council planning reference 15/01558/LBC,
condition 3

Document No: ACD1236/1/1

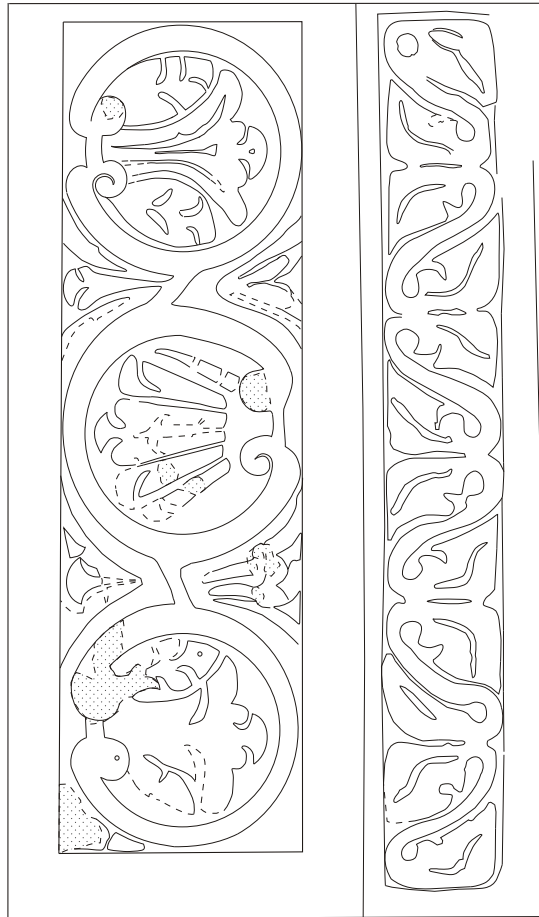
Fig. 5: Detail of decoration on
panel 9

9. Cut-down upper section of panelling, comprising two plain panels with two rectangular top panels containing decoration; the base has been cut off, along with the side currently adjacent to the floor (Plates 8-9). Where the original base of the panel has been cut away another stile has been reset off centre. The panels are set into the stiles using the post-and-panel technique. All panels are defined by ogee mouldings with chamfered corners, which can be broadly dated to the 17th century. The upper panel is carved with a scroll decoration of leaves. Below this is a deeper panel of strapwork carved with three joined circles; the outer circles contain an identical open leaf design, whilst the inner design is inverted and features a more densely packed leaves. 0.90m by 0.64m.

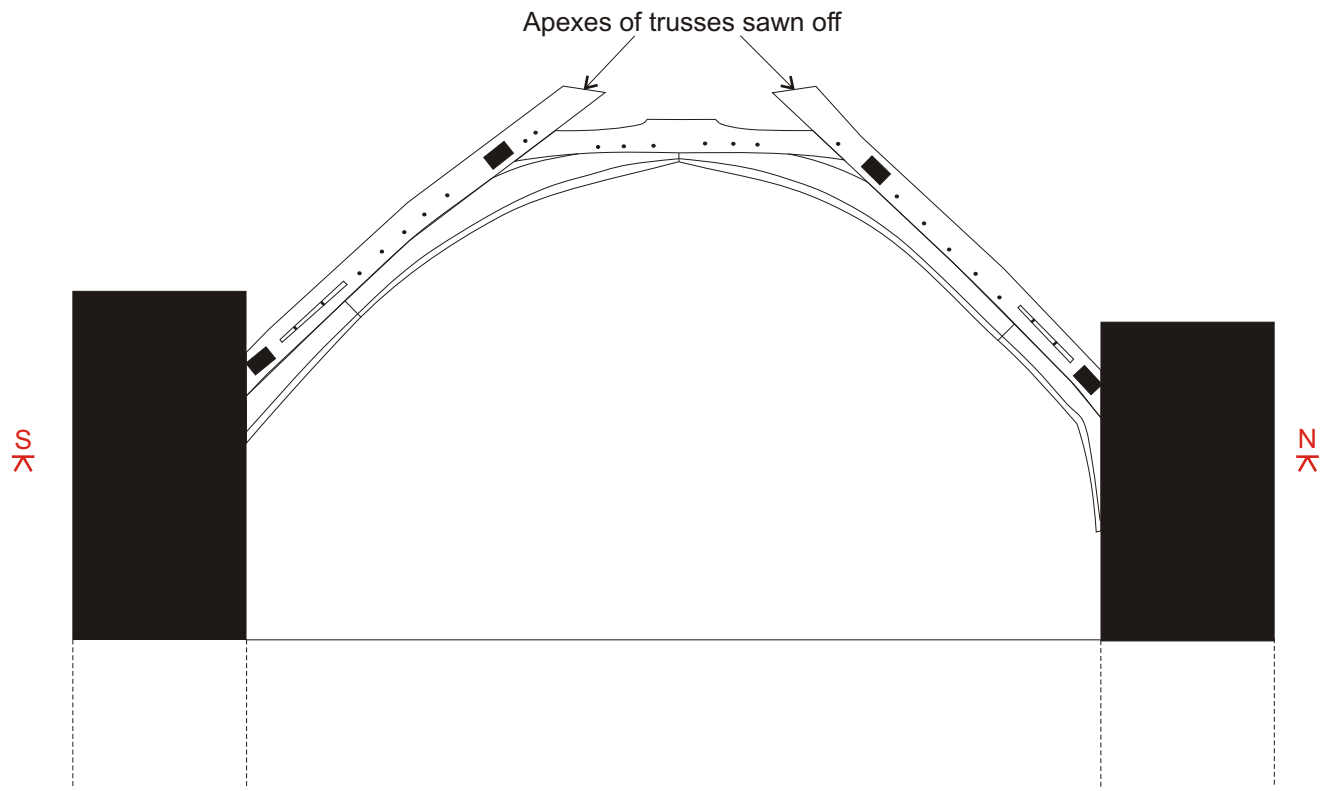
PROJECT
Greenslinch Farm,
Silverton, Devon
TITLE
Fig. 6: Roof truss in the
west wing

- 5.5** The recorded roof truss is located in the present rear west wing, which was almost certainly the original hall and would have been open to the roof, as evidenced by the smoke-blackening on the truss. The truss is a jointed cruck, arched-braced roof with two through purlins. The collar is slightly cambered and joined to the rafters with pegged mortice and tenon joints. The truss and the purlins display empty sockets (with pegs remaining) for supporting wind braces located between the rows of purlins. Upon removal of the existing ceiling that had been at collar level it was identified that the apex of the truss had been removed, and all woodwork supporting the roof was modern, supported on slightly earlier (perhaps 19th-century) back purlins.

All modern roof timbers have been omitted from the drawing

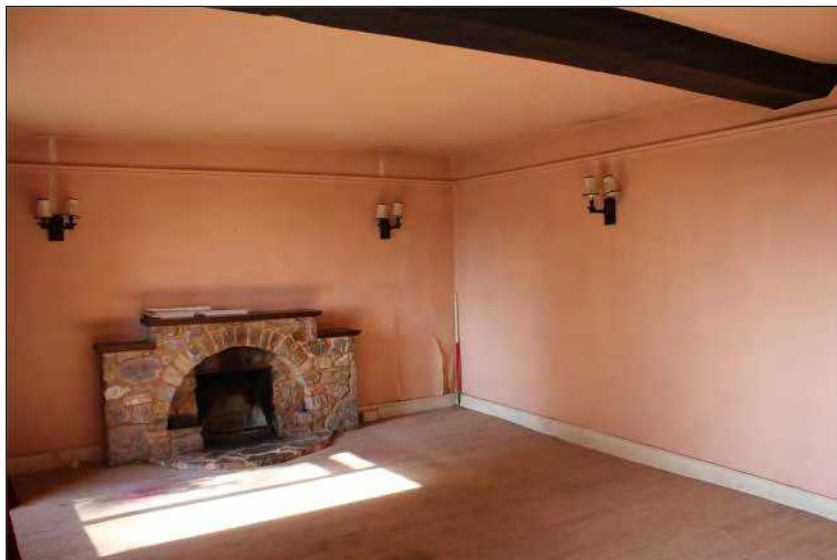
5.1 The recorded partition is located within the present rear, west range on the west side of the house; its divides a living room that faces south from an east-west aligned corridor along the rear north side of the house. The current architectural finishes to the living room include a low skirting board and picture rail (Plate 1), which are present on all walls including the south face of the partition. The room is

Plate 1: The living room showing the partition to the right of the scale, viewed from the southeast. 1m scale

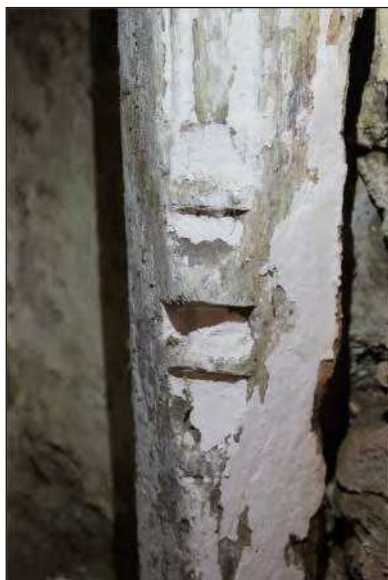
Plate 4: Detail of a stop on the corridor doorframe, viewed from the southeast

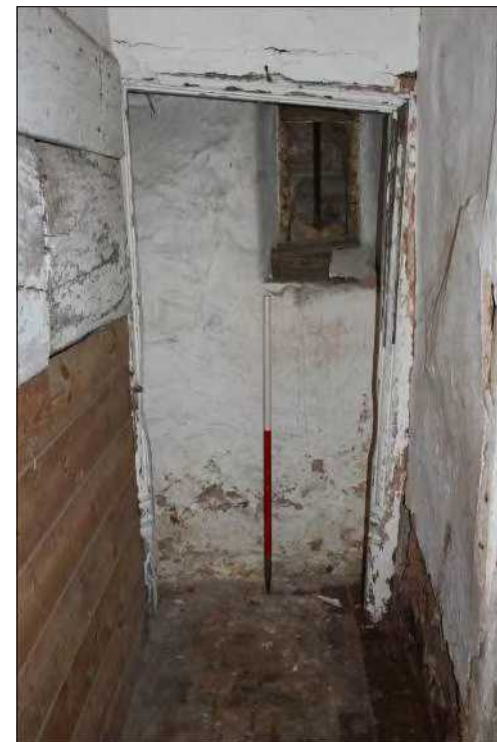
5.2 The corridor is narrow – 1.05m wide – and links a rear lobby in the main east range with a blocked doorway in the west wall of the west range (Plate 2). This opening is partially splayed, and the blocking contains a narrow wooden-framed window with diagonal security bar, which itself has been blocked with bricks. The inside of the opening is defined by a wooden, pegged doorframe with a chamfer terminating in a high-level scroll, flat and bar stop (Plates 3-4), which is stylistically datable to the decades around 1650 or slightly earlier. In the north wall there is an opening into a stair turret. This was a thick wooden frame, which is partially obscured by plaster, and a secondary, inner moulded doorframe with the remains of 18th-century H-hinges. To the east is a doorway, now blocked in brick and incorporating a window. The floor of the corridor is mainly orange-red brick, laid in two directions, with an area of repair using concrete.

Plate 3: The blocked doorway at the west end of the corridor showing the 17th-century doorframe, viewed from the east. 1m scale

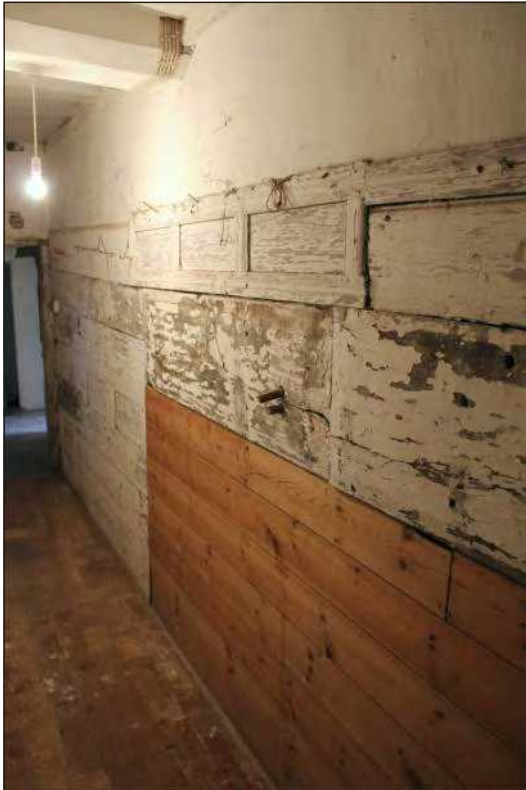
5.3 The partition is formed from vertical studs, which supports lath and plaster on its south face; this has been covered with wallpaper. The north side facing the corridor has been finished using a number of reused wooden architectural fittings (Plate 5). This extends to a height of up to 2.02m from the floor. Above this, the partition is plastered. A total of 19 different fittings and repairs have been identified, and are listed below, with measurements representing length by height as set into the partition.

Plate 5: The partition, viewed from the northwest

- 7.1** The works involved the removal of the partition and enlargement of the living room to its original size. Whilst this removal has an impact on the historic building, the significance of the partition is mainly drawn from the reused panels it contains rather than its current function within the house. Its removal allowed the former hall – the primary room of the medieval and early post-medieval house – to be reinstated to its original size. By doing this, the 17th-century layout of the room will also be recreated, enhancing the appreciation of the contemporary features currently hidden away in the corridor – namely the doorframe, the stair turret and the north end of the bridging beam. In this context, the removal of the partition can be considered as enhancing the understanding of the early development and layout of the house. Its removal has also led to the discovery of a foot patten.

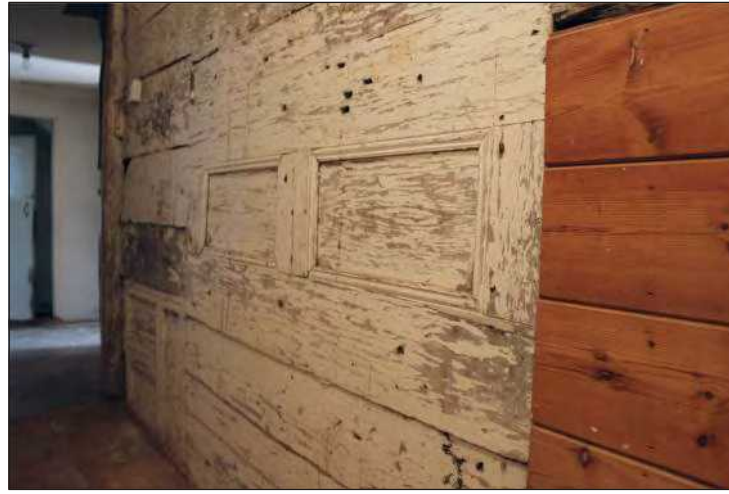
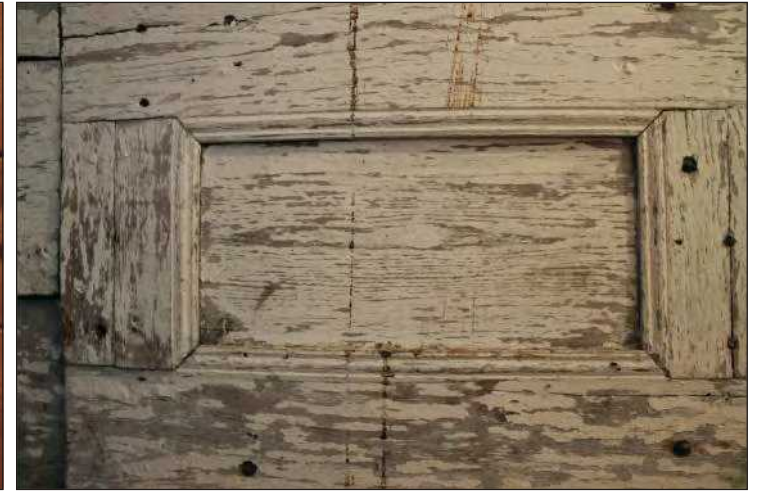
7. Fragment of a floor board. 0.84m by 0.24m.
8. Panelling, comprising two panels flanked by wide plank stiles and separated by horizontal rails with ogee moulding (Plates 6-7). This moulding is continuous with moulding on applied vertical fillets. All the joints are nailed. The present top stile displays a number of keyhole and figure of eight-shaped openings. This panel is of a different design to nos 9, 12 and 14. 1.34m by 0.64m.

Plate 6: Panel 8, viewed from the northwest

Plate 7: Detail of the moulding on panel 8, viewed from the north

- 6.6** The origin of the reused wood within the partition is unknown. It would be expected that it derives from the Greenslinch Farmhouse, but some of the pieces could have come from one of the nearby barns or houses within the hamlet. The most significant pieces are the panels 8, 9, 12 and 14. These can be generally dated to the 17th century, and the group of panels 9, 12 and 14 are very similar in both size and moulding to the painted panelling at the merchant's house of 18 North Street, Exeter (Parker *et. al.* 2013). Here dendrochronological analysis of one of the panels produced a felling date of A.D. 1573-1609, providing an early 17th-century date for the rebuilding of the house. However, the decoration on the panels is reminiscent of the work of the carpenters Thomas Dennis and William Searle who were producing chests in the second half of the 17th century. Taken with the other surviving architectural features, such as the doorframe in the corridor, a date possibly in the 2nd quarter of the 17th-century seems likely, although a later 17th-century date cannot be ruled out. If associated with the extensive remodelling of the house then these two types of panels could have been displayed in two of the primary public rooms of the house, or perhaps one of the corridors or lobbys.

- 7.2** The partition contains reused wood of varying dates, some of which is more significant than others. The most significant pieces – the 17th-century panelling – has been retained and displayed within the house.

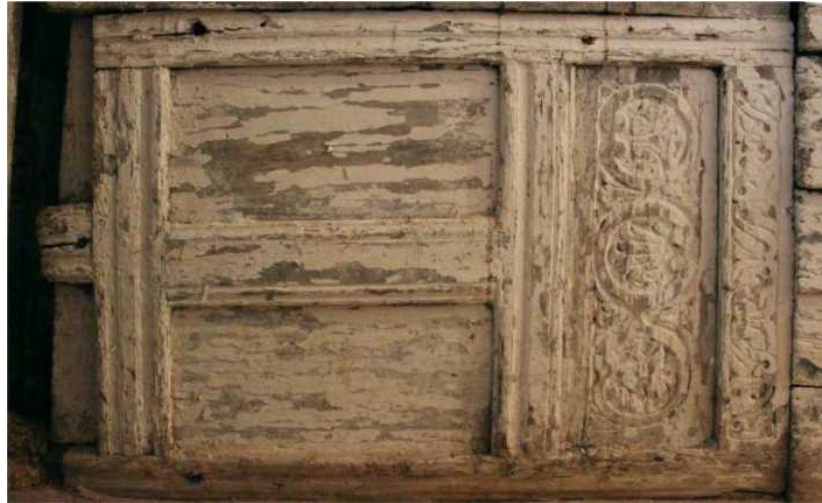
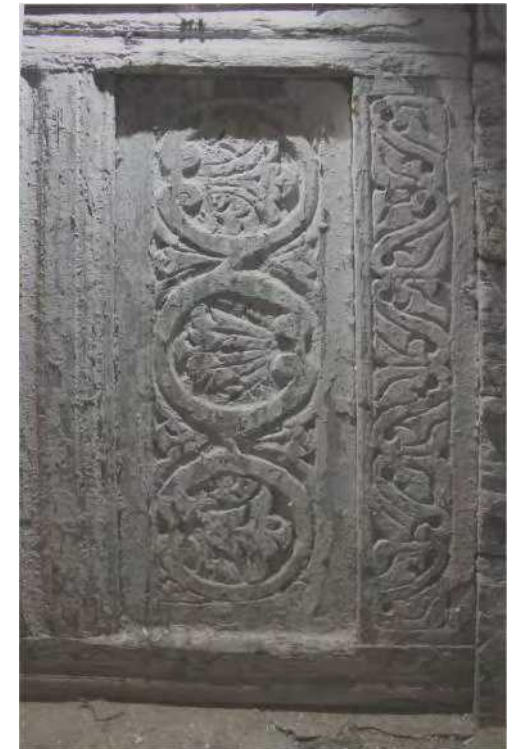
Plate 8: Panel 9, viewed from the north

Plate 9: Detail of the decoration on panel 9, viewed from the north

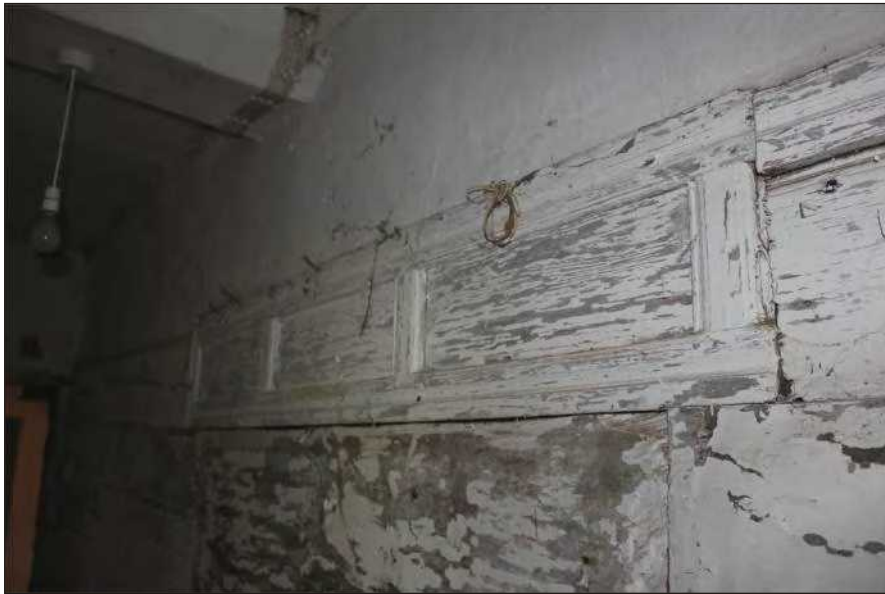
12. Fragment of a top section of panelling, cut off on its current western side (Plate 10). It comprises three panels and the start of a fourth panel. The construction technique and moulding is the same as no. 9. 1.86m by 0.36m.

Plate 10: Panel 12, viewed from the northwest

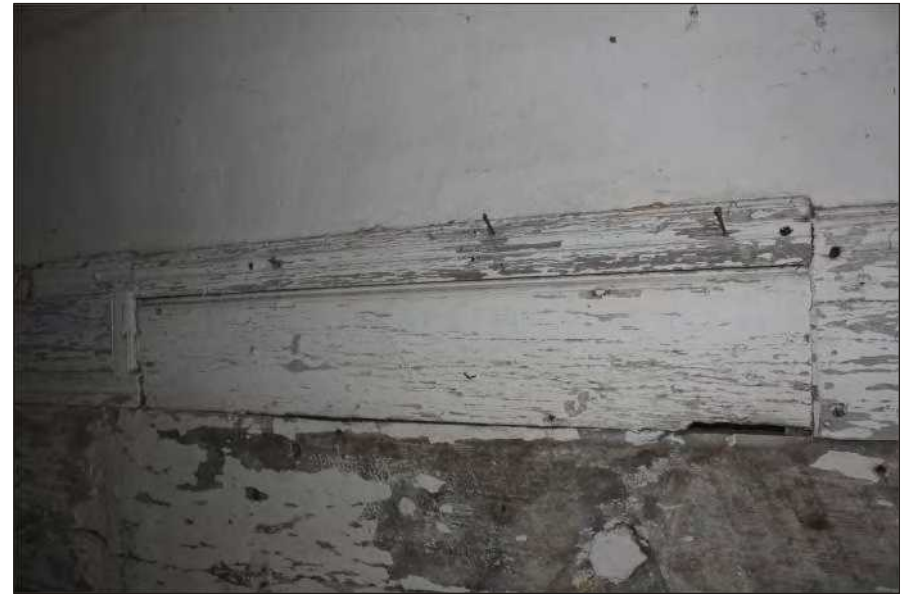
13. Fragment of a floor board displaying holes of various sizes and a scar of a now-removed bracket fitting. 1.54m by 0.46m.
14. Fragment of a rail from a top section of panelling as no. 12 (Plate 11). It has the same moulding and mortices as nos 9 and 12. 1.24m by 0.10m.

15. Fragment of a skirting board with ovolo moulding to the top edge (Plate 11). The detail of the moulding is very slender when compared to the *in situ* skirting boards in the house. 1.22m by 0.24m.

Plate 11: Panel 15 and skirting board 15, viewed from the north-northwest

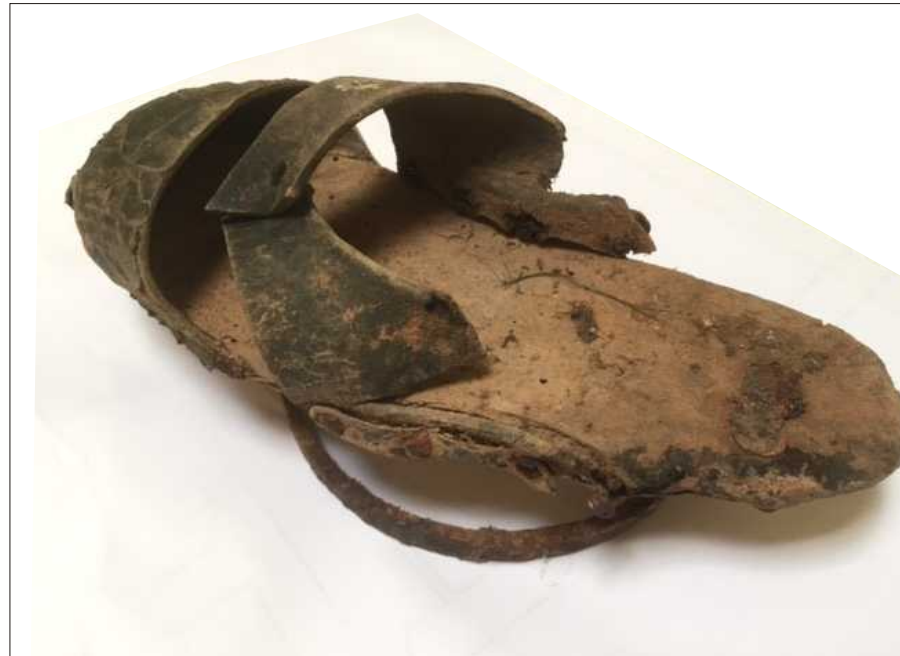
- 5.4** When the partition was removed an object was found concealed within the partition panelling. The object was a foot patten, a wood and metal overshoe used to protect shoes and elevate the wearer slightly in muddy or wet conditions. The foot patten consists of a flat piece of shaped wood with an iron ring attached to the underside. A toe piece and two leather straps are riveted to the wooden platform. The leather straps would have been tied together to keep them in place, hence the perforations at the ends. Foot pattens came into use around c. 1600 and usage declined during the 19th century as rubber overshoes and wellington boots became more common. The historical concealment of footwear within the fabric of buildings for superstitious reasons is well documented.

Plate 12: Foot patten found concealed within the partition.
Courtesy of Peter Butler

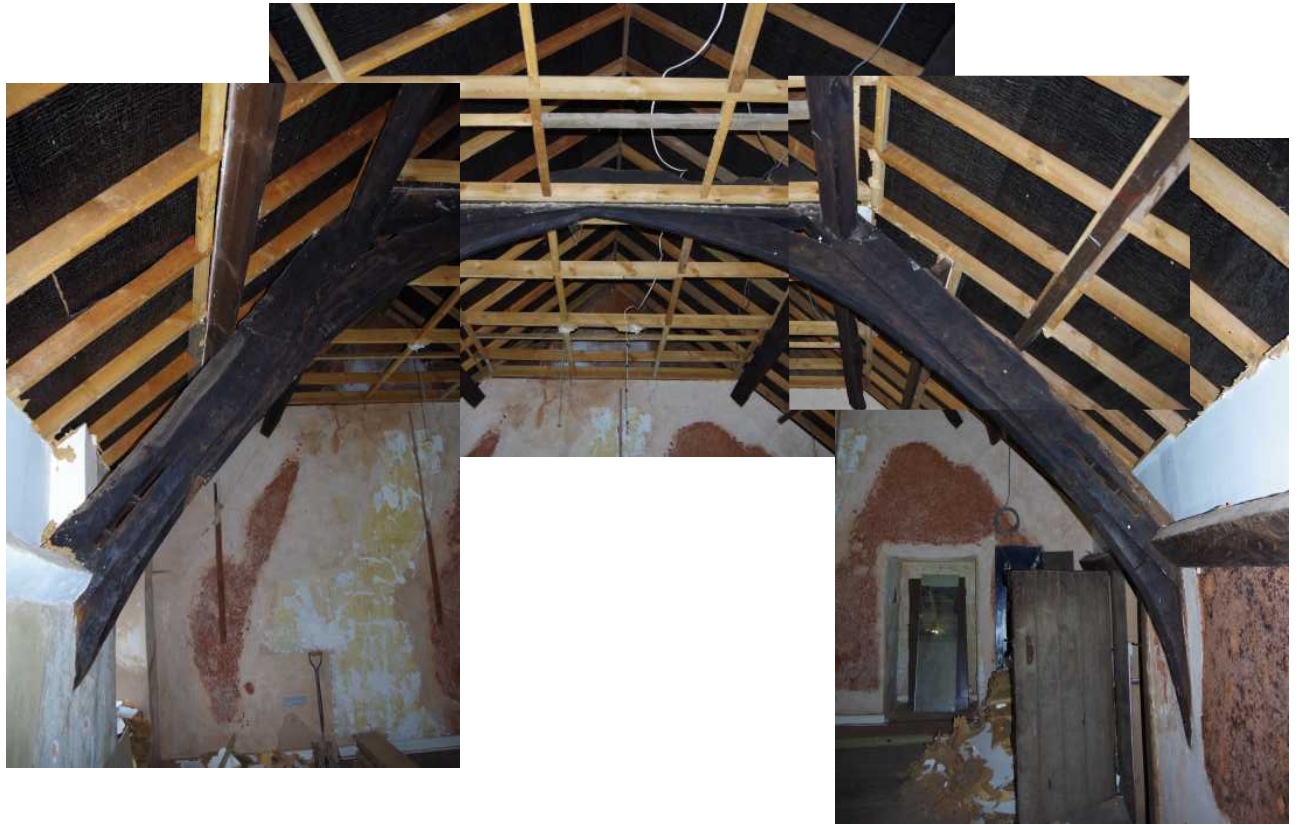
Plate 13: Composite photo of the roof truss, looking west

- 7.3 The roof truss is a reasonably good example of a medieval jointed cruck, arched braced roof. Although altered and partially dismantled, the principal features, or evidence for them, can be discerned. The evidence of smoke-blackening, along with that for wind braces, supports the idea that the hall was originally open to the roof.

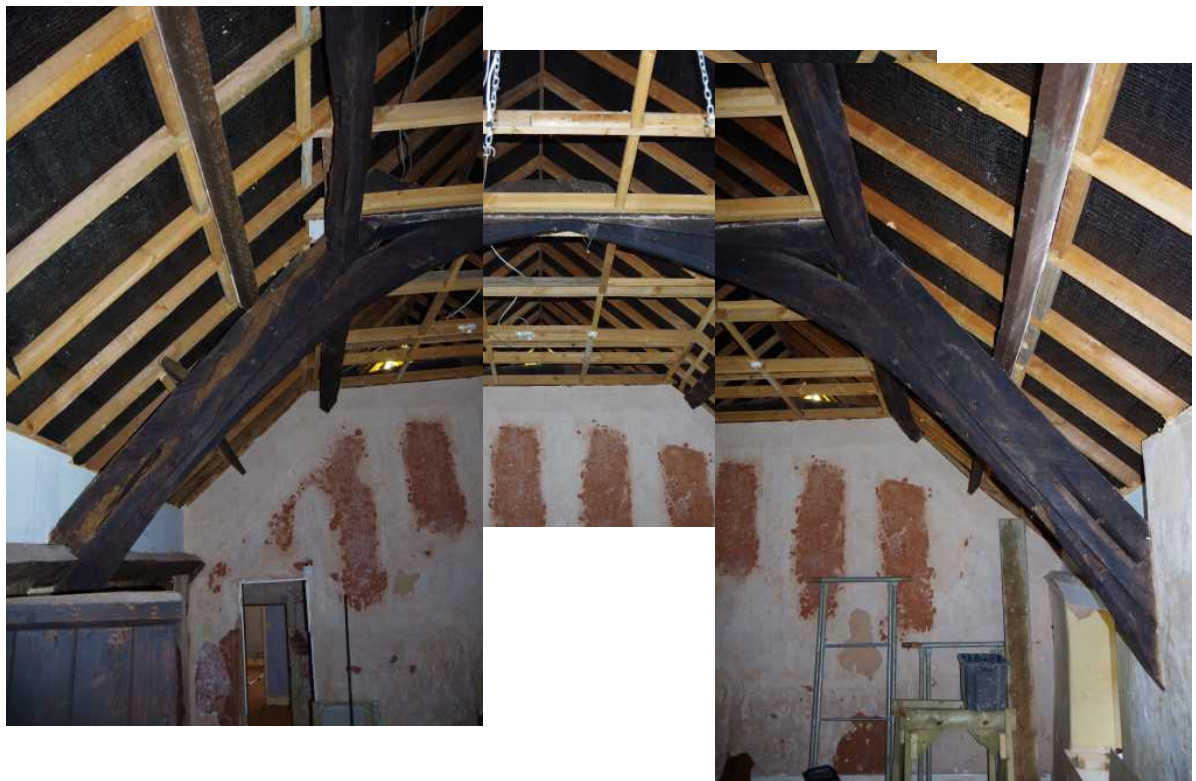
- 5.6** There is a second truss of the same type to the east of this one, concealed within a wall partition. Below the ceiling level the faint outline of the trusses can be seen in the plaster, and following removal of the ceiling top of the cambered collar and tops of sawn off trusses were exposed (see centre of Plate 14).

Plate 14: Composite photo of the roof truss, looking east

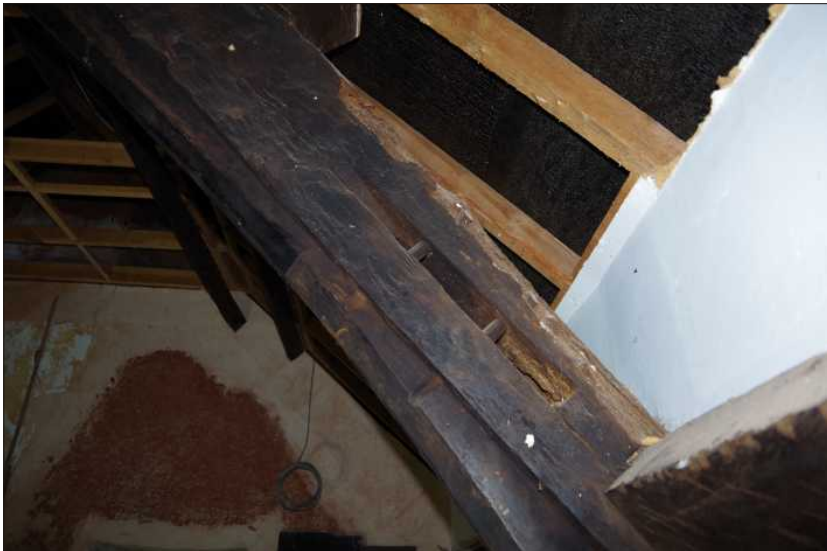
Plate 15: Detailed view of empty socket in the truss with wooden pegs for supporting a wind brace, looking west

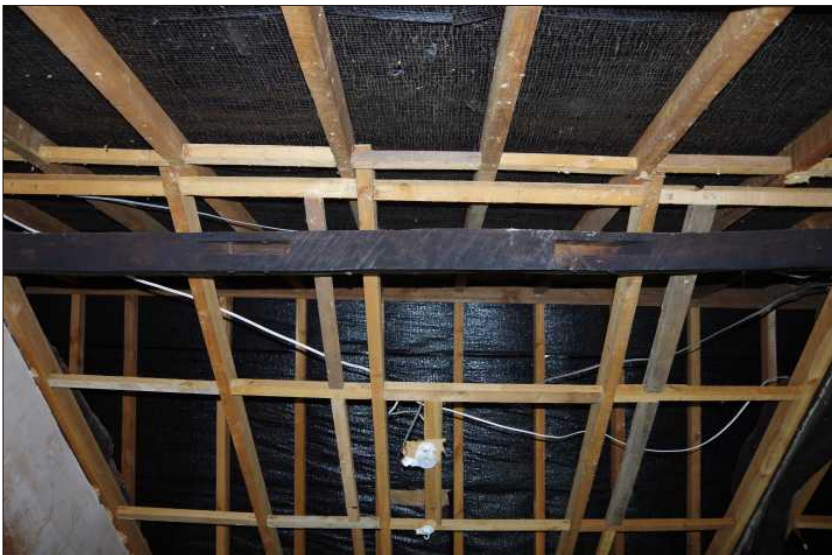
Plate 16: Detailed view of empty sockets in the purlin with wooden pegs for supporting a wind brace, looking north

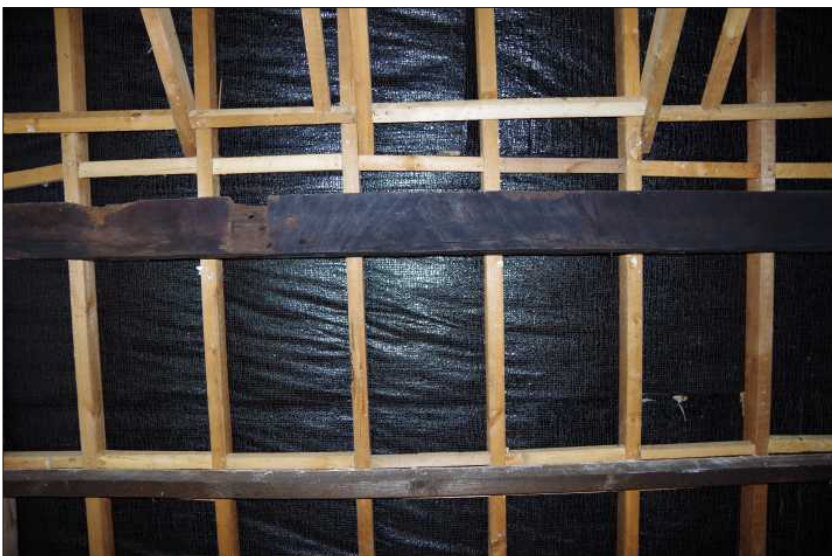
Plate 17: Detailed view of empty peg holes in the purlin for supporting a wind brace, looking south
