OLDAPORT CAMP, MODBURY, DEVON

Higher Level Stewardship Scheme Archaeological Survey and
Results of Archaeological Excavation

Scheduled Monument: Iron Age promontory fort known as
Oldaport Camp (National Heritage List No. 1020234)

Document No: ACD879/1/2

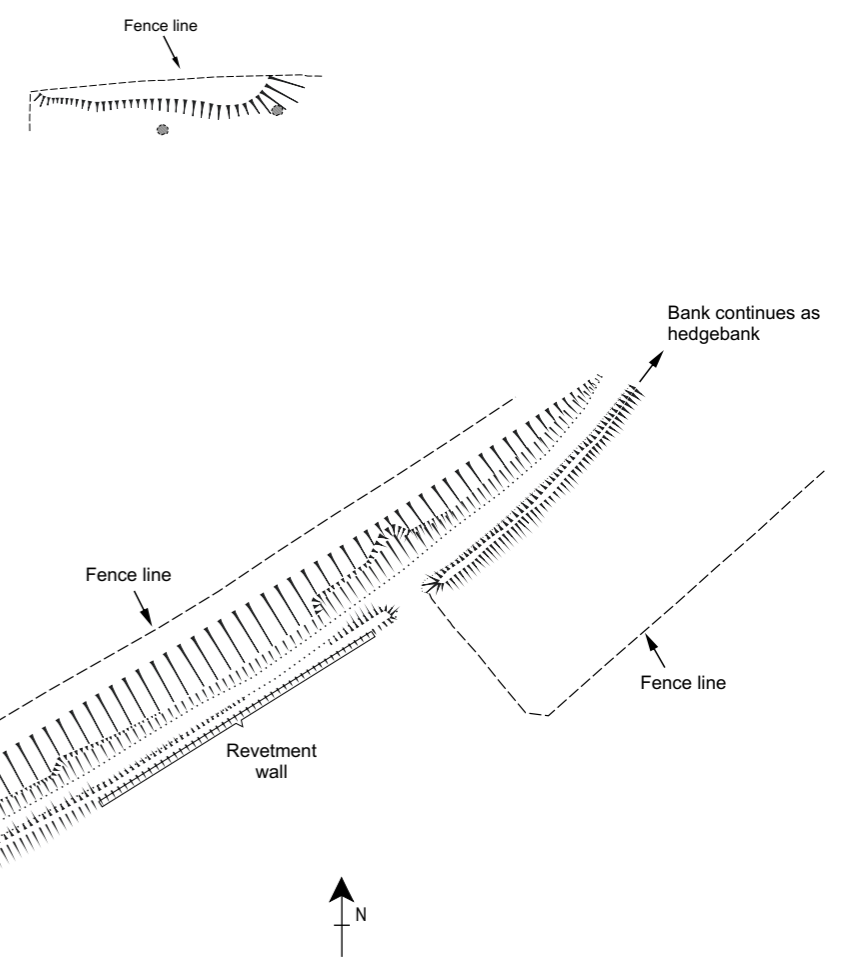
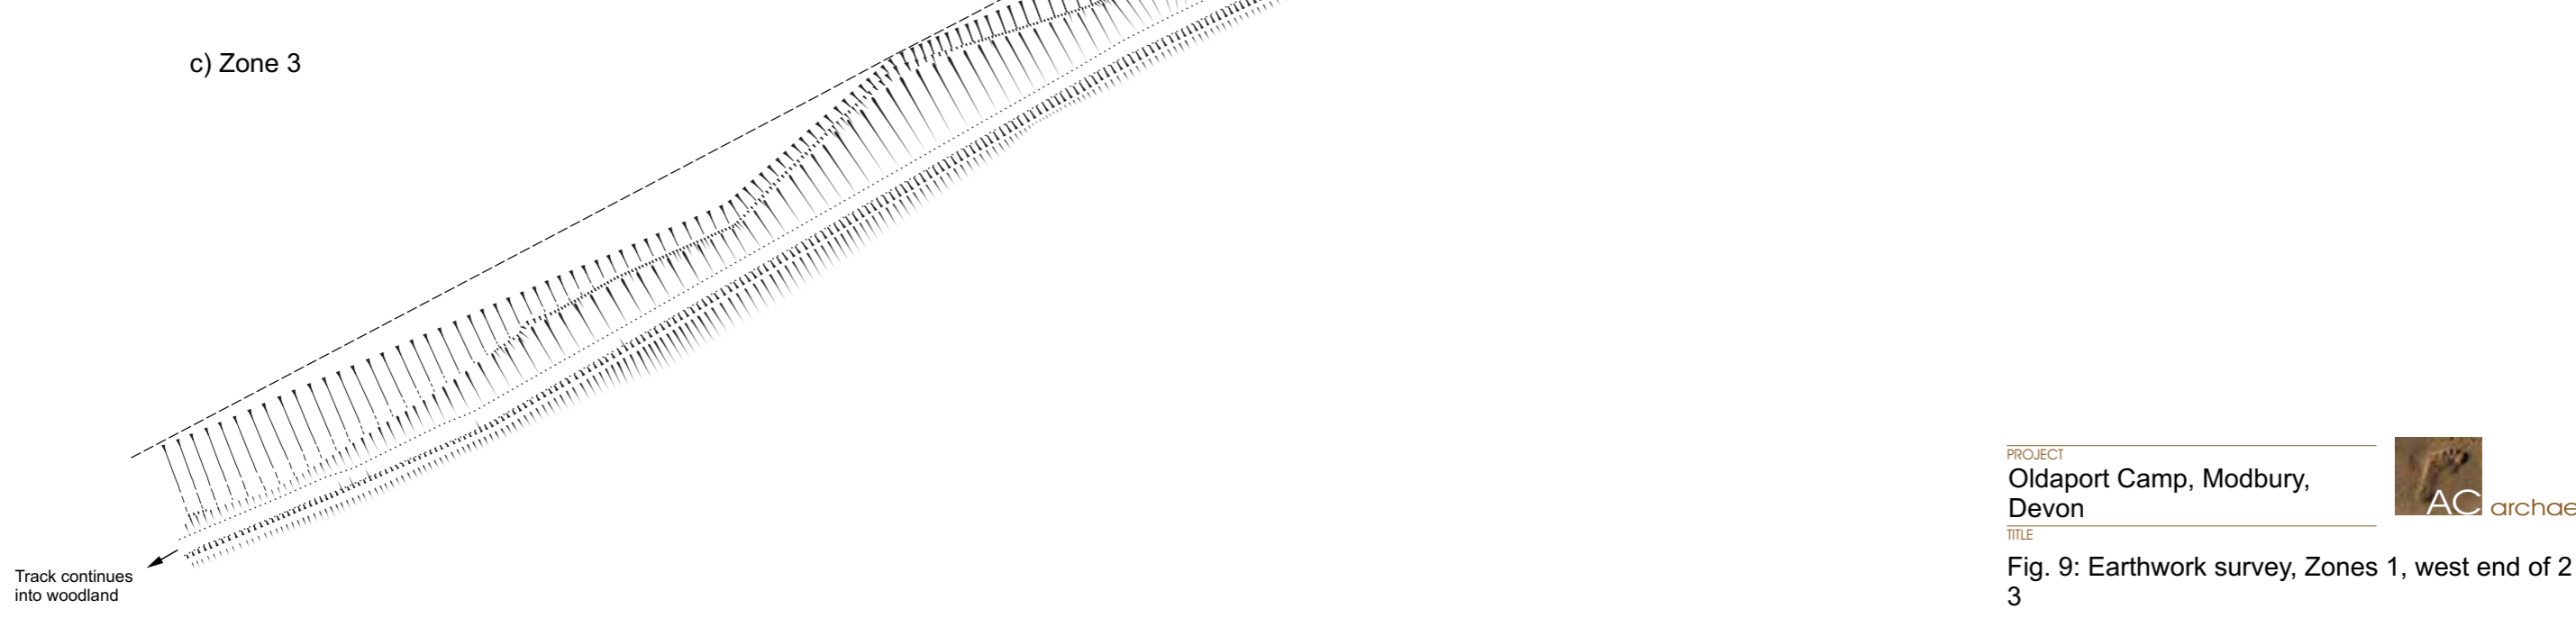
Fig. 9: Earthwork survey, Zones 1, west end of 2 and 3

a) Zone 1

b) West end of Zone 2

c) Zone 3

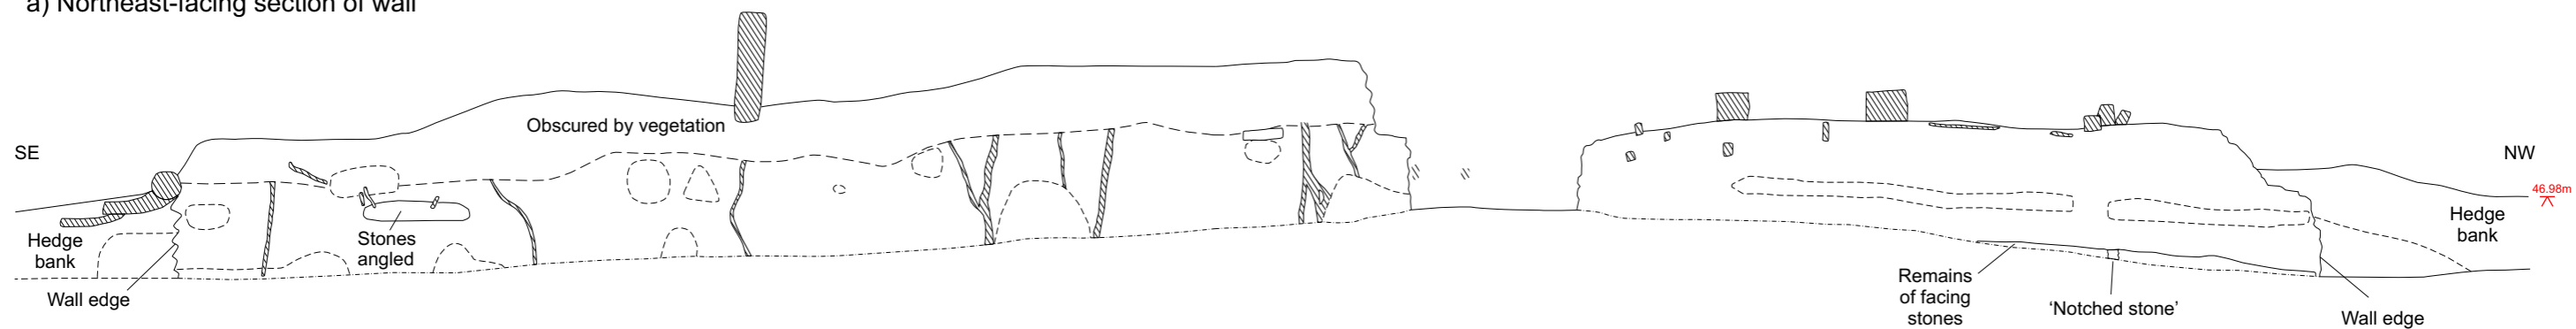
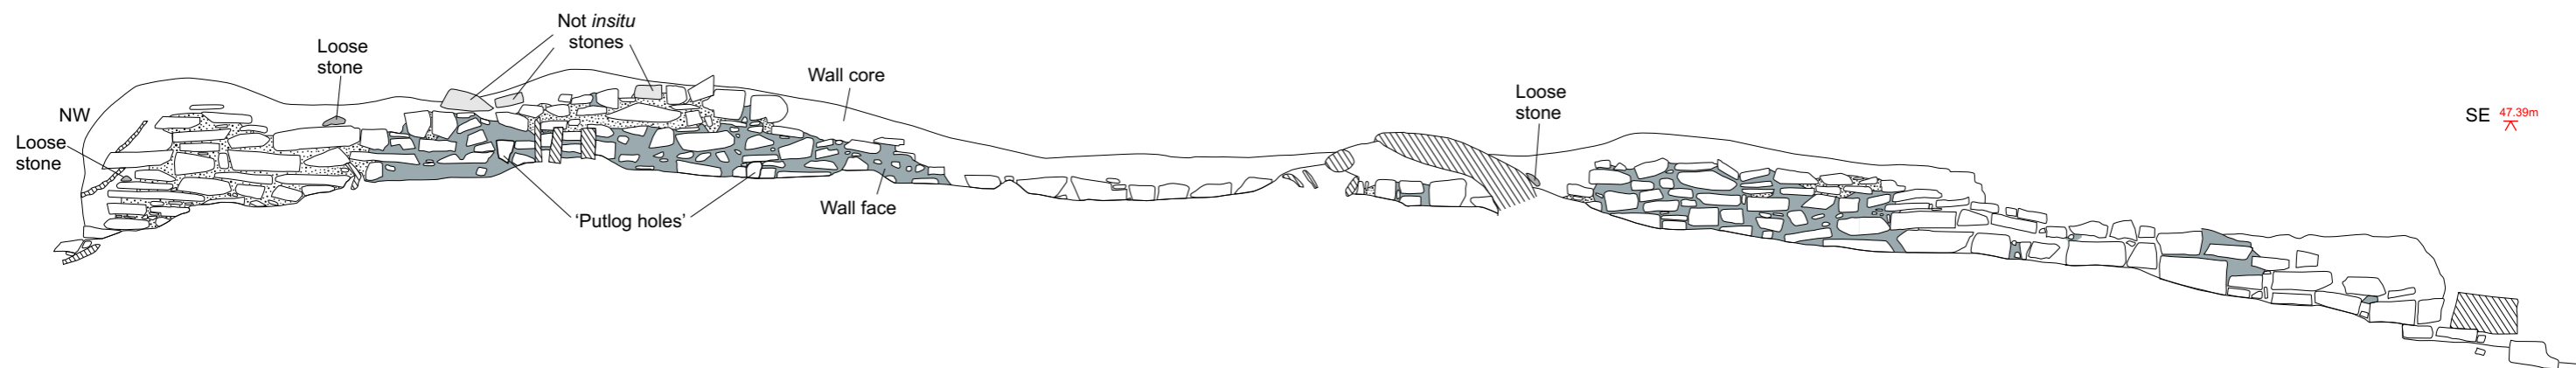
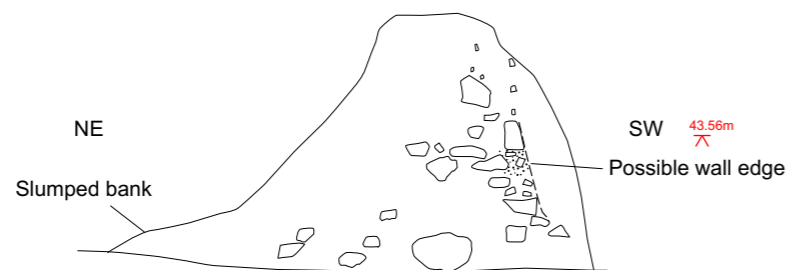
Fig. 10: Zone 1, elevations and sections of the northeast wall

a) Northeast-facing section of wall

b) Southwest-facing section of wall

c) Section of hedge bank (west end)

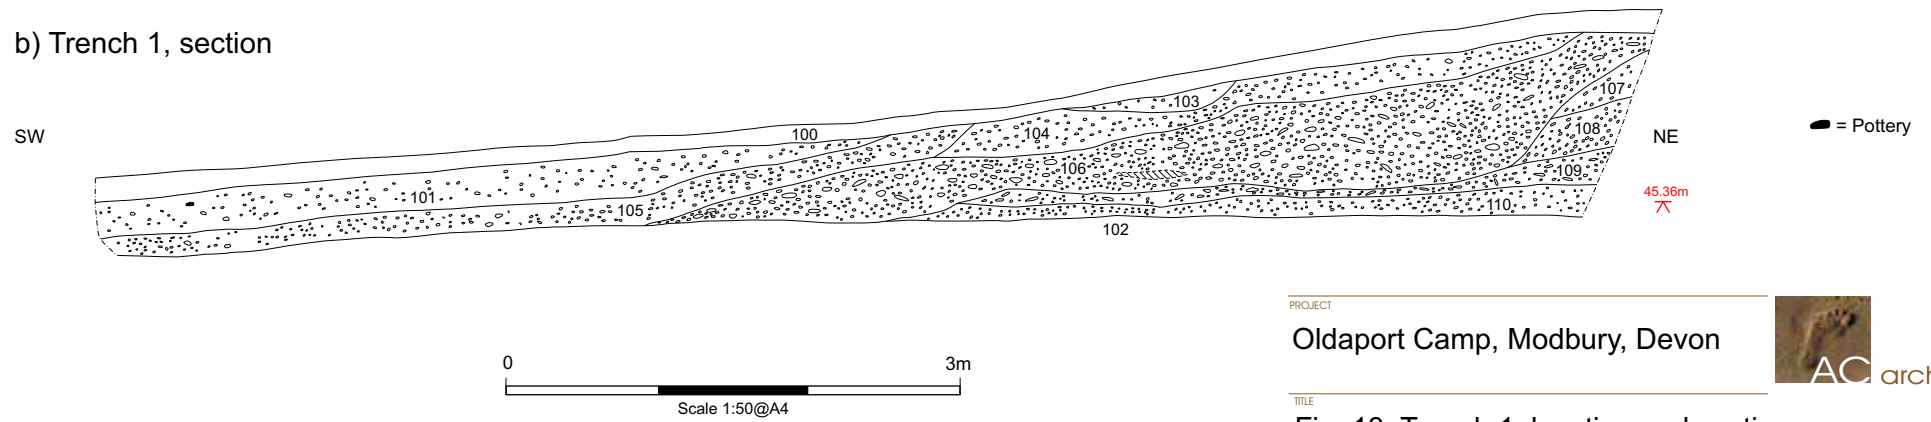
TITLE
 Fig. 13: Trench 1, location and section

a) Zone 1, plan

b) Trench 1, section

12.1 The management survey (above) includes two recommendations that involve intrusive archaeological investigations within the monument. Recommendation 7 states that in Zone 1 "to the rear of the wall the bank should be trimmed to encourage low grass, the problem of part-buried farm machinery in the southern end of the extant bank should be remedied by controlled archaeological removal". In Zone 2 where damage is being caused by poaching of grazing animals Recommendation 10 states that to characterise below-ground deposits "it is proposed that a transect of 1m² test pits is excavated across the terrace, to the immediate southwest of the spring". These interventions took place in January 2015 and are reported here. The works were conducted following the granting of Scheduled Monument Consent and followed the approved project design (Passmore 2014). In Zone 1 a single trench (Trench 1) was excavated adjacent to the farm machinery and in Zone 2 a transect of four test pits (2-5) were excavated. The locations of the excavations are shown in the accompanying plan (Fig. 2).

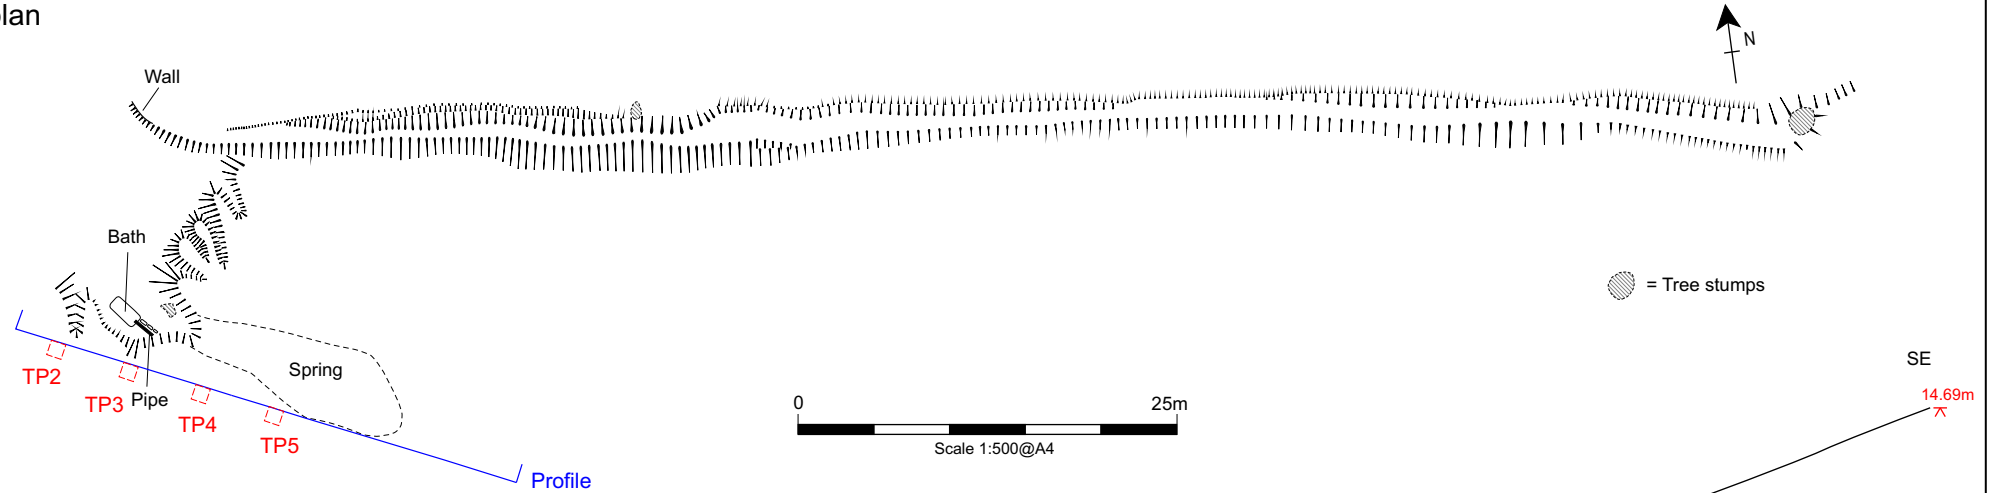
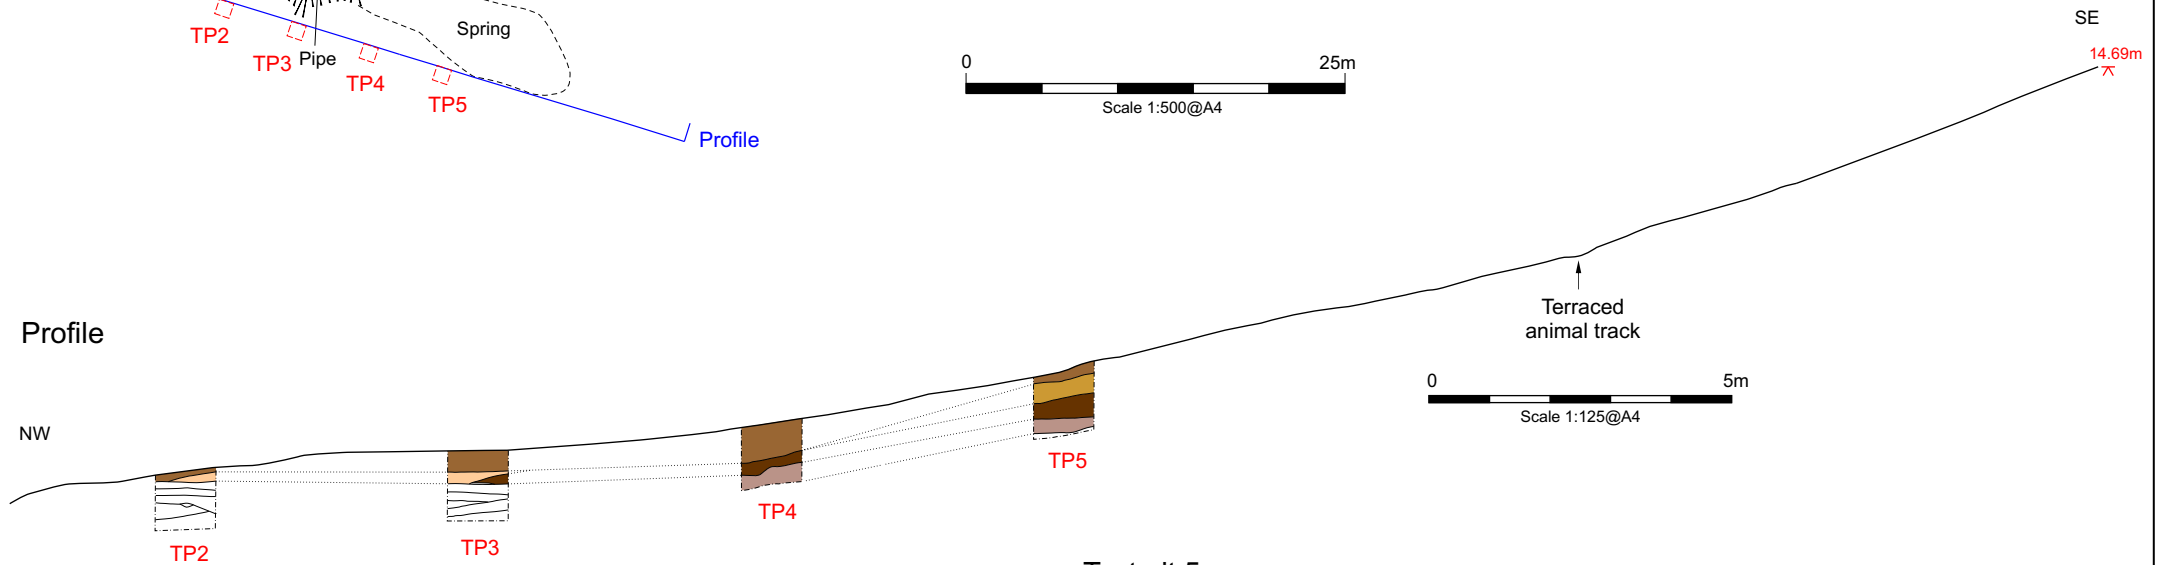
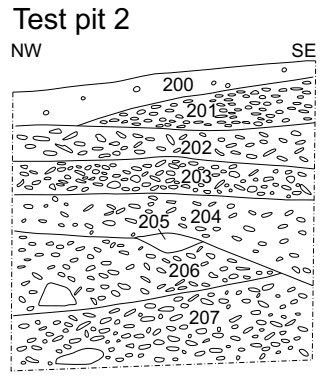
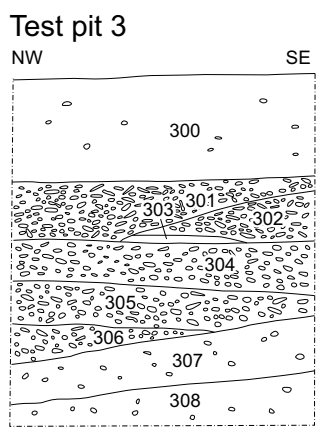
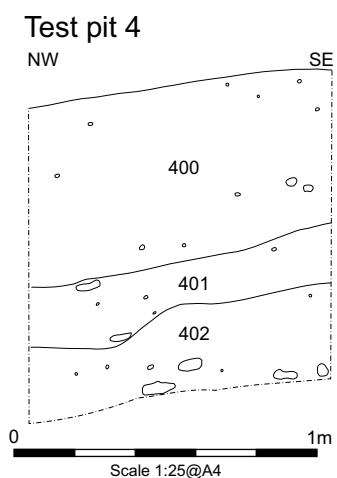
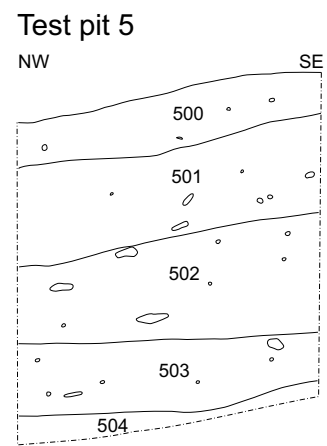
TITLE
Fig. 14: Test pit locations, profile and sections

Zone 2, plan

Profile

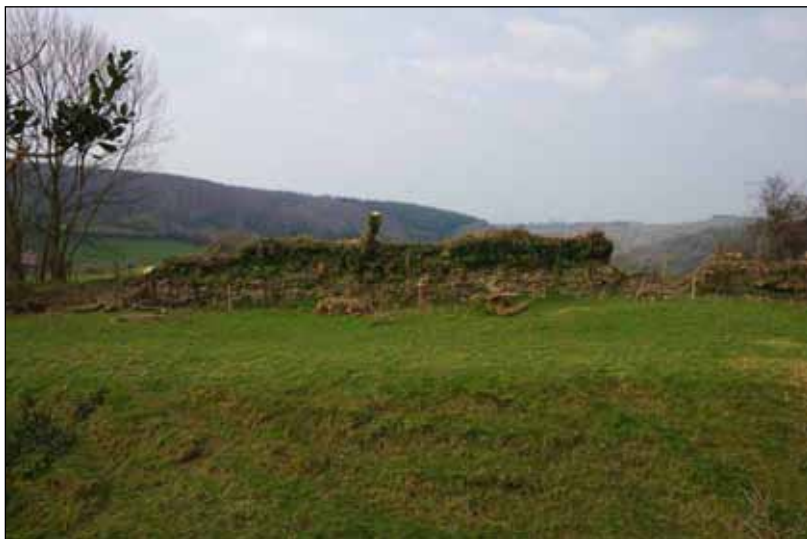
- 5.7** *Condition:* On the northeast side of the wall there was a concentration of ivy and other surface plants growing on the top portion of the wall, and on the southwest side vegetation is mainly growing from the top of the wall. It is not clear how much damage the roots are doing versus the protection from frost damage that the foliage may provide. There are small shrubs and nettles growing close to the base of the wall and a few growing in it and on top of it. These have the potential to grow into larger plants whose roots may cause damage to the stone work. There are a few large stumps (from recently chopped-down trees) and the roots have caused major damage to the wall, displacing stones and mortar. Removing these roots is likely to cause further damage. There is a break in the wall which has partially filled with slumped bank material containing some loose stone. Tree stumps and small shrubs grow within this breach. It is possible that there may be the remains of some stonework below this material, which could be damaged by the plant growth. The earthworks, except the large ditch, have few signs of erosion, but are susceptible to animal and plant erosion. The northeast side of the large ditch shows significant evidence of stock erosion through poaching where shrubs and bushes provide shade and shelter.

Plate 1: Zone 1, northeast wall exterior, south end, viewed from the east. 2m scale.

- 5.8.2: R2:** The post and wire fence along the front side of the wall should be removed, and replaced with a temporary electric fence, moved regularly, to prevent stock animals from rubbing against the front of the wall. This was completed in January 2015.

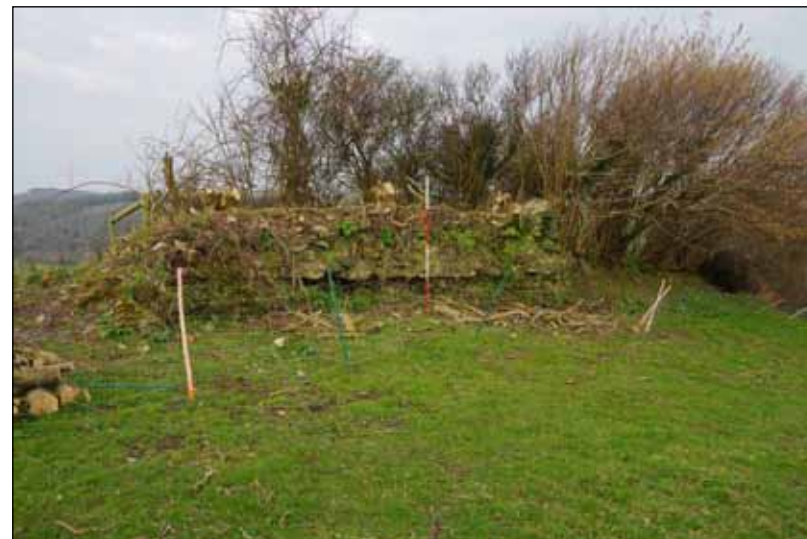
Plate 2: Zone 1, northeast wall exterior, north end, viewed from the southeast. 2m scale.

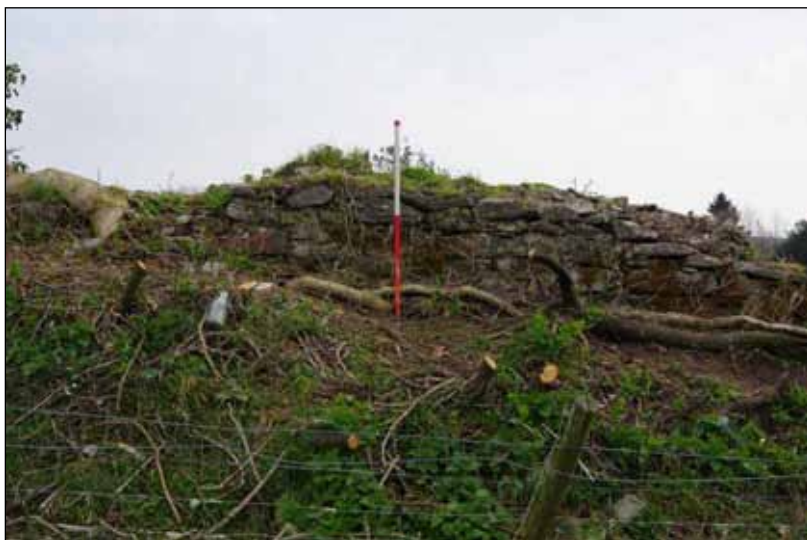
Plate 3: Zone 1, northeast wall and bank interior, viewed from the west. 1m scale.

- 5.8.4: R4:** The post and wire fence along the rear side of the wall and associated bank should be removed and replaced with a temporary electric fence, moved regularly, to prevent stock animal access to the earthwork at the rear of the wall. This should be located away from the base of the bank to avoid poaching.

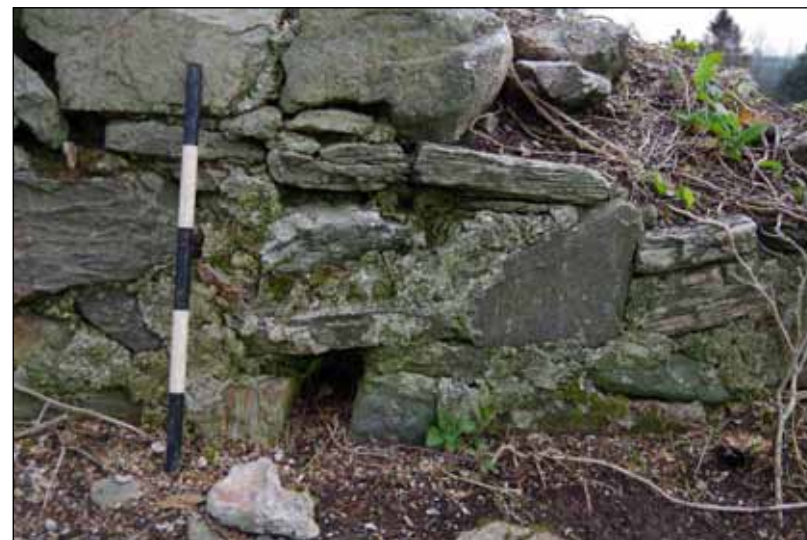
Plate 4: Zone 1, northeast wall interior, showing possible putlog hole and render, viewed from the west. 0.5m scale.

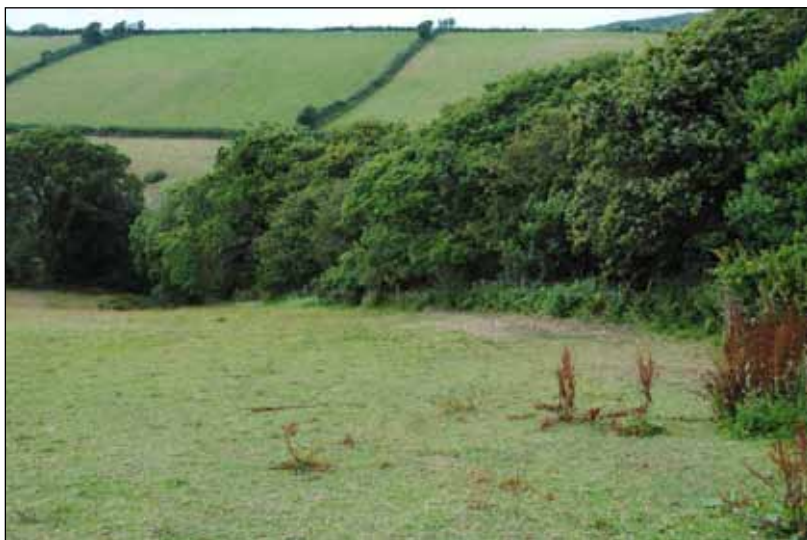
- 6.3** *Condition:* During the current project it was clear that the external face of the northwest wall is under significant threat from unchecked vegetation growth. This appears to have caused collapse and undermining. The hedgebank is in poor condition with evidence of animal burrowing, root disturbance and stock erosion. The spring has no formal structure associated with it, but the depression in which it sits and the area around it is significantly damaged by stock erosion.

Plate 7: Zone 2, view of northwest angle wall

- 6.4.1: R10:** The current post and wire fence encroaches on the hedgebank in a few places. The nature of this hedgebank is uncertain, but there is good chance that it is related to wall material. When this fence next requires replacing, a system of fencing which does not damage the hedgebank should be erected.

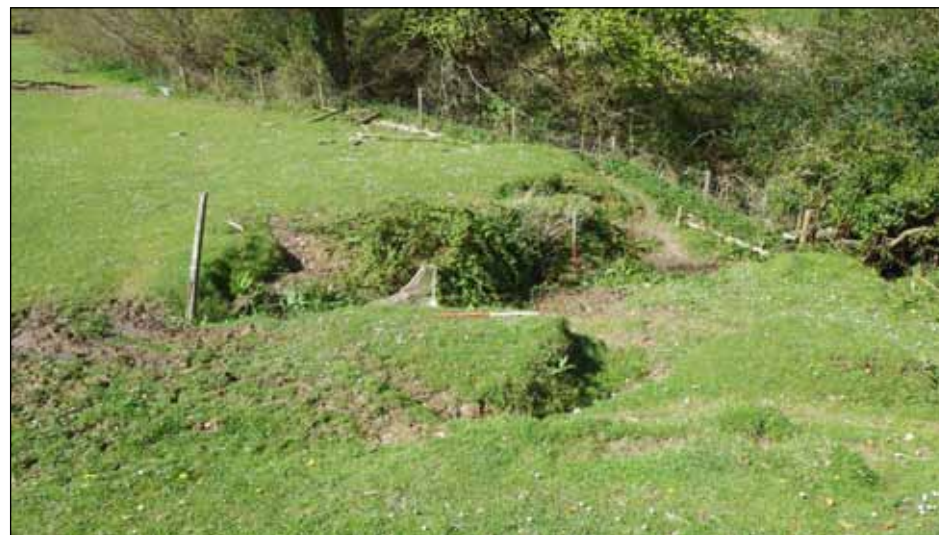
Plate 8: Zone 2, the spring, viewed from the southeast. 1m and 1m scales.

- 6.4.2: R11:** The area of the spring is being damaged by stock erosion. The nature of the archaeological deposits that form the terrace above the Ayleston Brook where the spring is located are poorly understood. It was proposed that this area would be investigated through a geophysical survey. However, due to the narrow width of the terrace and the wire fence along the northern boundary, meaningful results are unlikely to be achieved. Instead, it is proposed that archaeological deposits within this area should be tested by test pitting (and if necessary additional coring) with the aim of informing the management of the area of the spring. It is proposed that a transect of 1m² test pits is excavated across the terrace, to the immediate southwest of the spring. This was completed in January 2015 and is reported below in Section 12. The results of the excavations indicate that the terrace in which the spring is located is formed from infilling of a natural slope, perhaps representing former bank material. R11 is therefore updated. No specific recommendations are put forward although consideration should be given to options to halt erosion at the base of the spring. This could include movement of the drinking trough further uphill where below-ground deposits are less sensitive or the creation of a revetment of the current eroded area to stop this erosion creeping back into undisturbed archaeological deposits. Any significant management proposals to the area of the spring should be accompanied by archaeological monitoring and recording in the form of a watching brief.

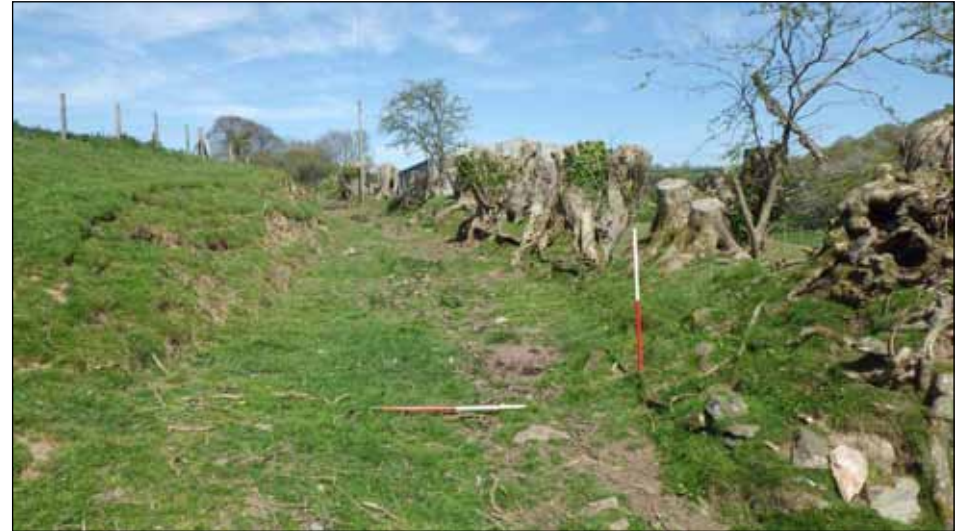
Plate 10: Zone 3, northeast end of green lane, viewed from the southwest. 1m and 1m scales.

- 7.4.1: **R13:** Remove dead and leaning trees (to prevent damage from windage) from the green lane and manage the vegetation, particularly by trimming overhanging branches, to allow the green lane to be maintained as a track.

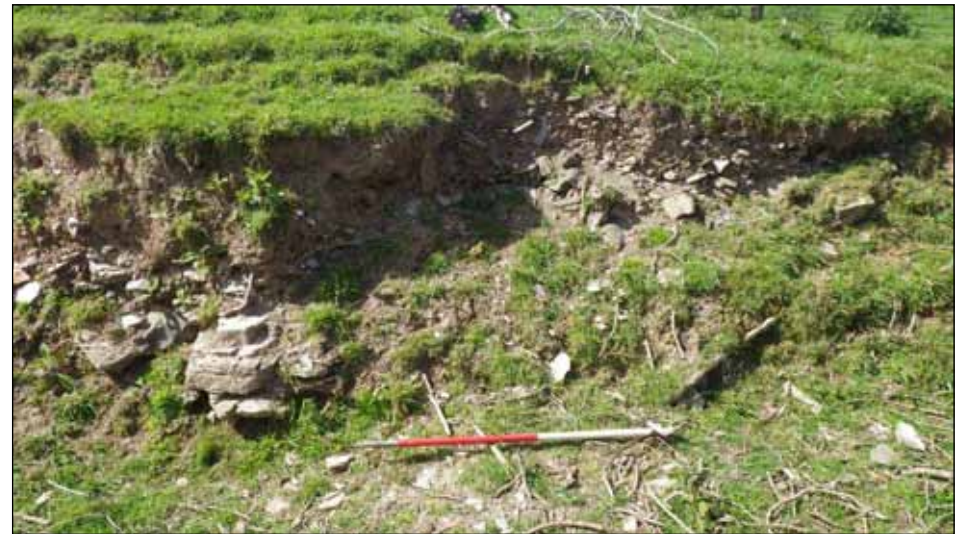
7.3 *Condition:* This slope is mostly wooded and has several patches of erosion from stock use and some animal burrowing. At the eastern end where the track first begins to dip down below the level of the spur there is widespread erosion of the slope on its north side and a patch of tumbled stone and mortar was revealed just below the location of the south tower as marked on the SM map (Fig. 2).

Plate 12: Zone 3, erosion below site of South Tower, viewed from the south. 1m scale.

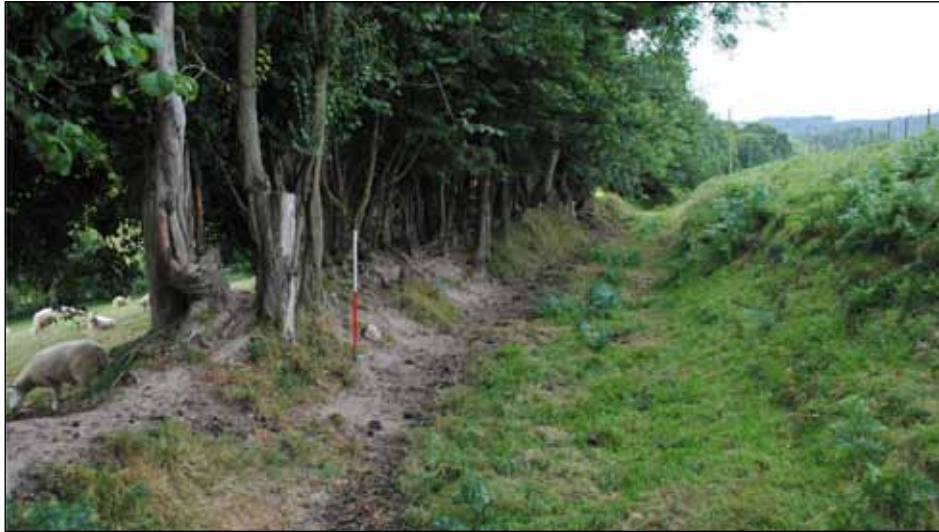
Plate 13: Zone 3, view of hedgebank erosion.

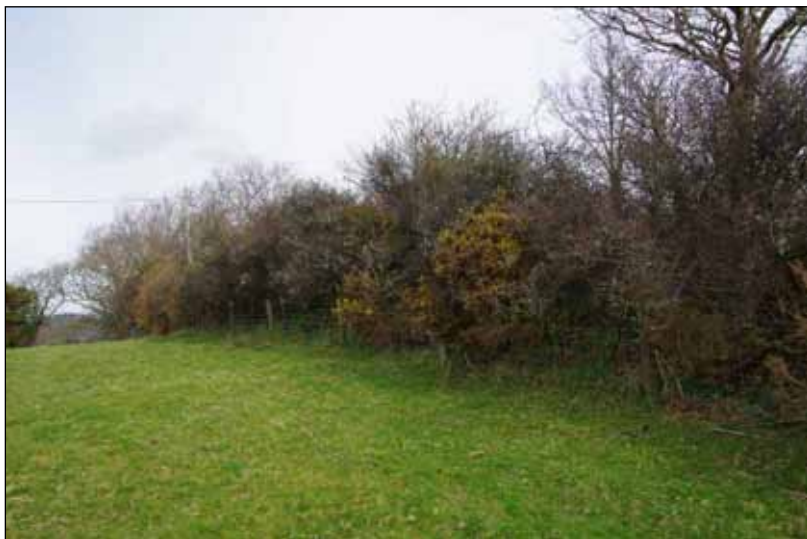
- 9.3** *Condition:* The Pitty field hedgebank is covered in mixed shrubby vegetation, gorse and a few small trees. The hedgebank appears to be earthen with little obvious stone within the bank. There is much evidence for animal burrowing. There are two short sections of facing stone; at the north end the internal side is faced by dry stone walling which turns the corner to join with the northern hedgebank of Pitty field. Central to the hedgebank is a telegraph pole dug into the bank and to the south of this is the second short stretch of dry stone walling on the inside face of the hedgebank. There is a well-maintained wooden post and wire fence protecting the hedgebank from stock erosion.

Plate 17: Zone 5, the Pitty field eastern hedgebank, viewed from the southwest

- 9.4.1: R16:** No works which would result in further damage to the hedgebank should be undertaken.

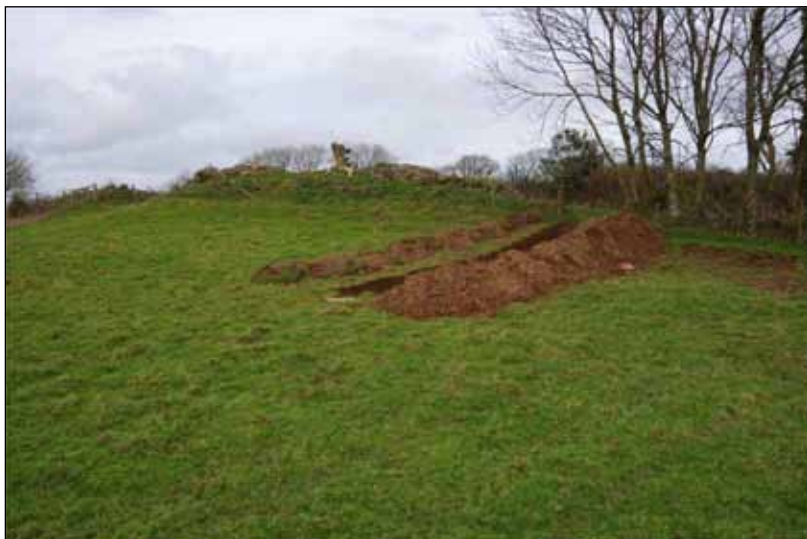
Plate 21: Zone 1, general view of excavation Trench 1, viewed from the south. 1m scale

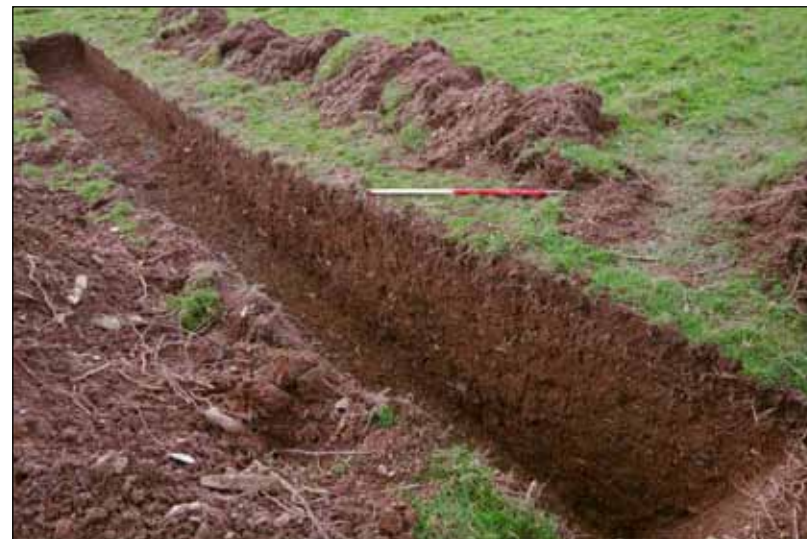
Plate 22: Zone 1, oblique view of southeast-facing section of the excavation Trench 1. 1m scale
