SEATON NEIGHBOURHOOD DEVELOPMENT AREA - PHASE 7, PLYMOUTH

Results of an archaeological trench evaluation

Document No: ACD1250/4/2

Date: August 2016

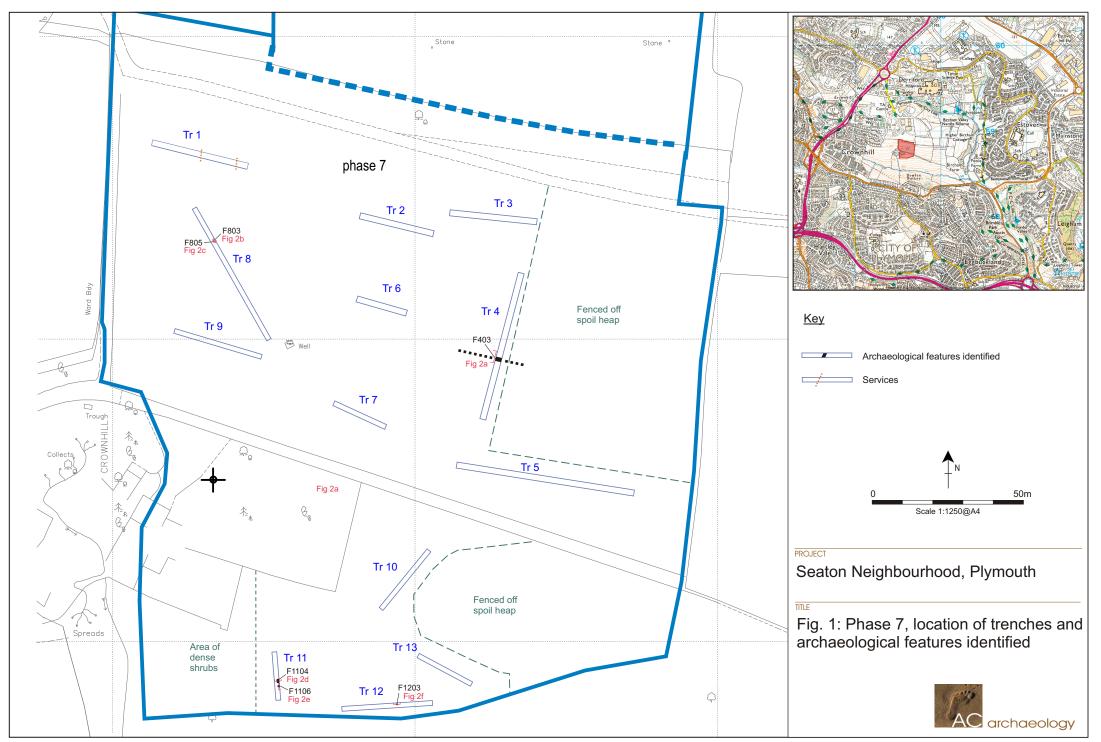
Fig. 2: Sections

a) Section of ditch F403

b) Section of posthole F803

d) Section of pit F1104

e) Section of pit F1106

f) Section of pit F1203

c) Section of posthole F805

Cutting into the natural 402 was a linear boundary ditch (F403). It had a broad v-shaped profile, measured 1.25m wide by 0.45m deep, and was orientated east-west (Plate 4). The feature contained a single fill (404) of loose mid reddish-brown clayey silt with frequent slate inclusions. No finds were present within 404 or the overlying soils.

Two postholes (F803 and F805) had been cut into the natural 802. Posthole F803 was circular and measured 0.30m diameter by 0.10m deep and had a broad u-shape profile with a fairly flat base (Plate 5). It contained a single fill (804) of dark greyish-brown clayey silt with moderate slate inclusions and flecks and small lumps of charcoal. Posthole F805 was circular and measured 0.40m diameter by 0.20m deep and had a broad u-shape profile and slight concave base (Plate 6). It contained a single fill (806) of dark greyish-brown clayey silt with moderate slate inclusions and flecks and small lumps of charcoal.

Two features were partially exposed within the trench cutting into natural 1103. Pit F1104 was sub-circular, measured 1.10m long by a minimum of 0.17m wide and 0.25m deep, with gradual sloping sides and a fairly flat base (Plate 9). It contained a single fill (1104) of pale reddish-brown clayey silt with moderate slate inclusions and rare charcoal flecking. Pit F1106 was sub-circular, measured a minimum of 1.10m long by 0.17m wide and 0.26m deep, with moderate sloping sides and a concave base (Plate 10). It contained a single fill (1107) of pale reddish-brown clayey silt with moderate slate inclusions.

A single feature was cut into the natural 1202. Pit F1203 was circular, measured 0.60m diameter by 0.27m deep, with steep sides and a concave base (Plate 11). It contained a single fill (1204) of mid reddish-brown clayey silt, with moderate slate inclusions, charcoal flecking and ash inclusions.

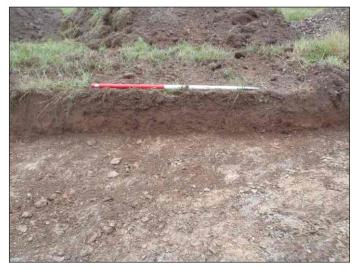
Plate 2: Trench 1, south-facing section showing typical deposit sequence in the northern field. Scale 1m

- **5. RESULTS** (Figs 1-2; Plates 2-11; Appendix 1)
- 5.1 Archaeological features were encountered in trenches 4, 8, 11 and 12; all other trenches were archaeologically sterile. The trenches containing archaeological features are described below, and full details of the deposit sequence in all trenches are tabulated in Appendix 1 (Plates 2 and 8).

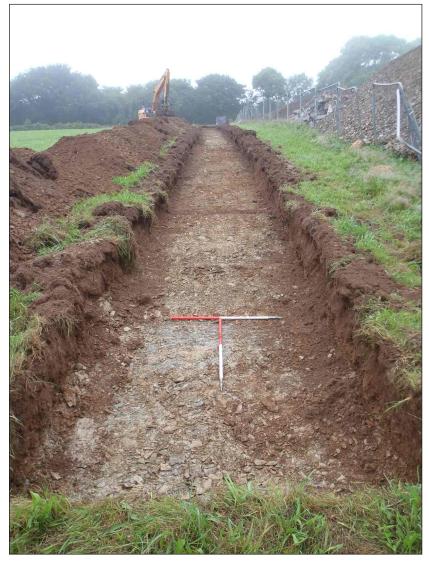
Plate 3: Trench 4, general view, looking north. Scales 1m

Natural (402) was encountered 0.50m below ground surface level at the north end of the trench and 0.60m at the south end, and comprised mid blueish-grey slate bedrock (Plate 3). The overlying soil sequence comprised 0.15-0.20m of subsoil (401), a mid-reddish-brown silty loam, which was sealed by 0.30-0.40m of dark reddish-brown silty loam topsoil (400).

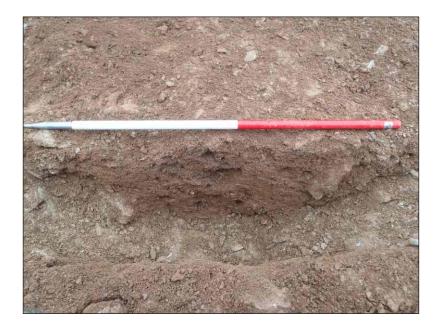
Plate 4: East-facing section of ditch F403. Scale 1m

- 7.2 The few archaeological features are scattered across the development area and, other than ditch F403 that probably represents an historic field boundary that had been removed by the early 19th century, all probably relate to late 19th- and 20th-century military activity post-dating the cessation of farming at Coleridge. No finds were recovered to indicate any potentially earlier activity.

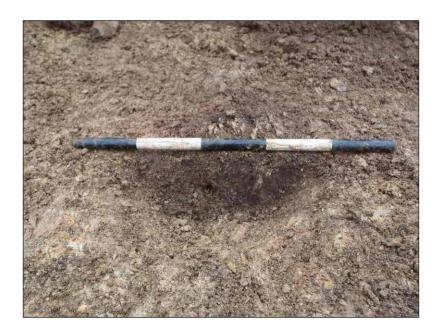
Plate 5: Southwest-facing section of posthole F803. Scale 0.50m

A single piece of undiagnostic ironworking slag (18g) was recovered from context 804, the fill of posthole F803. The other finds were recovered from the topsoil in trench 3 and comprised six sherds of post-medieval pottery (101g) and two fragments of clay tobacco pipe stem (5g). The pottery was a single sherd of 18th-century glazed red earthenware ware and five sherds of 19th- or 20th-century industrial white ware. One of the clay tobacco pipe stems has two initials 'J' and 'P' either side the spur, which are likely to be the maker's mark.

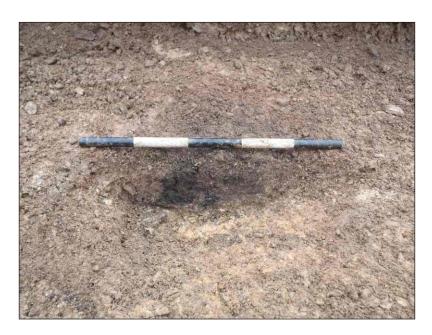
Plate 6: Southwest-facing section of posthole F805. Scale 0.50m

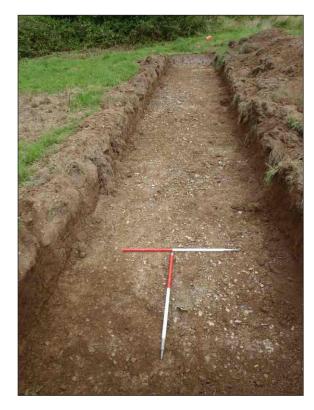
Plate 7: Trench 11, view looking north. Scales 1m

Natural (1103) was encountered 0.77m below ground surface level, and comprised mid blueish-grey, mid purplish-red and pale reddish-brown slate bedrock with patches of pale blueish-grey sandy silt (Plates 7-8). The overlying soil sequence comprised 0.40m of mid yellowish-brown clayey silt colluvium (1102), 0.19m of subsoil (1101), consisting of mid yellowish-brown clayey loam with moderate slate inclusions, and 0.19m of dark-reddish-brown, silty loam topsoil (1100).

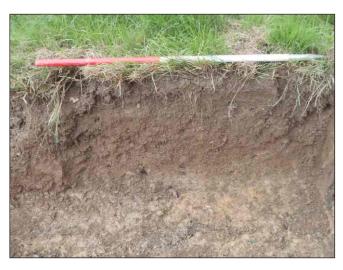
Plate 8: West-facing section of trench 11 showing typical deposit sequence in the southern field. Scale 1m

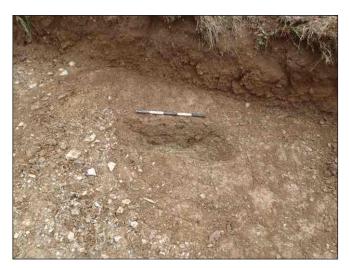
Plate 10: West-facing section of pit F1106. Scale 0.50m
