LAND AT CAMP FIELD, OAK VIEW, BROADHAYES FARM, STOCKLAND, DEVON

Results of Archaeological Monitoring and Recording

Report No: ACD1435/2/0

Date: August 2016

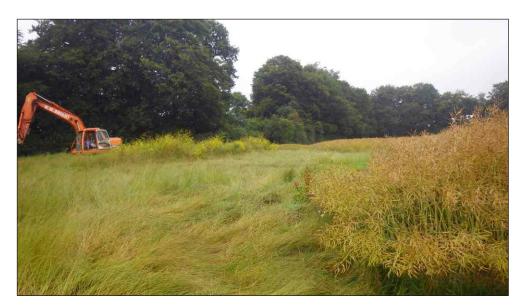
Plate 1: Pre-excavation view of temporary platform, looking northeast

The temporary platform measured approximately 15m by 10m and consisted of a terrace that was a maximum of 0.3m high on the downslope (south) side and was cut into the hillslope by a maximum of 0.25m to the north. The terrace consisted of a mid brown silty-loam re-deposited ploughsoil.

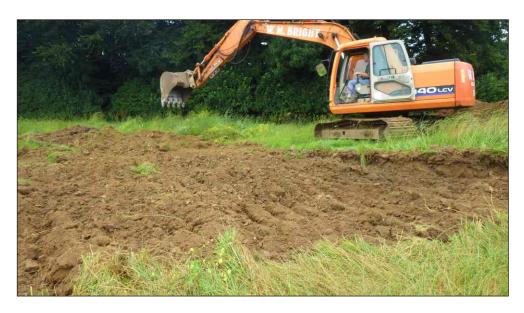
Plate 2: View of reversal works showing profile through temporary platform, looking northwest

Where the platform had cut into the hillslope on the upslope side, this had been maintained within the ploughsoil. No underlying deposits or features were exposed within this. No pre-modern finds were recovered during the works.

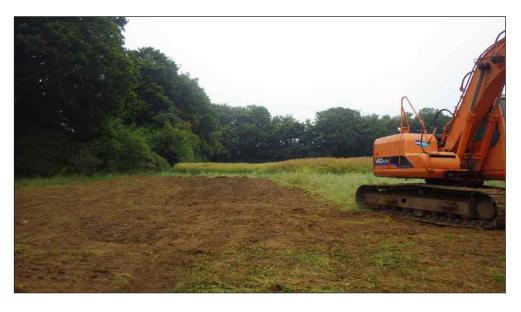
Plate 3: Showing completed reversal work to temporary platform, looking northeast

Following the removal of the temporary platform, the natural gradient of the hillslope was re-instated.
