LAND AT PINHOE SHOOTING CLUB, LANGATON LANE, PINHOE, DEVON

Results of an Archaeological Trial Trench Evaluation

Report No: ACD1449/2/0

Date: September 2016

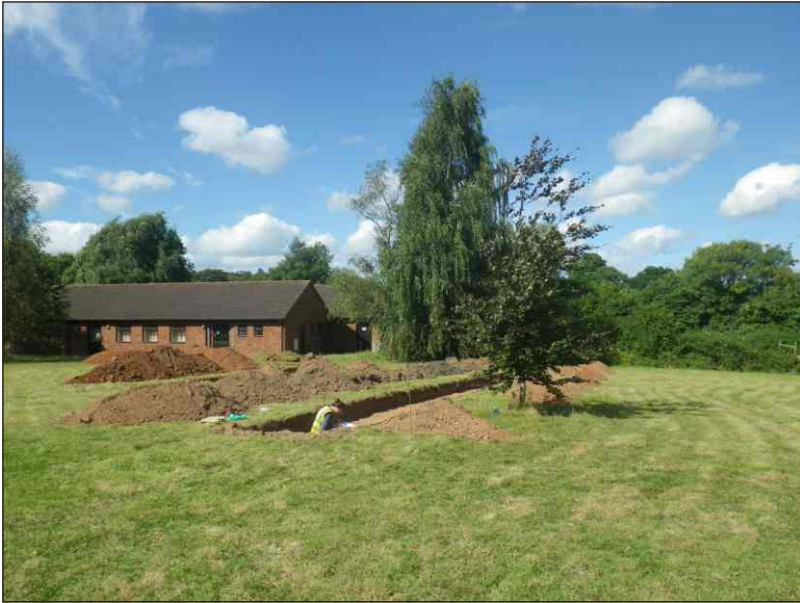
Plate 1: General view of site looking northwest from Trench 3

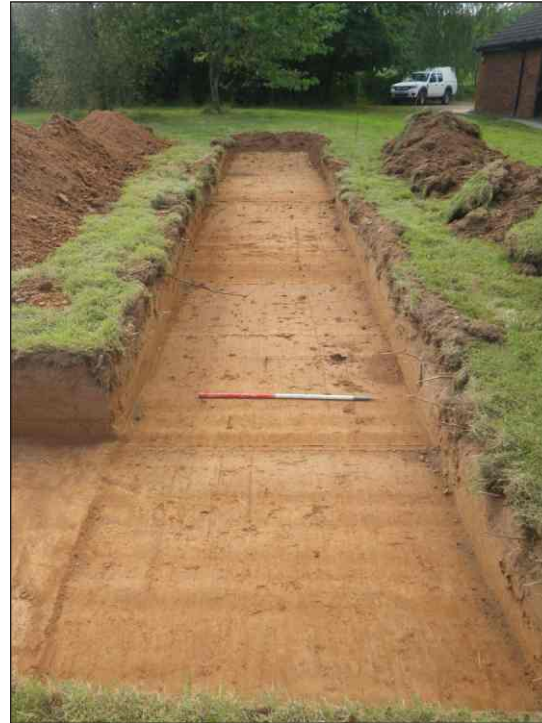
Plate 2: Trench 1, view to west (scale 1m)

Trench 1		Length 20m	Width 1.5m	Alignment NNW-SSE and ENE- WSW
Context	Description	Depth	Interpretation	
100	Light brownish-red sandy-loam	0m-0.15m	Topsoil	
101	Mid brownish-red sandy-loam	0.15-0.3m	Subsoil	
102	Mid red sandy-clay with weathered breccia gravels	0.3m+	Natural subsoil	
103	Mid red clay with frequent gravel inclusions	0.15-0.3m	Re-deposited natural subsoil dump

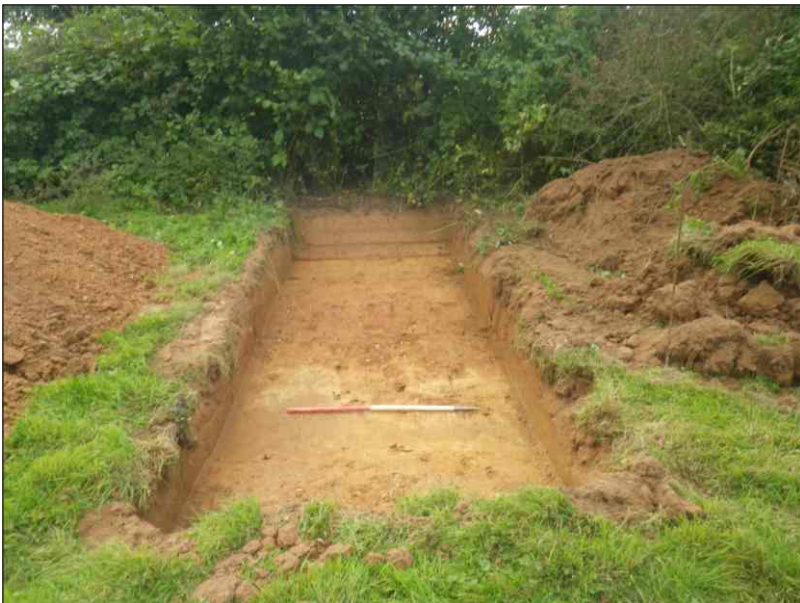
Plate 3: Trench 2, view to north (scale 1m)

Trench 2		Length 5m	Width 1.5m	Alignment NNW-SSE
Context	Description	Depth	Interpretation	
200	Light brownish-red sandy-loam	0m-0.19m	Topsoil	
201	Mid yellowish-red sandy-loam	0.19-0.58m	Subsoil	
202	Mid red sandy-clay with weathered breccia gravels	0.58m+	Natural subsoil

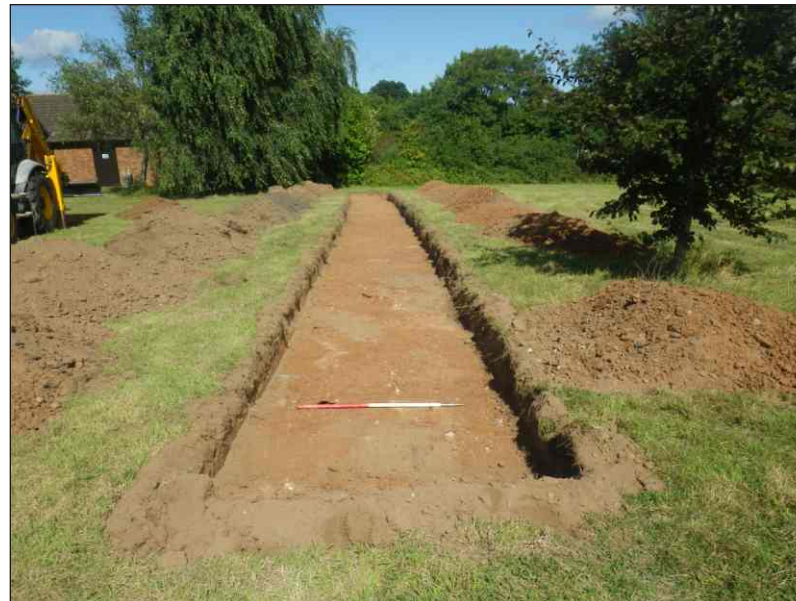
Plate 4: Trench 3, with modern wheel rutting visible in foreground. View to north (scale 1m)

Trench 3		Length 30m	Width 1.5m	Alignment N-S
Context	Description	Depth	Interpretation	
300	Light brownish-red sandy-loam	0m-0.11m	Topsoil	
301	Mid brownish-red sandy-loam	0.11-0.3m	Subsoil	
302	Mid red sandy-clay with weathered breccia gravels	0.3m+	Natural subsoil
