PLYMPTON CASTLE, PLYMPTON, PLYMOUTH

Results of archaeological monitoring and recording

Scheduled Monument: Plympton Castle (National Heritage List
no. 1003865)

Document No: ACD1384/1/0

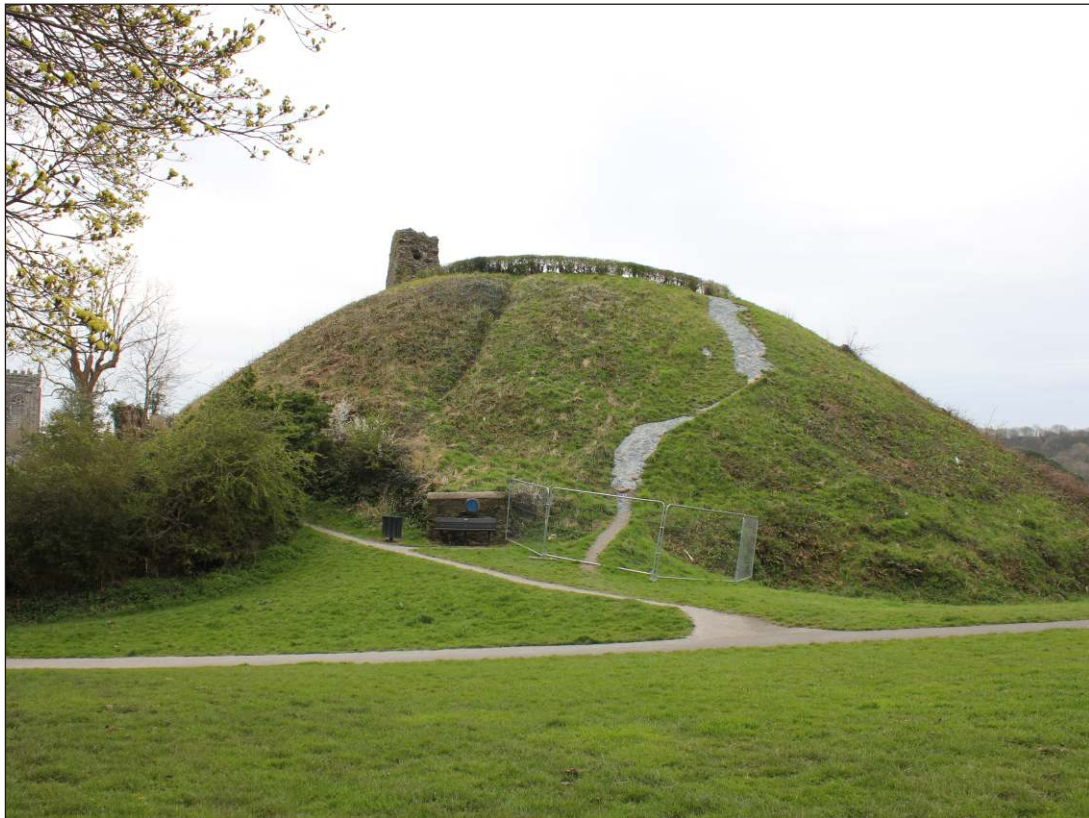
- 2.1 The consolidation works comprised two elements. Firstly, replacement of stones displaced from the keep, and secondly, restoration of an unauthorised path on the northwest side of the motte and removal of a bank below the motte to deter future reuse of this path (Plate 1).

Plate 1: View of the motte from the bailey showing location of restored path, looking southeast

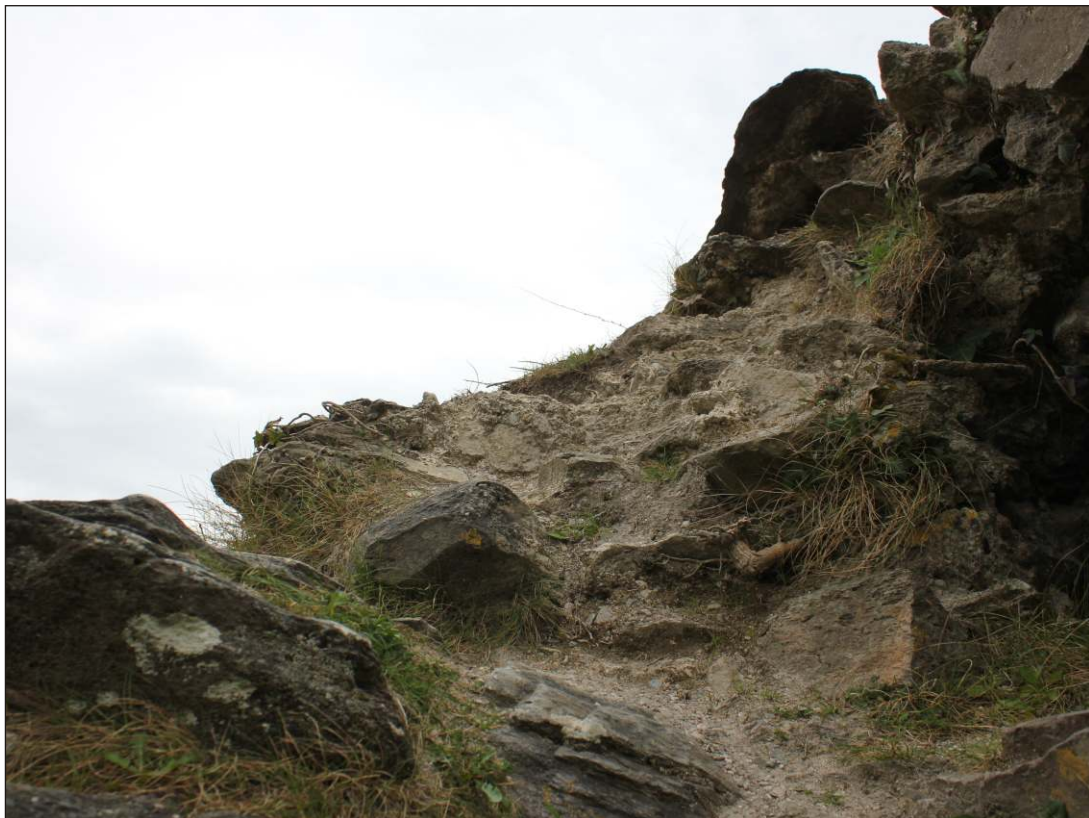
Plate 2: General location of stone 1 looking east viewed from within the keep

3.2 The locations of the replaced stones are shown on Fig. 2. Stone 1 was located on the top of the northeast part of the wall, adjacent to the outer face (Plates 2 and 3). Stones 2 and 3 were located on the top of the southeast part of the wall; stone 2 within the core and stone 3 at the present face (Plates 4-6). Stones 4 and 5 were located on the south side of the wall, within a void in a plinth situated at the currently exposed base of the keep (Plates 7-8). Stones 1-3 were mortared into the wall, whilst additional packing was used around stones 4-5 to partially infill the surrounding void.

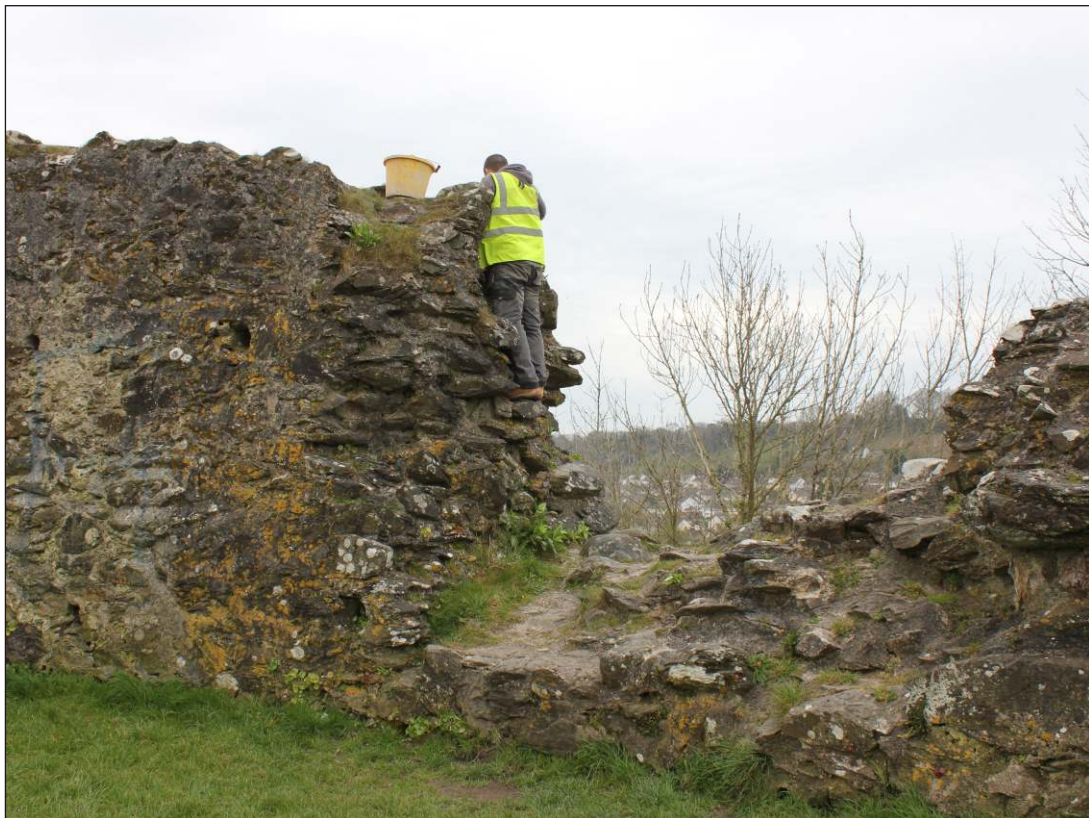
Plate 4: General location of stones 2 and 3 viewed from within the keep during replacement of stone 2, looking east

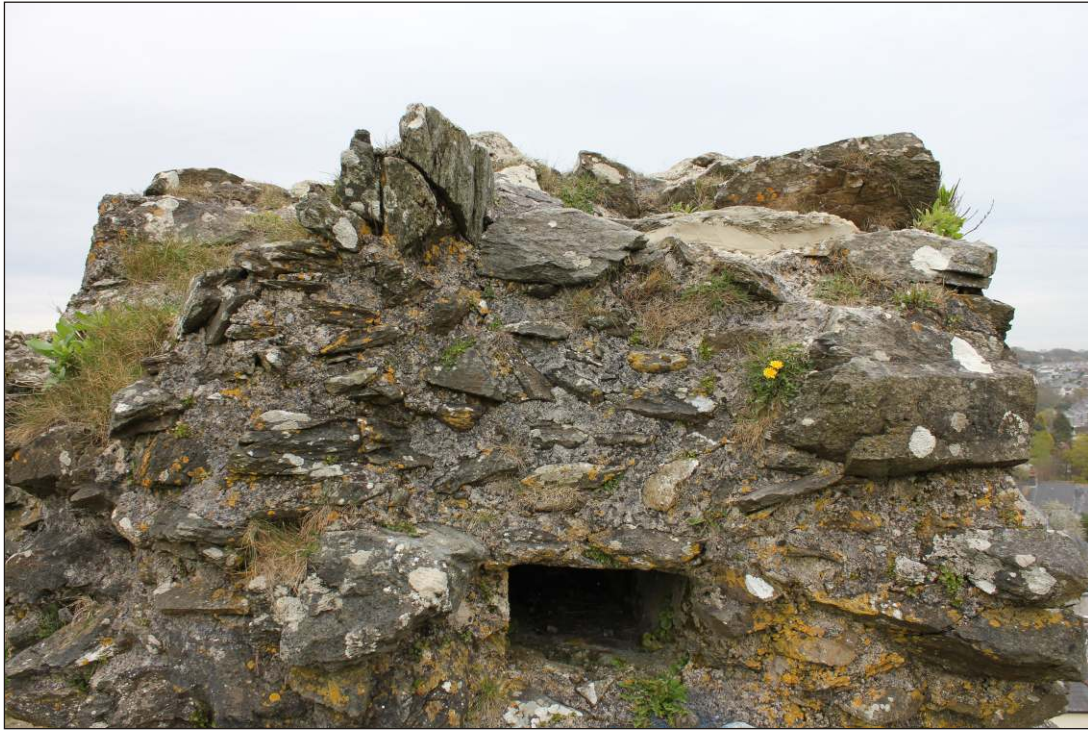
Plate 5: Stone 2 following consolidation, looking north

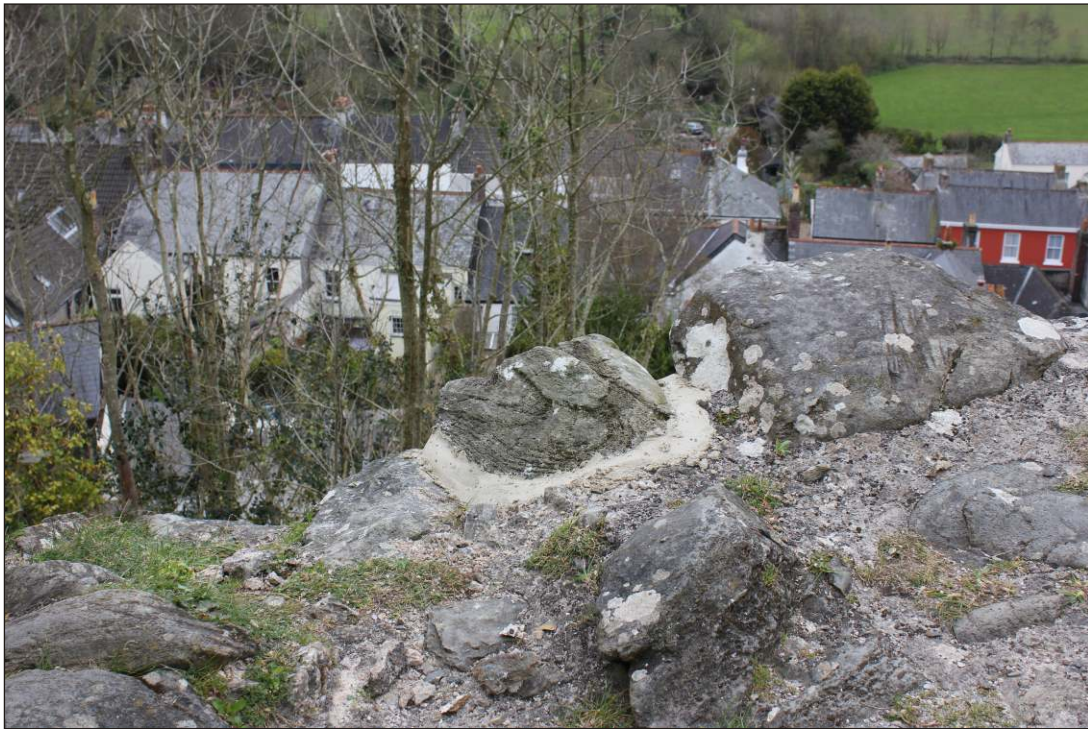
Plate 6: Stone 3 following consolidation, looking southeast

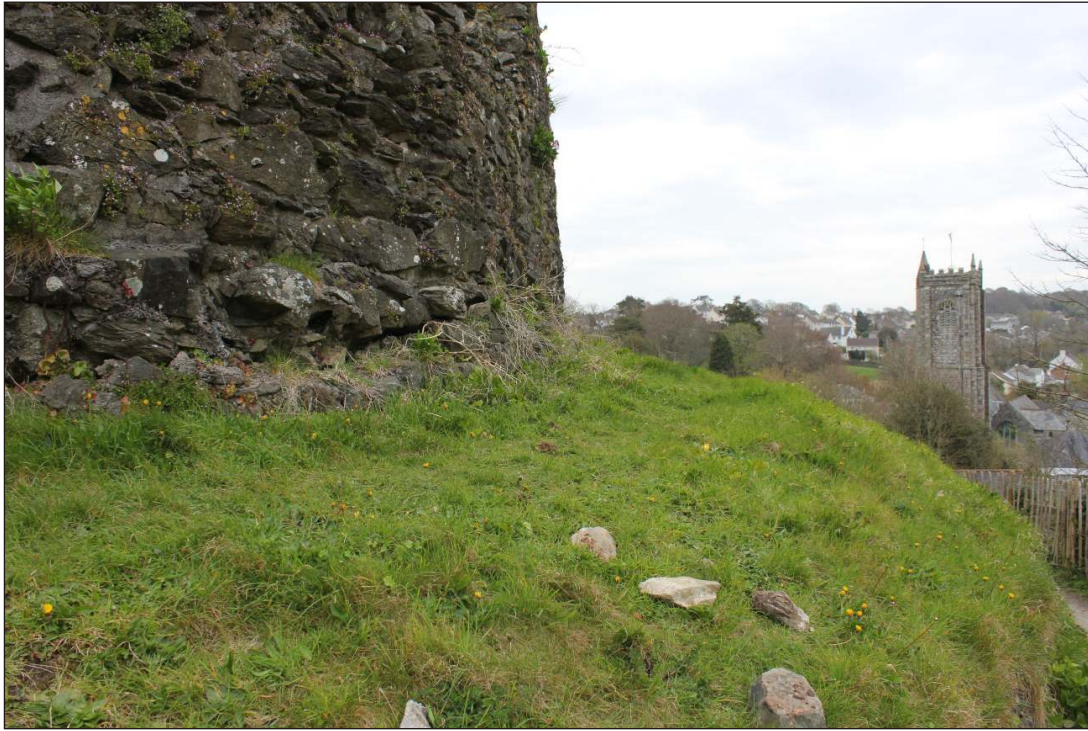
Plate 7: General location of stones 4 and 5, looking east-northeast

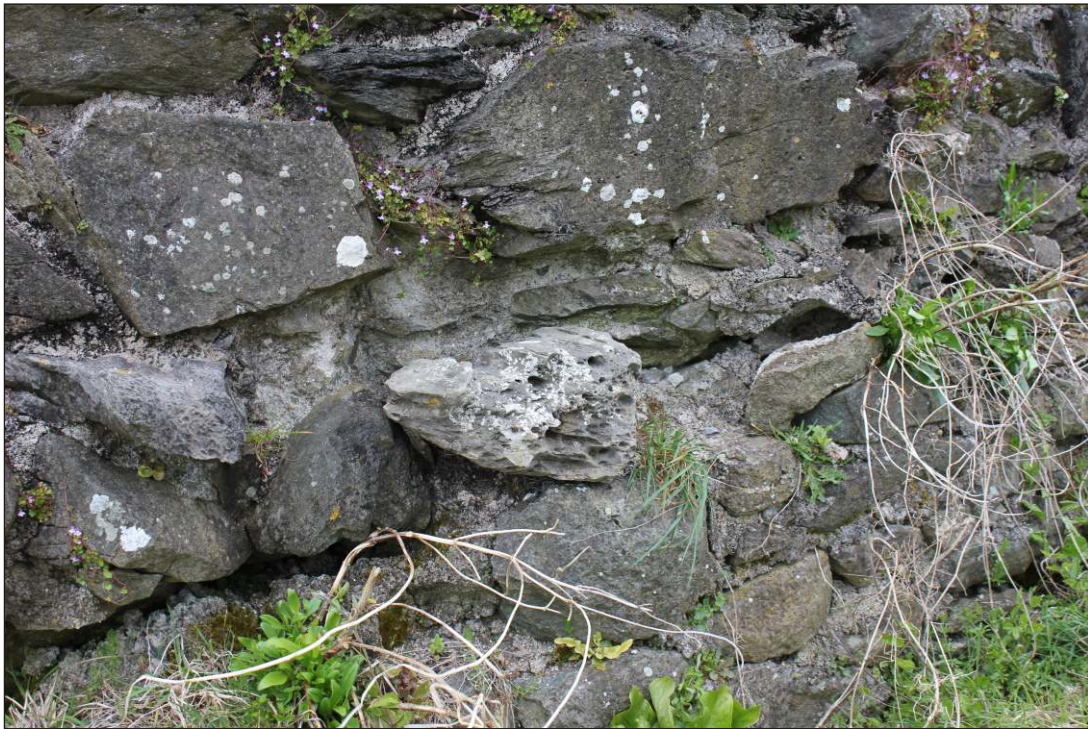
Plate 8: Stones 4 and 5, test fitting prior to consolidation, looking northeast

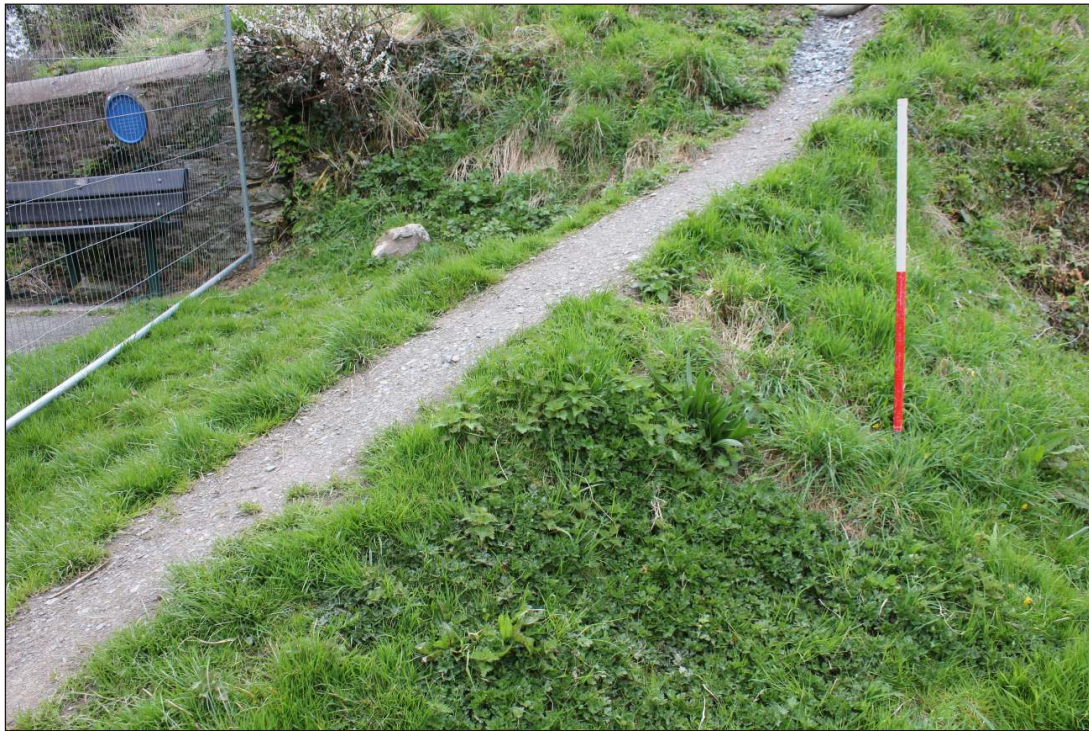
3.3 The bank was located to the south of the bench seat set into the northwest side of the motte, between the bench and the earthwork ditch around the motte. It measured 5.25m long by up to 1.80m wide, and 0.30m high on its north side but between 0.50m and 1.10m high on its south side where it slumped into the motte ditch (Plates 9-10). It had formed on a flatter earthwork on the northwest side of the motte, which overlaid the position of the bailey ditch.

Plate 9: The bank prior to removal, looking southeast. (1m scale)

3.4 The bank was removed using a tracked mini-digger fitted with a toothless grading bucket under the direct supervision of the site archaeologist. Removed spoil was reused as topsoil on the restored path to cover up gravel and sandbags that had already been laid. The maximum depth of the excavation was 1.30m adjacent to the motte, but elsewhere was shallower (Plates 11-12). The removed material consisted of soft grey-brown silty clay with variable frequencies of inclusions, and incorporated lenses of more compact stony silt. These consisted of small slate fragments, modern plastic and bottle glass, iron objects including wire, and clinker, none of which was retained.

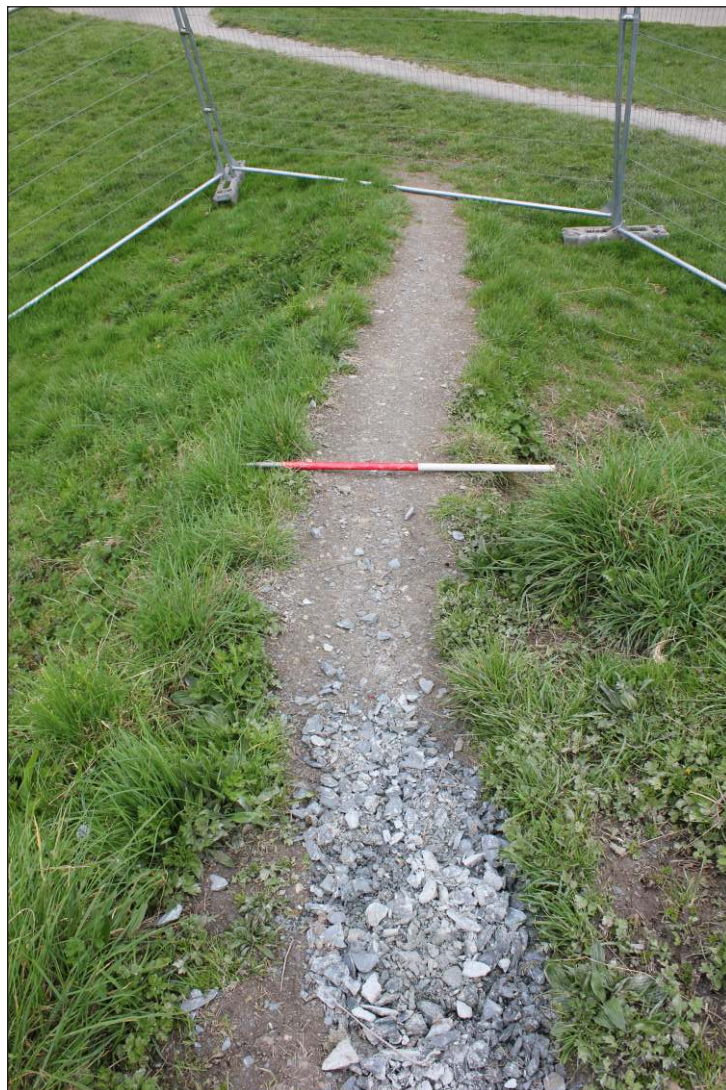
Plate 10: The bank prior to removal, looking northwest. (1m scale)

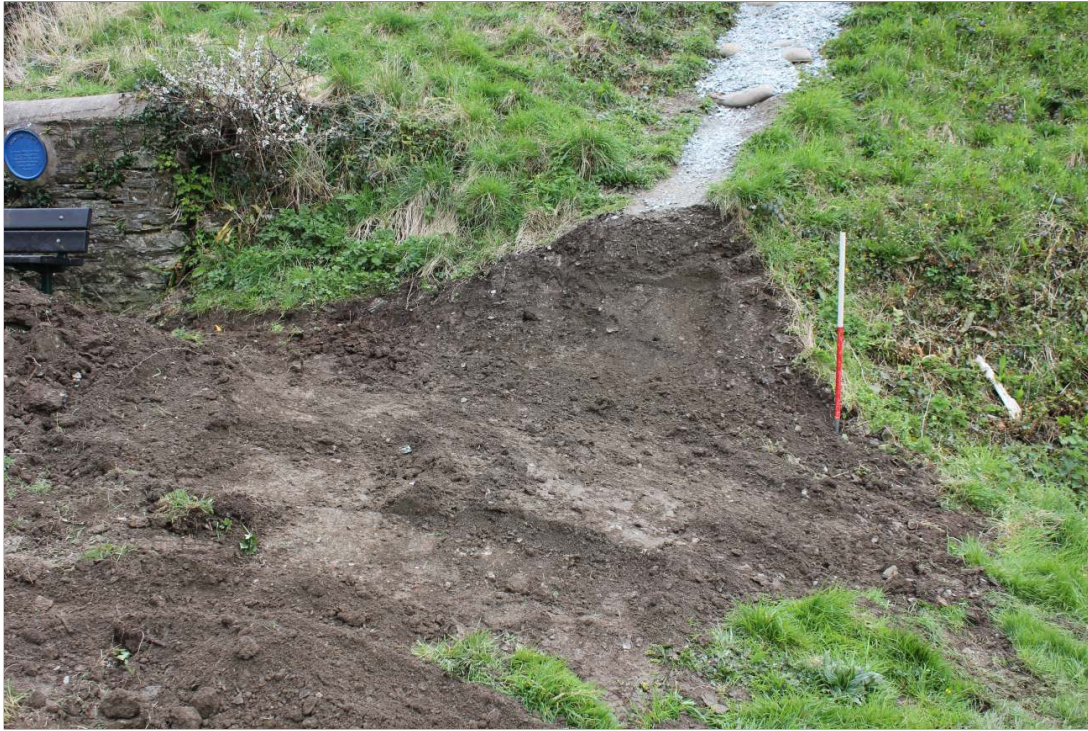
Plate 11: The bank during latter stage of removal, looking east. (1m scale)

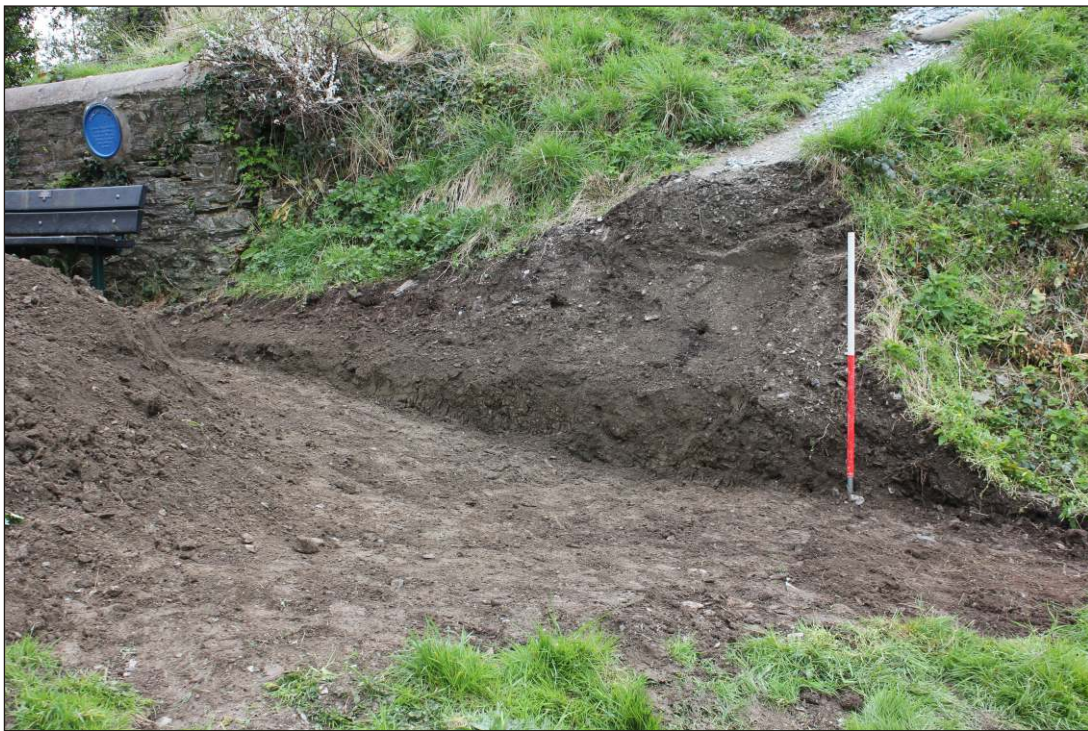
Plate 12: The bank during latter stage of removal, looking northeast. (1m scale)
