LAND TO THE REAR OF ST JOHNS HOUSE, ST JOHN STREET, LICHFIELD, STAFFORDSHIRE

Results of archaeological monitoring and recording

Lichfield District Council planning reference 15/01284/FUL,
condition 3

Document No: ACD1414/2/1

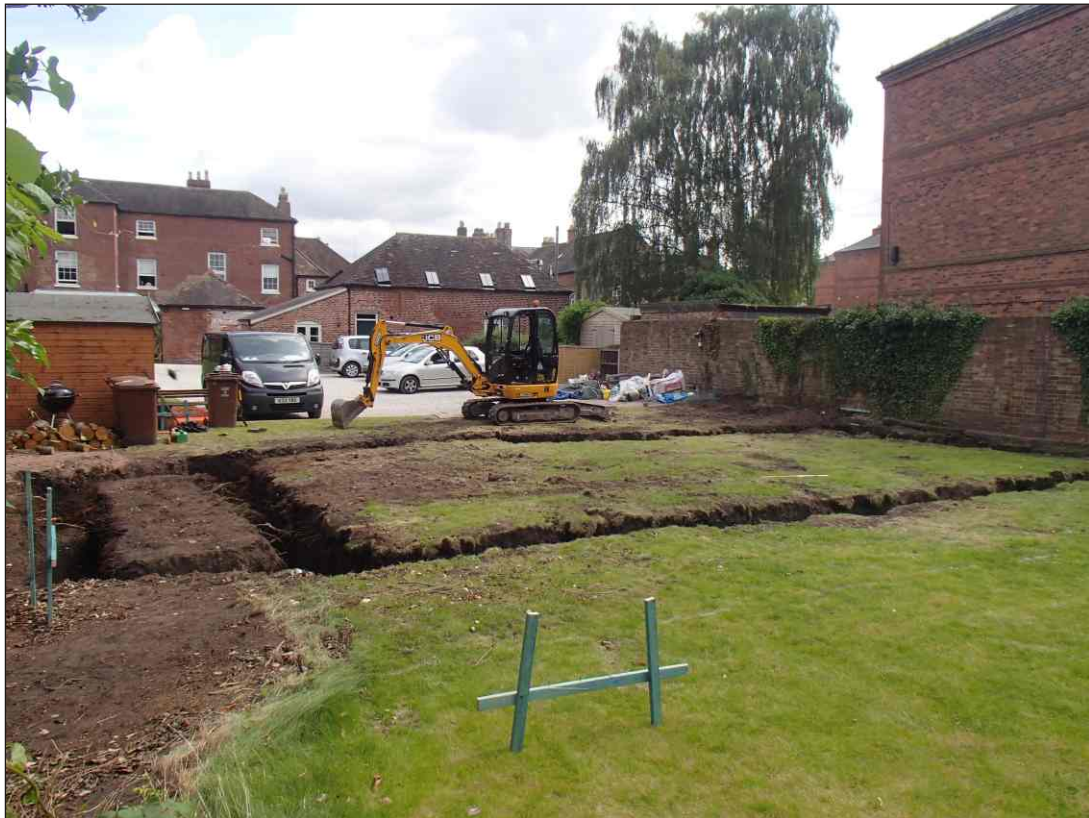
Plate 1: General view of site, view to the northeast. (Scale 1m)

5.2 The foundation trenches were excavated directly from the surface, through the lawn without any prior ground reduction (Fig. 2b; Plates 1-2). The trenches measured 600mm wide, and were excavated to the top of the natural geology generally at depths of between 700-900mm from the surface, although locally were deeper to a maximum depth of 1100mm.

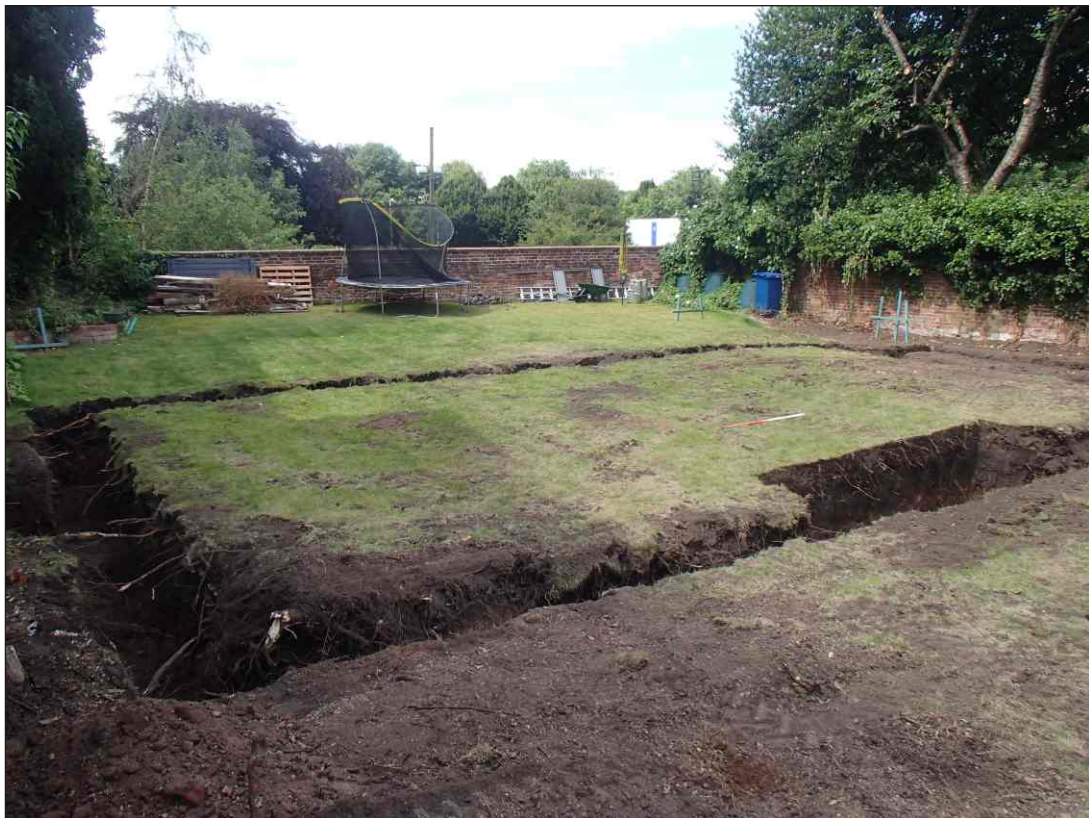
Plate 2: General view of site, view to the southwest. (Scale 1m)

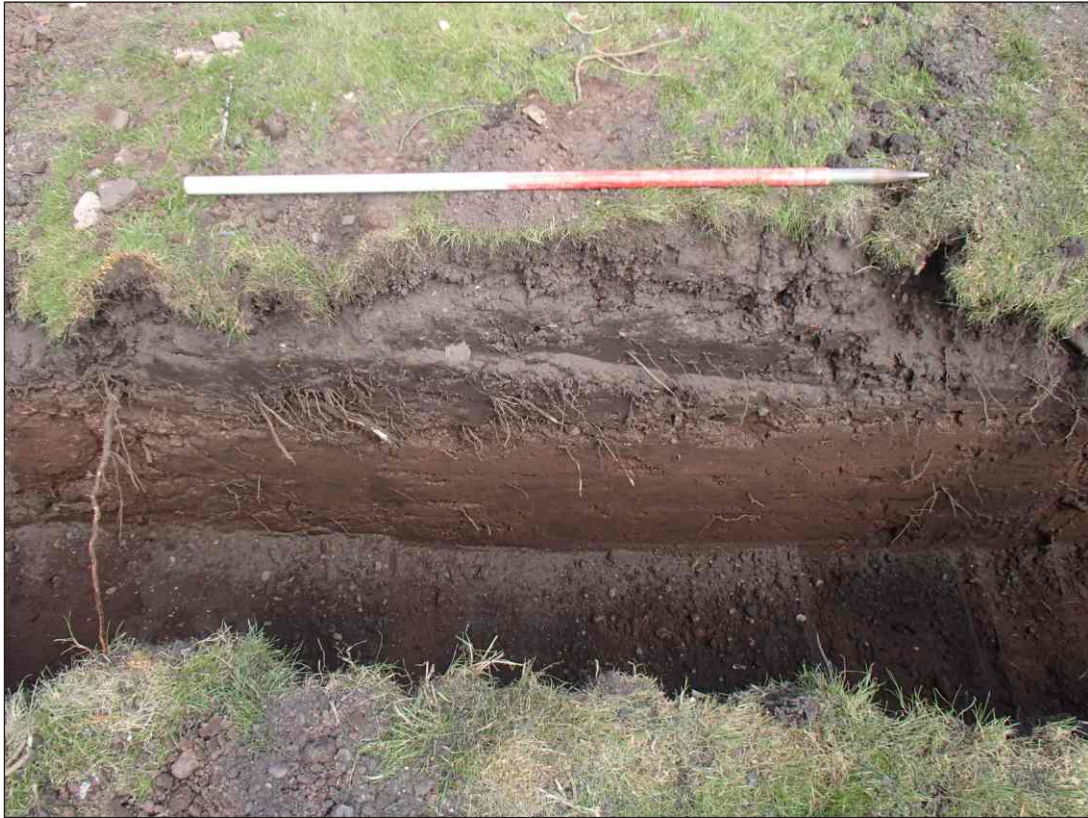
Plate 3: A typical soil profile, view to the southwest. (Scale 1m)

5.3 A simple deposit sequence was exposed (Plate 3). The turf and topsoil (100) measured 60mm deep and consisted of dark brown sandy silt with rare inclusions of post-medieval brick, blue-on-white industrial china, coke and coal fragments, and small to medium-sized rounded stones. This topsoil overlaid a lower soil layer (101) of dark reddish brown sandy silt clay with very rare inclusions of brick, small rounded stones and charcoal flecks. This layer measured between 640mm and 1040mm deep. It overlaid a natural deposit (102) of compact medium brown silty clay with abundant small rounded pebbles.

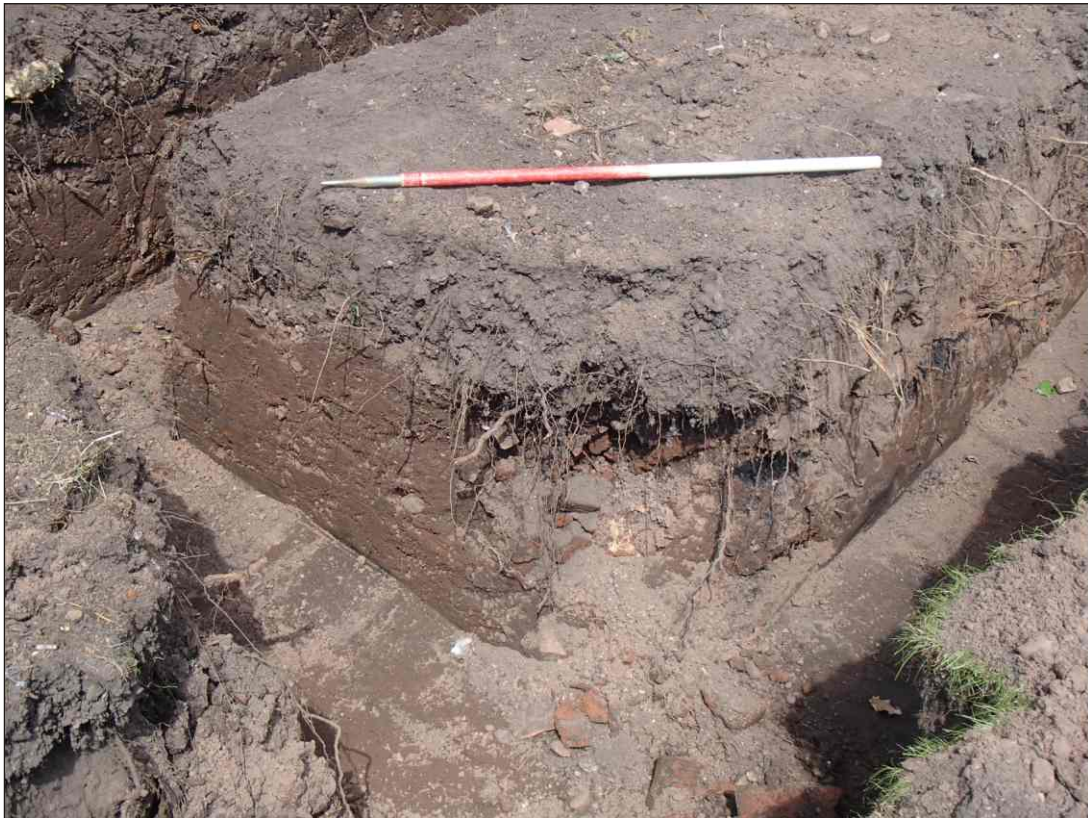
Plate 4: Southwest corner of the new building showing a modern rubble-filled pit (partially collapsed) cutting into 101, view to the north. (Scale 1m)

5.4 Cutting into 101, and sealed by the turf and topsoil 100, was a series of 20th-century rubble dumps mainly consisting of whole and fragments of brick, stone and concrete, as well as plastic and scrap metal (Plate 4).

7.1 The monitored excavations produced no archaeological deposits that are likely to predate the later post-medieval period, or any residual early finds. The lower deposit (101) is almost certainly associated with the use of the area as the garden of the mid-late 18th-century St Johns House. Historic mapping records changes to this garden, and most recently, buildings and structures such as greenhouses have been removed, and a car park created to serve the current bed and breakfast hospitality use of the house. The rubble-filled pits and overlying turf and topsoil date to the late 20th-century and are probably associated with this current use of the property.
