TONE WORKS GREASE RECOVERY PLANT, MILVERTON ROAD, WELLINGTON, SOMERSET

Results of historic building recording and an archaeological watching brief

Taunton Deane Borough Council planning reference
43/11/0080, condition 22

Document No: ACD986/2/0

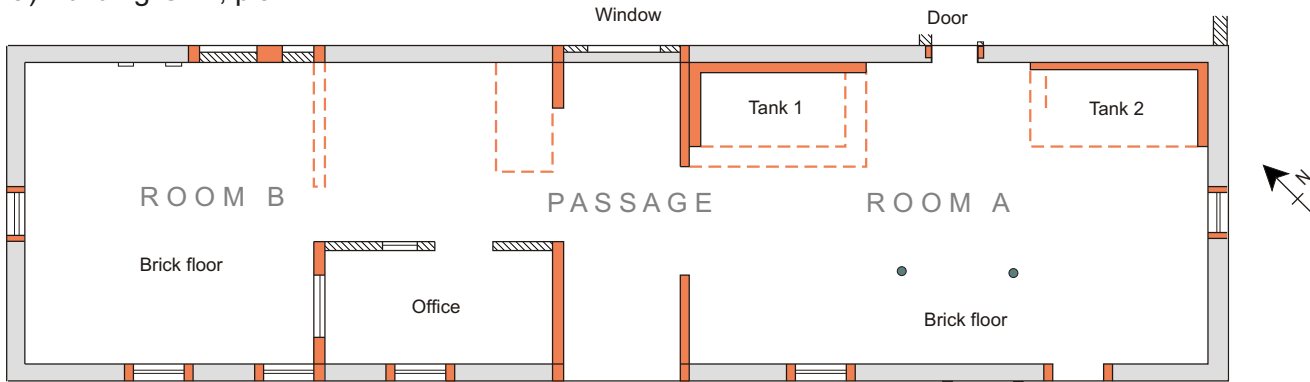
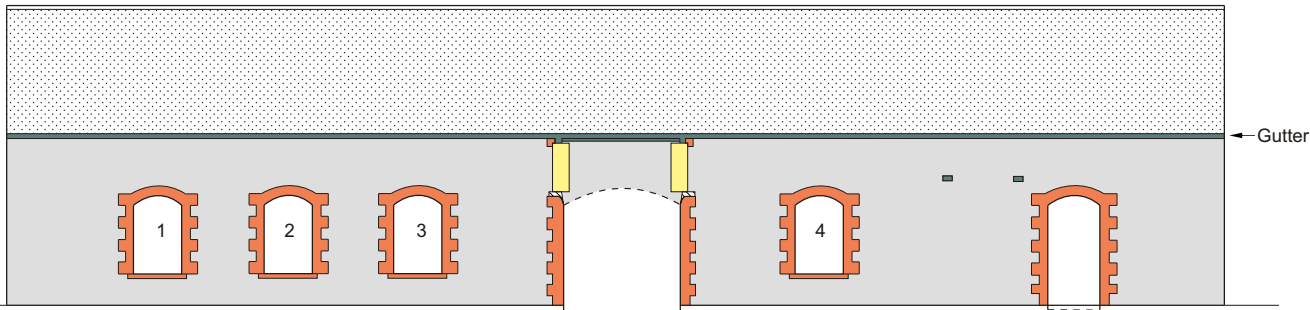
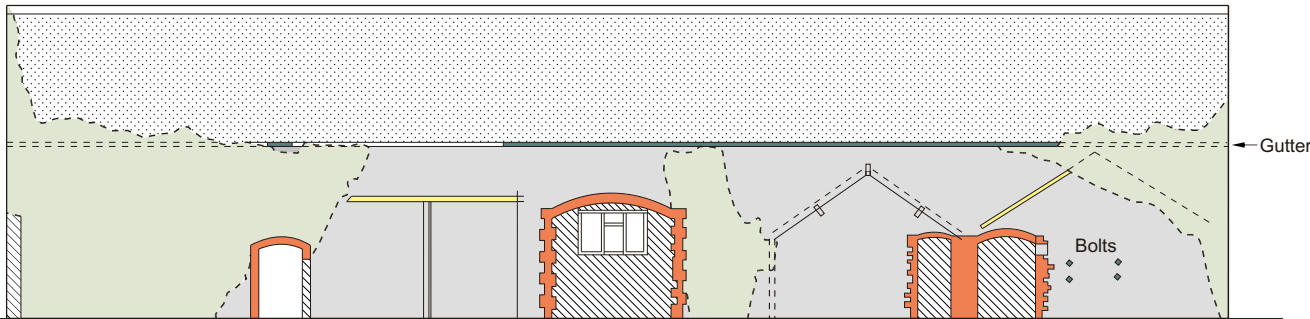
a) Building GR1, plan

d) Northwest elevation

b) Southwest elevation

e) Detail of window 3, northwest elevation

c) Northeast elevation

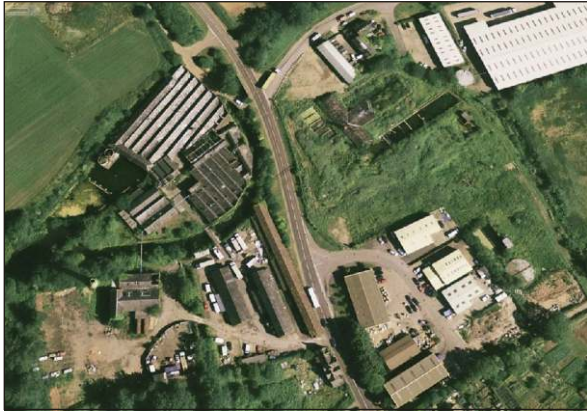
Plate 1: Vertical aerial view of the Grease Works in 2006 showing its context. The large Tone Works is to the west. (Google Earth, 2006)

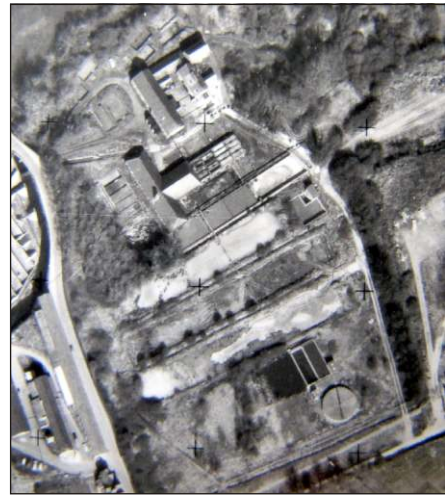
Plate 2: The Grease Works from the air, 29 March 1973. The site is at its full development. (NMR Ordnance Survey 73039 Library 10457.006)

Period 6: 1965-73 (Plate 2)

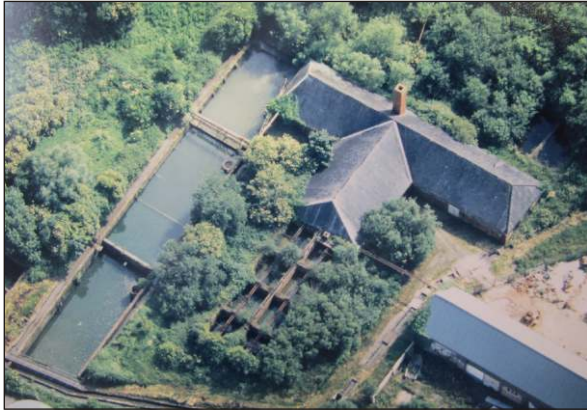
Plate 3: The older part of the site, oblique aerial view from the north, 29 June 1993, showing the Main Settling Tank T1, Building L1 and chimney, Building GR1 (bottom right), Pump house PH1 (bottom left) and Channel C1 with 'bridges'. Overhead pipes are seen associated with Building L1 (NMR ST1221.19. NMR 4893.31)

- 2.10 The flow sequence through the buildings, pits and settling tanks is not fully understood, but it is clear that underground and overhead pipes (the latter no longer extant, but seen in aerial photographs, e.g. Plate 3) conveyed effluent through the separation and settling processes.

Period 7: 1973-93 (Fig. 8 and Plate 3)

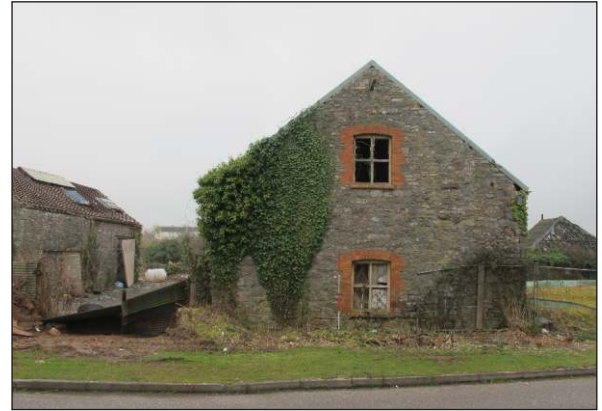
Plate 4: Building GR1, northwest gable wall with yard and Building GR2 on left, from northwest. (2m scale)

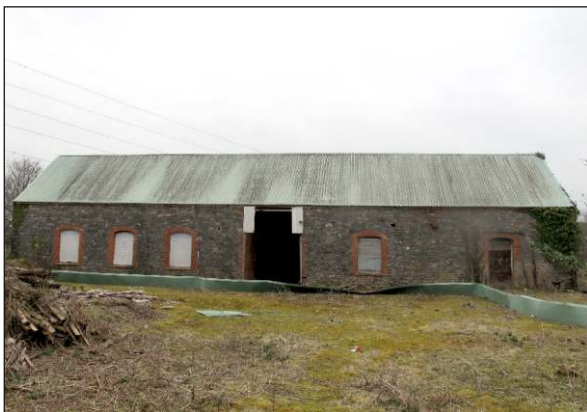
Plate 5: Building GR1, complete southwest elevation, from southwest. (2m scale)

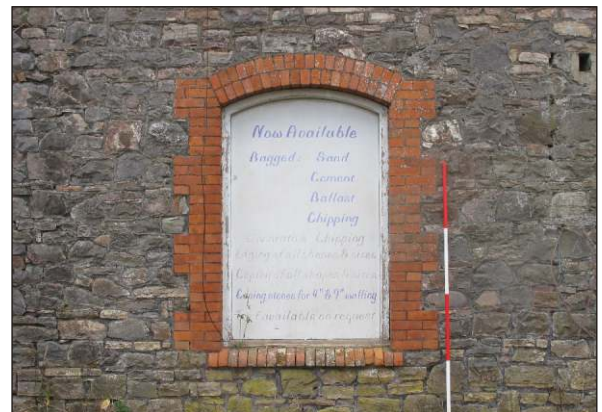
Plate 6: Building GR1, southwest elevation, detail showing the quality of brickwork around the third window, from southwest. (2m scale)

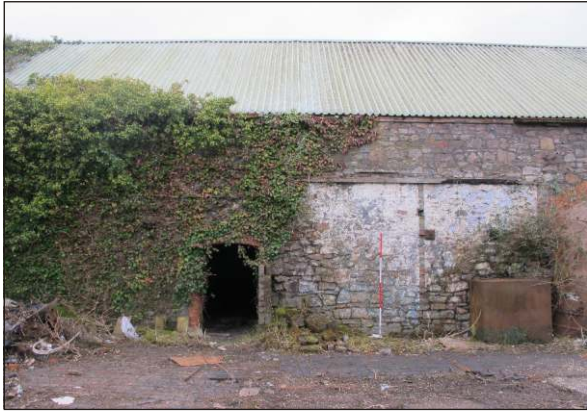
Plate 7: Building GR1, northeast wall, with door from Room A, trace of attached buildings GR8 and GR9 and brick floor in yard, from northeast. (2m scale)

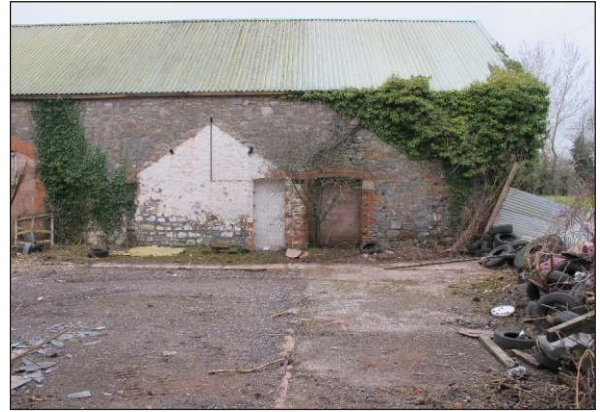
Plate 8: Building GR1, northeast wall, with blocked doors and trace of attached buildings GR7 (left) and GR4, including foundation line, from northeast

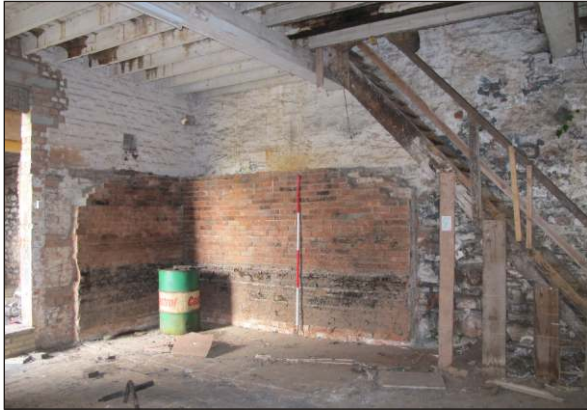
Plate 9: Building GR1 interior of Room A, with remains of tank 1 and stairs, from south. (2m scale)

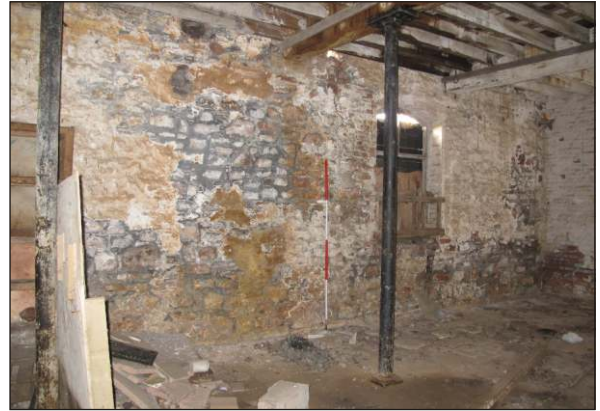
Plate 10: Building GR1 interior of Room A, southwest wall, window and two iron pillars supporting floor timbers, from east. (2m scale)

- 6.16** The timber beams and joists are less well preserved in this room, and on the southwest side two slender cast-iron round pillars support beams which must have become weakened at some stage. Close to the northeast doorway a timber staircase against the wall rises to the first floor over the site of Tank 1. Broken timber steps and floor joists were deemed unsafe and prevented access to the surviving part of the upper floor.

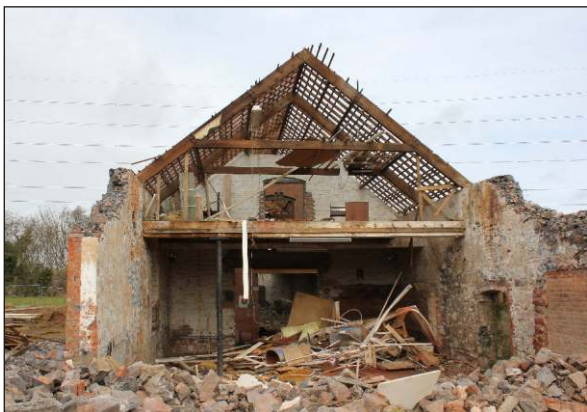
Plate 11: Building GR1 partly demolished section showing Room A with roof timbers and iron pillar supporting upper floor, from southeast

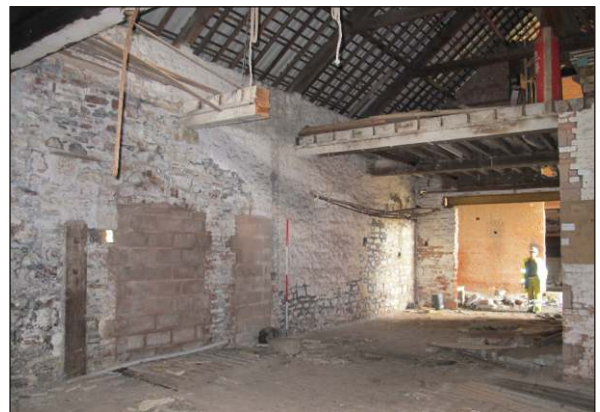
Plate 12: Building GR1 interior of Room B showing northeast wall, blocked doorways, sawn off upper floor timber, and opening to passage, from west. (2m scale)

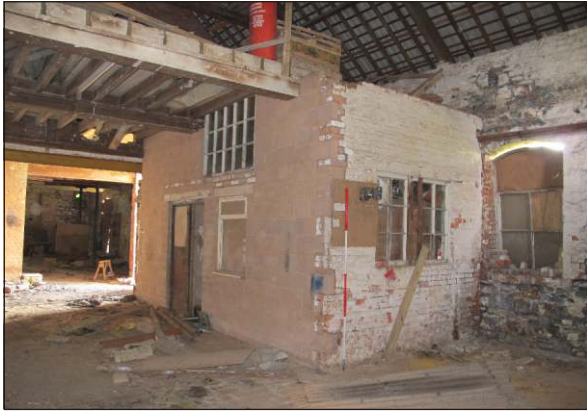
Plate 13: Building GR1 interior of Room B showing early wall and newer concrete block 'Office' wall, from north. (2m scale)

- 6.20** An office or store was formed in Period 8 within Room B in the space bounded by the external stone wall and the brick walls of the passage and the internal division, by closing the gap with a concrete block wall into which were inserted a doorway and two windows of different styles. This room, filled with hazardous debris, was not entered.

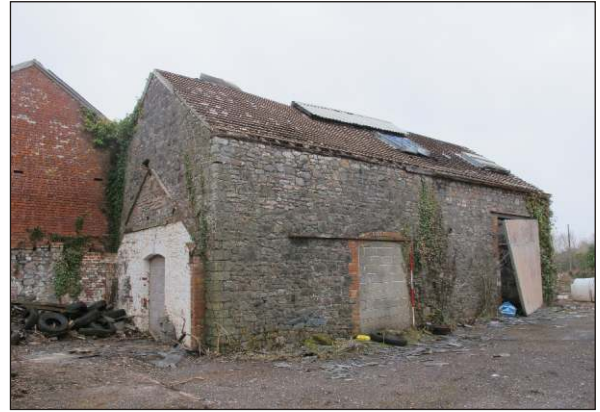
Plate 14: Building GR2 exterior, northeast and southwest elevations. Building GR3 and trace of GR4 on left, from west. (2m scale)

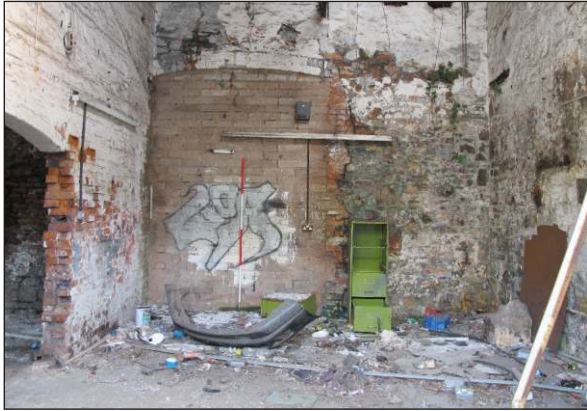
Plate 15: Building GR2 interior of Room A showing blocked arch in northeast wall, from southwest. (2m scale)

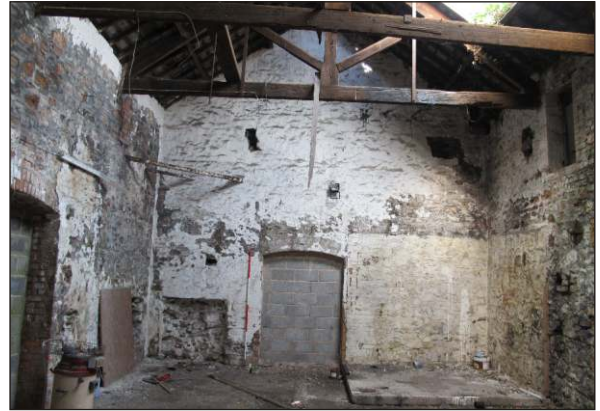
Plate 16: Building GR2 interior of Room B, showing blocked doorway in northwest wall, iron corner bars and roof timbers, from southeast. (2m scale)

- 6.34** There is no evidence for an upper floor, so both rooms are open to the roof. The three roof trusses in Room B are of king post construction, but the timbers are in a poor condition. A timber frame for the central ridge vent survives, and light to the room is provided by two large skylights in the north east roof pitch and two smaller skylights (covered with sheeting) in the south west pitch.

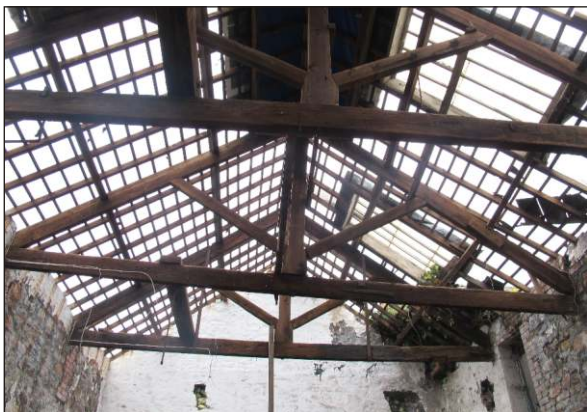
Plate 17: Building GR2 interior of Room B, showing roof timbers with slates removed, from southeast

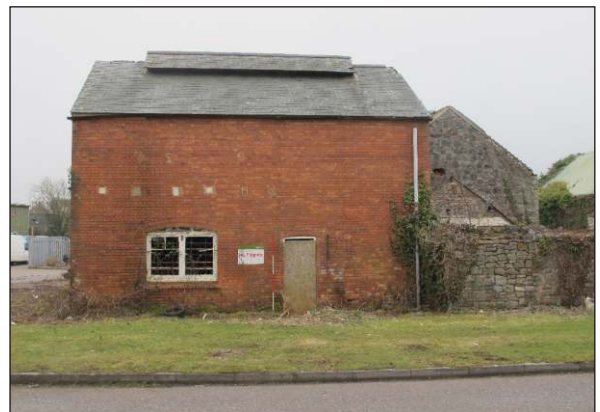
Plate 18: Building GR3 exterior, northwest elevation with GR4 on right, from northwest. (2m scale)

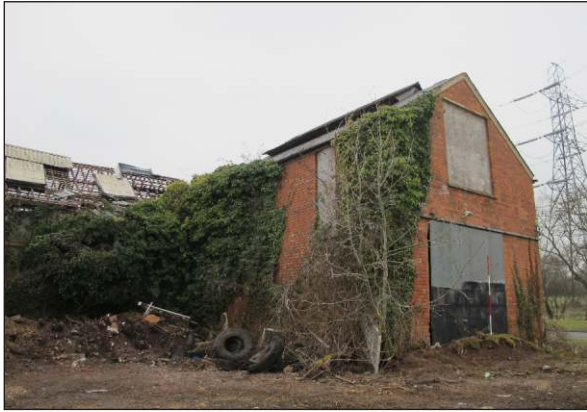
Plate 19: Building GR3 exterior, southeast and northeast elevations, from east. (2m scale)

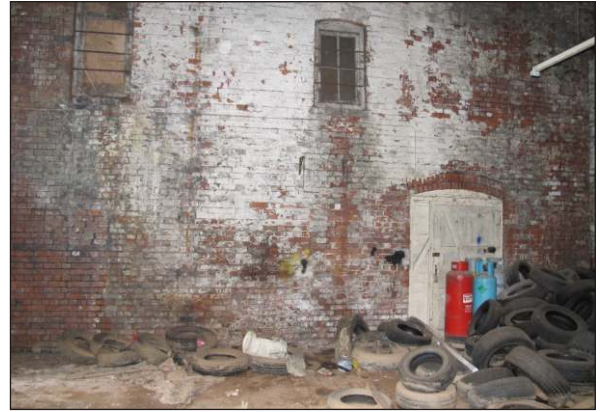
Plate 20: Building GR3 interior showing southeast wall with door and two upper windows, from northwest

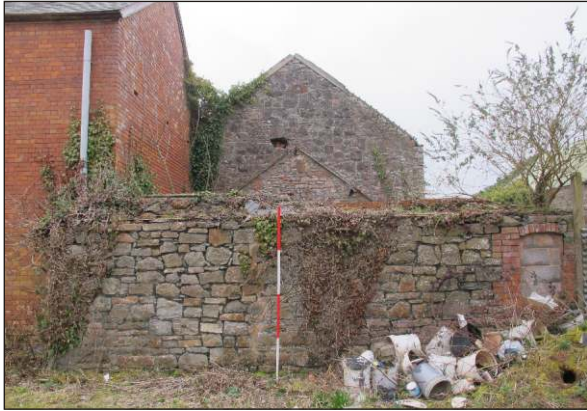
Plate 21: Building GR4 exterior of northwest stone wall with small window. Gable roof outline seen behind on end wall of GR2, from northwest. (2m scale)

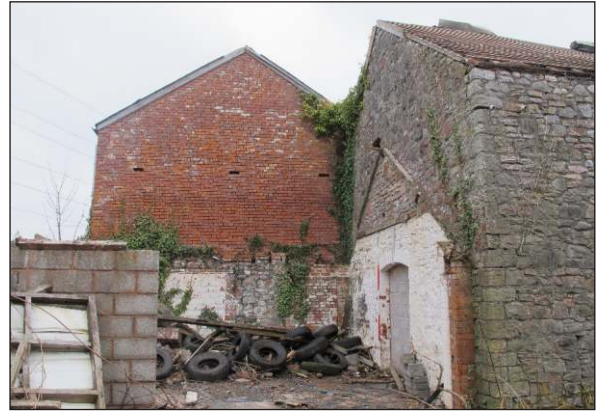
Plate 22: Building GR4, cleared interior, showing relationship with buildings GR2 (right) and GR3 behind, from southwest. (2m scale)

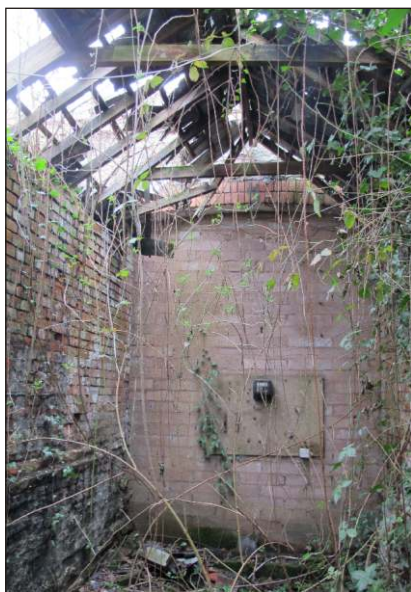
Plate 23: Building GR5, interior showing roof and blocked arch into GR2, from northeast

- 6.43** This is a Period 2 boiler house, built against an arched opening into Building GR2. It is a narrow building with brick walls (laid in English bond) and internal dimensions of 6.07m by 2.4m, at the thicker base. A small door 1.03m wide in the northeast gable end gave access into a confined space beneath a damaged slate roof. Shaped firebrick boiler supports partly exposed in the floor and red burnt soil are evidence that this held a boiler. It appears to have been disused for a long time. There is an iron frame for a draught regulating plate at the north end of the northwest wall and, outside, the corner of this wall has been repaired. There is no evidence for pipework or any trace of the freestanding chimney, which had been demolished by Period 7. When Building GR5 was demolished many of the bricks were observed to have soot-stained mortar.

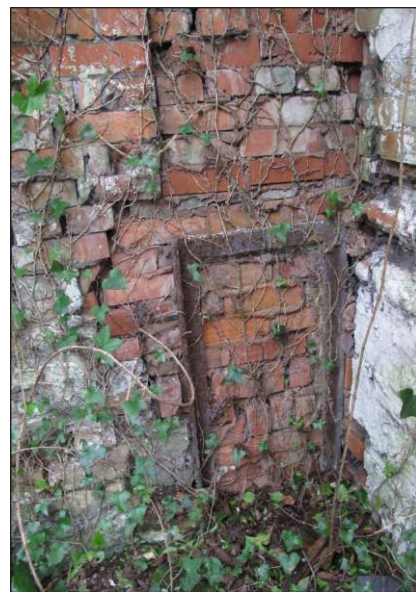
Plate 24: Building GR5, iron frame for draught regulating plate in northwest wall, from south-southeast

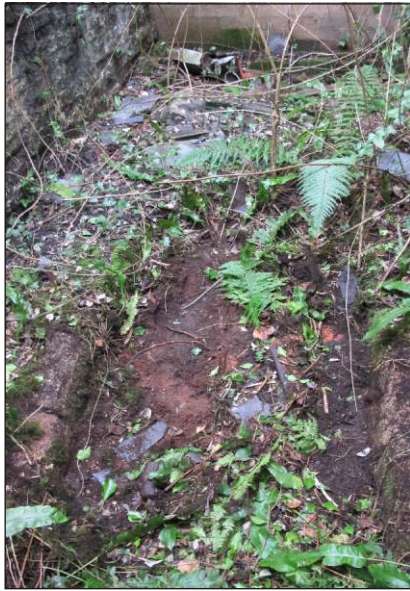
Plate 25: Building GR5, interior, shaped firebrick boiler supports c.97cm apart exposed in floor with burnt soil, from northeast

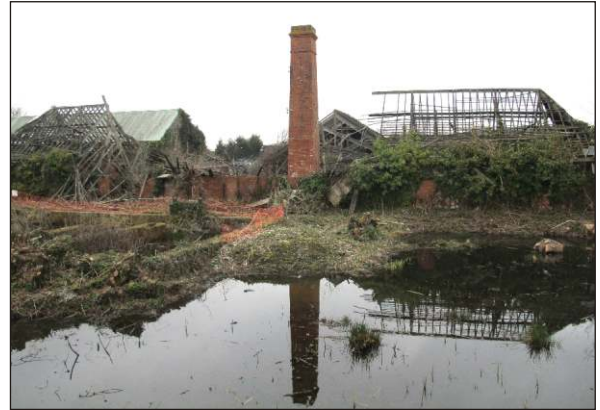
Plate 26: Building L1, complete southwest elevation and chimney, with northwest (left) and southeast (right) wings, from southwest

- 6.57** A Period 2 square brick chimney is positioned just off-centre in the main range of Building L1, just inside the southwest wall. The undated insurance plan is the only map to show the chimney although it is not named. The chimney stack is of plain orange-red bricks, well built and in good condition. It has a height of *circa* 10.4m, the plinth base is 1.64m wide and the chimney tapers gently to a 1.16m width at the top above a simple swell of four brick courses. Flashing from the old roof line adheres to the stack and there are two pairs of electrical or telephone insulators on the west corner. The brickwork is in stretcher bond, but the plinth base is English bond with its top finished with shaped plinth bricks. The function of the chimney is unclear, since there is no indication of a flue or furnace around the base.

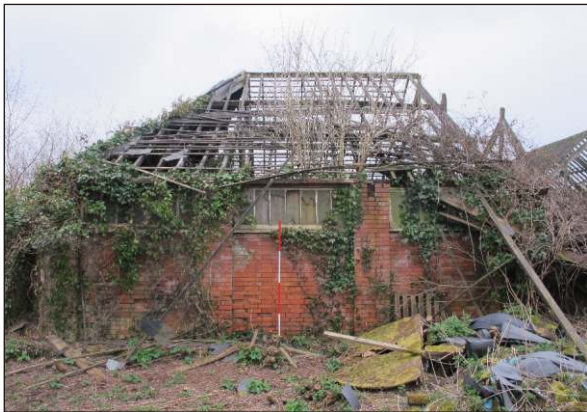
Plate 27: Building L1, northeast wing exterior with raking stretcher bond brickwork and windows, from northwest. (2m scale)

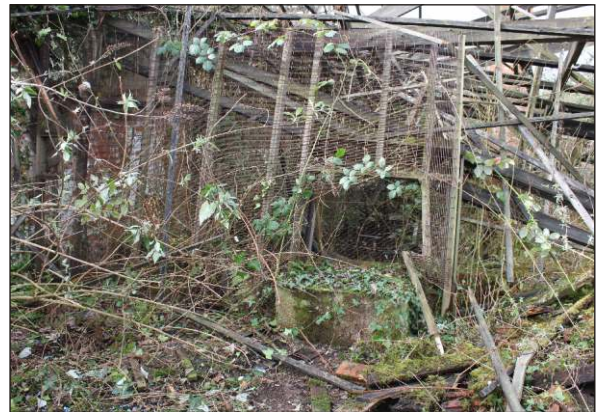
Plate 28: Building L1, interior of northeast wing with concrete base, collapsed metal screens and tank beyond, from east

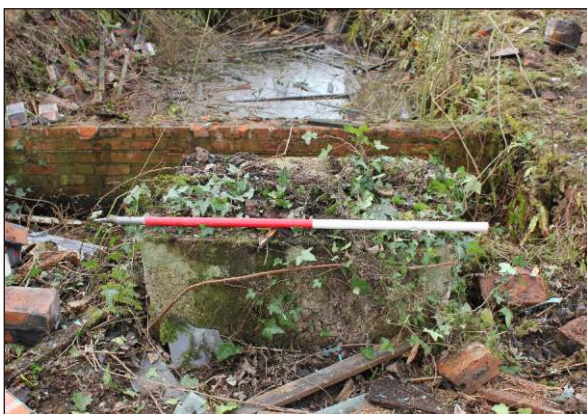
Plate 29: Building L1, interior of northeast wing after clearance, showing concrete base and tank, from northeast. (1m scale)

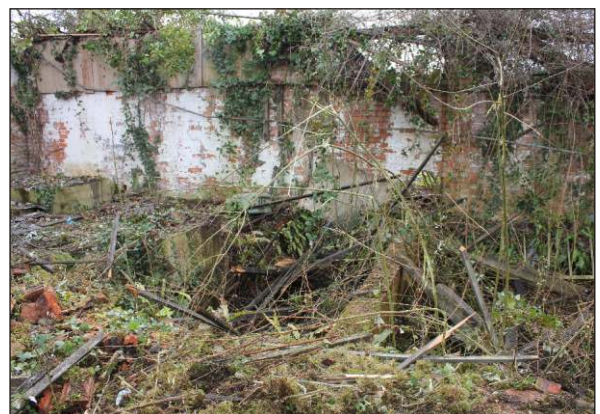
Plate 30: Building L1, interior of northeast wing after clearance, showing nature of tank and concrete bases, from northwest

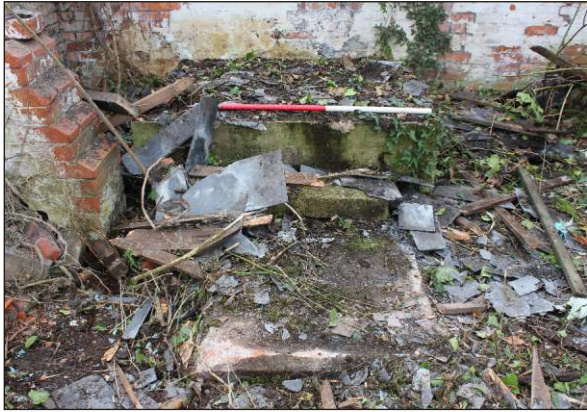
Plate 31: Building L1, interior of northeast wing, concrete machine base, from north. (1m scale)

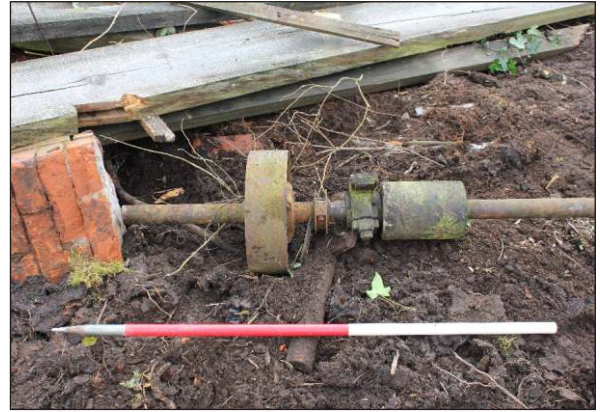
Plate 32: Building L1, detail of line shaft removed from northeast wing. (1m scale)

6.54 Before demolition, a light girder crane was observed high up in the surviving hipped roof of the north east wing, while the collapsed area includes a roof truss with a line shaft attached. This 8m length of line shaft has three bearings, a pulley for a belt drive over the sunken tank and two more of different sizes at the other end. The line shaft is incomplete and in any case may have collapsed with the roof trusses away from the first concrete plinth upon which a motor must have had a belt drive. The roof trusses in this wing are king posts with struts. They have iron brackets for interleaving purlins, differing from elsewhere in the building which may indicate a replacement. Some trusses at the corner of the building have white ceramic transmission insulators.

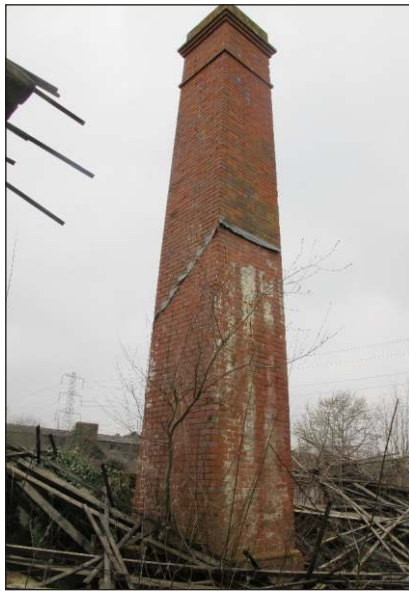
Plate 33: Chimney stack L2, from east

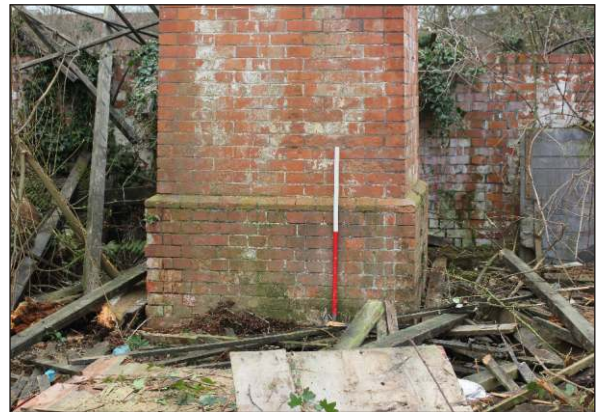
Plate 34: Chimney stack L2 base, from northeast (1m scale)

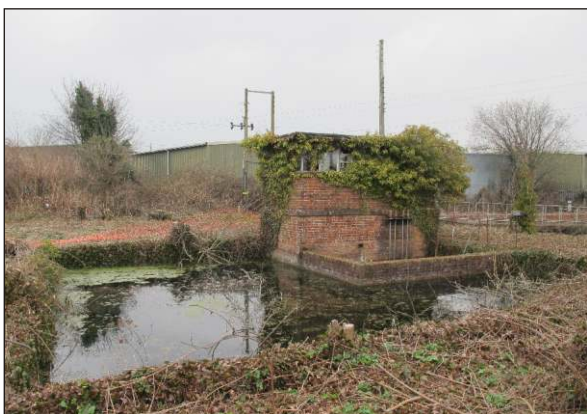
Plate 35: Main pump house PH1 showing southwest and southeast elevations and tanks (T3), from south (2m scale)

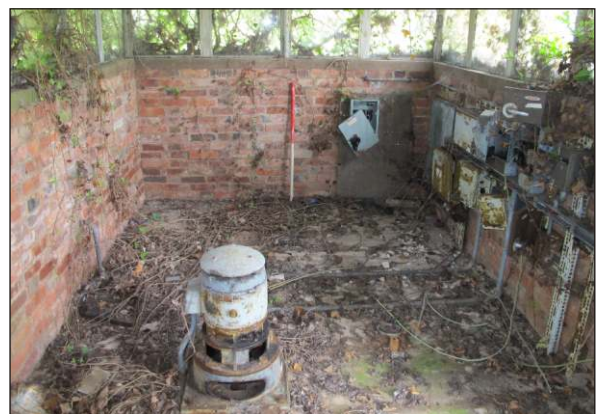
Plate 36: Pump house PH1 interior with Wm E. Farrer pump, from southeast. (1m scale)

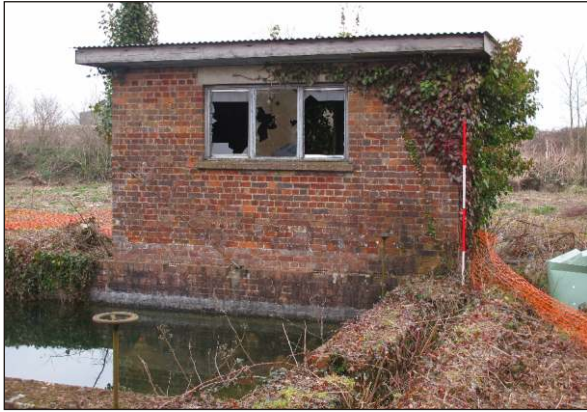
Plate 37: South pump house PH2 exterior, southwest elevation, from south-southwest. (2m scale)

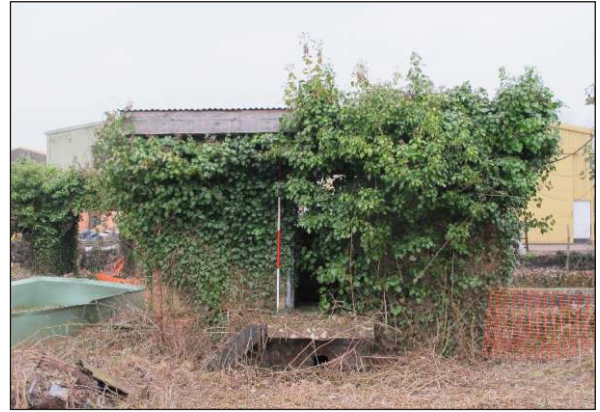
Plate 38: South pump house PH2 exterior, northeast elevation with overgrown door and steps, from northeast. (2m scale)

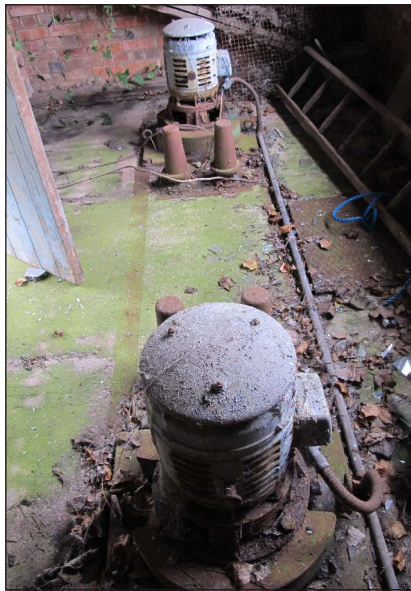
Plate 39: South pump house PH2 interior with two pumps, from northwest

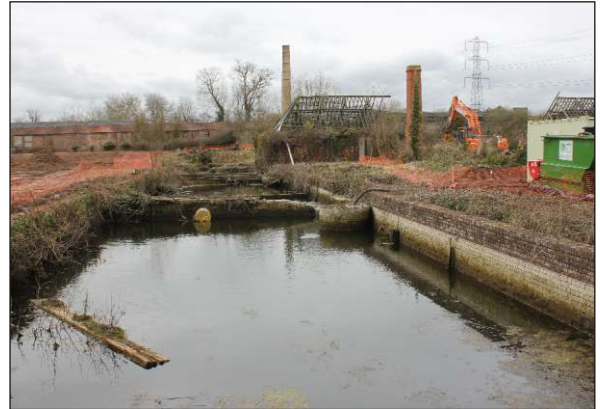
Plate 40: Main settling tank T1, general view with water partly drained, from northeast

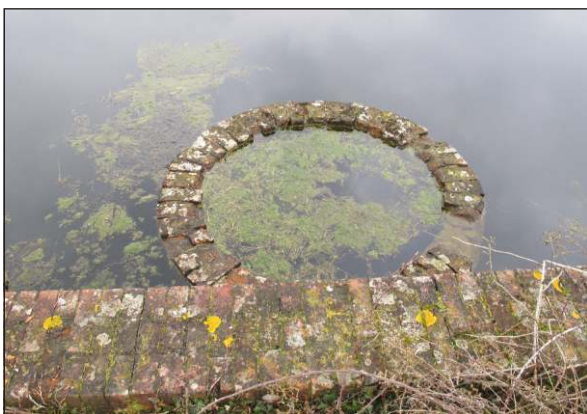
Plate 41: Main settling tank T1, circular brick overflow with water level high; northwest wall in foreground, from northwest

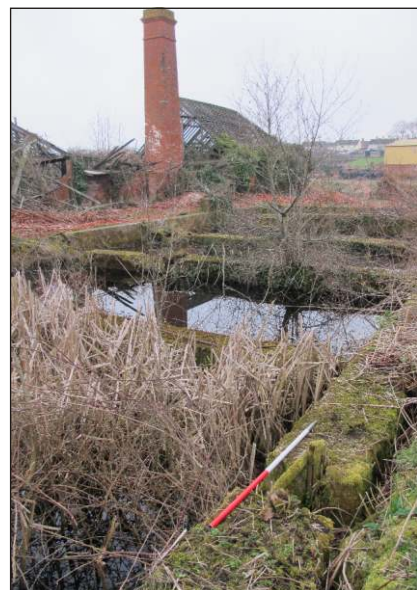
Plate 42: Five linked concrete tanks (T2) close to Building L1, with remains of wooden sluice from a channel in the foreground, from west-northwest. (1m scale)

- 6.66** These are Period 3 structures. The north end of Filter Bed B3 (Period 2) located southwest of Building L1 was altered to incorporate a concrete tank, *circa* 23m by 10m, subdivided into five smaller tanks which are inter-connected. A narrow channel along the south west side has at least one sluice or hatch into a tank, with some timberwork surviving in a fragile condition. The northern tank was recorded to be at least 1.5m deep. All the tanks were water-filled, but had been emptied at the time of a later observation.

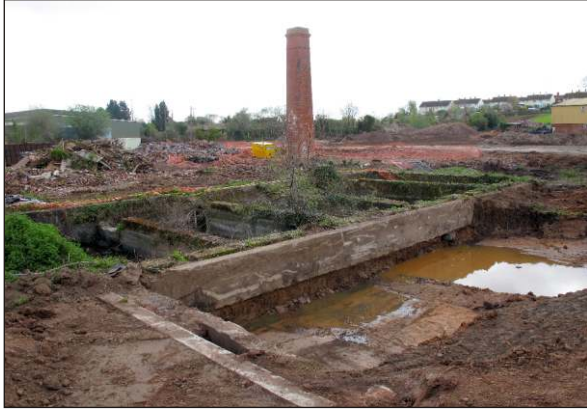
Plate 43: Five linked concrete tanks (T2), with filter bed B3 drained and cleared down to clay in foreground, from west

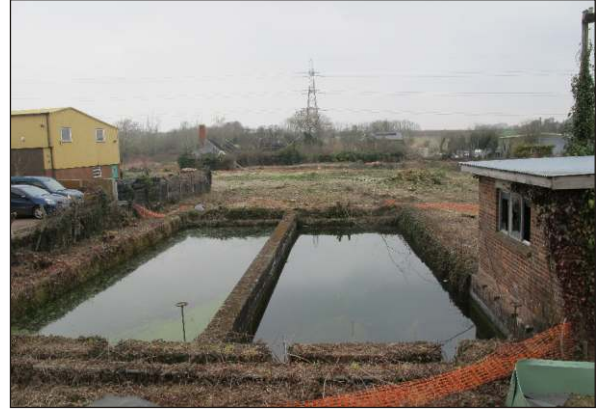
Plate 44: Twin tanks T4, channels and south pump house PH2, giving a good view over the site, from southeast

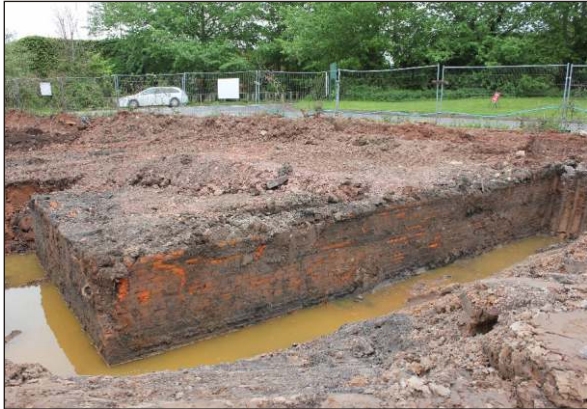
Plate 45: Magma Pit T5 as exposed, from east

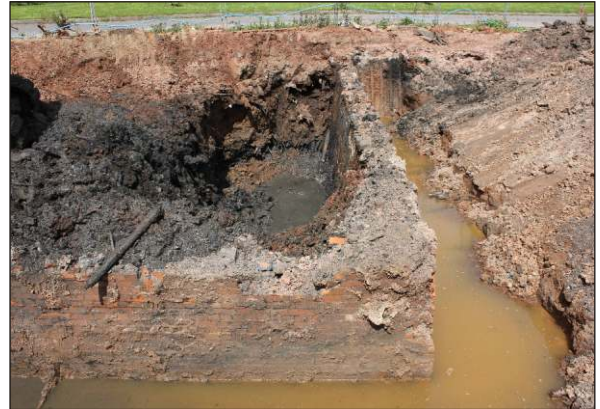
Plate 46: Excavation of Magma Pit T5, from southeast

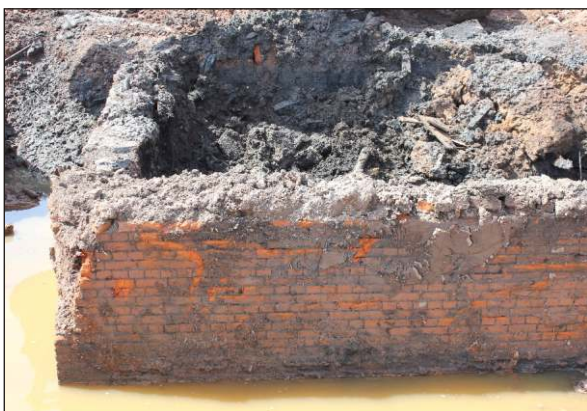
Plate 47: Excavation of Magma Pit T5 showing southwest wall, from northeast

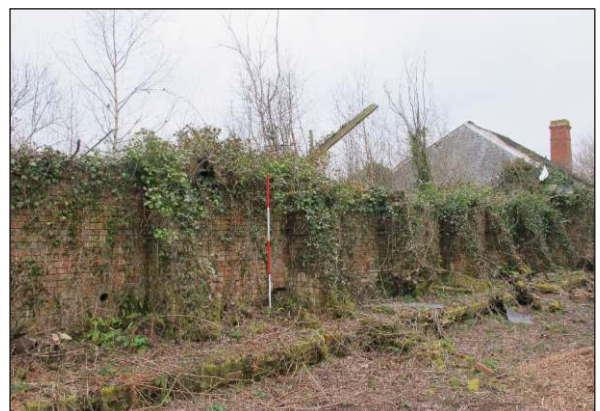
Plate 48: Buttressed Filter Tank (BFT) exterior of northwest brick wall, with filter bed B1 in foreground, from north. (2m scale)

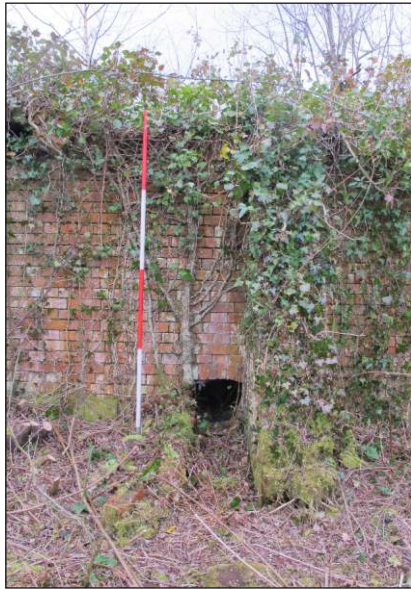
Plate 49: Buttressed Filter Tank (BFT) exterior of northwest wall and sluice outlet from chamber 3, from northwest. (2m scale)

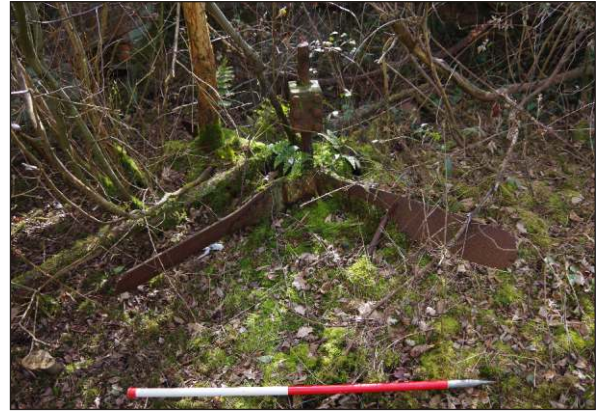
Plate 50: Buttressed Filter Tank (BFT). Iron 'paddles' inside chamber 3, from northeast. (1m scale)

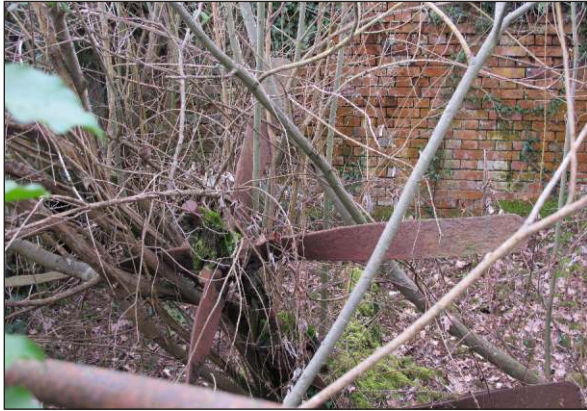
Plate 51: Buttressed Filter Tank (BFT). Twin iron 'paddles' inside chamber 5, from northeast

- 6.73 The interior is very overgrown with small trees but there is evidence of at least one footbridge with side rails across the chambers. The interior is subdivided by robust brick walls into eight chambers, measuring *circa* 5.8m by 4.4m, numbered on the plan 1-8 clockwise from the west corner (Fig. 10). Chamber 3, examined after the demolition of the exterior wall, has a central iron paddle near the floor with four blades each *circa* 1m long. The upright shaft has a rectangular block with six bolts and a short section of shaft above has been cut off when a higher paddle was removed in the past. Chamber 8, seen from above, has two sets of paddles (four blades each) with one bolted above the other on a single upright shaft. An oblique aerial photograph of June 1993 (Plate 3) shows walkways and drive shafts over the top of the chambers within which some paddles are visible. The drive mechanism is uncertain but there is a platform and box over chamber 1 outside the north east wing of Building L1 where concrete bases are likely to have supported the power source. The paddles agitated and aerated the contents of the chambers, perhaps while chemicals were added. Two large timbers fallen into in chamber 3 are the remains of supports for the walkways and drive shafts.

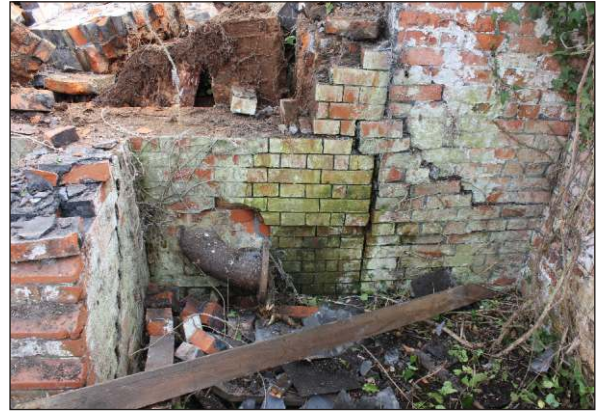
Plate 52: Buttressed Filter Tank (BFT) exterior of southwest wall, with iron pipe from chamber 8 into northeast wing of Building L1, from west

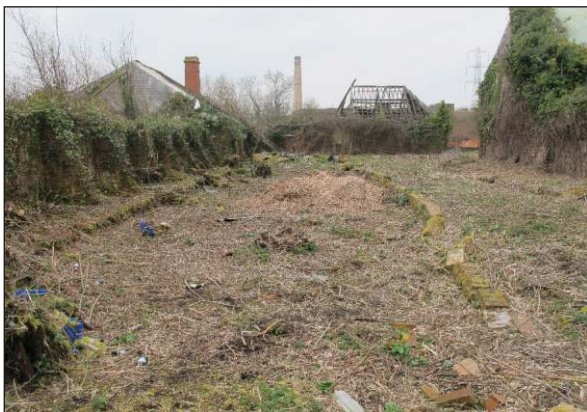
Plate 53: Filter bed B1 with low brick walls, from northeast. Buttressed filter tank BFT on left

Filter Bed B1 (ST 12697 21895) Fig. 9; Plate 53

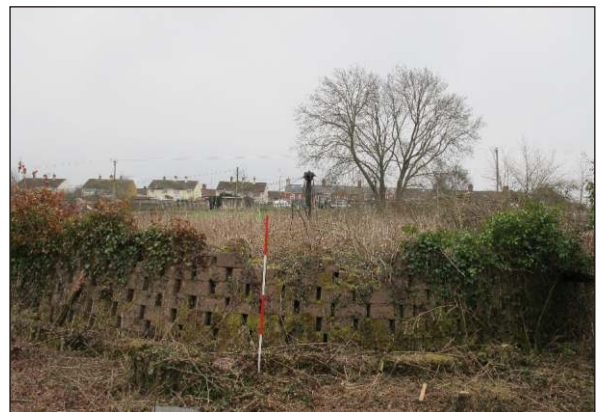
Plate 54: Round filter bed RF1 wall with voids and collecting channel in front, from northwest. (2m scale)

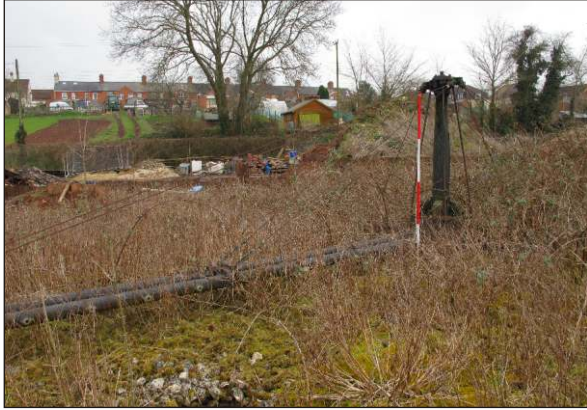
Plate 55: Round filter bed top, with clinker and double filter arm, from north. (2m scale)

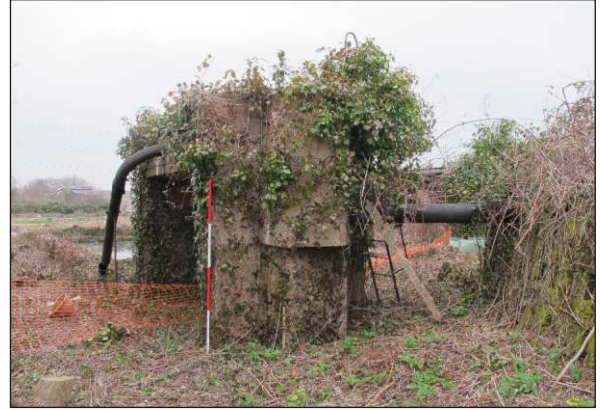
Plate 56: Concrete flow control feature RF2 associated with round filter bed, from south. (2m scale)

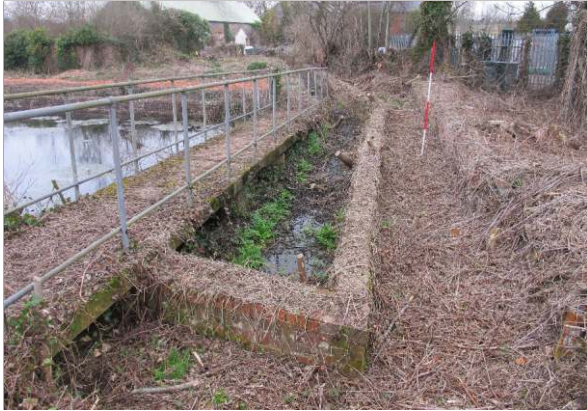
Plate 57: Channels C1b (with scale), C2 with footbridge F10, angled corner to channel C3 in foreground, from southeast. (2m scale)

Concrete Footbridge F10 (ST 12745 21890) Fig. 9; Plates 57 and 64

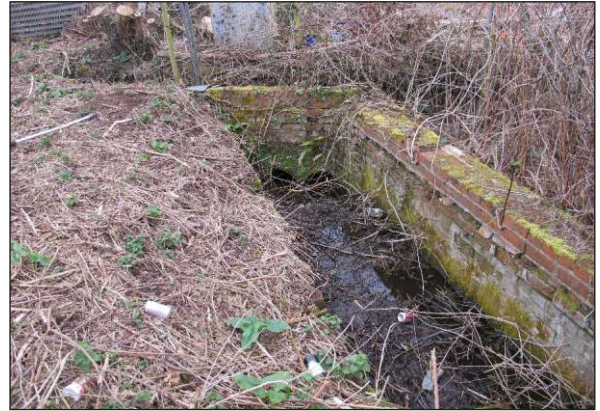
Plate 58: Channel C2 culvert pipes beneath overgrown corner of C1a and C1, from southeast

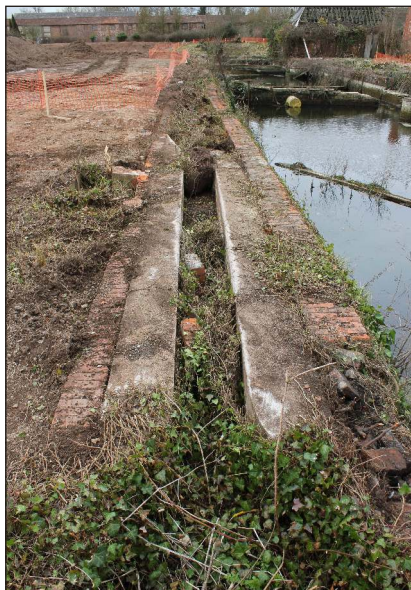
Plate 59: Channel C3 exposed on southeast side of main settling tank T1, from northeast. The associated chart flow recorder box F1 has been removed

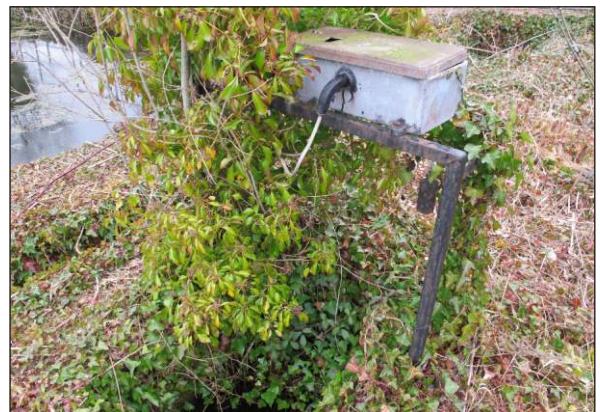
Plate 60: Chart flow recorder box F1 related to channel C3 on southeast side of settling tank T1, from south-southwest

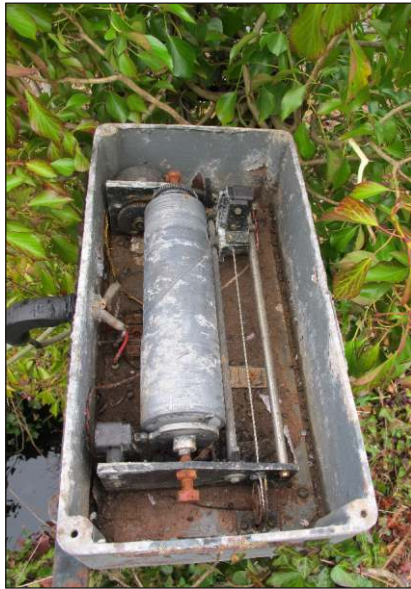
Plate 61: Chart flow recorder box F1 interior, with chart drum and pen assembly, from southeast

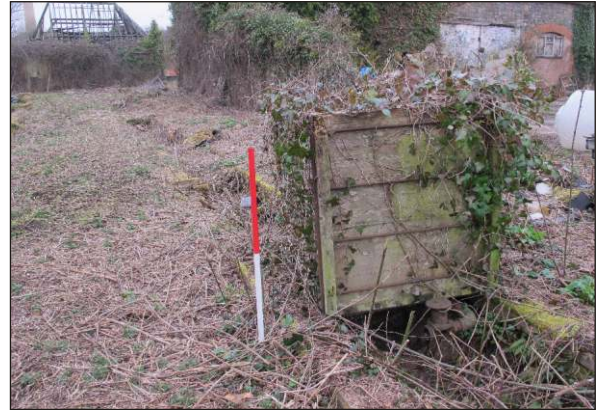
Plate 62: Wooden tank F4 over main channel C1a, from east. (1m scale)

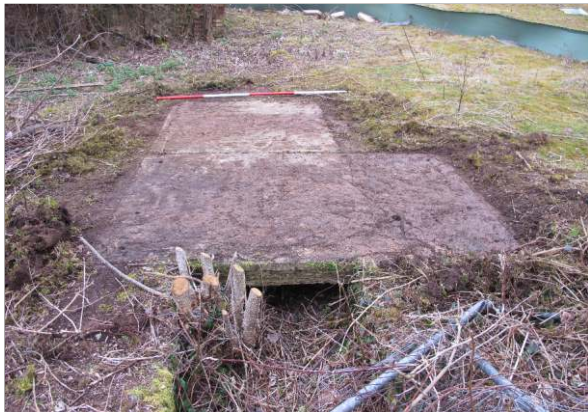
Plate 63: Stone slab bridge F6 over channel C1a between buildings GR1 and L1, from east. Drilled holes are seen in the main slab. (2m scale)

- 6.94 Period 3, modifications to Channel 1a include at least four slab bridges or covers. The main bridge (F6) is between Buildings GR1 and L1 and formed by two slabs. On close examination, the largest slab is made of a fine white sandstone and measures 2.35m by 1.52m with a thickness of 135mm (7ft 9ins x 5ft x 5.25ins). There are holes of 30mm diameter along the north side (four) and south side (three), while a single hole of 55mm diameter is further into the slab where it has cracked across.

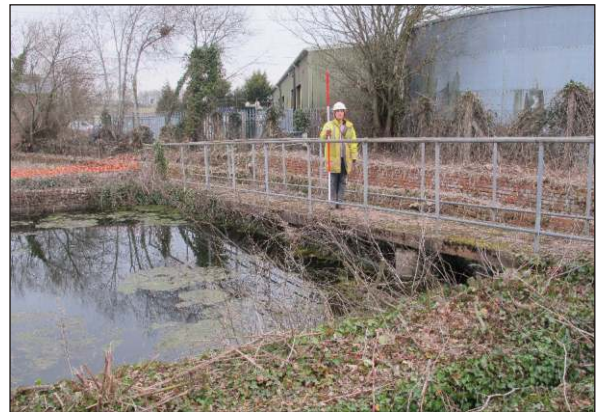
Plate 64: Concrete footbridge F10 at northeast end of main settling tank T1, with channel C3 in foreground and channels C1b and C2 behind, from south. (2m scale)

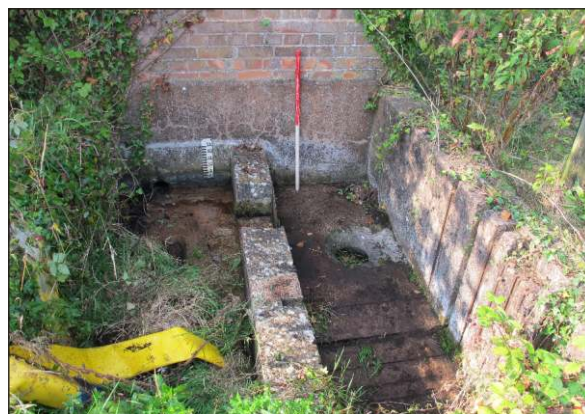
Plate 65: Small gauge tank F11, outside main pump house PH1 partly cleared, from northeast. (1m scale)
