# LAND AT BOVISAND LANE, DOWN THOMAS, DEVON

Results of historic building recording

South Hams District Council Planning Reference:  
58/0791/15/O, condition 7

Document No: ACD1513/2/0

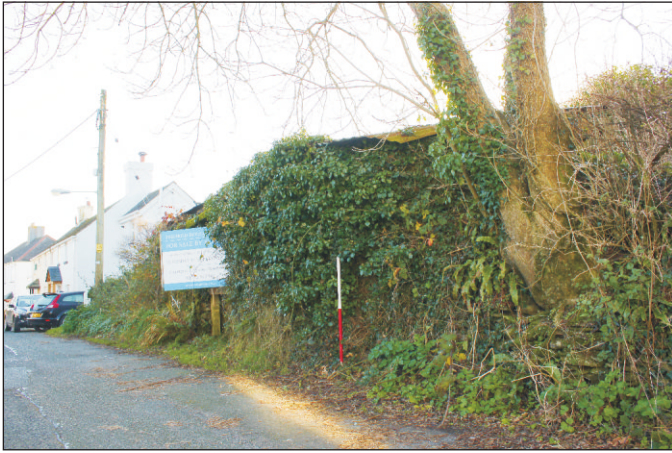
Plate 1: The barn looking southeast along Bovisand Lane. (1m scale)

- 5.1 The barn is a single-story structure that is terraced into the hillside; the ground within the plot is higher to the southwest, and the barn has been constructed to provide level access from Bovisand Lane, which it fronts (Plates 1-3). Bedrock is exposed under the southwest and northwest walls, rising above the floor level. It is constructed of local rubble siltstone along with slates, bonded with earth containing rare gravel and lime inclusions (Plates 4-5). Slate is also used as small packing between larger blocks of siltstone. Internally, the walls were finished with a thin coat of lime render, painted white, but this has largely come away leaving the masonry exposed. The upper 0.80m of the southeast wall is red cob and smaller patches of cob survive at the top of the northwest wall. The building appears to have originally been slightly higher, and the gable walls have been lowered to create the current slightly pitched roof. The barn measures 7.3m long by up to 3.4m wide internally by up to 3m high; the northeast corner is curved.

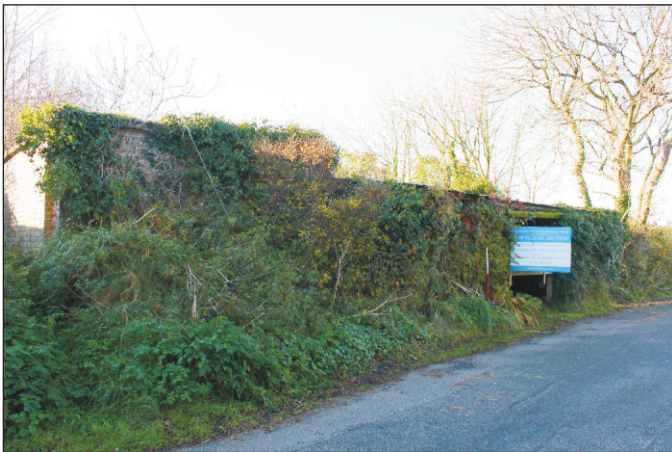
Plate 2: The barn and air raid shelter (foreground) looking west along Bovisand Lane. (1m scale)

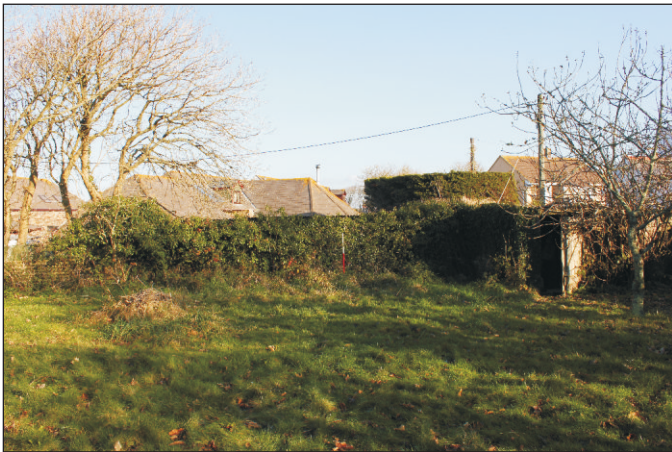
Plate 3: The rear of the barn and air raid shelter looking northeast showing the higher ground level within the plot. (1m scale)

- 5.7** The shelter is located to the southeast of the barn, constructed at the higher level of the plot rather than the lower road level (Plates 1, 3 and 10). It is accessed from a short, unmade path leading up from the road. The shelter is constructed of red brick laid in English bond using cement, and the masonry has been reinforced using thin steel bars (Plate 11). Internally it measures 7.6m square by 2.10m high. The walls are laid onto a 0.18m thick concrete foundation raft that is slightly terraced into the hillside. It is covered with a 0.13m thick flat reinforced concrete roof. Scars of corrugated iron sheeting used as shuttering during its construction are visible internally (see Plates 13-16). To the northeast of the structure is a blast wall, also constructed onto the foundation slab. It is linked to the shelter by the roof creating a covered entrance passage (Plate 12).

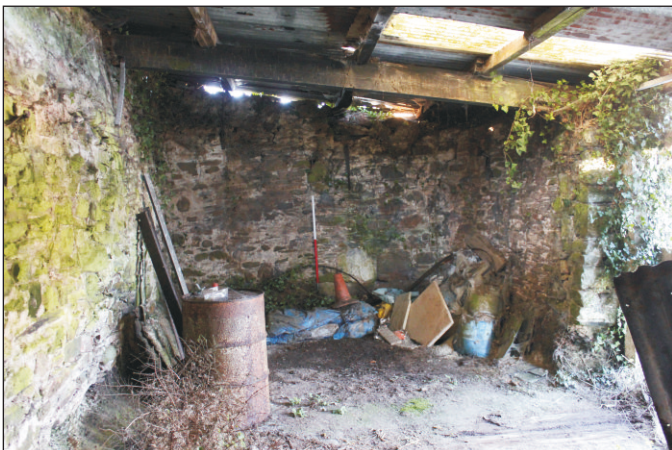
- 5.4** The roof structure is a 20th-century replacement that slopes down to the northeast. It is constructed of corrugated iron sheets laid onto battens that rest on the gable walls and are supported on two beams set into the southwest and northeast walls (Plate 4).

Plate 4: The interior of the barn, looking west-northwest. (1m scale)

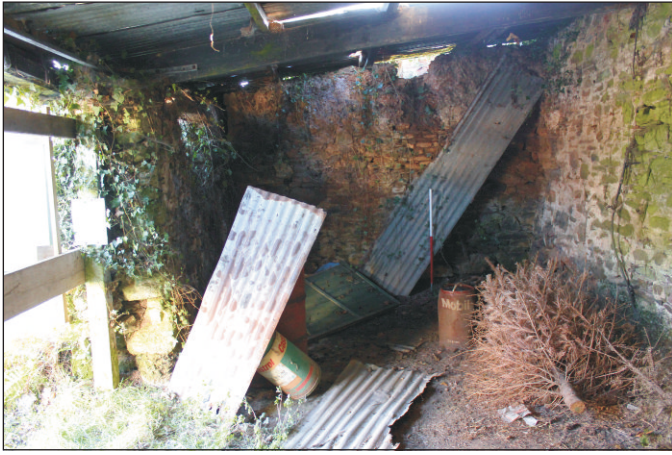
Plate 5: The interior of the barn, looking east-southeast. (1m scale)

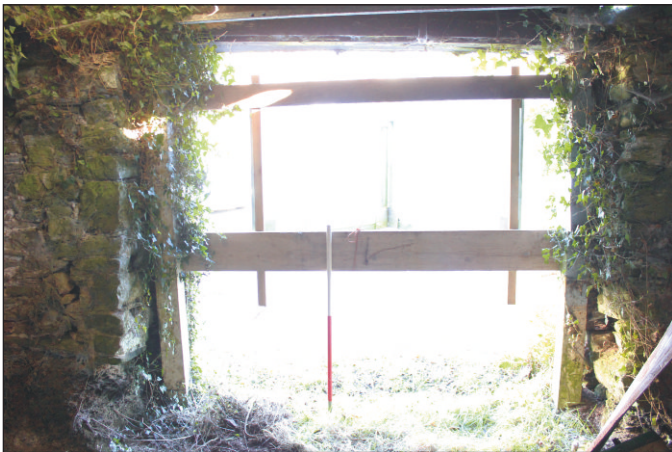
- 5.2 In the northeast elevation there is a wide central doorway, under a pair of wooden lintels (Plate 6). Set towards the outside of the opening is part of an early door frame formed by one of the lintels and an upright post. Inside this frame a 20th-century frame has added to support replacement (and now removed) doors. This retains pintles for hanging the doors. To the southeast of this opening is a small high-level window with an inward sloping cill and a wooden lintel (Plates 7-8). The latter has been reused and contains two pairs of wooden pegs. Any original window frame and glazing does not survive.

Plate 6: The entrance to the barn, looking north-northeast. (1m scale)

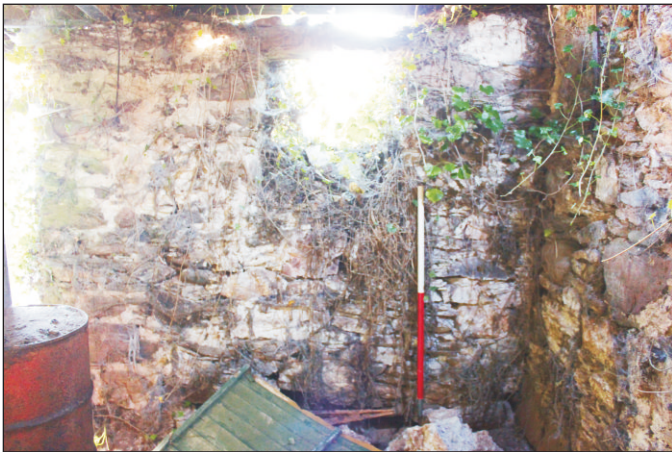
Plate 7: The window in the barn, looking north-northeast. (1m scale)

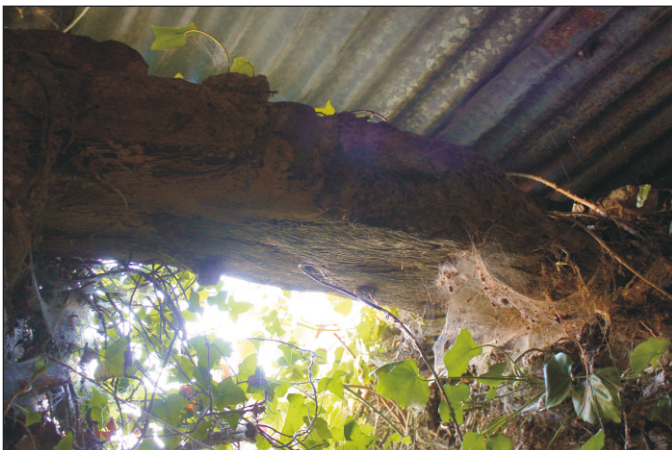
Plate 8: The window lintel showing the pegs, looking northeast

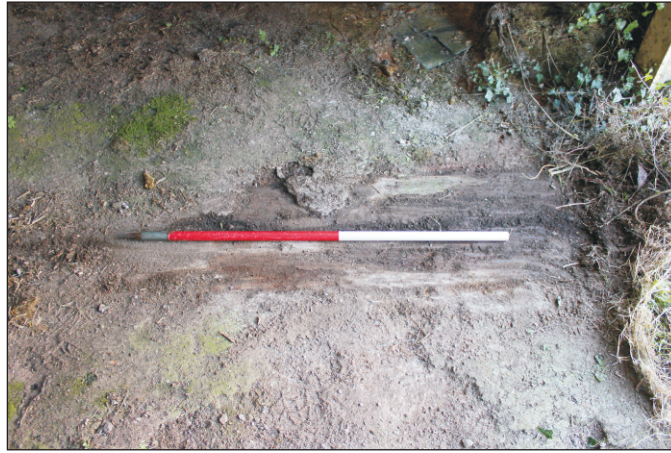
- 5.5** The floor is a thin skim of lime mortar laid over the terraced bedrock. In the centre of the building, in front of the doorway, are two very slightly sunken planks of wood, aligned northeast to southwest; these appear to have acted as a drain (Plate 9). Other than the 20th-century pintles on the door frame there are no internal fixtures and fittings.

Plate 9: The wooden boards in the barn floor, looking west-northwest. (1m scale)

6.2 There are no surviving datable features, but it is likely that the barn dates to the 18th or early 19th century. The building has no architectural features to indicate a specific use. The presence of a probable drain, along with the window, may indicate that it housed animals, although the wide door may hint at another use, perhaps the storage of apples and production of cider (English Heritage 2006, 56); since there is no evidence for a first floor, this may account for the tall height, allowing room for a press at one end of the building. The building remained in agricultural use – at least latterly as storage – until recently; it presumably ceased to have an agricultural role when Paige's Farm was converted into domestic accommodation. During the 20th century new doors and a new roof were added.

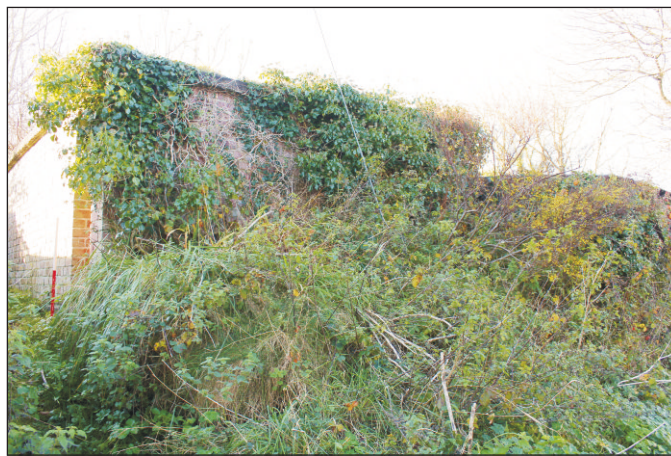
Plate 10: The shelter looking southwest from Bovisand Lane. (1m scale)

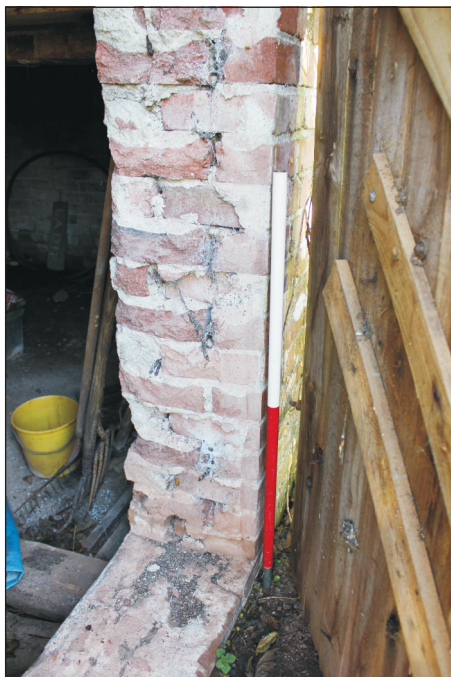
Plate 11: The modern rear opening to shelter showing the reinforced brickwork, looking east-northeast. (1m scale)

- 5.10** Post-war the building has been used as an agricultural store. The internal dividing wall has been partially broken through allowing internal access to the two rooms. A doorway has also been created in the southwest wall enabling the store to be entered directly from the plot. To the southeast of this is a small high-level opening, probably inserted to create a vent. Shelves have been added to the northeast room, and hooks for storage in the southeast room.

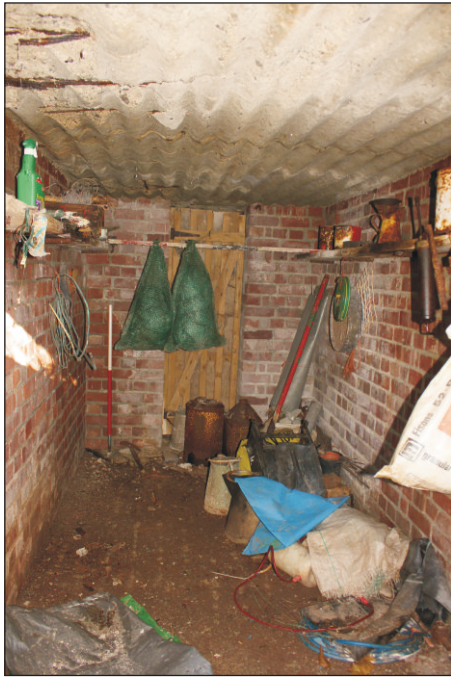
Plate 13: The west room of the shelter, looking north-northeast. (1m scale)

- 5.8** The shelter originally contained two separate rooms, entered from the passage (Plates 13-16). The present doors are of a crude plank and batten design without frames, and are instead fixed using hinges to single posts. These are almost certainly post-war replacements, although there is no evidence for any earlier doors or associated frames.

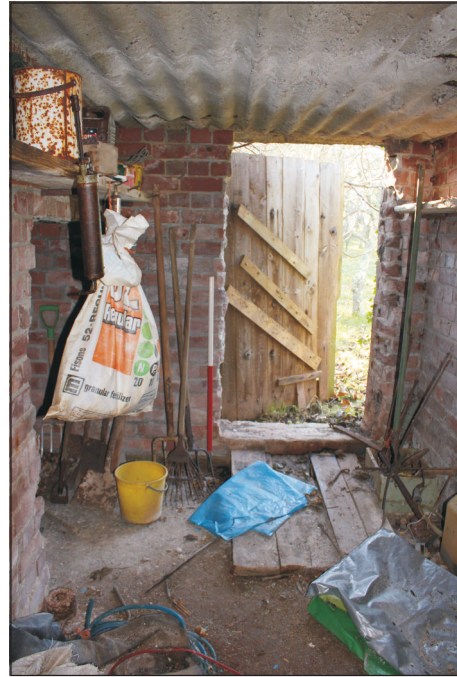
Plate 14: The west room of the shelter, looking south-southwest. (1m scale)

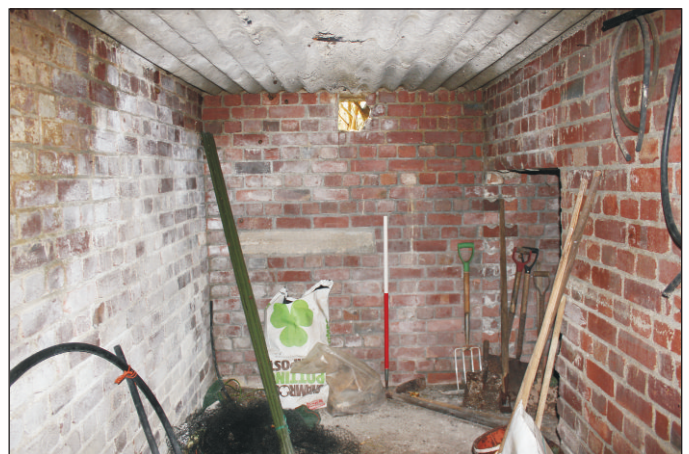
- 5.9** In the southwest wall is a concrete block (Plate 16). Its function is unclear, and there is no evidence (e.g. a blocked opening) that it formed a lintel. Other than this block, internally there are no original fixtures or fittings such as seats or benches.

Plate 16: The west room of the shelter, looking south-southwest. (1m scale)
