DEER BARN, STEVENSTONE, ST GILES IN THE WOOD, DEVON

Results of archaeological monitoring and recording

Report No: ACD1557/2/0

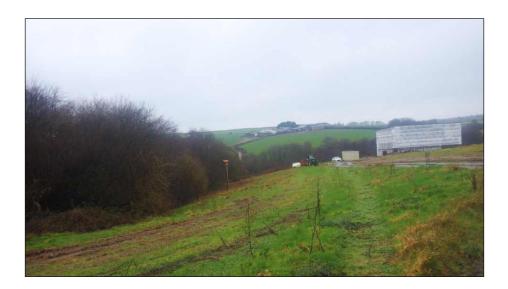
Plate 1: General view of site, looking north

Archaeological monitoring and recording was undertaken by AC archaeology during groundworks associated with the conversion of a Deer Barn, Stevenstone, St Giles in the Wood, Devon (SS 52528 18639). The site is located 800m to the southwest of St Giles in the Wood and 1km southeast of Stevenstone House (Fig. 1). It is positioned within a pasture plot on ground at that slopes gradually down to the west (Plate 1).

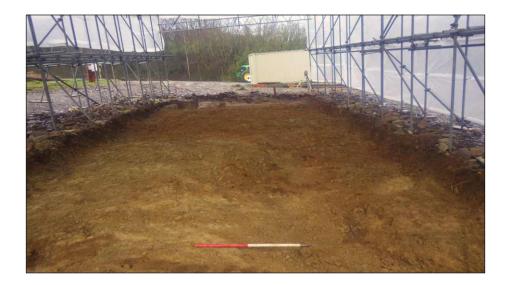
Plate 2: Showing stripped area. View to south (scale 1m)

Monitored groundworks comprised the bulk reduction of the footprint of the barn (Plate 2). This measured 16m long and 8m wide. Natural subsoil, which consisted of a light yellowish red clay with abundant gravel inclusions, was exposed at a depth of approximately 0.2m below existing levels (Plate 3). It was overlain by a light brown silty clay made ground with frequent, poorly sorted sub-angular rubble and gravel inclusions.

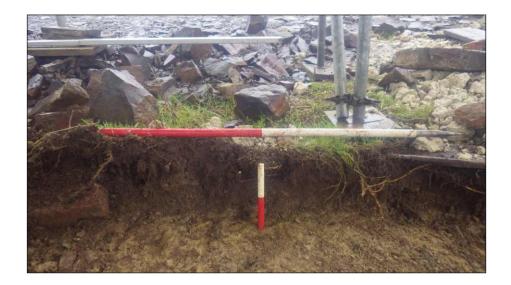
Plate 3: Representative section of stripped area. View to east (scales 1m and 0.2m)
