2 Brook Cottages, Netherton, Devon

Results of Historic Building Recording

Document No: ACD1539/1/0

Teignbridge District Council planning references 16/03001/FUL and 16/03002/LBC

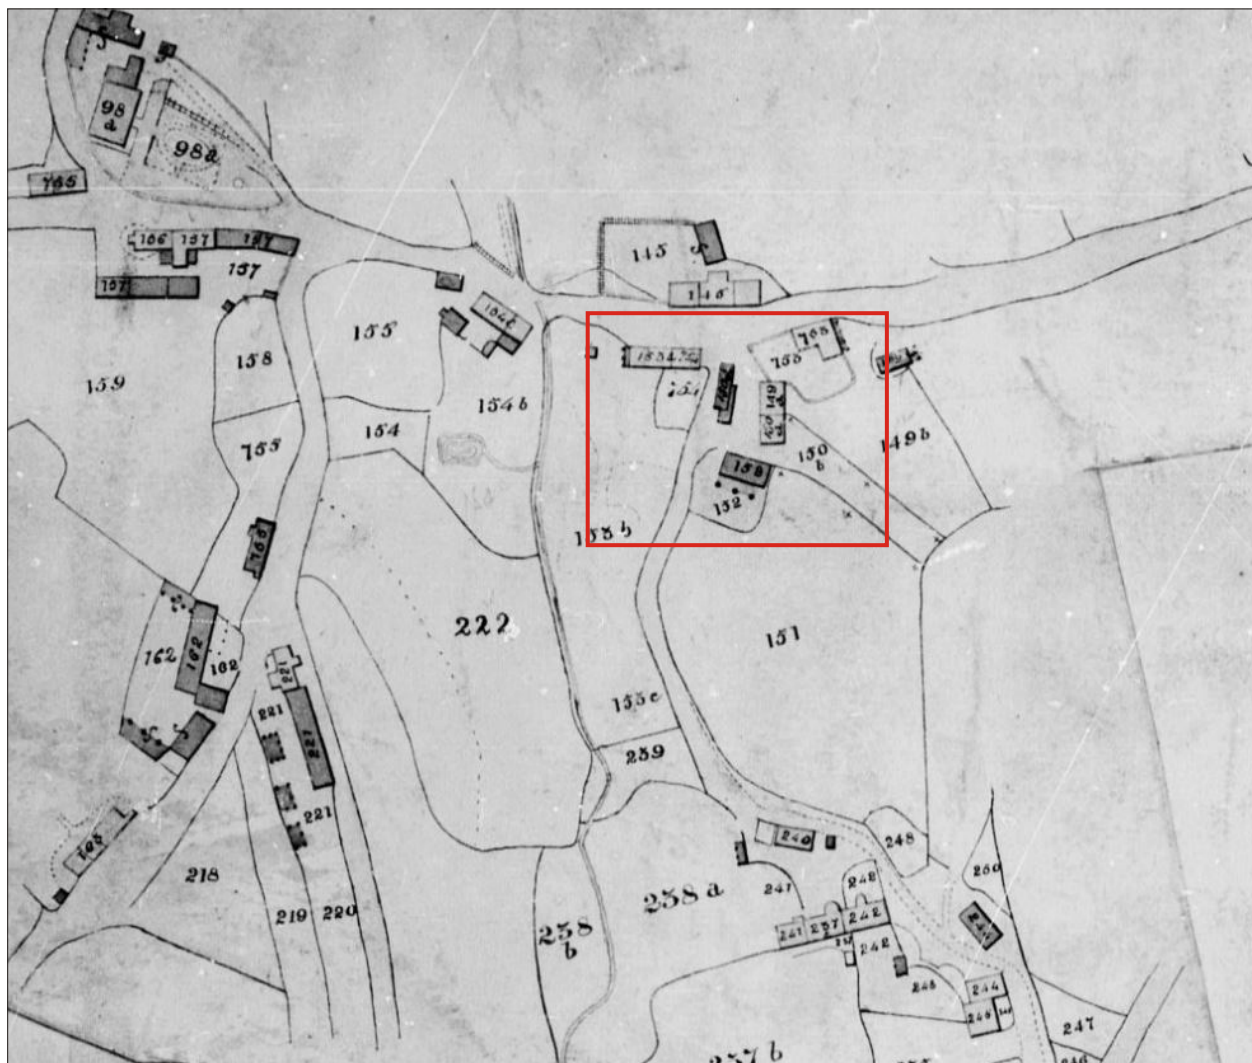
TITLE
Fig. 2: Extracts from the
Combeinteignhead tithe
map, 1839

- 4.2** The earliest identified map to depict the property is the 1839 tithe map for Combeinteignhead (Fig. 2). The building is recorded as being divided into two properties – plots 149a and 150a – forming part of Blatchfords & Redaway and Webbs Tenements, with each in separate occupation. Both tenements included additional adjacent land – plots 149b and 150b. Fuller details taken from the 1837 apportionment, including 1864 amendments, are set out in Table 1 below. One version of the tithe map shows the cottages as a rectangular building, whilst the version held at the Devon Heritage Centre depicts the present No. 2 as having an extension, presumably a porch, on the west side and a much smaller extension to the east.

4.3 Plot 150a represents the present No. 2 Brook Cottage, and the barn mentioned in the apportionment was the building (now demolished) located to the northwest of the cottage. Within the present property was another barn – in plot 152 – located to the southwest of the cottage. This has also been demolished but its north wall partially survives along with a terrace cut into the bedrock for the east wall. The data presented in the tithe map and apportionment indicates that these tenements were small with few parcels of land, mainly cottages and barns and small adjacent fields (commonly orchards), along with rights to pasture on Milber Down. In the wider landscape the map records Netherton as being located with an area of extensive relict medieval strip fields, which has been picked up by the Devon Historic Landscape Characterisation project.

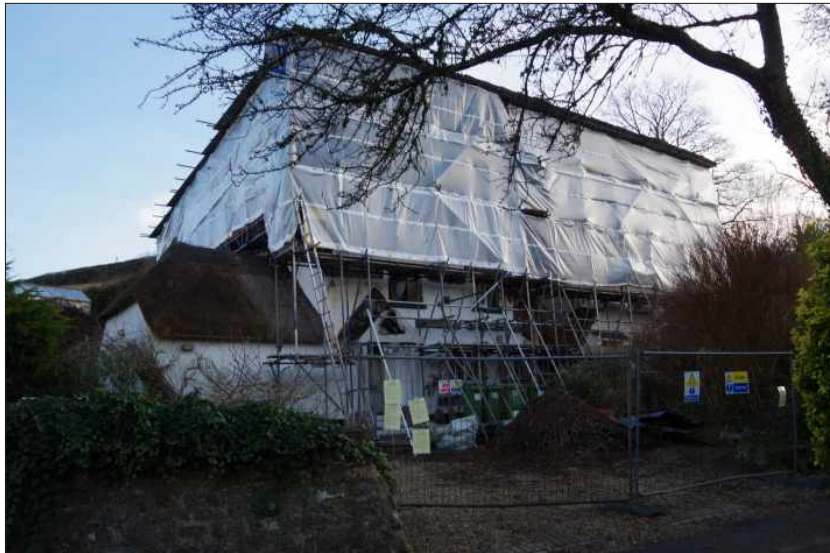
Plate 1: Nos 1 and 2 Brook Cottages viewed from the highway, looking southeast

1.2 The property is a semi-detached cottage, with No. 1 situated to the north (Plate 1). It is located on the eastern edge of the hamlet of Netherton. The cottage is situated on low ground at a height of around 12m aOD on the east side of a stream that leads into the River Teign. The cottages, and a demolished building to the south, were constructed on a flat terrace cut into a steep hillside to the east. There is a spring directly in front of the property to the west. The underlying solid geology comprises Permian breccia of the Oddicombe Breccia Formation. No superficial geological deposits are present, although in the valley bottom to the west the breccia is overlain by Quaternary tidal flat deposits of clay, silt, sand and gravel (British Geological Survey online 2017).

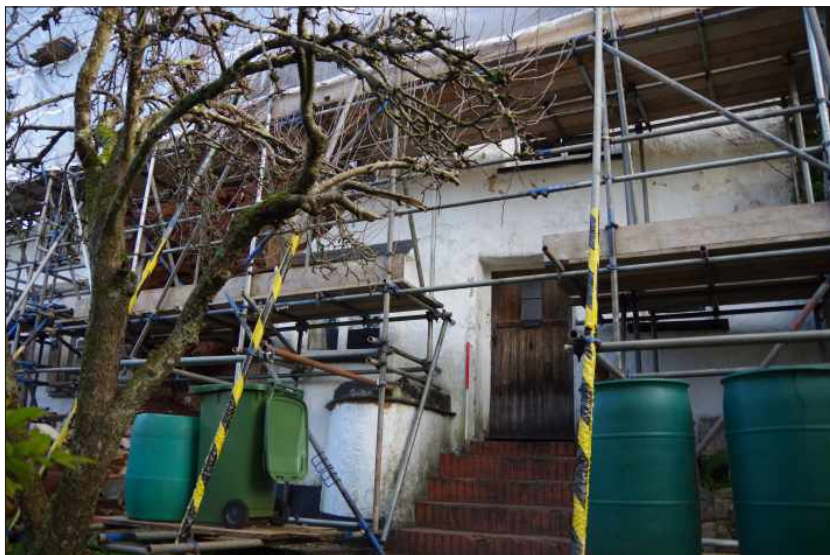
5.1 The property is a two-storey building that has been constructed on a man-made terrace which cuts into the bedrock on the east side, with the land stepping down towards the northwest. The west elevation is the principle elevation, and looks out over the village (Plate 2). The entrance doorway is higher than the front garden, which itself is raised above the present access driveway and spring to the west. The front door is slightly offset to the right, and is of early 20th-century date with two long lower panels and six upper smaller panels, all glazed and with ovolo moulded beading; the exterior face has been finished with wooden planks and gives the appearance of an

Plate 2: The south elevation, looking east-northeast. 1m scale

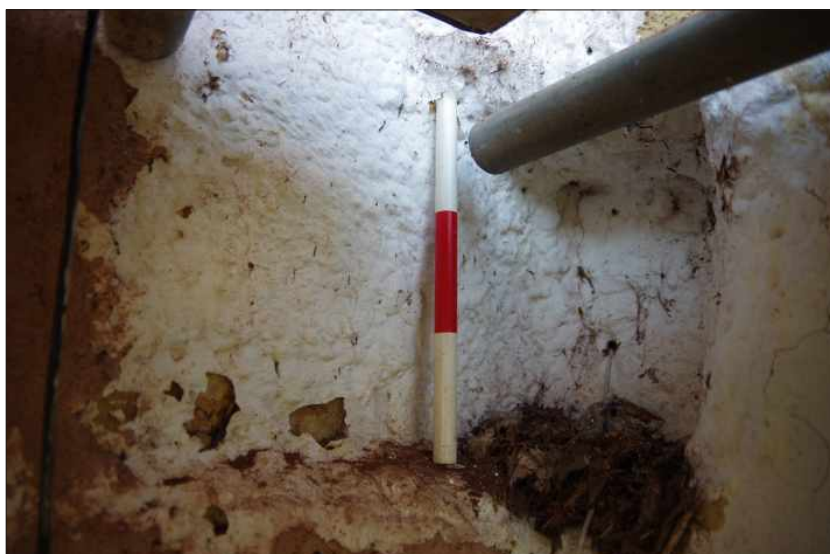
- 5.2** The kitchen to the right of the door is lit by a small two-pane, side-opening 20th-century window. The living room to the left has a larger two-light, side-opening 20th-century window, with two panes in each light; internally secondary glazing has been added. The opening has a concrete external cill and tiled inner cill. It is set within a slightly projecting walk-in bay, finished with a slate roof. In the north corner of this bay there is a shallow projection or niche (Plate 3). It gives the impression of a squint window (cf. Wringworthy Farm, Mary Tavy; Parker 2013), but is too small for such a feature and its function is unknown.

Plate 3: The niche in the south elevation, looking east. 0.30m scale

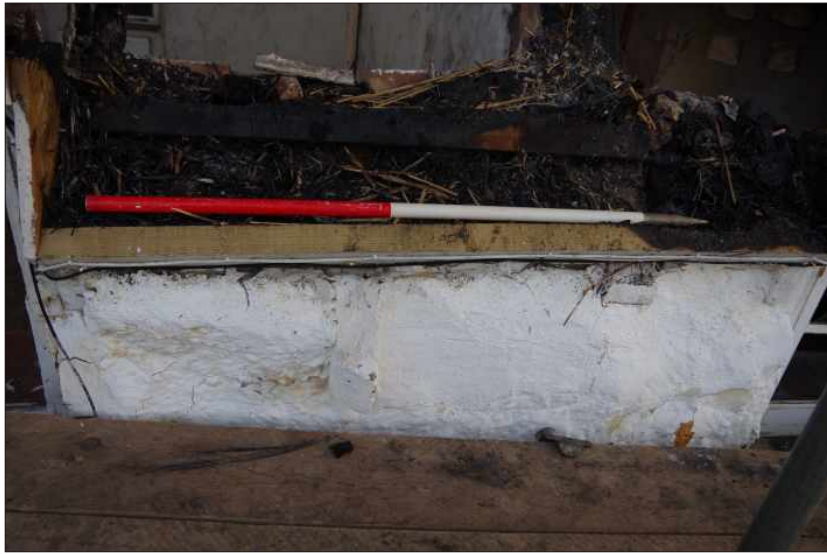
- 5.4** The south elevation forms the gable end of the cottage. The first 1m of the wall projects off from the remainder of the gable, and is constructed of plastered stone; an opening visible internally (see 5.6 below) cannot be seen on this face. It seems likely that the rest of the gable end (from first-floor level) is constructed of bricks as drilled red bricks are visible in the wall within the former roofspace (Plate 6), but the masonry is mainly obscured below by both the internal and external finishes.

Plate 4: The first-floor masonry of the south elevation showing ends of roof timbers, looking east. 1m scale

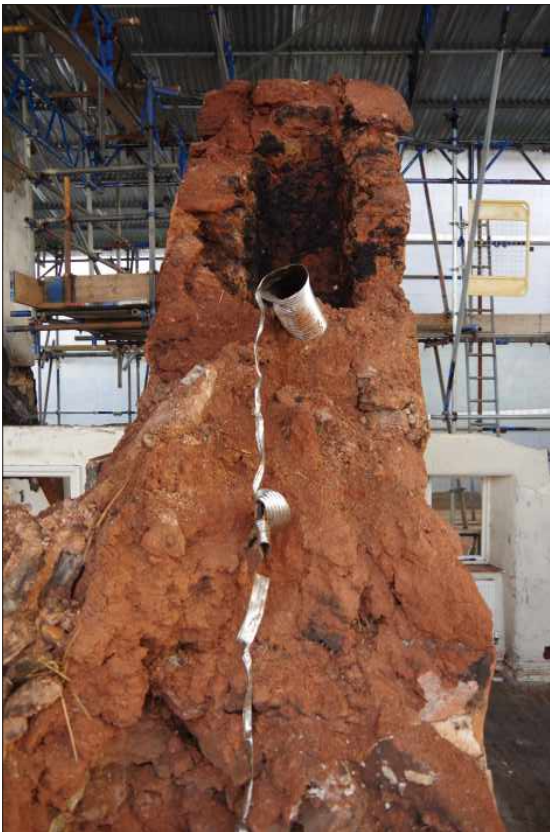
Plate 5: The partition wall with No. 1 showing the chimney stack, looking east

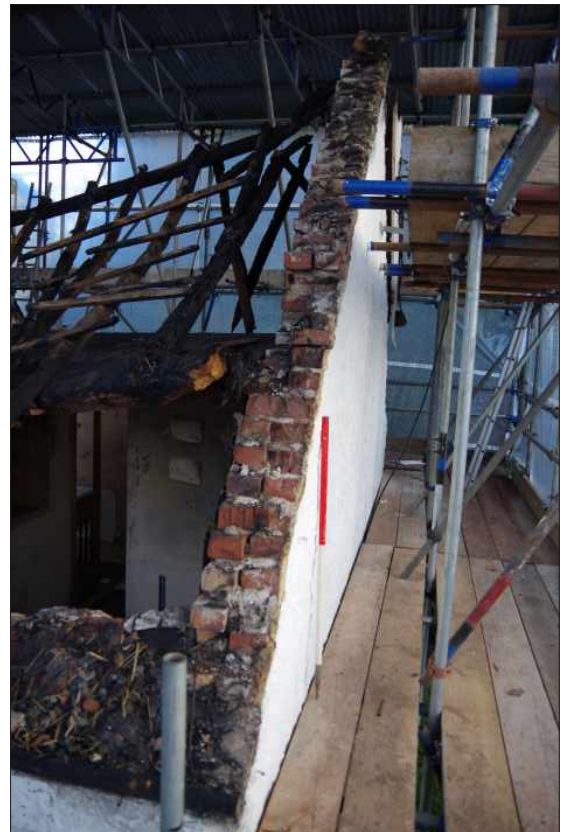
Plate 6: The south gable at first-floor level showing bricks of 20th-century rebuild, looking northeast. 1m scale

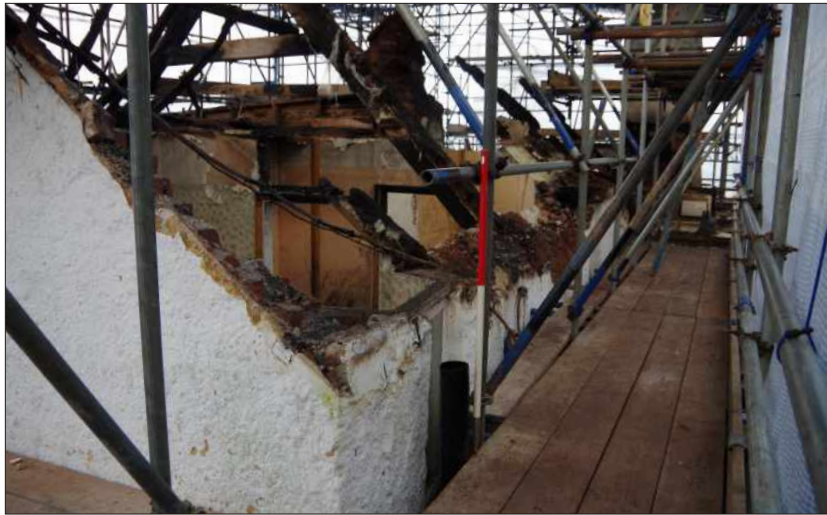
- 5.5** The east elevation, to the rear of the property, is rendered, but much of the wall appears to be of cob construction (Plate 7). Due to the topography, the only features are at first-floor level. At the south end of this elevation is a small single-pane, side opening frosted window to the bathroom, whilst at the north end is a similar window to the main bedroom. Both are 20th century in date, with concrete cills and timber lintels; two courses of red bricks survive above the north window. At the northwest corner there is a concrete block repair to the top internal face of the wall, with a cob repair to the exterior. Between this repair and the window there is a section of plaster exposed within the wall, with the outer part of the wall beyond rebuilt in breccia stonework. Below the north window there is a slightly projecting vertical band of cob, which may represent the remains of the south wall of the extension recorded here on the tithe map.

Plate 7: The north elevation at first-floor level, looking north-northwest. 1m scale.

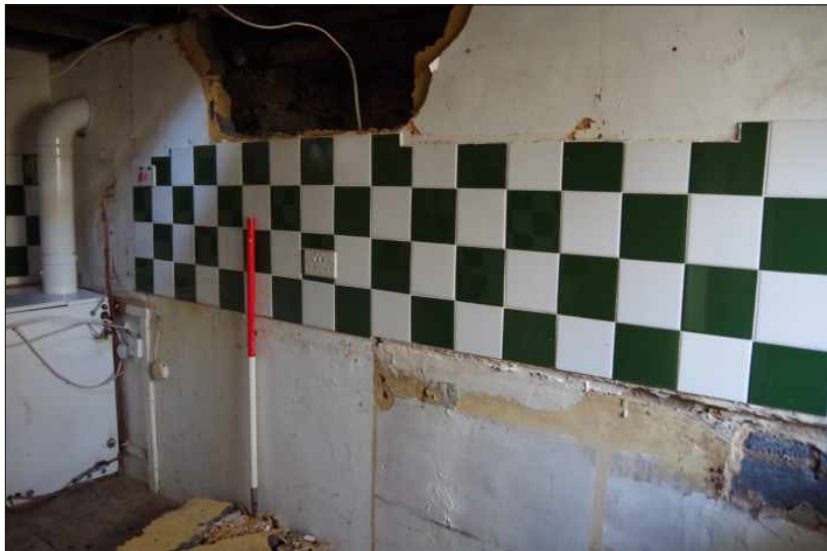
- 5.6** The front door leads into a small lobby from which the staircase rises to the first floor. Doors from this lobby provide access to a kitchen to the south and the living room to the north. The north and south elevations of the kitchen have been relined with concrete block walls (Plate 8), set away from the earlier walls – the latter are of rubble

Plate 8: The kitchen showing the lining to the south wall, looking southeast. 1m scale

alterations, in particular the insensitive insertion of concrete block linings to walls. The historical associative value is also reduced by the historic loss of associated farm buildings and the change in the local landscape, whereby the collection of small farming tenements documented in the 19th century is now longer apparent in the landscape.

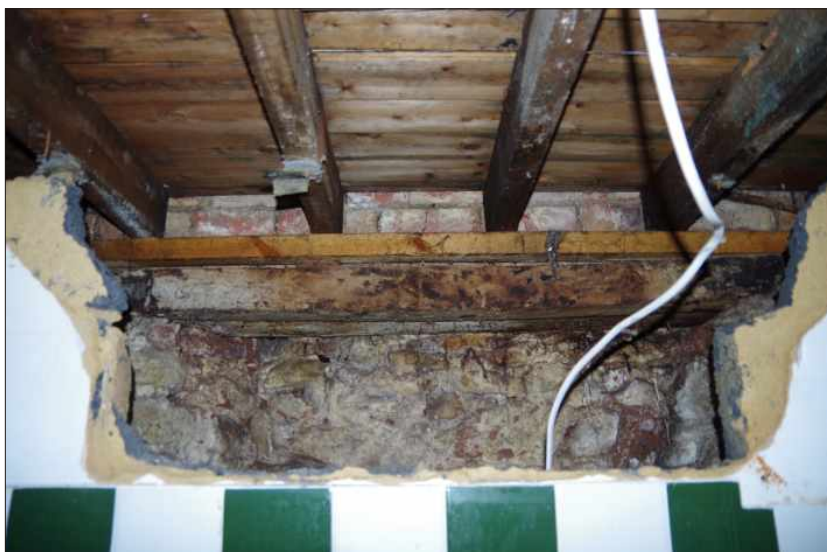
stone construction, and the south elevation incorporates a former splayed opening under wooden lintels (Plate 9). It has been infilled with rubble stone. Above the lintel red brick brickwork laid in stretcher bond is visible. The north wall of the kitchen is a modern tongue and grooved partition forming one side of the staircase and under stairs cupboard. The first floor is supported by an off-central bridging beam; this is chamfered but any stops are obscured behind modern finishes to the walls. The joists are 20th-century pine replacements set into original sockets in the top of the beam. At the northwest corner of the room is a small wooden box below the joists. From above, unused original stepped mortices for earlier joists are visible (Plate 10). This probably represents a step associated with a previous staircase.

Plate 9: The blocked opening in the south wall of the kitchen, looking south.

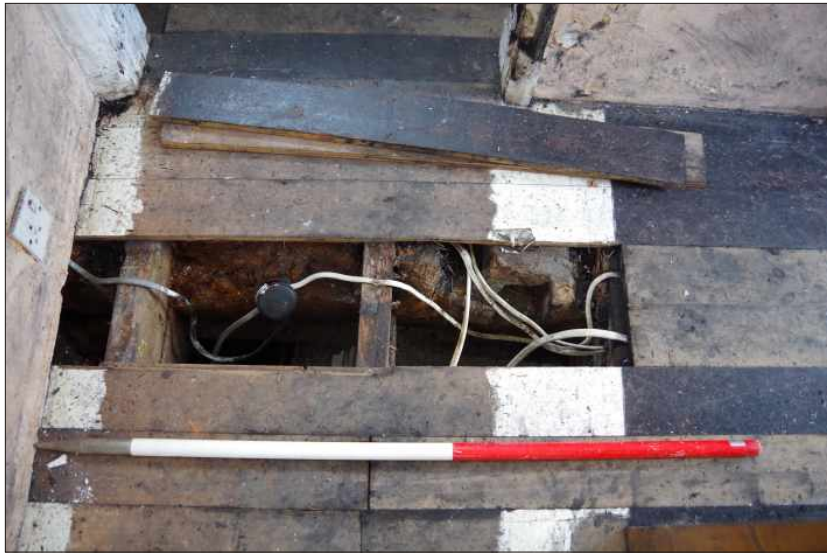
Plate 10: The top of the bridging beam in the kitchen showing former joist sockets, looking south. 1m scale.

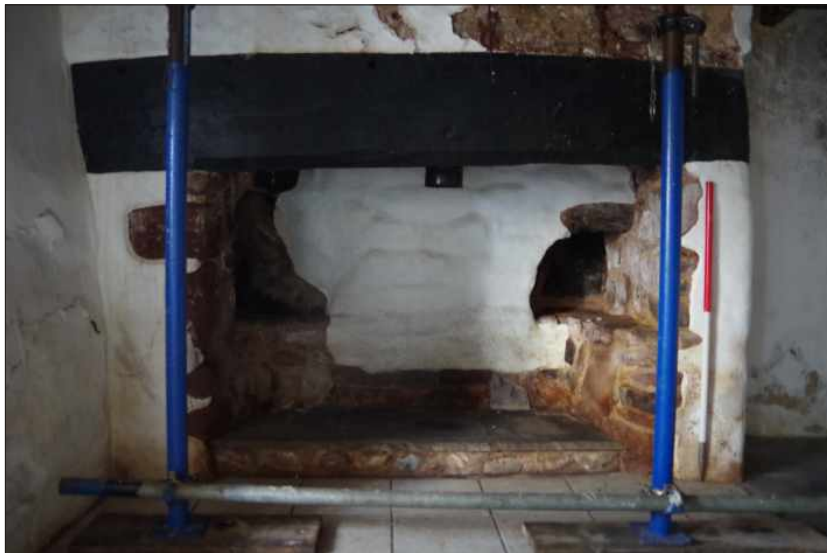
- 5.7** Set towards the west end of the north wall of the living room is a large fireplace, with the opening under an original timber lintel (Plate 11). This is chamfered with simple stepped stops. The fireplace has been heavily repaired and has a raised hearth with a flagstone surface. The rear corners incorporate stone bread ovens, both of which have also been repaired. Although the west oven retains its original opening arch, there is no evidence for historic metalwork associated with these ovens. To the east of the fireplace a doorway into No. 1 has been infilled using concrete blocks (Plate 12). At the north end of the east elevation is another blocked doorway. The walls to either side of this opening have been altered and partially narrowed; one side now includes a small recess. The south wall is a partition to the stairs and under stairs cupboard, and constructed of painted wooden panels incorporating doors to the entrance lobby and the cupboard (Plate 13). The first floor is supported on two bridging beams, one located at the partition with the stairs, and the other close to the fireplace. All are chamfered with – where visible – stepped stops. All but three of the joists were replaced in the 19th century with square-profiled joists with beaded decoration. The original joists (marked on Figs 4 and 9) have chamfered edges with simple stepped stops (Plate 14).

Plate 11: The fireplace in the living room, looking north. 1m scale

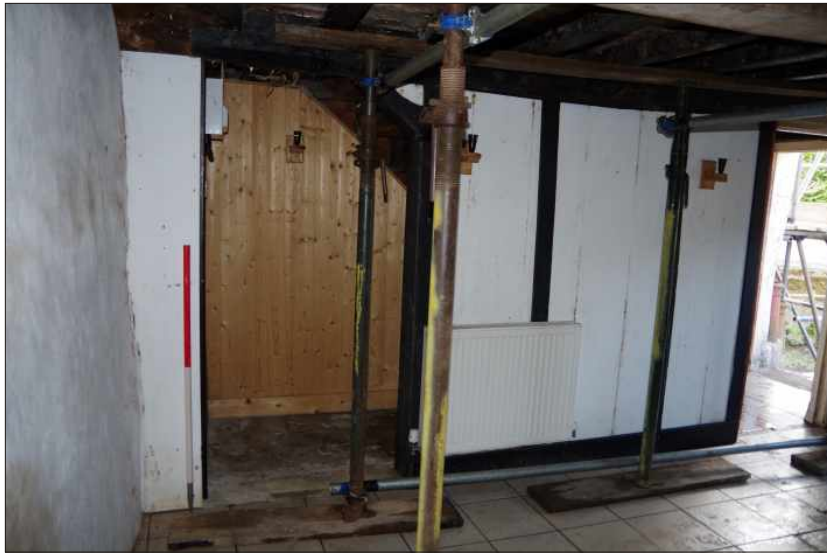
Plate 13: The partition between the living room and stairs, looking south. 1m scale

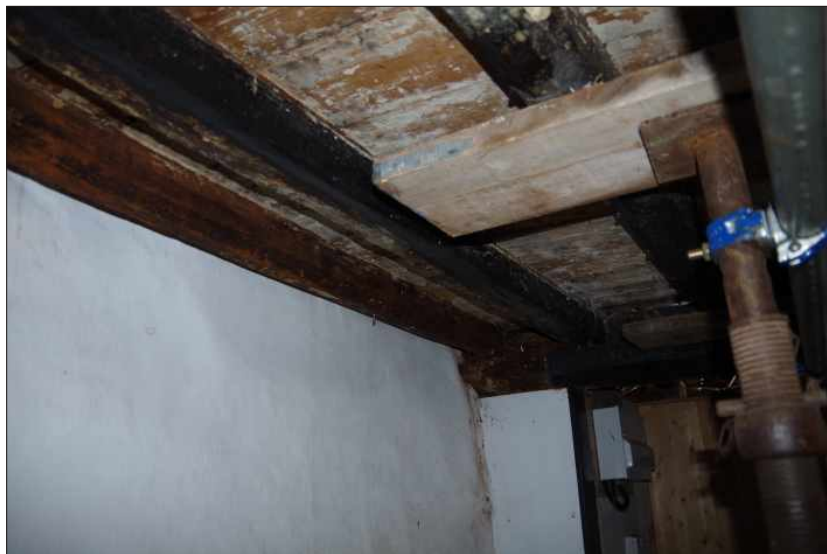
Plate 14: The north end of the bridging beam over the partition showing two of the original joists (to left and right), looking southeast

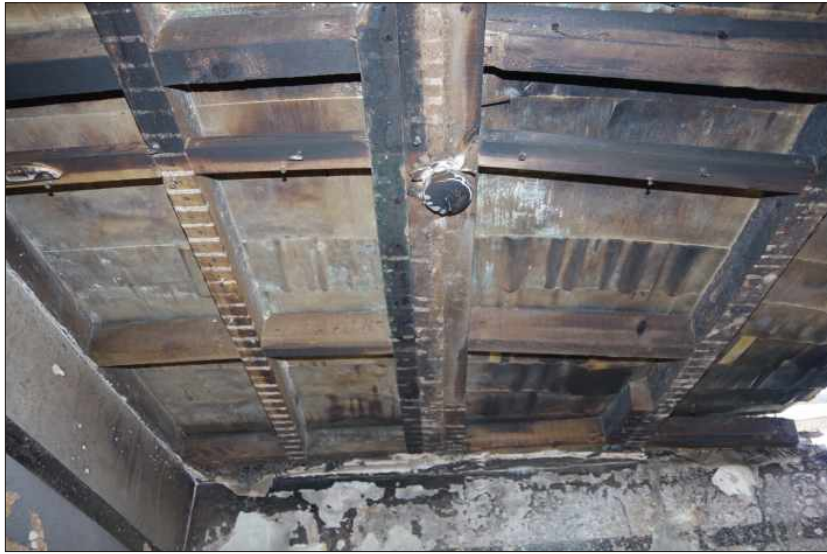
- 5.8** The stairs, which are a later 20th-century replacement, lead to the north bedroom and, up a step, to a corridor leading to a bathroom and the south bedroom (Plate 15). The south wall of the bedroom is lined with cement plaster applied to fibreboard attached to a wooden frame in front of the brick rebuilt gable. The west wall of the bedroom retains old plaster laid onto earlier painted thin plaster. Remains of a lath and plaster ceiling survive, with late 20th-century floor boards in the attic above (Plate 16). The partitions between the bedroom, the stairs and bathroom are all later 20th-century timber frames and finishes. The staircase projects into the bedroom and above this is a small cupboard lined with tongue-and-grooved boards. The internal walls to the bathroom are finished with wooden panelling and wallpaper (Plate 17); this room has a plasterboard ceiling.

Plate 16: The ceiling of the south bedroom showing the evidence for lath and plaster, with the modern wall lining beyond, looking south

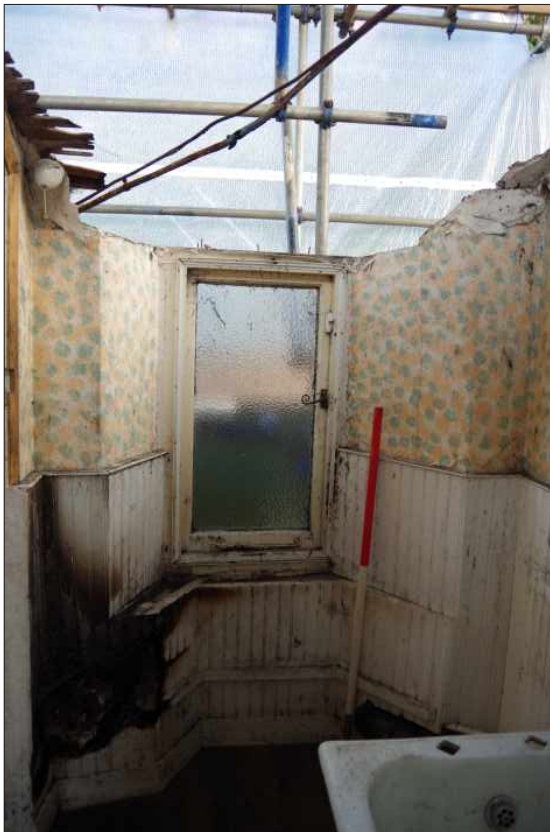
Plate 17: The bathroom showing its modern finishes and window, looking east. 1m scale

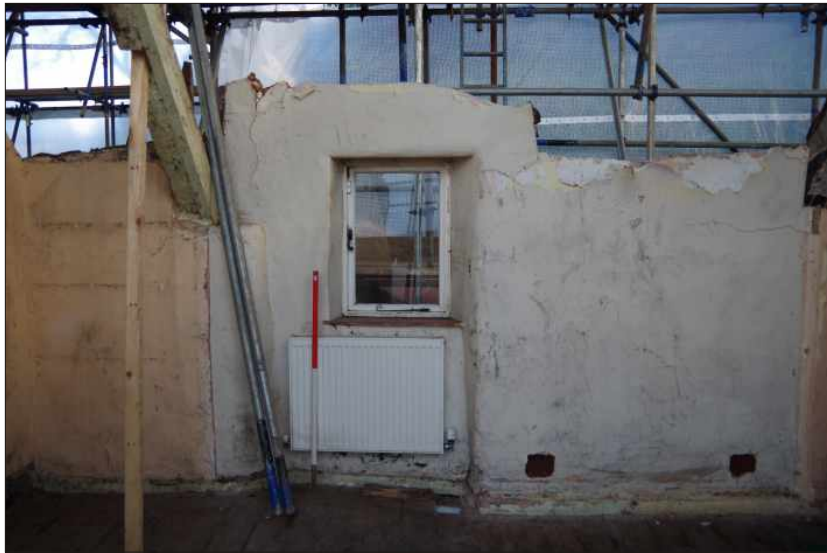
- 5.9** The north, east and west walls of the north bedroom are cob, finished with plaster (Plate 18); around the chimney stack in the former, some modern plaster has been applied over the historic finish. The stack itself, exposed above the former ceiling level, is constructed of breccia and features angled weathering stones at the top. The surviving wall of the former cupboard recess in the west side of the stack is lined with plaster. To the east of the stack was a cupboard, which has now lost its doors and shelves (Plate 19). The back of the cupboard was formerly a doorway to No. 1, and the opening has been infilled using concrete blocks laid directly onto the floor boards. The window in the east elevation is set within an irregularly shaped walk-in opening. The south wall forming the partition with the stairs is under a roof truss, and is of lath and plaster construction with modern boxing-in of a lintel over the doorway (Plate 20).

Plate 19: The east side of the north bedroom showing, from left to right, the blocked opening to No. 1 in the north wall, the remains of the north truss, and the window in a possible door opening, looking east. 1m scale.

7.2 One version of the 1839 tithe map depicts a small projection at the northeast corner of the property. Evidence for this survives as slightly projecting cob masonry. A blocked ground-floor doorway led into this room; directly above, on the first floor, is a window set within an irregularly-shaped splayed walk-in opening, adjacent to which is an area of altered masonry including a length of narrower wall. Taken together it seems likely that this projection was a stair turret. This position is common in local buildings, both in houses floored over from the start and where stairs have been added to floored-over former medieval open halls. No evidence for the first-floor layout survives but the broad present arrangement of two bedrooms at the front of the house, served by a rear corridor (or simply a door in a partition wall seems likely.

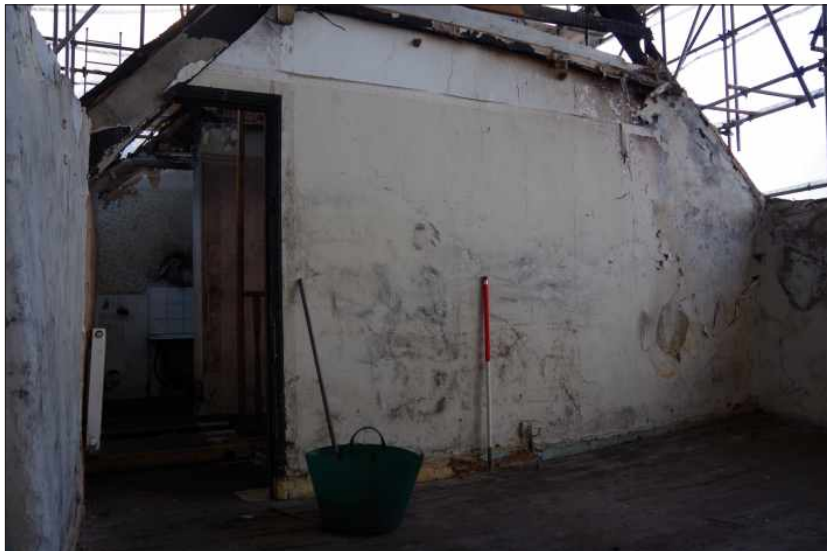
Plate 20: The partition between the north bedroom and the stairs, looking south. 1m scale

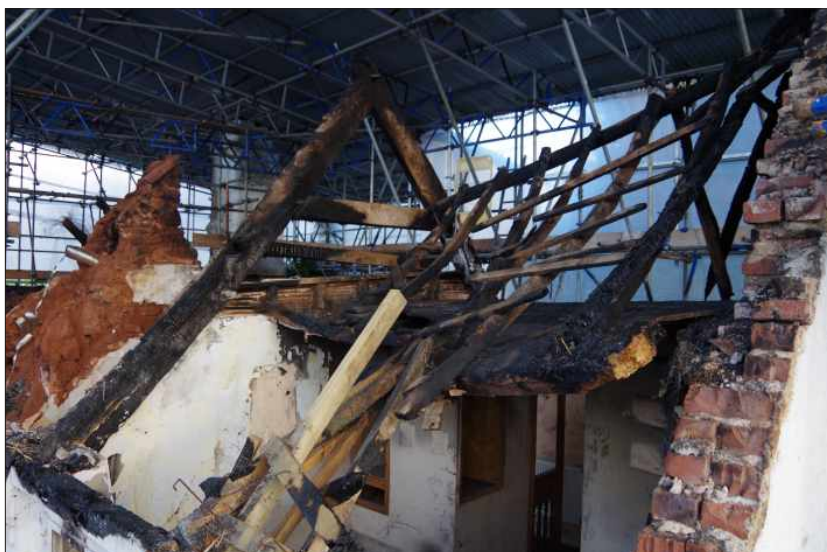
- 5.10** Within this property the roof was supported on two trusses as well as the rebuilt south gable. There were two further trusses within No. 1. Other than the trusses, the rest of the roof structure only survives within the south half of the building on its west side, and all the thatch has been lost (Plates 21-23). The northern truss is located at the north end of the property on the line of the front of the stack. Only the lower part of the eastern principal rafter survives, along with an attached batten that formerly supported the ceiling. The south truss is located on the north side of the stairs, and is open within the former loft space. It comprises principle rafters set into the tops of the walls, with a pegged mortice and tenon joint at the apex. It has a high-level straight collar (allowing for first-floor accommodation), which appears to be fixed to the rafters with mortice and tenon joints, although one face is burnt and the other obscured by additional bracing precluding detailed observation. A second, applied collar, has been added between the original collar and the top of the partition. The ridge purlin was set diagonally within the top of the truss. There was a single pair of through side purlins fixed with pegs, of which only one now partially survives. Secondary rafters were attached to this purlin using pegs; the south pair of secondary rafters were replaced in softwood when the adjacent gable was replaced. Replacement battens fixed to these rafters were nailed. Below the purlin the secondary rafters have also been replaced during the 20th century with softwood, and these incorporate steel tips for thatch.

Plate 21: The surviving roof structure, looking northeast

7.3 There is few architectural details to date the house, the main evidence being the roof and plan form. The roof structure with entirely pegged joints, through purlins and an angled ridge purlin is regionally a late medieval style that continues into the early post-medieval period. Two-storey rural houses developed from the mid 16th-century onwards, and a mid-late 16th-century date is suggested for Nos 1 and 2 Brook Cottages.

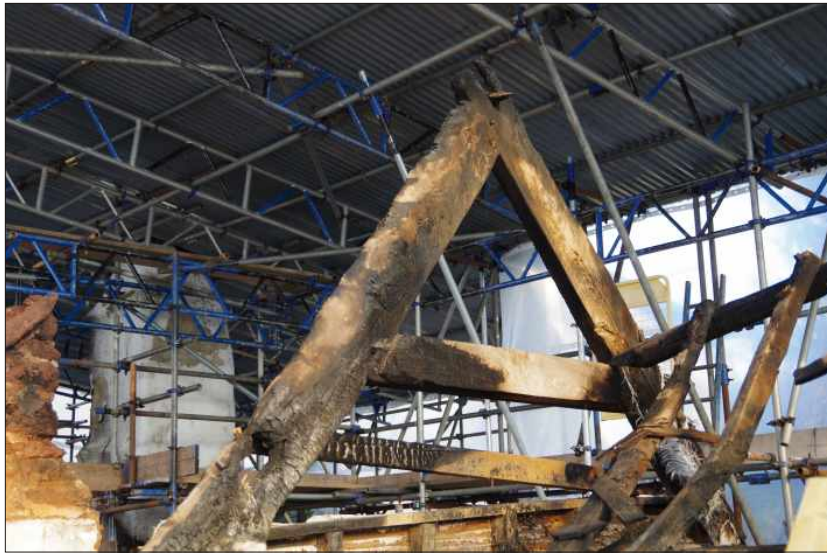
Plate 22: The south roof truss, looking northeast

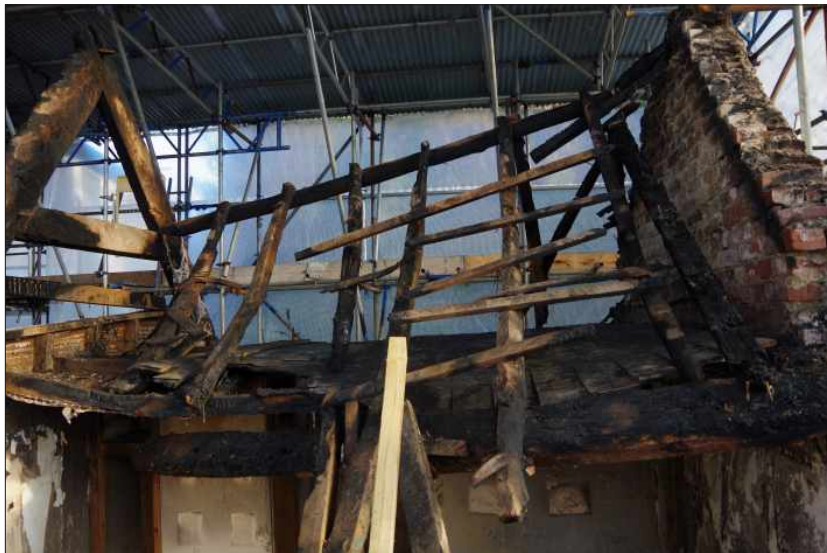
Plate 23: The surviving roof structure, looking east
