HORNER FARM, HOLNICOTE, LUCCOMBE, SOMERSET

Results of archaeological monitoring and recording

Report No: ACD1583/1/0

Date: March 2017

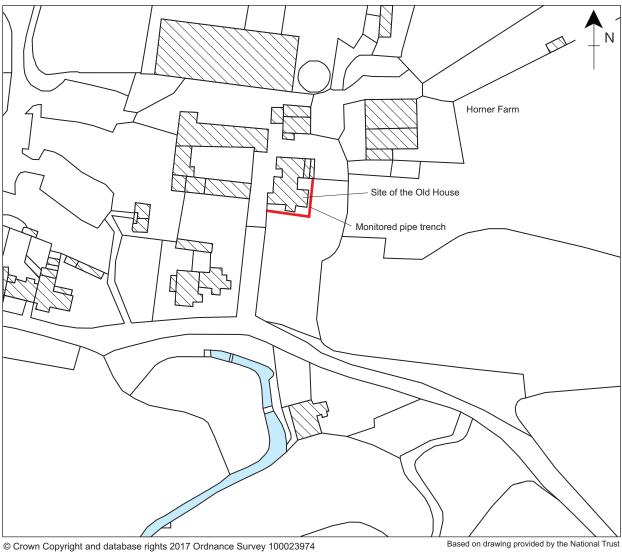
Fig. 1: Location of site and monitored pipe trench

The monitored groundworks comprised the machine-excavation of a trench, which measured 0.25m wide and between 0.8m and 1m deep (Fig.1 and Plates 2-3). This extended around the eastern and southern perimeter of the store that replaced the Old House.

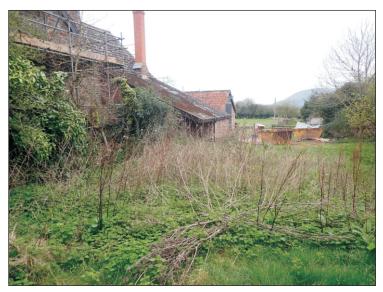
Plate 1: Pre-excavation view of monitored area. Looking north with the site of the Old House to the left

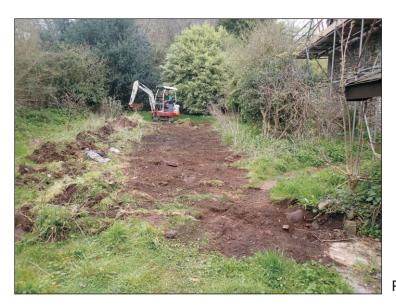
Plate 2: Working view looking south

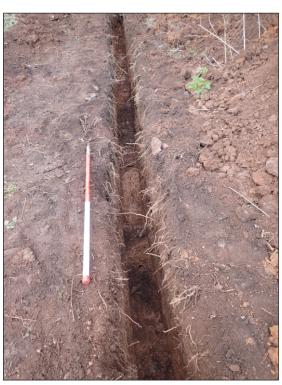
The section of the trench that was dug along the southern side of the building was excavated into the natural subsoil, which consisted of a mid yellow to mid reddish-brown silty-clay and was exposed at a depth of 0.3m below existing levels. This was overlain by a former hard standing comprised of red sandy-silt with abundant sandstone gravel and cobbles beneath a pea gravel dressing.

Natural subsoil along the east side of the old was exposed at a depth of around 0.4m below existing levels. This was overlain by a mixed dark reddish-brown silty-loam topsoil, which contained abundant sandstone rubble and gravel inclusions, with these increasing in density towards the north portion of the trench.

Plate 3: Showing excavated pipe trench. View to south (scale 1m)
