UNDERHAYES, OLCHARD, IDEFORD, DEVON

Results of historic building recording

Teignbridge District Council planning reference 16/01762/LBC,
condition 4

Document No: ACD1541/2/0

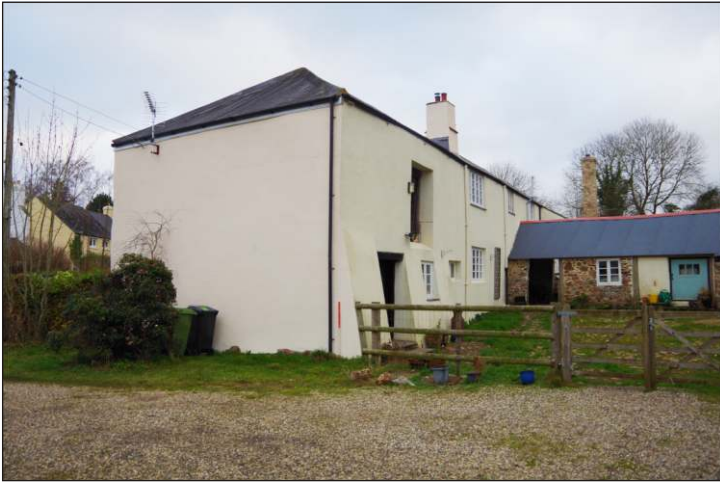
- 5.1** The property is a two-storied vernacular cross-passage farmhouse, dating to the early to mid 17th-century. It is rectangular and aligned east-northeast to west-southwest. The front of the property faces Olchard Lane, with the rear overlooking a vegetated roughly cobbled yard. Abutting the east end of the south elevation is a late 19th-century extension and to the rear of the cross passage a late 19th-century linear outbuilding. The walls are constructed of lime-rendered cob and stone, with two concrete block buttresses at the west end of the south elevation, positioned to either side of the taking-in door of the hayloft. There are two S-shape steel ties in the north elevation; any associated ties in the south elevation are not visible externally. The building has a turnerised slate roof with a straight end to the east gable and a hipped roof over the hayloft at the west end. It has a central axial stack and a projecting front lateral stack.

Plate 1: Underhayes viewed from the driveway, looking north. (1m scale)

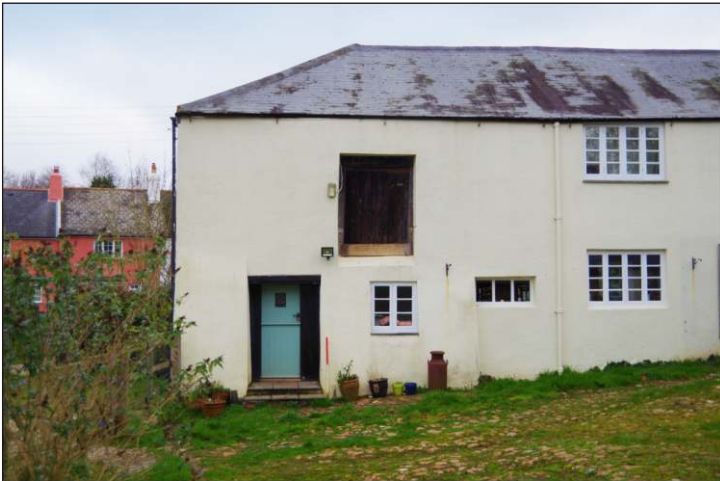
Plate 2: West end of the south exterior elevation, looking north-northwest. (1m scale)

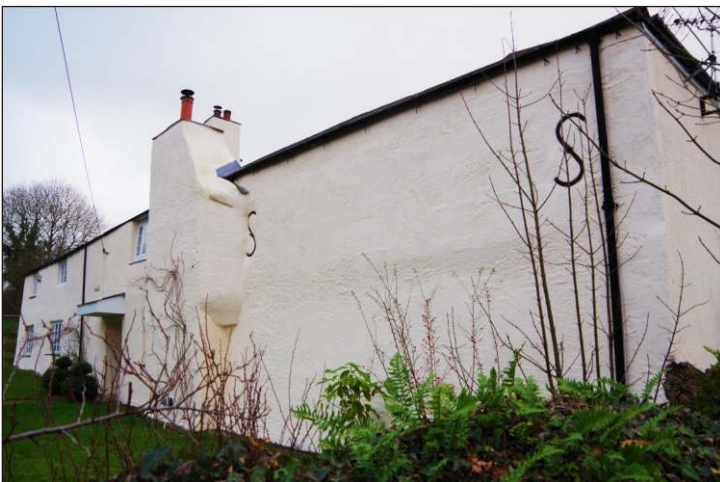
Plate 3: North exterior elevation, looking east

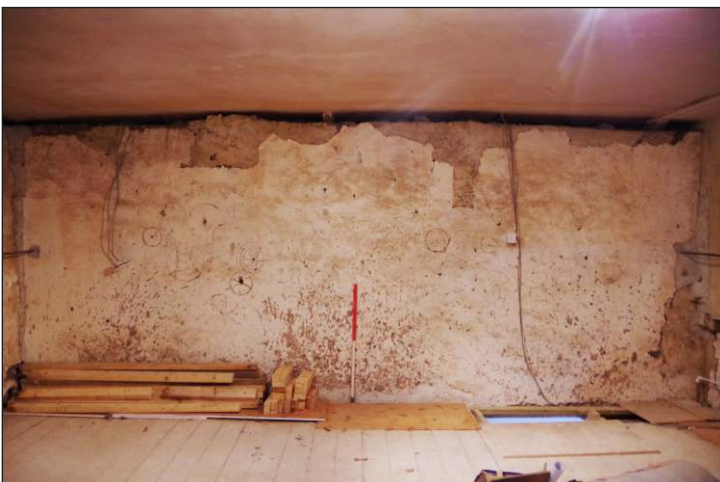
- 5.3** The north elevation (Plates 4-8) retains original plaster with modern repairs at the edges. This wall displays the majority of the daisy wheels, circles and concentric circles. They are consistently in a central horizontal band and extend the full width of the room; the marks are inscribed at variable depths into the plaster. Along the lower half of the elevation there appears to be some damage, with abundant gouges visible, possibly from former threshing or crushing machinery.

Plate 4: North interior elevation of the hayloft, looking north-northwest. (1m scale)

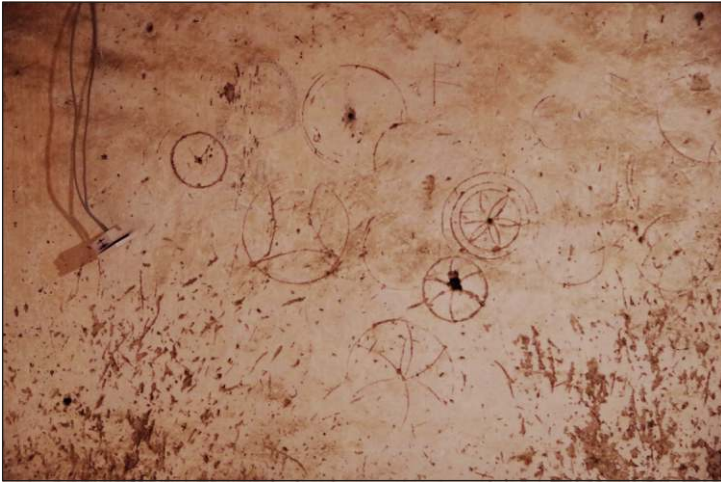
the same period as the other inscriptions. Additionally, towards the west end of the north elevation, were two 'F' style crossing of lines and an 'e'. Within a circle below an 'F' and the 'e' is a 'W' and 'M' style crossing of lines with a 'D' or 'P' at either end.

Plate 5: Detail of marks at west end of north elevation, looking north-northwest

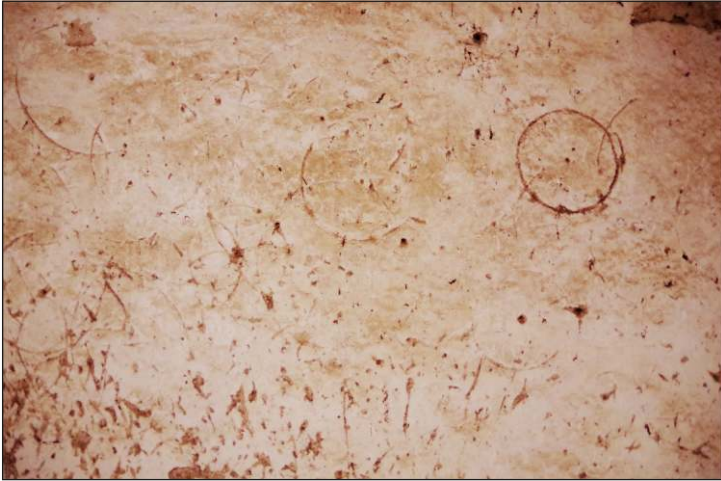
Plate 6: Detail of central marks on the north elevation, looking north-northwest

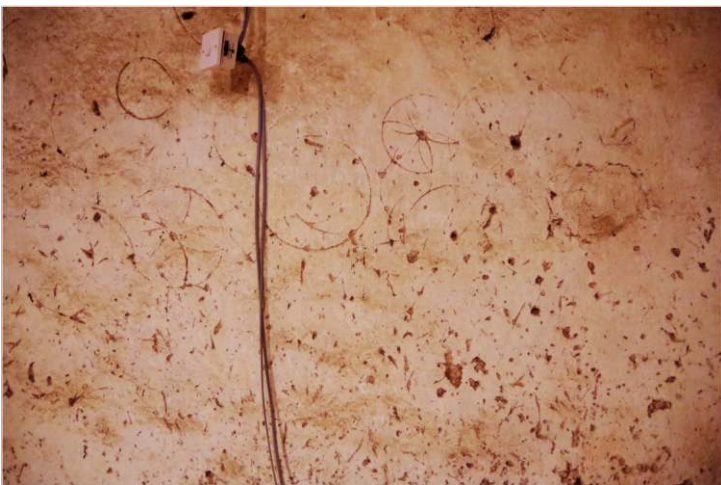
Plate 7: Detail of marks at east end of north elevation, looking north-northwest

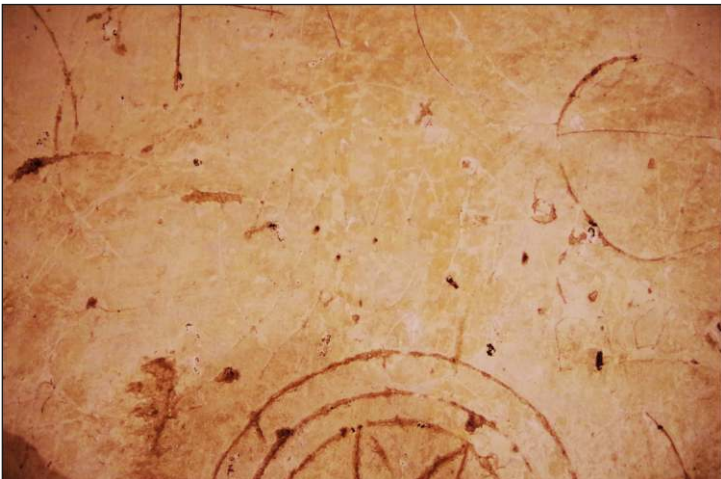
Plate 8: Detail of inscribed lines inside of a circle, looking north-northwest

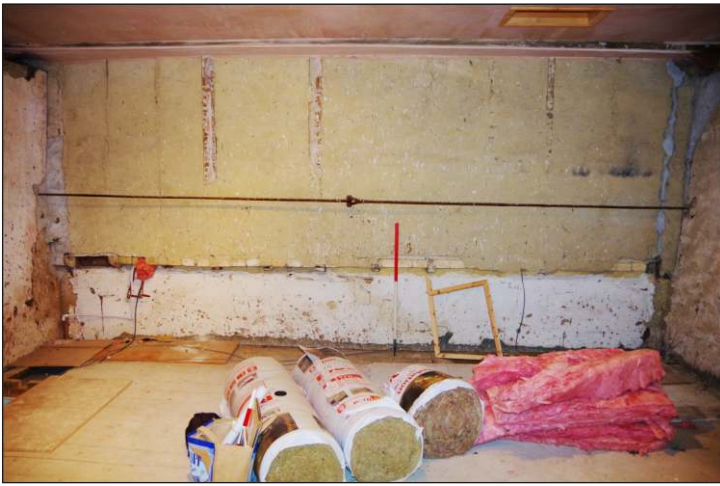
- 5.4** The east elevation (Plate 9) displays the same plaster to the lower third of the wall as on the north elevation. The upper section projects out into the room, with parts of a timber stud wall exposed displaying scars for former lath and plaster. The panels between the studs are finished in a different plaster to the remainder of the room. A wall plate below the studs has been removed and replaced with a single course of buff coloured 'Candy' brick. Other modern alterations and insulation are also visible.

Plate 9: East interior elevation of the hayloft, looking east-northeast. (1m scale)

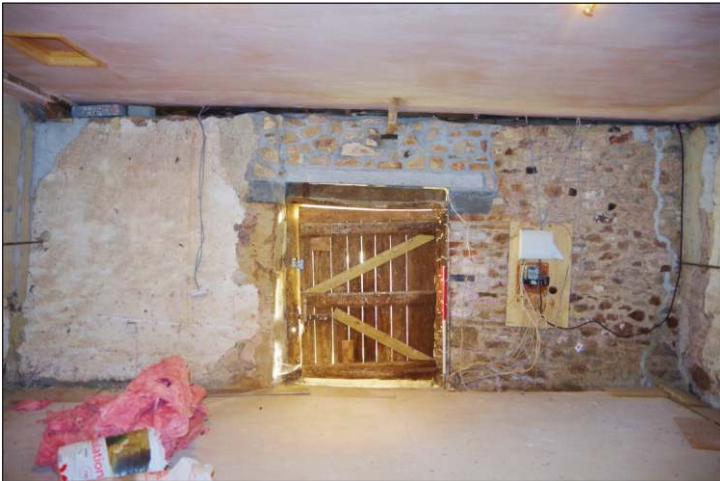
- 5.5** The south elevation (Plate 10) incorporates the central taking-in door. To the east of this opening the wall is finished with its original plaster. Elsewhere rubble stonework is visible, along with several phases of repair and rebuild including probable late 19th- or 20th-century repointing. Above the taking-in door a concrete lintel has been inserted and the stonework above rebuilt.

Plate 10: South interior elevation of the hayloft, looking south-southeast. (1m scale)

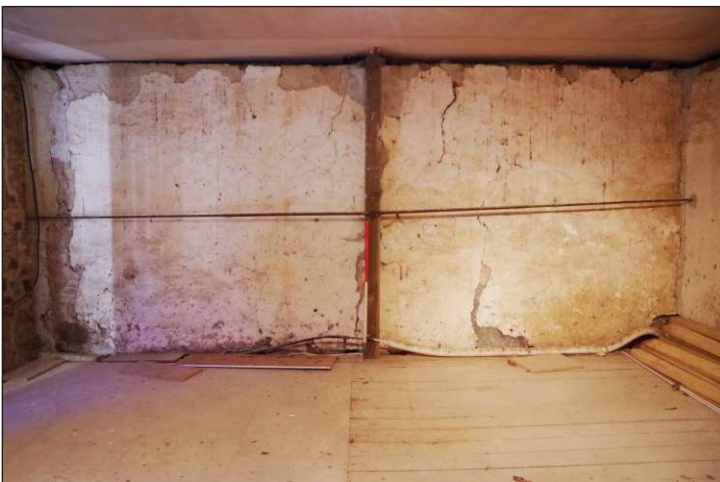
- 5.6** The west elevation (Plates 11-16) retains its original plaster with modern repairs at the edges. Here is another band of apotropaic marks inscribed into the plaster, and extending the full length of the room. Daisy wheels, circles, concentric circles and inscriptions including double 'V's, 'W's and 'M's and possibly the name 'Walt' are inscribed into the plaster. The marks have been inscribed at the same height as those on the north wall.

Plate 11: West interior elevation of the hayloft, looking west-southwest. (1m scale)

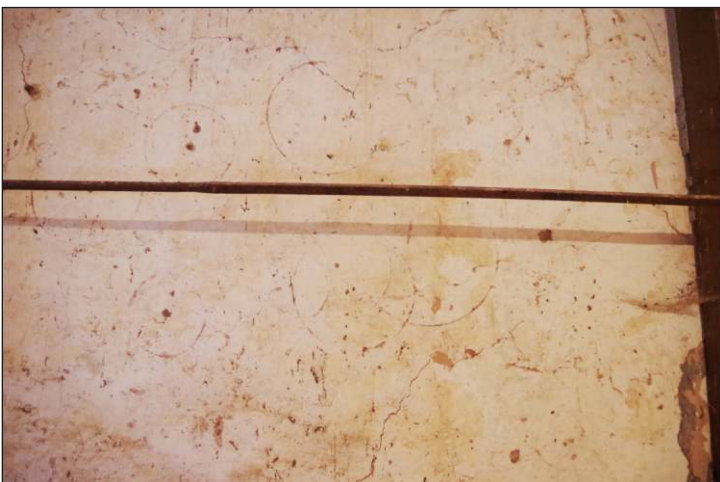
Plate 12: Detail of marks at south end of west elevation, looking west-southwest

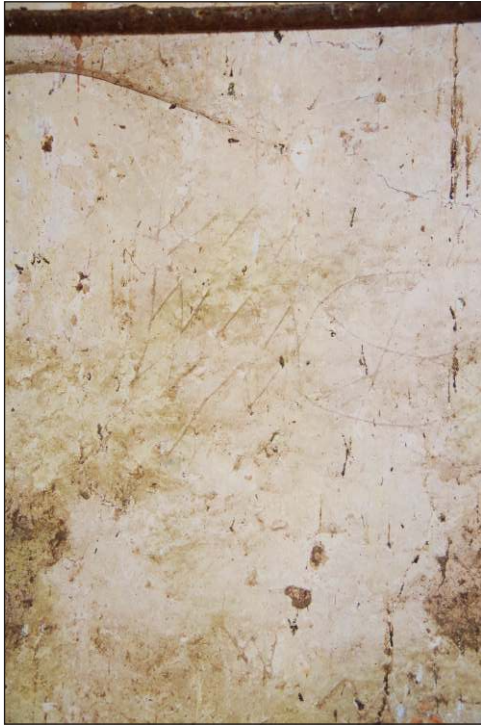
- 5.10** In addition to the circular motifs, a recurring theme of 'M', 'V' and 'W' style crossing of lines can be identified, some of which are placed within the circular motifs. It is believed that the use of the 'V' and 'M' shapes, along with 'W' representing double Vs for Virgin of Virgins, were used to invoke the protection of the Virgin Mary, and this style of marks generally dates from the 16th to 18th-centuries (Hall 2015, 153).

Plate 13: Detail of 'V', 'W' and 'M' inscribed lines at south end of west elevation, looking west-southwest

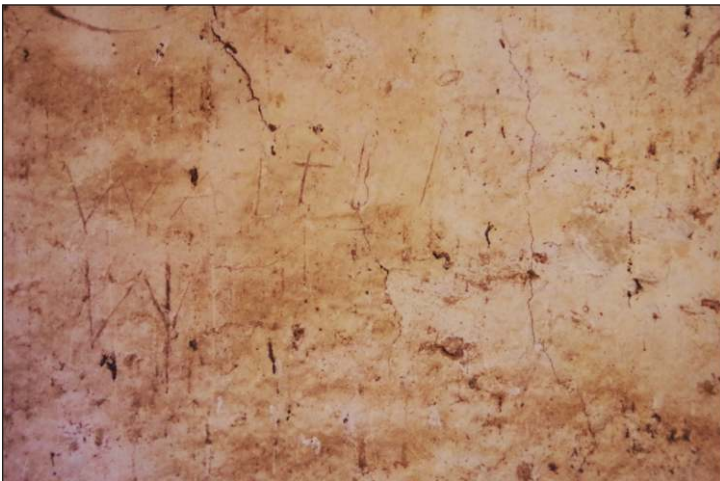
- 5.11** Towards the south end of the west elevation near to where a cluster of 'V', 'W' and 'M' are located there is the possible inscribed name 'Walt', which appears to be of

Plate 14: Detail of 'Walt' inscribed at the south end of the west elevation, looking west-southwest

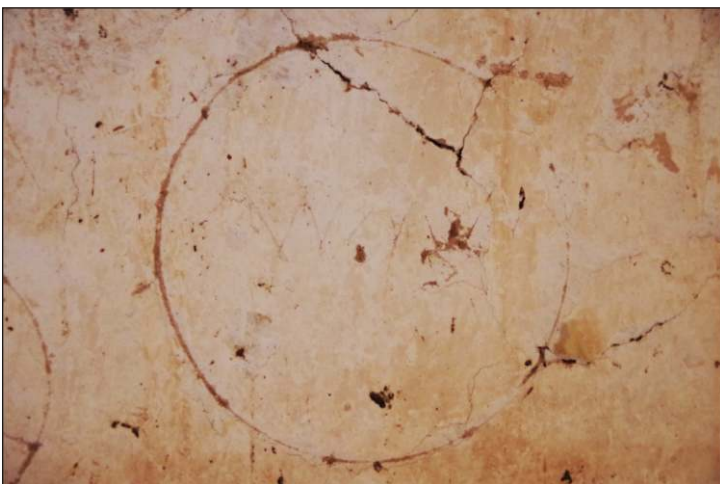
Plate 15: Detail of 'V', 'W' and 'M' inscribed lines at south end of west elevation, looking west-southwest

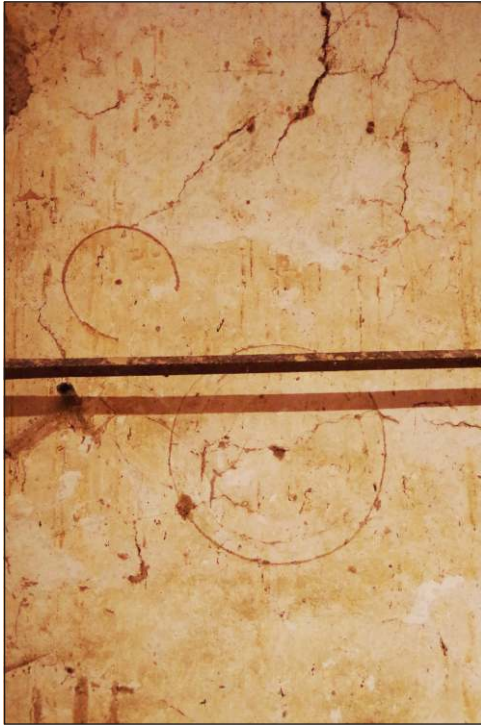
Plate 16: Detail of marks at north end of west elevation, looking west-southwest
