# MOUNT WISE PHASE 3A, DEVONPORT, PLYMOUTH

## Results of archaeological investigations

Plymouth City Council planning reference 14/1572/FUL,  
condition 21

Document No: ACD1316/2/0

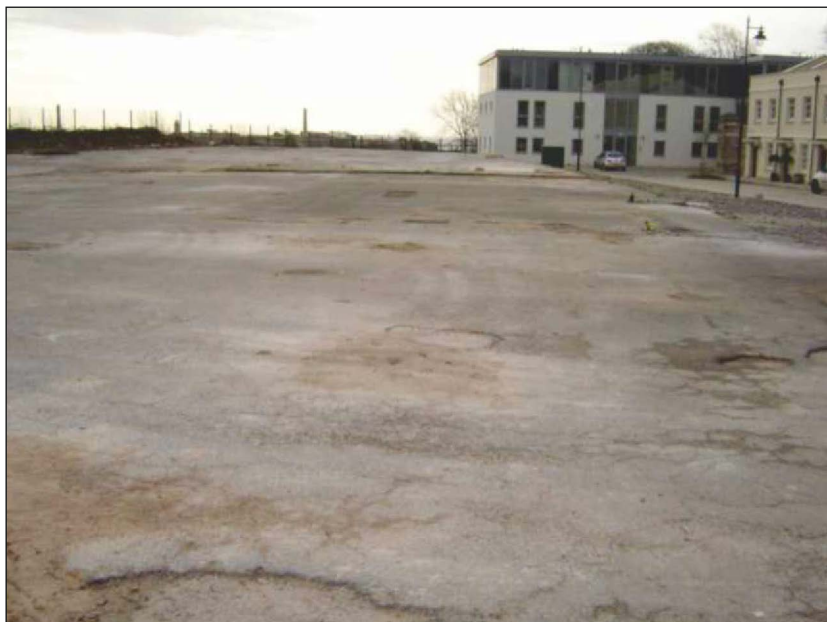
Plate 1: General view of the site prior to groundworks, looking south.  
Photograph courtesy Henry W Pollard & Sons Ltd

- 5.1 Prior to the start of the works the area of the development had been a level car park (Plate 1). The car park was built partly on former landscaped grounds at the south end and tennis courts to the north. Beneath the car park tarmac and hardcore (up to 0.50m below car park surface) the site was found to have a very limited depth of deposits above rubble and solid limestone bedrock (Plates 2 and 3). The depth of the deposit beneath the car park layers increased to the southeast where at a depth

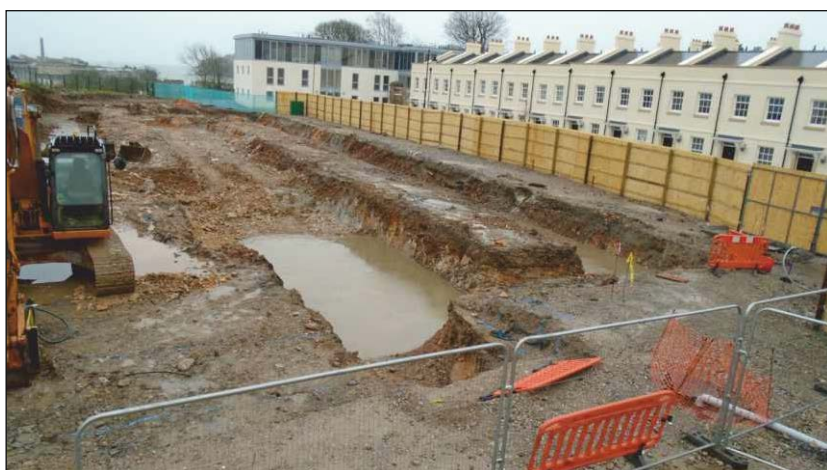
Plate 2: General view of groundworks, looking southwest. Photograph courtesy Henry W Pollard & Sons Ltd

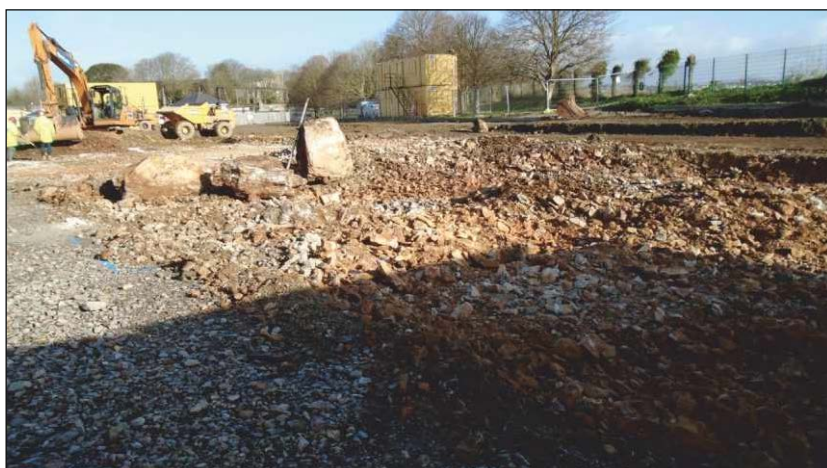
Plate 3: South end of the site showing shallow stratigraphy, looking northeast.  
Photograph courtesy Henry W Pollard & Sons Ltd

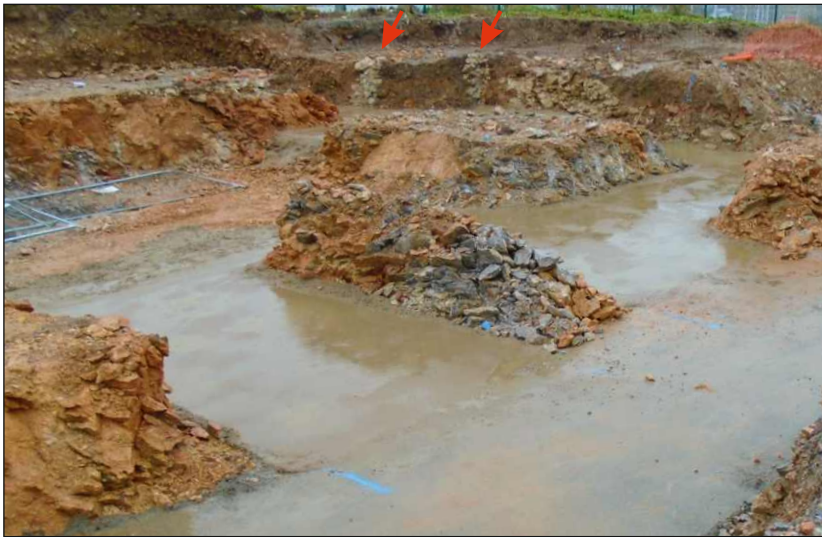
Plate 4: Southeast corner of the site with arrows showing the northeast to southwest parallel walls S601 and S602, looking southeast. Photograph courtesy Henry W Pollard & Sons Ltd

- 5.2** The Dock Lines walls comprised the inside of the inner ditch line (S603/S604) and two parallel walls (S601 and S602) projecting in an approximately northeast-southwest alignment (Plate 4). These are elements of the Dock Lines previously exposed in the evaluation trenches by Exeter Archaeology. To the east of these a section of wall (S605) probably representing the lining of the outside of the earliest phase of Dock Line ditch was exposed (Plate 5). The features were exposed to a depth of approximately 1.3m and as this was the limit of the formation level the wall foundations and base of the ditch were not exposed.

- 7.3** The features S601-S604 represent part of the circuit that appears to have had its line retained through the full history of the defensive work formed in earliest mid-18th century phase and continuing until this part was filled and landscaped in the late 19th and 20th centuries. The purpose of the projecting walls (S601 and S602) is not known, but they are located in the position of a foot bridge marked on a map of 1896 (Fig. 3), previously recorded by Exeter Archaeology, and may have been built to support a bridge crossing the defunct defences and allowing access from the grounds to the east of Admiralty House to a small area of land defined by an angle of the ditch and the quarry to the east. Alternatively, an 1857 map shows a gun platform close to this position (Pye and Woodward 1996, 164, fig. 78) and similar parallel walls for supporting gun platforms have been observed on the Lines to the north at the musketry keep of George's Bastion (Rainbird *forthcoming*).

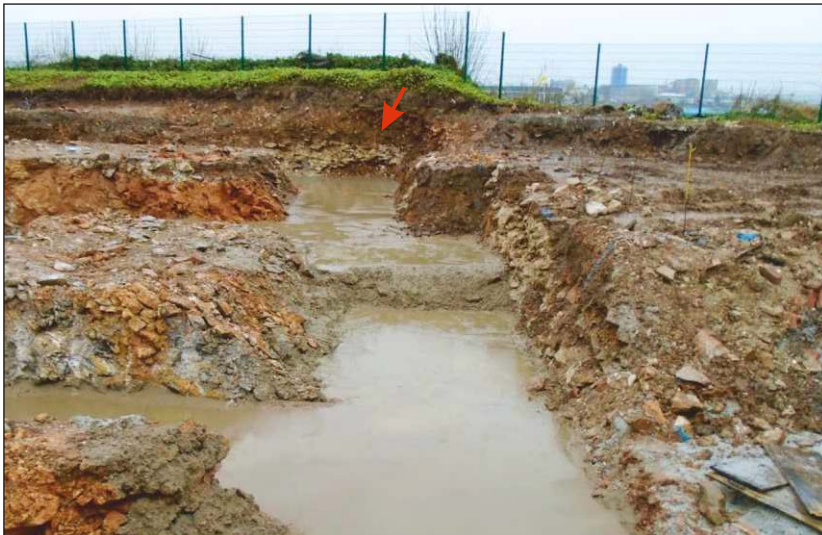
Plate 5: Southeast corner of the site with arrow showing the outer wall S605 of the early dock lines ditch, looking southeast. Photograph courtesy Henry W Pollard & Sons Ltd

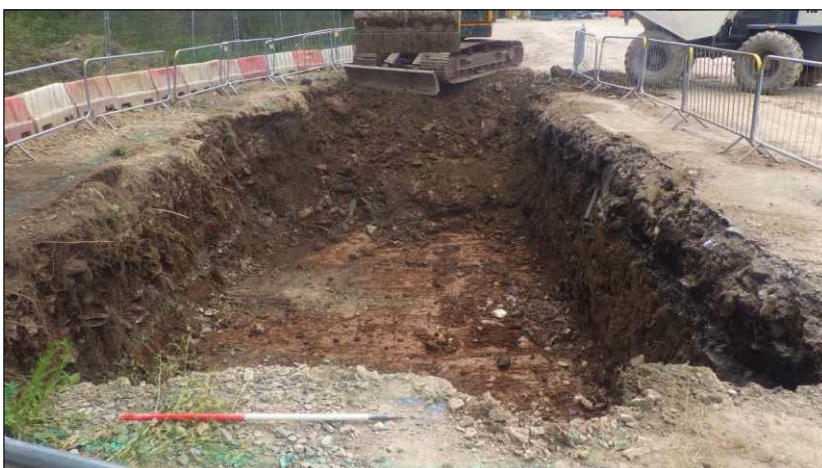
Plate 6: Soakaway tank 1 during excavation, looking southwest. (1m scale)

- 5.3** This tank was located towards the northeast corner of the site, outside of the projected alignment of the 1750s/1760s Dock Lines (Plate 6). It measured 11m long by 5m wide and was excavated to a depth of 2.50m below the ground surface. A probable natural deposit of dark brownish-red friable silty-clay with common limestone inclusions (1003) was exposed from a depth of 1.90m below the surface. Within the southwest side of the trench this was overlain by 0.10m thick buried topsoil consisting of dark brown friable silty-loam (1002), which appeared to have been historically truncated by an episode of landscaping. This was sealed by a 1.55m thick layer of made-up ground (1001) comprising mixed deposits of stone, sand, silty-loam and clay ranging in colour from greyish yellow to mid brown and in consistency from firm to loose. The deposits included various inclusions of limestone and river gravels as well as unfrogged bricks. This made-up ground was sealed by a 0.25m thick layer of mid grey-brown friable silty-loam with occasional sub-rounded gravels (1000). No archaeological features were exposed and no finds recovered.

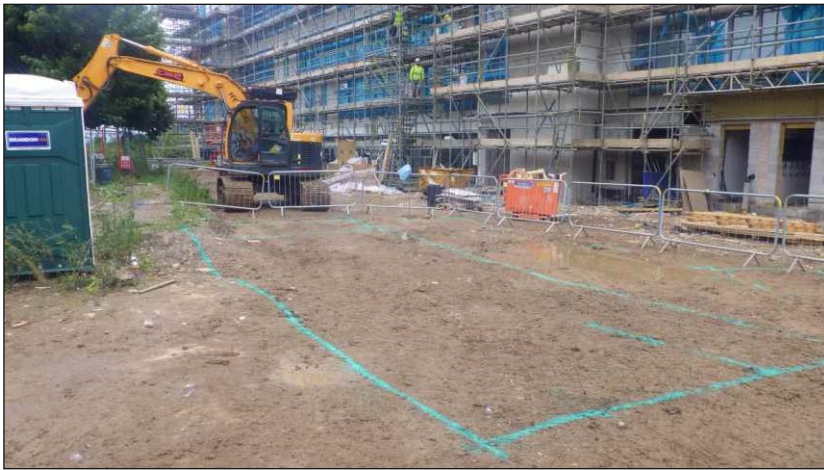
Plate 7: Location view of soakaway tank 2, looking southwest.

- 5.4** This tank was located to the east of the northeast corner of the apartment block, and measured 11m long by 5m wide, and was excavated to a depth of 3m below the surface (Plate 7). It was partially located within the projected course of the 1750s/1760s Dock Lines. Natural light red-yellow friable silty-clay with frequent limestone fragments (2002) was exposed at a depth of 2m from the surface, and was overlain by a 0.60-0.80m levelling layer (2001) consisting of mid yellowish-brown friable clayey-loam with abundant limestone boulders and gravel inclusions.

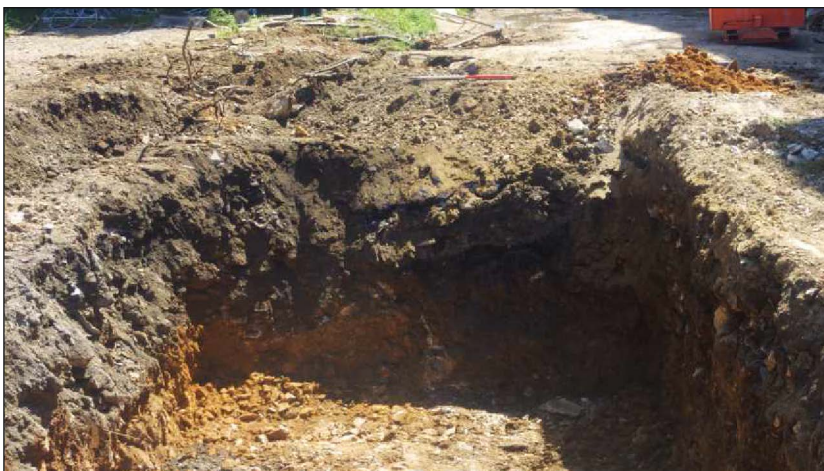
Plate 8: Soakaway tank 2, north-facing section showing Dock Line ditch F2003. (1m scale)

- 5.5** Layer 2001 was cut by the Dock Lines ditch (F2003) that passed through the trench on a north-northeast – south-southwest alignment (Plate 8). The full extent and depth of the ditch was not exposed within the trench. Against the edge of the ditch, at the base of the trench, part of an outer retaining wall (2004) was exposed. This comprised four courses of limestone blocks that only survived within the southern 4m of the trench. The lowest exposed fill (2005) was a deep light yellowish-brown friable clayey-loam with abundant limestone boulders and gravel inclusions, above which was a group (2006) of shallow black and white clay fills. The ditch was sealed by up to 1.40m of a dark grey loose silty-sand levelling deposit containing brick inclusions and service trenches.

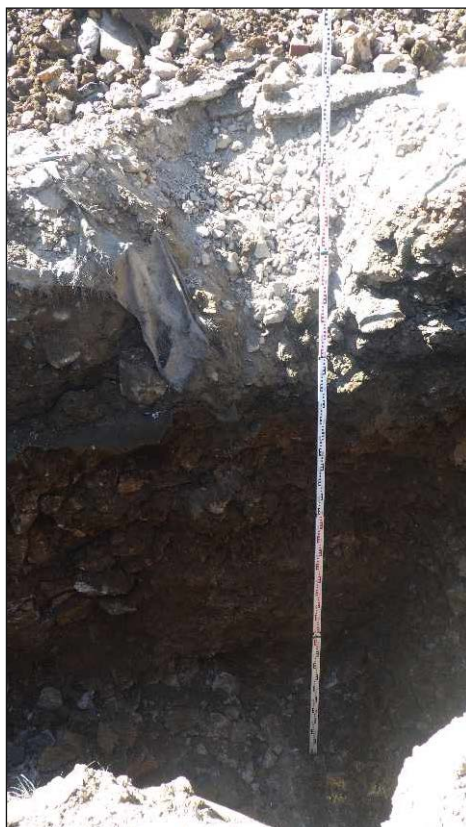
Plate 9: Trench 2, north-facing section showing Dock Line ditch F406.

- 5.9** Solid bedrock (307) was exposed at a depth of 0.35m from the surface. At this level the Dock Lines ditch (F406) was exposed (Plate 9). This had steeply-sloping sides and a slightly curving base, and measured c. 6m wide by 3.80m deep. Fragments of walling in the sides of the ditch, cut into ledges in the bedrock, were noted, but these were very fragmentary. The ditch contained a thin primary fill (405) of dark greyish-black silty-clay with abundant limestone, which was overlain by thick layer (404) of mid reddish-brown silty-clay with rare limestone fragments. Above this was a further fill (403) – a reddish-brown silty-clay with abundant limestone inclusions – that continued west beyond the top of the ditch cut on this side of the trench. The final fill of the ditch (402) was a mid grey-brown silty-clay with abundant limestone inclusions. The ditch was sealed by a 0.10m thick former topsoil (401) of dark brown silty-clay and a 0.25m thick layer of modern levelling (400).

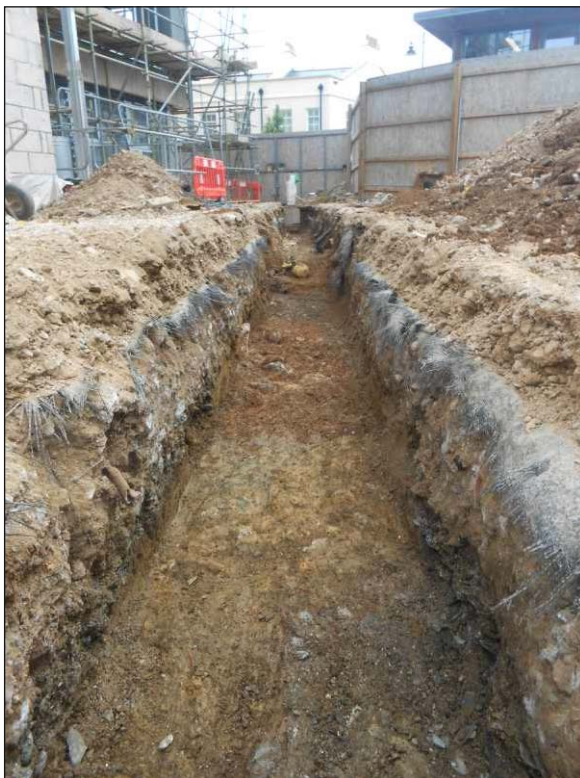
Plate 10: Service trench, location view showing wall 102/103 mid trench, looking southwest

- 5.11** However, to the north of the apartment block excavations were taken to a depth of 0.75m below the surface, and in one location archaeological deposits were present below the base of the concrete (100). The earliest deposit was a layer of loose grey-black silty-clay containing common gravels, glass, brick, lime mortar and fragments and charcoal flecks (105). A north – south aligned wall (102/103) had been cut through this layer (Plates 10 and 11). The surviving foundation of the wall measured 0.80m wide and was constructed of limestone pieces measuring between 0.14m and 0.48m long, bonded in light reddish-brown compact very slightly silty clay with occasional gravel. The wall was overlaid by a layer of mottled yellow compact clay containing brick and slate fragments (101). All recorded deposits were disturbed by an existing service trench (F106) that was partly exposed in the northern side of the current trench.

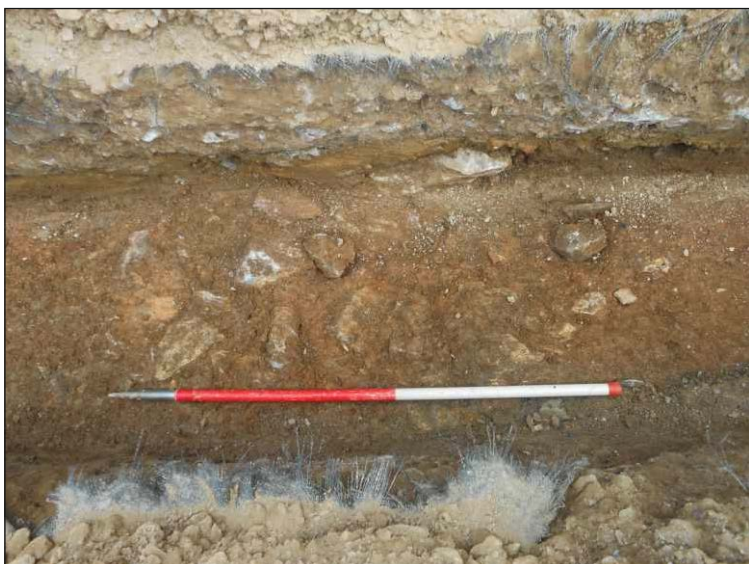
Plate 11: Service trench showing wall 102/103, looking southeast. (1m scale)

- 7.4** Wall 103 recorded in the service trench north of the apartment block is located to the west of the course of the Dock Lines ditch. The position and alignment of the wall correlates with the course of a pathway running around the inside of the rampart that is recorded on an Ordnance Survey map of 1857 (Pye and Woodward 1996, fig. 78).
