36 HIGHER SHAPTER STREET, TOPSHAM, EXETER

Results of historic building recording and archaeological monitoring

Exeter City Council planning reference: 16/1543/03
(Condition 5)

Document No: ACD1578/2/2

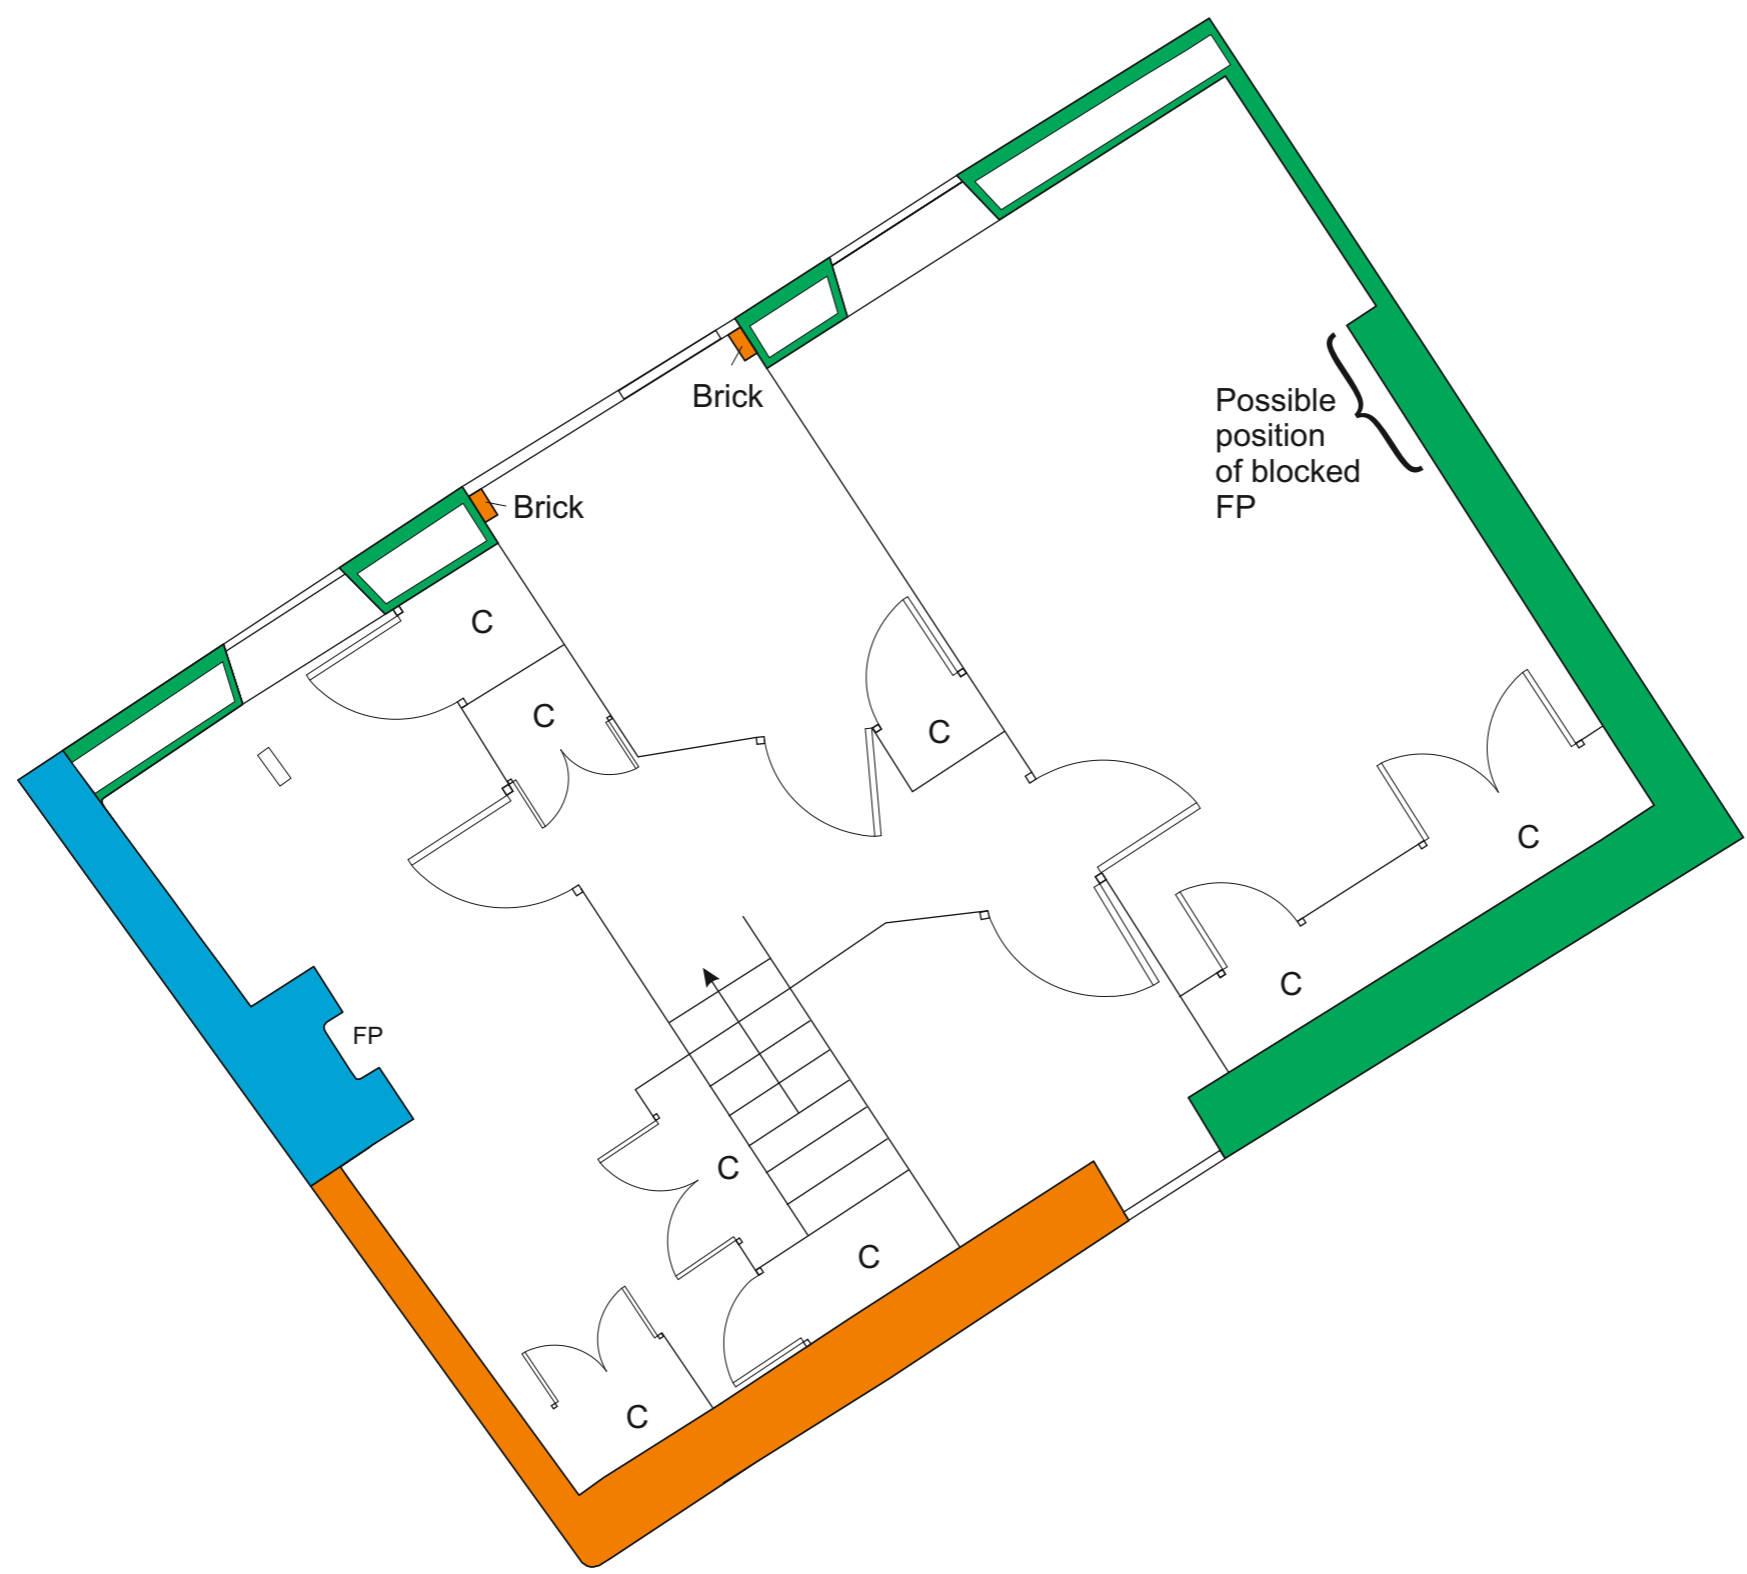
TITLE
Fig. 3: First-floor phase plan

The stairs lead to a landing giving access to four rooms; at the front of the landing opposite the stairs is a cupboard that can also be accessed from the west bedroom. In the full-depth west

bedroom is a low beaded skirting board that is also present inside a second cupboard at the front of the building. The main bedroom door is planked with very thin strap hinges (Plate 6). In the southeast corner there is a fitted cupboard over the stairs with the same planked door and strap hinges as seen on the main doorway. There is a projecting chimney stack in the west wall; the fireplace has been blocked. To the west, the wall has collapsed, and has been replaced with plasterboard attached to a wooden frame, and finished with replacement beaded skirting. The remainder of this wall is light brown cob with inclusions of gravel and brick fragments. The exterior has been refaced in brick delineating the position of the demolished adjacent property, and may have been added when this building was attached to the side of no. 36. Two phases of brick masonry of the chimney stack are visible.

The front central room is small, with a full width reveal to the window defined by 20th-century brick lining and reset wooden posts (Plate 7); the post to the right-hand side displays scars of lathe and plaster. There is a built-in cupboard within the southern wall. On the opposite side of the landing is a central bathroom, which contains entirely modern fixtures and fittings.

The east bedroom extends to the depth of the house and contains a built in cupboard along the southern wall. The room has low beaded skirting boards that have been reset in between the cupboards and over a blocked fireplace in the east wall. To the north of the former fireplace is a high level recessed ledge (Plate 8). All of the walls appear to be boarded over an earlier finish.

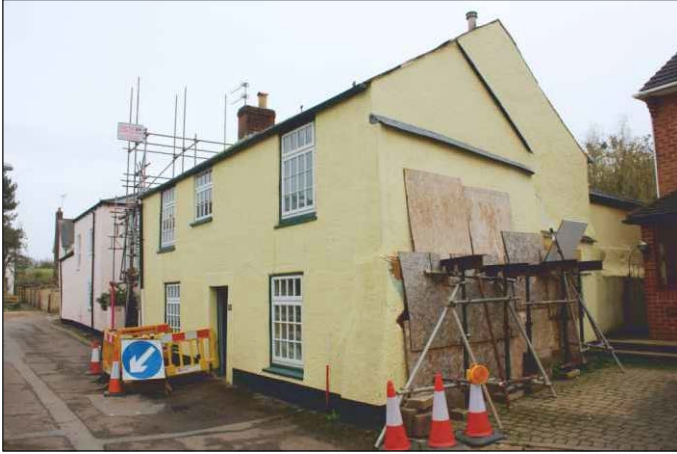
The principle facade of the slate roofed, two-storey property faces north onto Higher Shapter Street and is set straight onto the highway (Plate 1). It has a broadly symmetrical elevation composed of a central doorway and pairs of windows either side; the windows on the first floor are slightly offset to the gables. There is additional central first-floor window which is slightly offset to the north. The front door is a 20th-century planked door with six top-frosted light fixtures. The four external windows are early 20th-century 12-pane fixed windows with four-pane top-opening lights. The first-floor central window is of the same design but is shallower with eight lower panes. A cast-iron down pipe survives at the northeast corner, but has been replaced with a plastic downpipe; the gutters are also plastic.

The west elevation of the front range displays several structural features including a mostly cob buttress in the southwest corner. At the front is the projecting masonry of a formerly attached property (no. 30) with a lower roof pitch than can be seen at no. 36. Below eaves level there is a further slight projection of the masonry with lead flashing. To the rear of the property at ground floor level, the wall projects out to the same line and is finished with slate tiles.

Plate 1: North and west elevations, view from the northwest. 1m scale

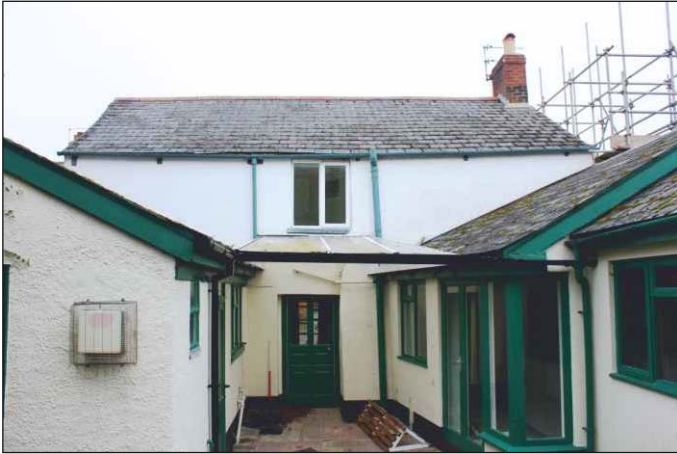
The south elevation is entirely rendered with a central splayed opening containing an early 20th-century panelled door, the upper panel of which contains two panes. To the east of the doorway is a largely rendered burnt stone buttress. Above the doorway there is a single first-floor double-glazed window.

Plate 2: South elevation, view from the south. 1m scale

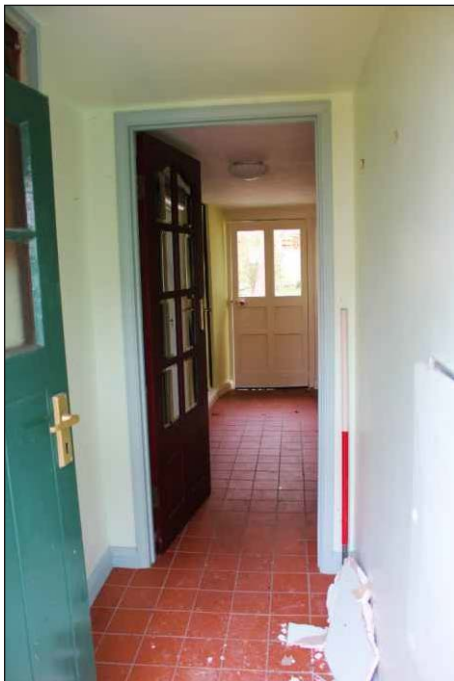
The front door leads to a central passage with a 20th-century tiled floor; this is divided by a modern partition into an entrance lobby and a rear corridor (Plate 3). The walls between the lobby/corridor and adjacent rooms are formed from timber frames with a series of closely-set slender studs and diagonal braces, with some repairs and replacements visible (Plate 4). At the time of the initial survey the north end of the eastern wall was not visible.

Plate 3: Lobby and rear corridor, view from the north. 1m scale

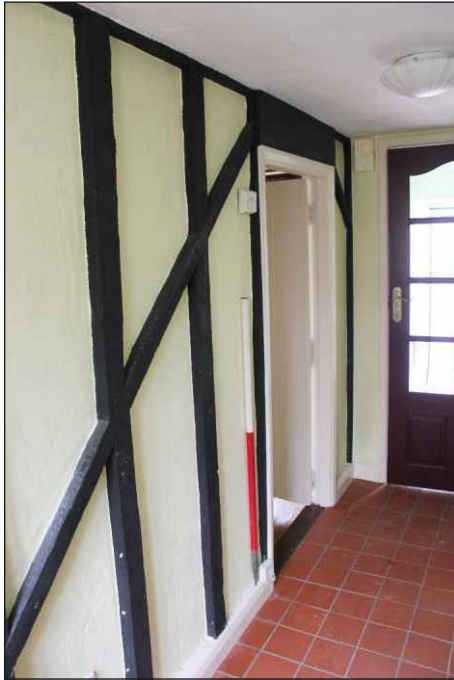
Plate 4: Rear corridor timber framing, view from the southeast. 1m scale

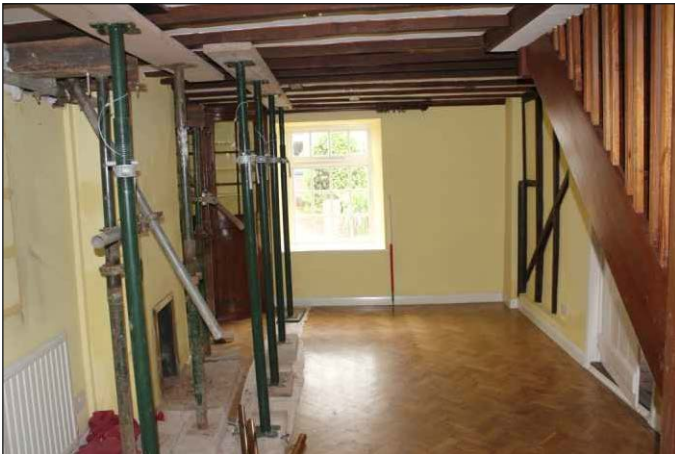
The west room has with an off-centre protruding chimney stack in the west wall with a reclaimed Dutch brick hearth laid onto concrete (Plate 5). It has a parquet floor, and contains a 20th-century staircase to the first floor; it also features a metal framed double door to the rear kitchen. The ceiling is composed of thin stained battens with scars of removed lath and plaster. The modern ceiling is set between these timbers.

Plate 5: Ground floor west room, view from the south. 1m scale

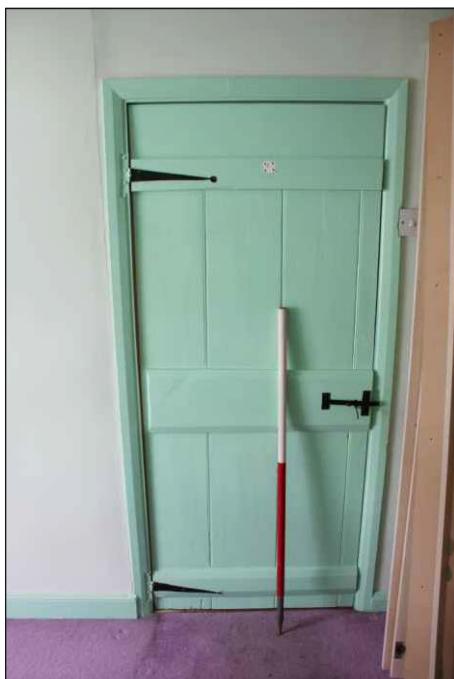
Plate 6: First floor main bedroom door, view from the west. 1m scale

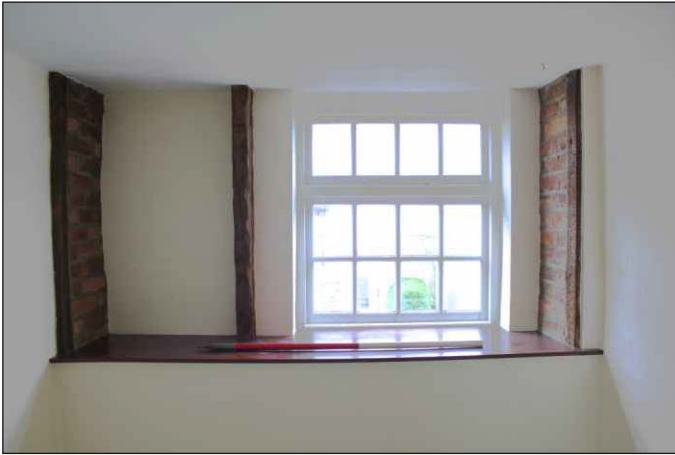
Plate 7: First floor central room window reveal, view from the south. 1m scale

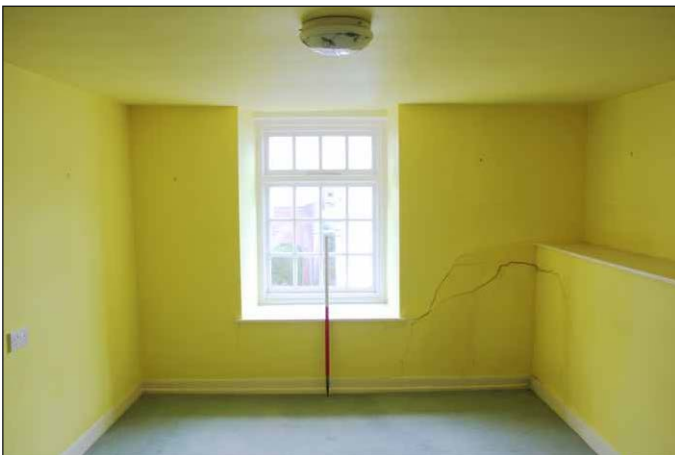
Plate 8: First floor east bedroom, view from the south. 1m scale

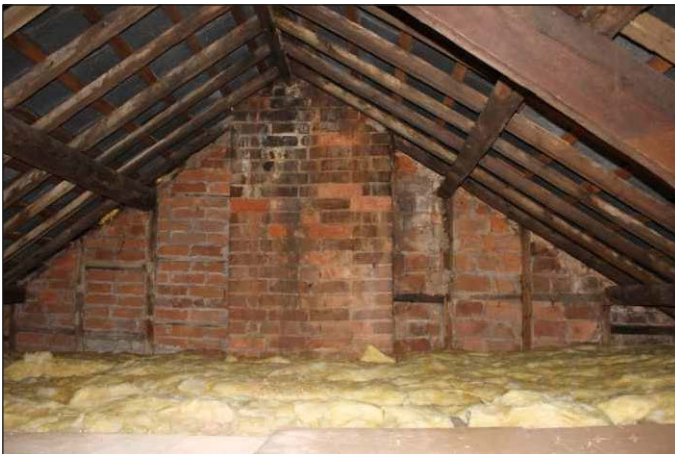
The loft is accessed through a modern hatch and has been boarded out, but an old beam is visible below. The loft is continuous over the whole width of the building. The east and west gables incorporate projecting brick chimney stacks with timber framing either side filled with noggin of variously-sized bricks (Plate 9); the southwest section has been rebuilt in the late 20th century following the collapse of the wall (see also Section 5.6 above). The roof is also supported on three trusses of principal rafters with lapped apexes and nailed joints. The rows of back purlins support secondary rafters and a modern slate covering laid on battens. The secondary rafters have plaster adhering to the sides and it appears that a ceiling has been removed. The trusses are braced by short struts down to the tie beams at first-floor ceiling level.

Plate 9: Loft, east gable, view from the west

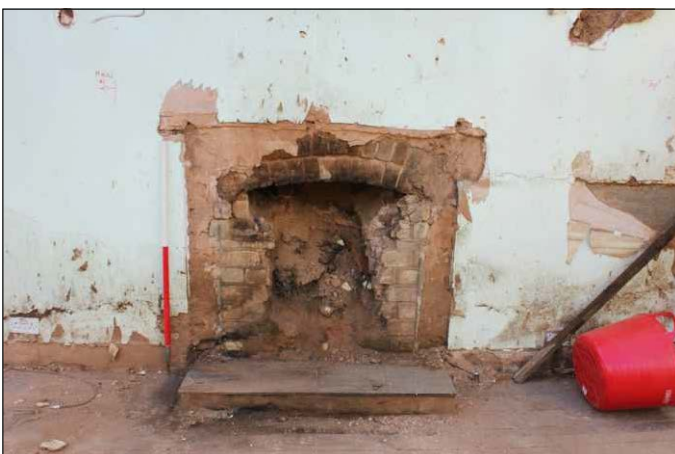
The ground-floor fireplace in the east wall has a brick arched head, repointed in the 20th-century, set into a brick chimney stack (Plate 10)

Plate 10: Ground floor, east room fireplace revealed during demolition, view from the west. 1m scale

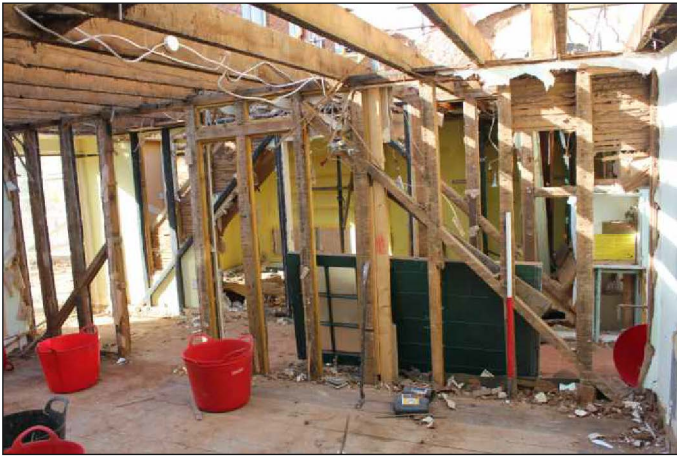
Both ground-floor timber-framed partitions were fully exposed, including the north end of the east partition that had not previously been fully recorded. The exposure of this wall also confirmed that the doorway had been moved to the south (Fig. 4; Plate 11).

Plate 11: Ground floor, east hall partition revealed during demolition, view from the northeast. 1m scale

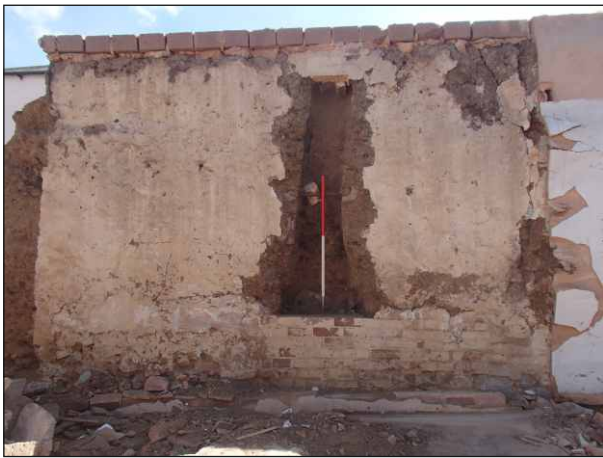
The southeast extension was built against a tall east boundary wall built of cob contemporary with the east wall of the main house. A scar in this wall indicates the position of a chimney flue that must have served the former rear outbuilding recorded on historic Ordnance Survey maps (Fig. 5; Plate 12).

Plate 12: Southeast extension, rear wall showing chimney scar, view from the west. 1m scale

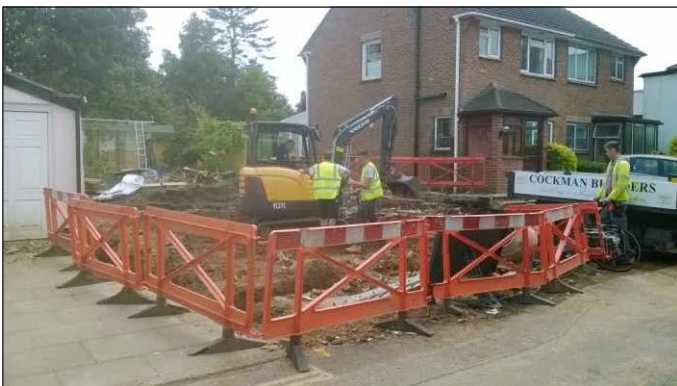
Plate 13: General view of the site following demolition of the standing building, view from the north

The groundworks were monitored following the demolition of the house (Plates 13 and 14). The following observations were made.

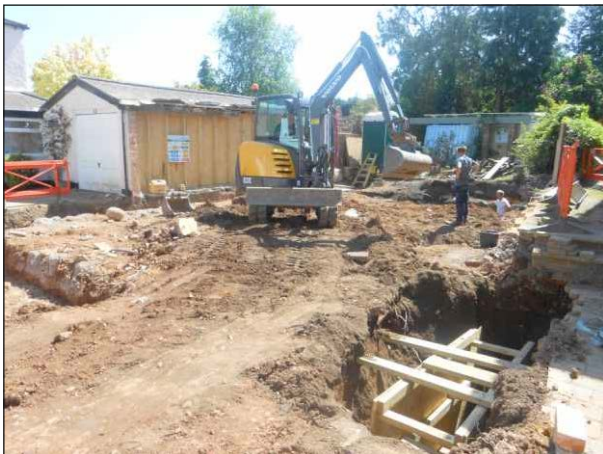
Plate 14: General view of the site, groundworks in progress, view from the west

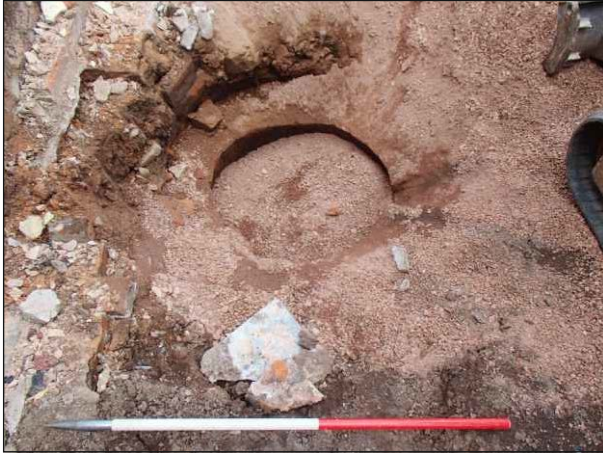
A well was located adjacent to the west boundary of the site, roughly central to the new house plot, and historically located in the garden to the rear of the main house below the later kitchen extension. It was brick-lined and was sub-circular with dimensions of 0.90m by 0.80m and was assessed as being 6.50m deep; for safety reasons it was not fully investigated (Plate 15).

Plate 15: The well, view from the southeast. 1m scale

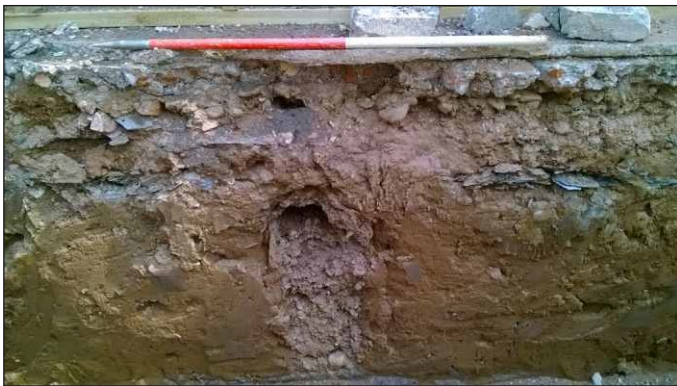
An ill-defined feature (F103) was recorded in section only and was beneath the modern garage to the east (Plate 16). It measured 0.46m wide at the top reducing to 0.20m at the base and was 0.7m deep with straight steep sides. It contained a single fill (104) comprising almost completely of loose fragmented slate. There were no finds. It may be a sump or drain associated with the construction of the garage.

Plate 16: Feature F103, view from the southwest. 1m scale

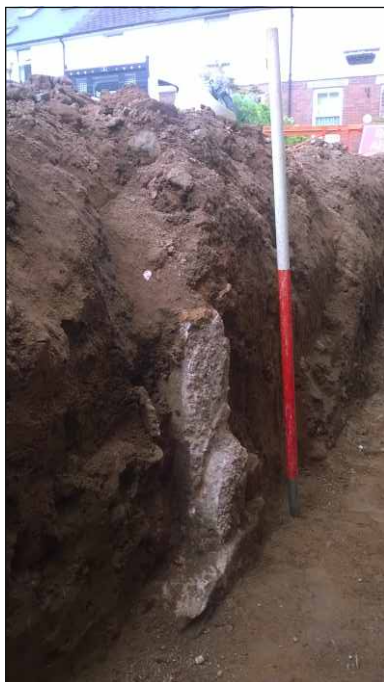
A wall foundation was also exposed in the west side of the east foundation trench Tr 1 (Plate 17). Foundation 107 comprised a concrete post on a concrete pad within a construction trench F108 measuring 0.67m wide by 0.40m deep, which was cut into post-medieval deposit 101. The backfills of the construction trench (105) and (106) contained modern finds, including brick and mortar, which were not collected.

Plate 17: Wall foundation 107, view from the east. 1m scale

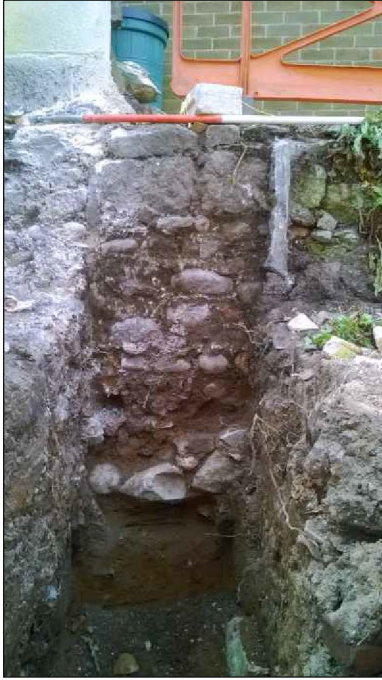
The foundations for a boundary wall was exposed at the southwest corner of the new building (Plate 18). Natural subsoil (102) was exposed at a depth of 1.6m below ground surface and above this were a series of deposits which were only exposed in section. The lowest deposit (113) comprised mid reddish-brown clayey sand it contained one sherd of post-medieval pottery and a piece of worked flint which is residual in this context. Above this was a foundation comprising of two courses of rounded and angular cobbles with remnants of lime mortar bonding surviving. Above this was a deposit (111) of dark brownish-red sandy clay, which provided a level surface for wall 110 formed of clay, cobbles and lime mortar measuring 0.30m thick. Above this was wall 109 comprised of sub-square and rectangular stone blocks bonded in mortar.

Plate 18: Wall foundations 110 and 109, view from the northeast. 1m scale

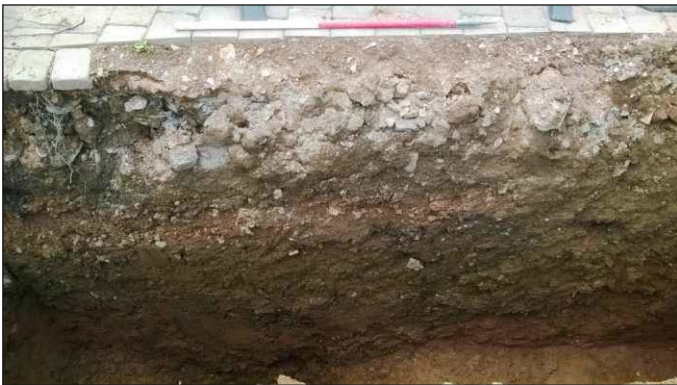
A northeast-southwest aligned ditch F117 was exposed in the base of Trench 4 (Plate 19), located approximately 4m back from the Higher Shapter Street. It was not fully exposed, and measured minimum of 1.20m wide by 0.65m deep. It contained two fills – a lower fill (116) of mid pinkish red clayey sand containing no finds or inclusions, and an upper fill (114) of mid to dark grey sandy loam containing animal bones, shell and charcoal, none of which were collected.

Plate 19: Ditch F117, view from the northeast. 1m scale

8.1 Ditch F117, whilst directly undated, due to its position clearly predates the current no. 36 Higher Shapter Street, which based on cartographic evidence (see Section 2 above) was present by 1801. The northeast-southwest alignment of the ditch is consistent with other field boundaries northeast of The Strand, and the feature is therefore interpreted as part of a boundary pre-dating the construction of Higher Shapter Street. The single recovered flint was residual, but may provide very limited evidence for general use of the area in prehistory.
