LAND AT EAGLE YARD, TUDOR STREET, EXETER, DEVON

Results of historic building recording, archaeological evaluation
and an archaeological watching brief

Exeter City Council Outline Planning Permission no. 14/1166/01
(Condition 8)

Document No: ACD1352/2/1

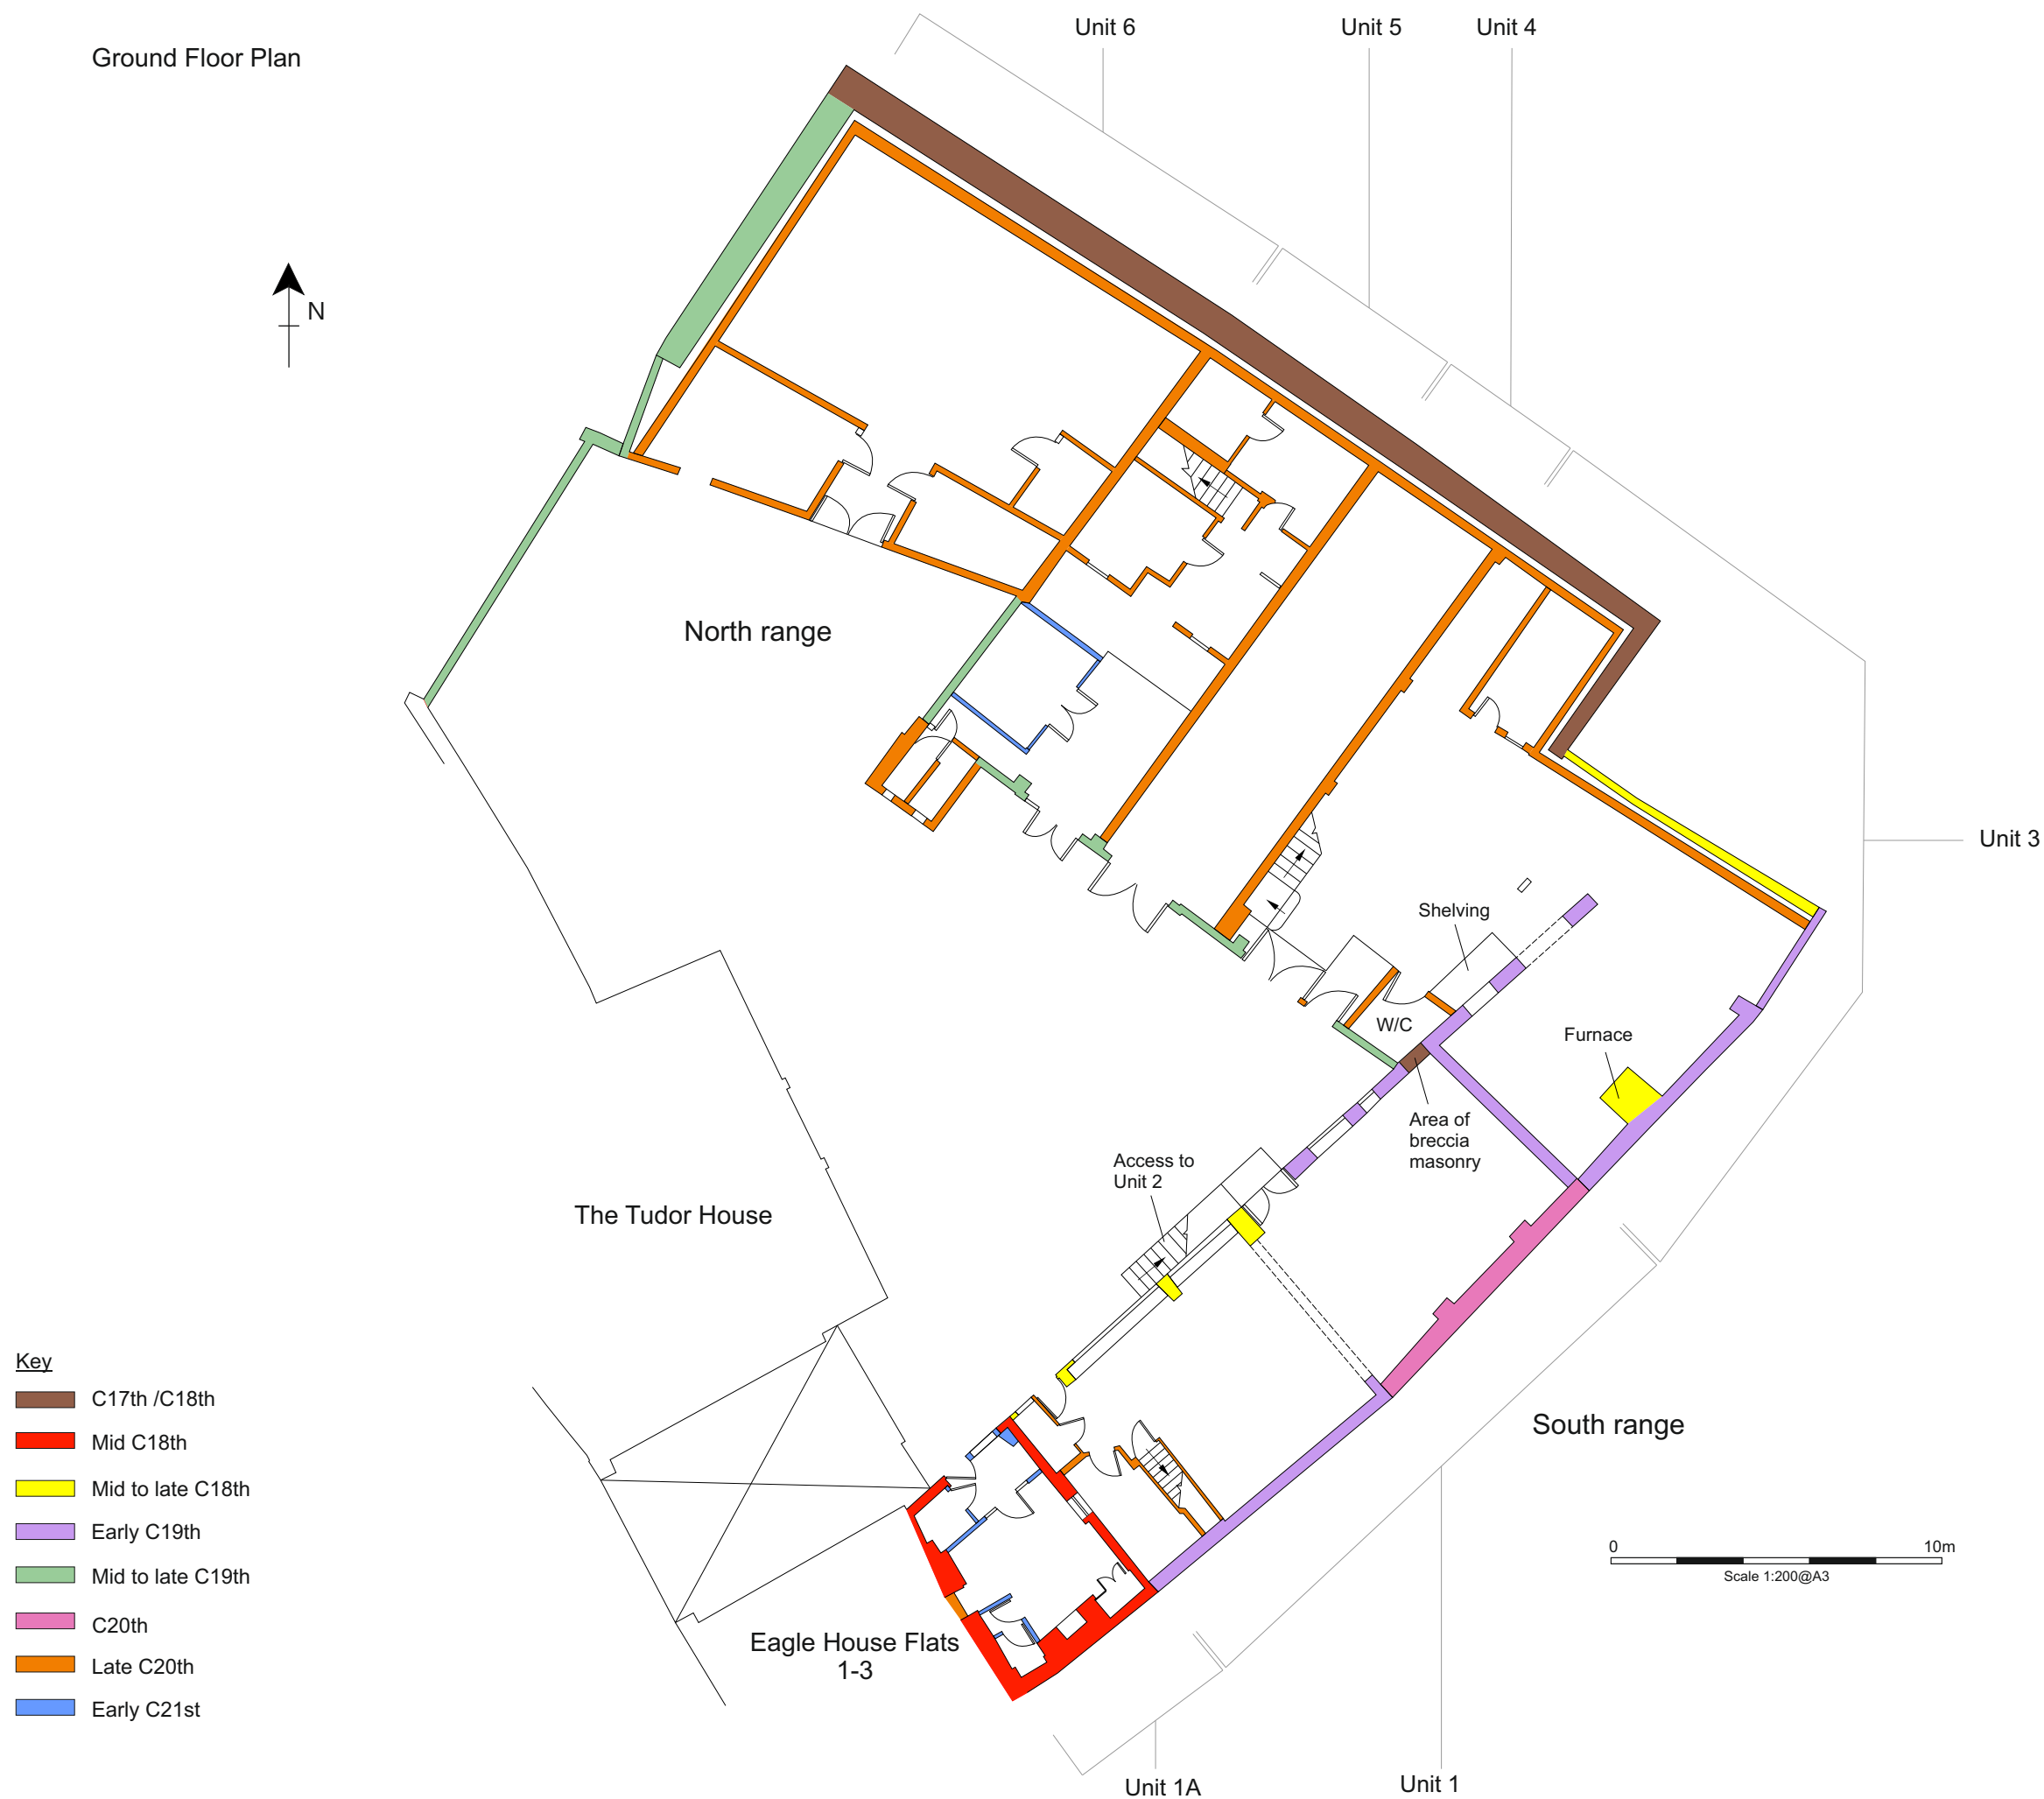
Ground Floor Plan

- Key**
- C17th /C18th
 - Mid C18th
 - Mid to late C18th
 - Early C19th
 - Mid to late C19th
 - C20th
 - Late C20th
 - Early C21st

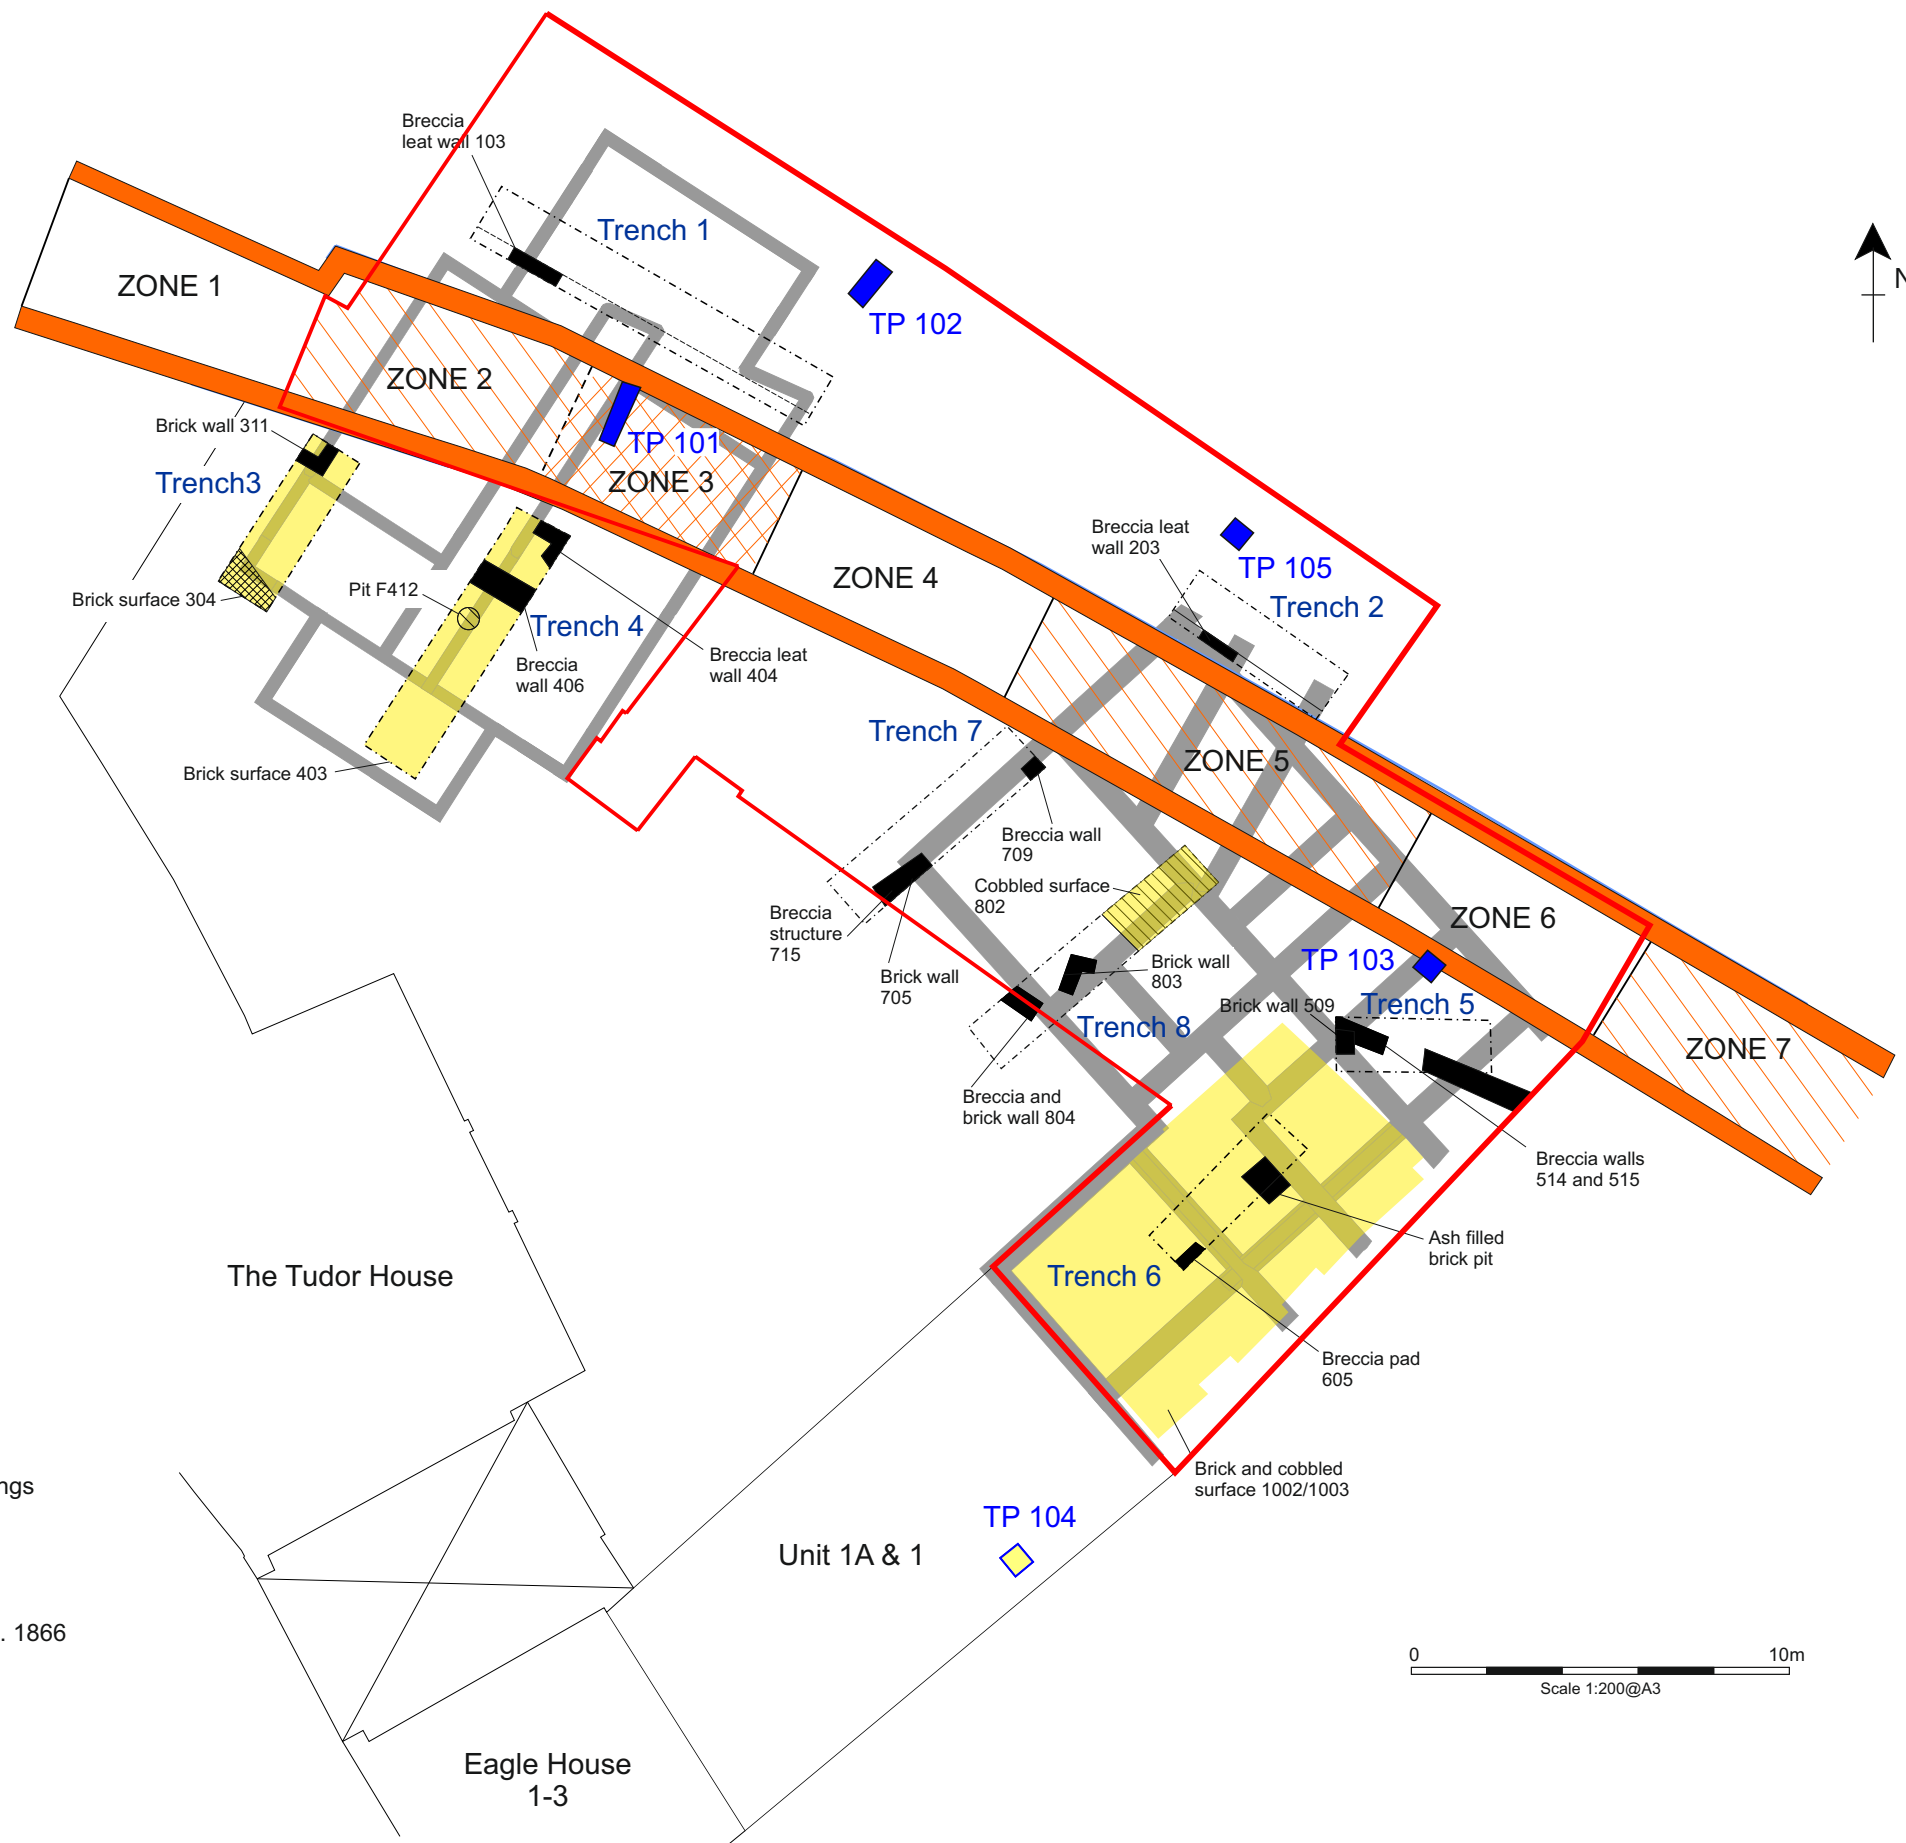
- Key**
- Foot print of demolished buildings
 - Leat walls (Breccia)
 - Brickwork barrel vault
 - Brickwork Jack arch dates to c. 1866
 - Surface
 - Structure
 - Proposed buildings

The Higher Leat was channelled through the site in a culvert. The roof of the culvert needed to be removed to allow for the checking and repair of the leat walls and also to allow the leat to be re-opened as a feature within part of the development. Previous examination had shown that the roof of the culvert was made of eight sections (Zones 1-8) of varying brick arches and concrete slabs (see above section 7.2 and Simon

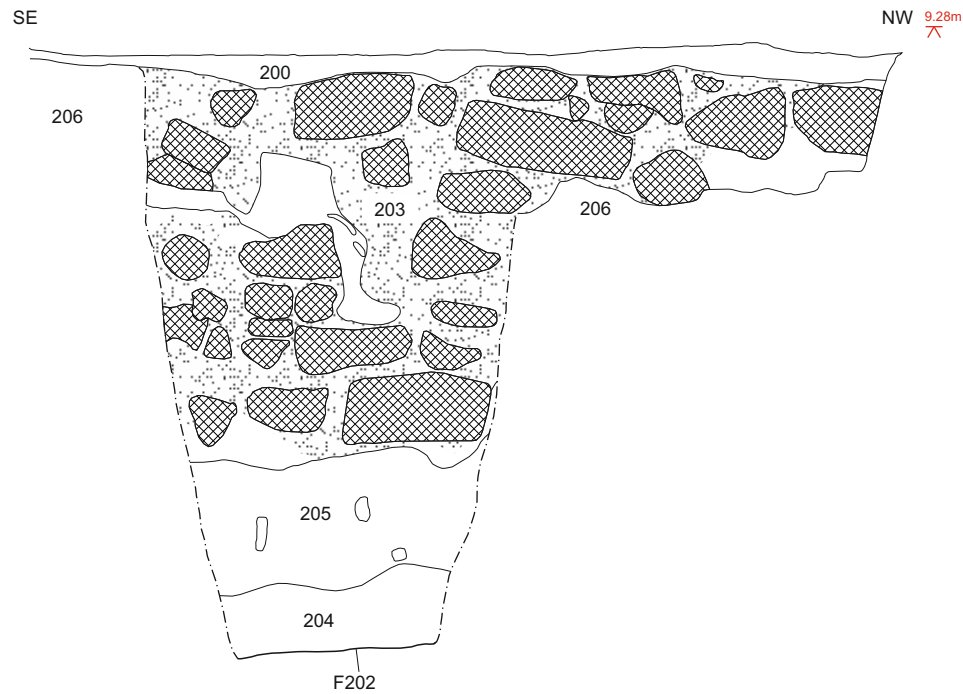
c) Section of F202

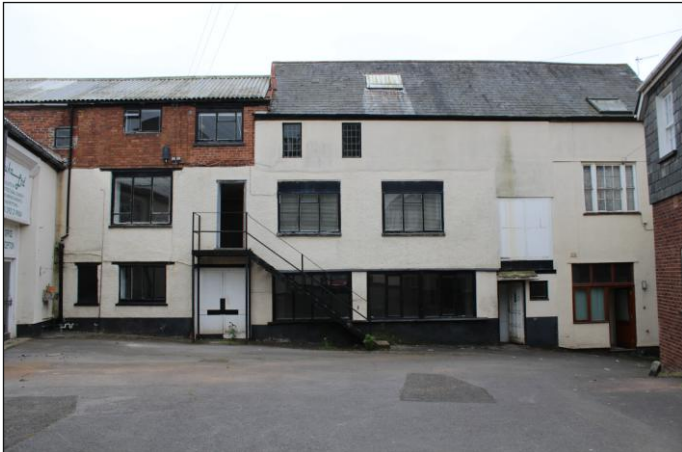
Plate 2: Northwest exterior elevation of the south range, looking southeast

- ### **The south range, northwest exterior elevation** (Plates 2-3)
- 5.4 The northwest elevation is the principle façade of the range. It has three storeys with a roughcast render finish to the ground and first floor, along with a modern smooth render finish to the southern half of the second floor and exposed brickwork to the northern half of this floor. The elevation displays three phases of construction with subsequent areas of repair and remodelling. During the soft strip of Units 1 and 1A it was revealed that the northwest elevation was of timber frame and brick construction.

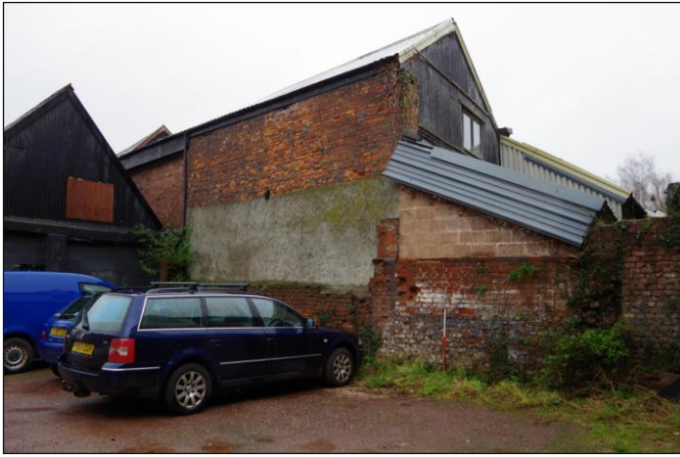
Plate 5: Southeast exterior elevation of the south range at the northeast end, looking west-southwest. 1m scale

- 5.10 The majority of the southeast elevation of the property was obscured by adjoining buildings along the south end of the elevation. From what was visible there appeared to be four distinct phases of build. The earliest element was towards the northeast end of the range, forming the rear elevation of Unit 3, and appeared to date to the late 18th/early 19th century. The ground floor was constructed of English cross bond, finished at first-floor level with an unpainted roughcast render. The second-floor wall had been rebuilt using poor quality and heavily degraded brickwork laid in English garden wall bond.

- 5.11 Abutting this masonry, to the northeast was a c. 2m high wall of English bond brickwork which represents either the remains of a building, now demolished, constructed over the Higher Leat channel in the early 19th century and which extended to the southeast outside of the development area. To the southwest, only the second floor was visible and comprises brickwork, in English Cross bond overlain by a repair or rebuild in Flemish Garden bond brickwork. Later masonry comprised late 20th-century concrete blocks forming the gable of the lean-to extension of the building over the leat.

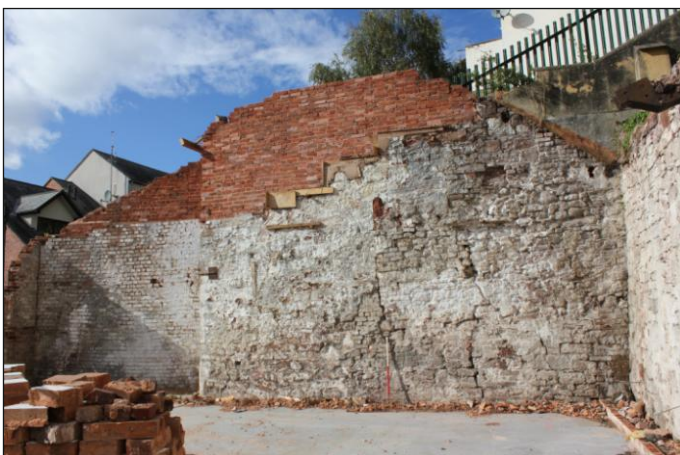
Plate 8: Northwest elevation of mid-19th-century foundry building taken during demolition, showing the earlier boundary wall, looking

- 5.14** The northwest elevation/boundary retaining wall, behind a late 20th-century concrete block wall, is constructed of brick towards the southwest end of the elevation. Here the wall steps slightly out to the northwest where it lies over The Higher Leat. The reasoning for this is unclear as no building has been depicted on any maps to the northwest of the boundary of Eagle Yard in this location. The wall appeared to be a single initial build with several areas of repair evident within the brickwork. Much of the wall was obscured by paint and it is not cohesively built in the same style, with some English bond, some English Cross bond and irregular bonding in places. At the northeast end of the elevation and along the base breccia has been integrated into the brick wall construction. This wall probably dates to the mid-19th century and was part of the large building of the Iron and Brass Foundry located along the northeast side of the property that was first depicted on the 1891 second edition Ordnance Survey map.

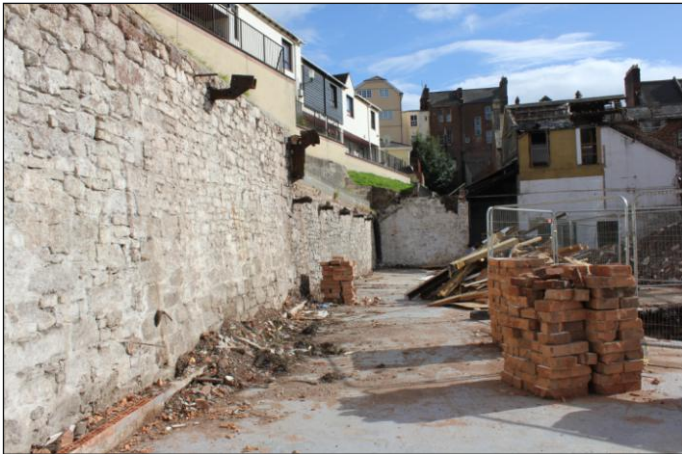
Plate 10: View along northeast breccia boundary wall, with in situ corbel-like iron braces of the mid-19th-century foundry, looking east

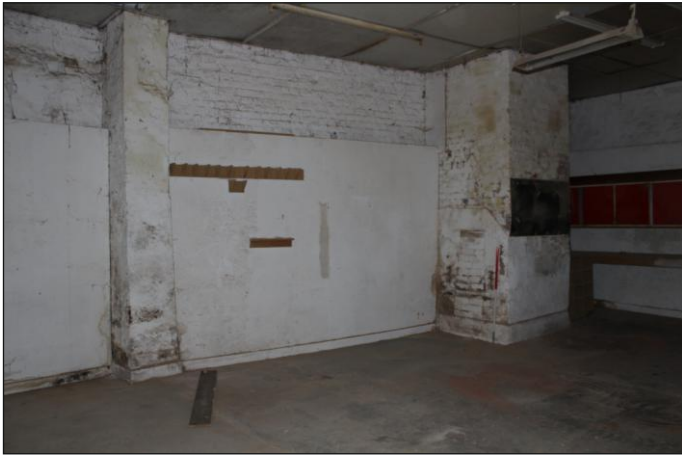
Plate 25: Unit 3, ground floor, brick furnace against the southeast elevation, looking south. 1m scale

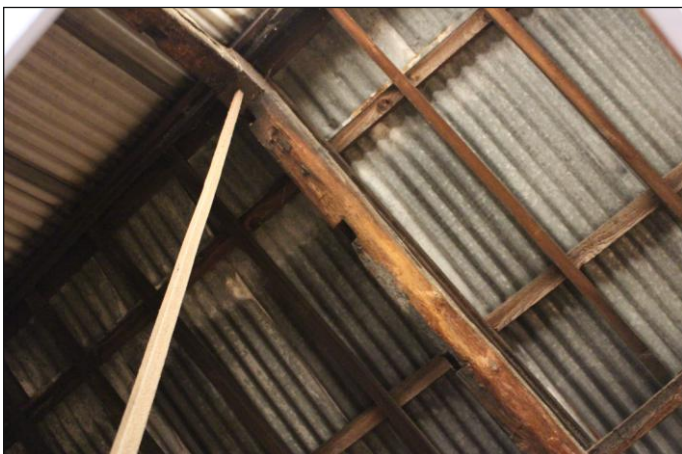
Plate 28: Unit 5, view of A-frame truss and iron king post, looking north

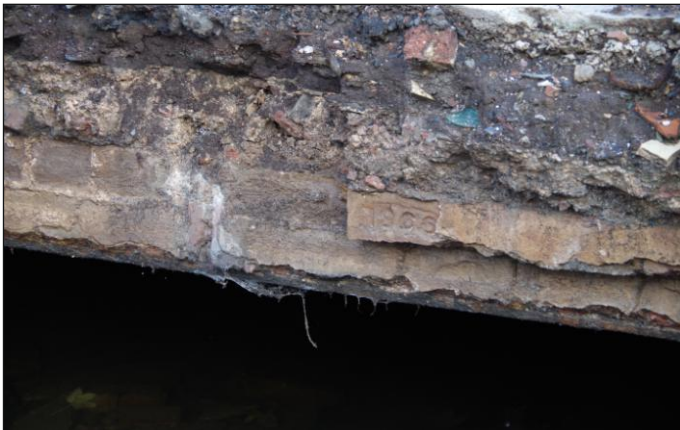
Plate 31: Higher Leat, Zone 3, brick dated 1866, looking northwest

The brick vaulting springs from a band of bricks laid on the breccia blocks with breccia blocks above and behind. This band does not exist where the vaulted arches were not present and indicate that the other zones did not replace earlier arches. The dating of the bricks indicate that the vaulted arches are not necessarily the earliest roofing of the leat, but all of the brick spans are either dated to, or typical of, mid-19th century construction.

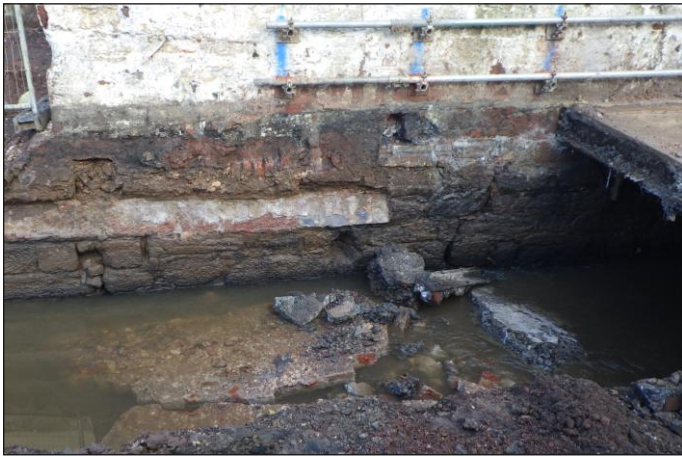
Plate 37: Higher Leat, transition from Zones 5 to 6 showing where line for brick vaulting ends, looking northeast

although it was clear that the vaulted brick arch sections had never extended beyond the lengths to which they survived when recorded. The majority of features and deposits on the site appear to date to the foundry phase of the site which continued until the 1930s. The brick floors and machine bases were eventually covered by tarmac and concrete as new uses for the site were adopted through the remainder of the 20th century.

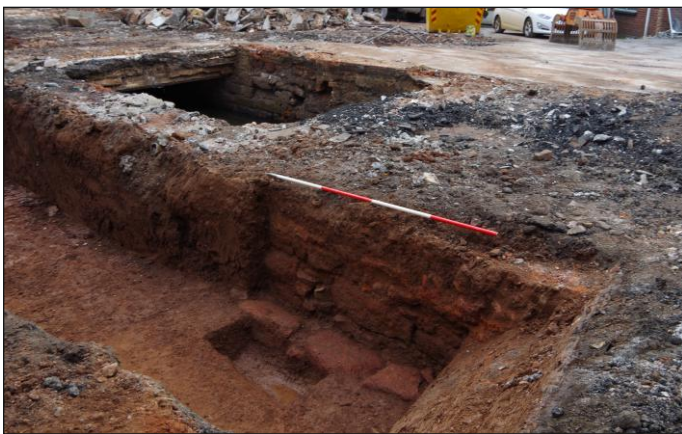
Plate 39: Evaluation Trench 1, leat wall 103, looking south. 2m scale

The sides of the leat were consistently formed of large shaped breccia blocks bonded by lime mortar. Although there were areas of repair in brick, the breccia blocks were of a single phase of construction with no evidence of breaks in the build. In the site directly to the northwest the stone phase, replacing a medieval phase constructed in wood, was given a general date in the post-medieval period (Passmore, Jones and Allan 2009). On the current site the finds from the fills of the construction cut for this wall (see below) provide a date in the mid-18th century for the refurbishment of The Higher Leat in stone.

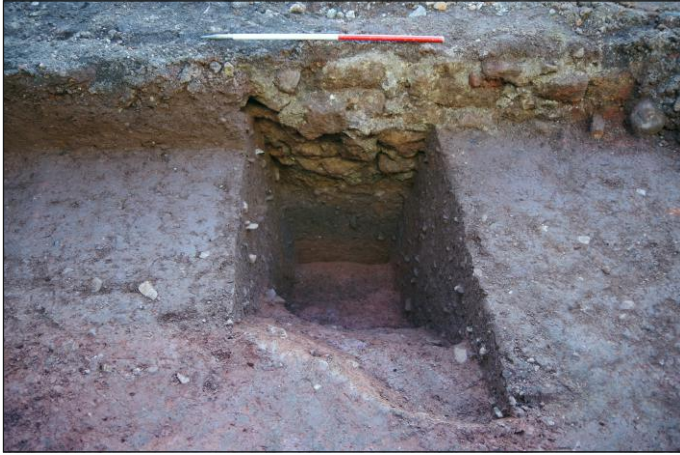
Plate 41: Evaluation Trench 2, leat wall 203, looking southwest. 1m scale

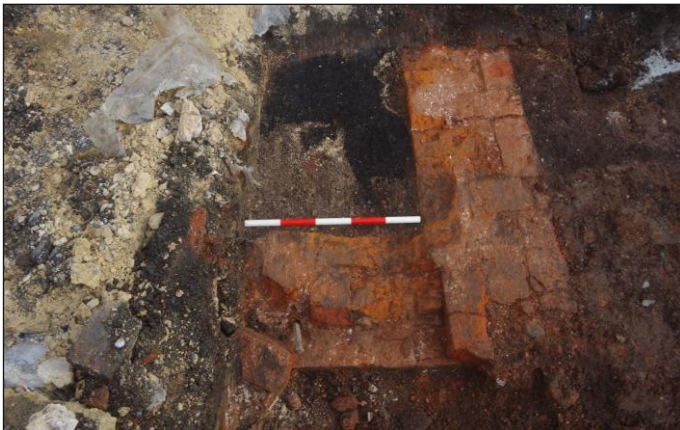
Plate 43: Evaluation Trench 3, wall 311, looking northeast. 0.5m scale

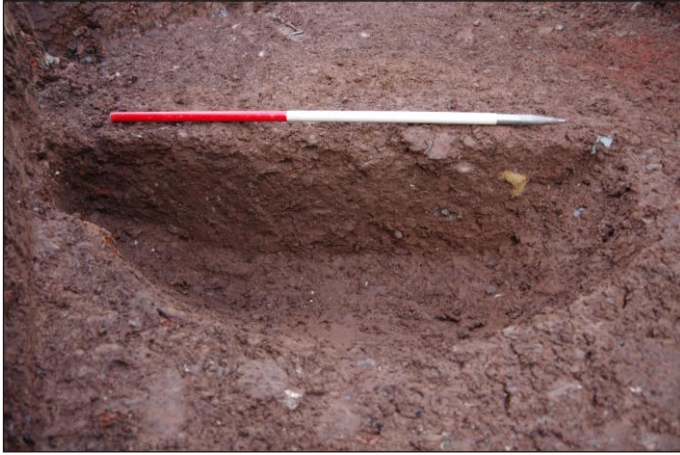
Plate 45: Evaluation Trench 4,
southwest-facing section of pit F412.
1m scale

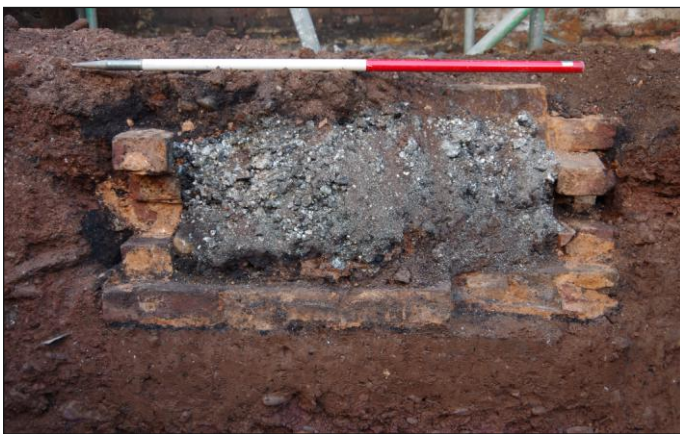
Plate 50: Evaluation Trench 6,
firebox, looking southeast. 1m scale

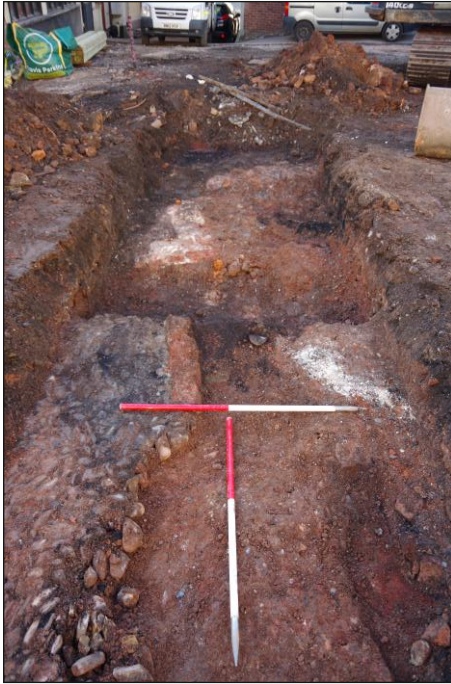
Plate 53: Evaluation Trench 8, cobble surface 802, looking southwest. 1m and 1m scales
