BLAGROVE'S BRIDGE, OAKE, SOMERSET

Results of historic building recording

Document No: ACD1528/2/0

Date: April 2017

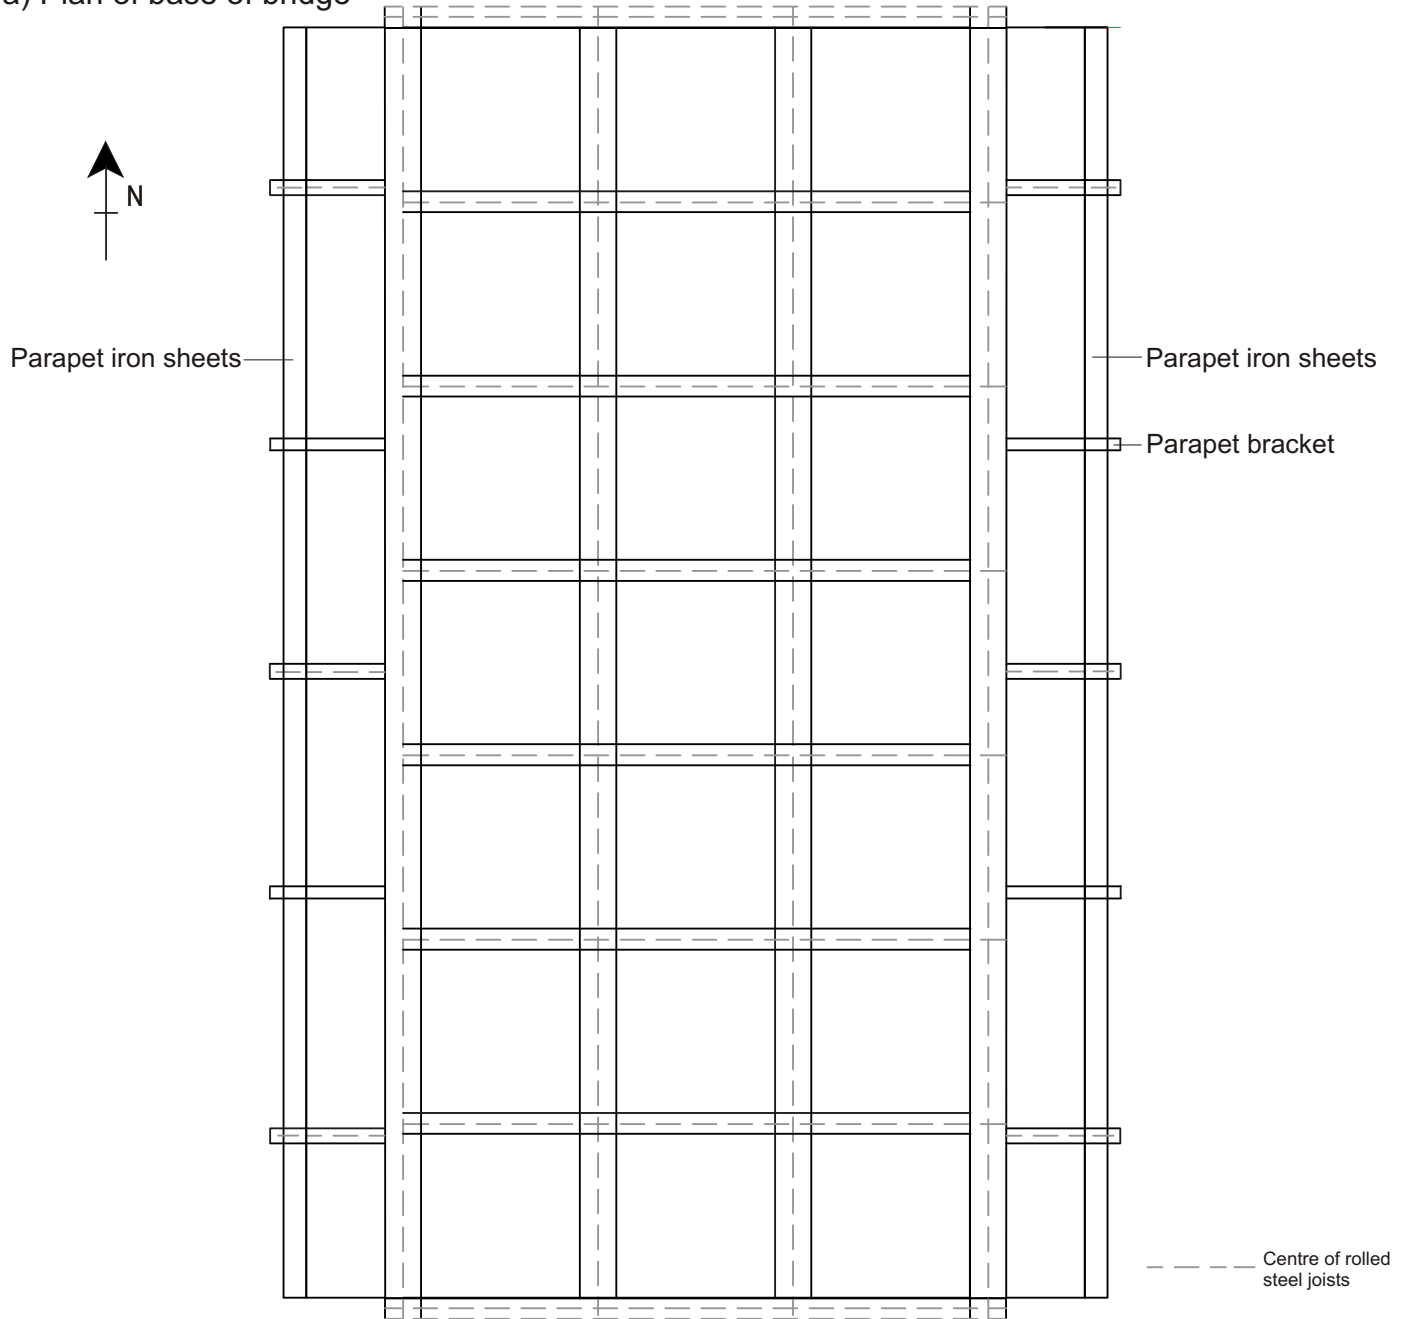
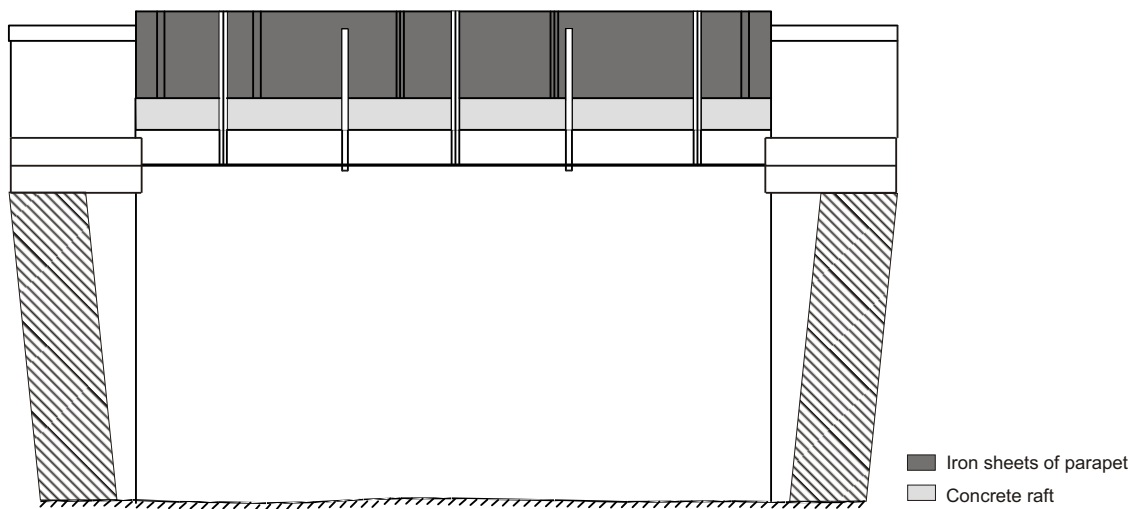
Fig. 2: The bridge

a) Plan of base of bridge

b) West facing elevation of bridge

- 5.1 The bridge carries the road, which approaches the bridge on an embankment, over the former railway. It comprises a single rectangular plate girder bridge approximately 5.5m wide and with a span of approximately 8.5m (Plate 1). It carries the road at a height of 4.45m above current ground level, the approximate height of the track bed. A pair of stone abutments, situated on the north and south side, support four rolled steel joist girders with 90° rolled steel joist cross bracings supporting the two-way spanning arched buckle plates (Plate 2).

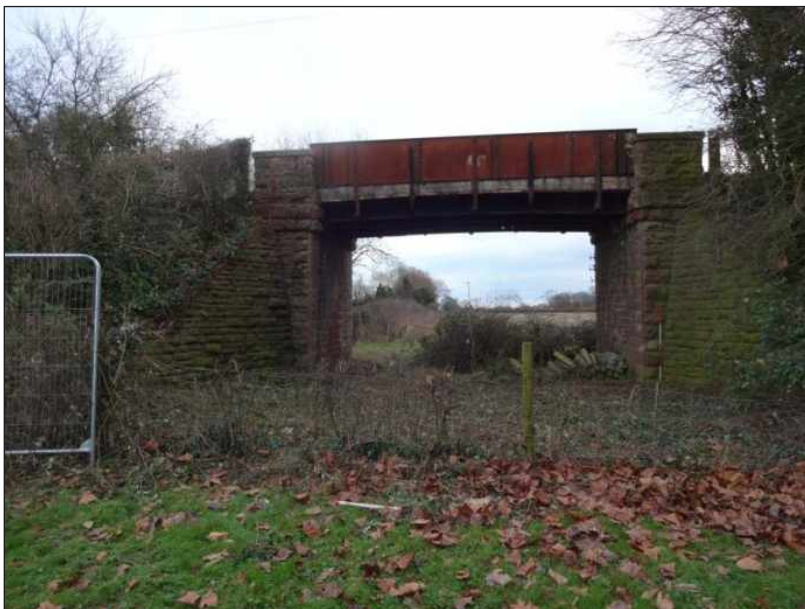
Plate 1: West-facing elevation of bridge (scale 2m)

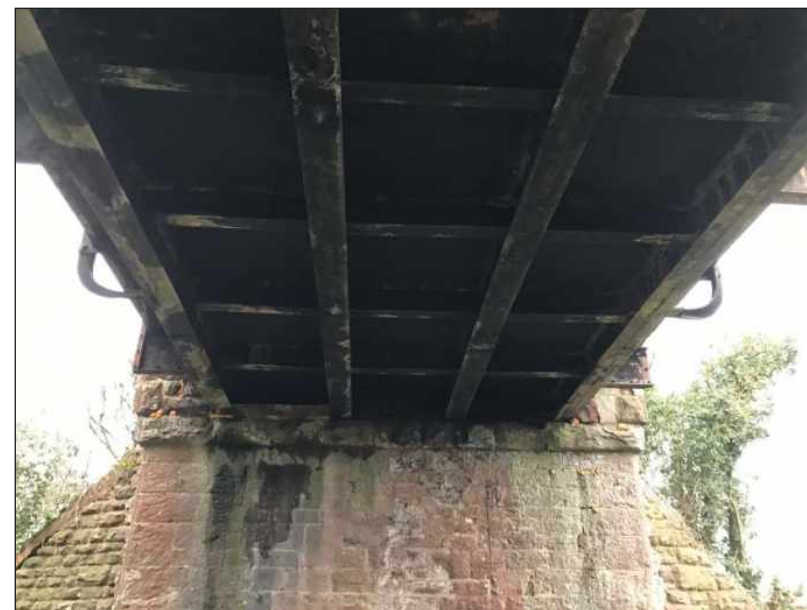
Plate 2: Detail of underside of the bridge

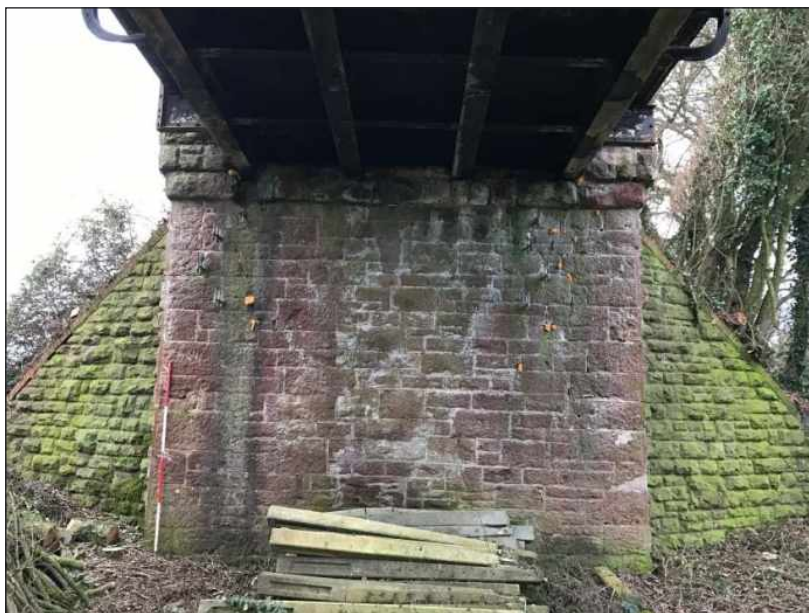
Plate 3: North-facing elevation of abutment wall (scale 2m)

- 5.2 The abutment walls on the north and south side of the bridge comprise up to 11 principal courses of pale cement mortar bonded large rectangular blocks of pitch-faced (inner face) sandstone blocks with the inner corner edges dressed with flat lines. The finish of the masonry of the outer faces is deliberately cruder than that of the inner faces. Both walls form the uppermost section of each corner of the parapet, with the iron parapet plates cut into the four stone sections, and the main carriageway set at a lower height between these parapet piers (Plates 3 and 4). The bridge rests of a rough corbelled course and the above this there is a further projecting course of masonry supporting the parapet piers. Much of the central portion of each abutment wall showed evidence of repointing, probably due to the presence of moisture (from the embankment behind) or water running down the walls. A number of iron

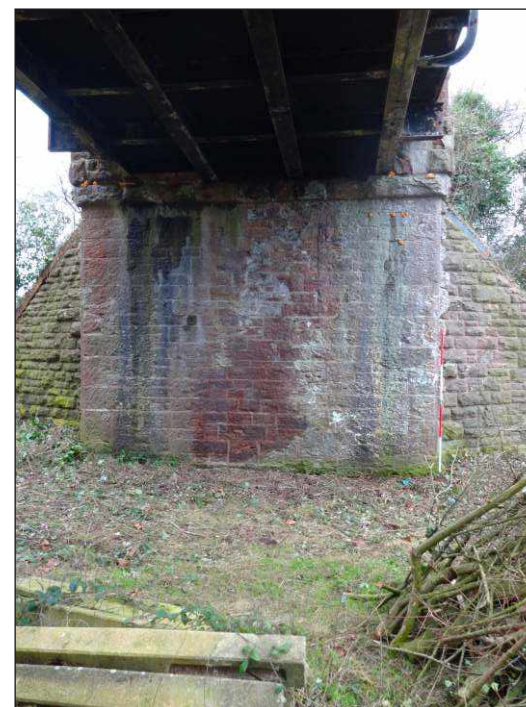
Plate 4:
South-facing elevation of
abutment wall (scale 2m)

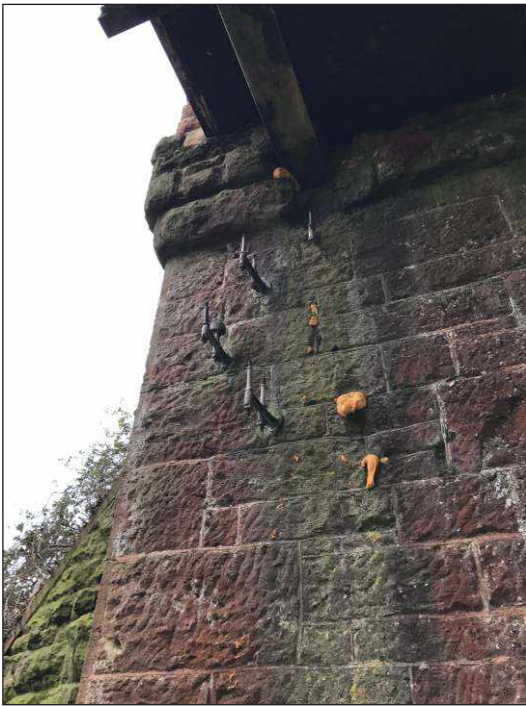
Plate 5:
North-facing abutment wall showing cable fittings associated with the former railway

cable fittings with ceramic transmission insulators, are still present on both abutment walls and are associated with the signalling on the railway (Plate 5).

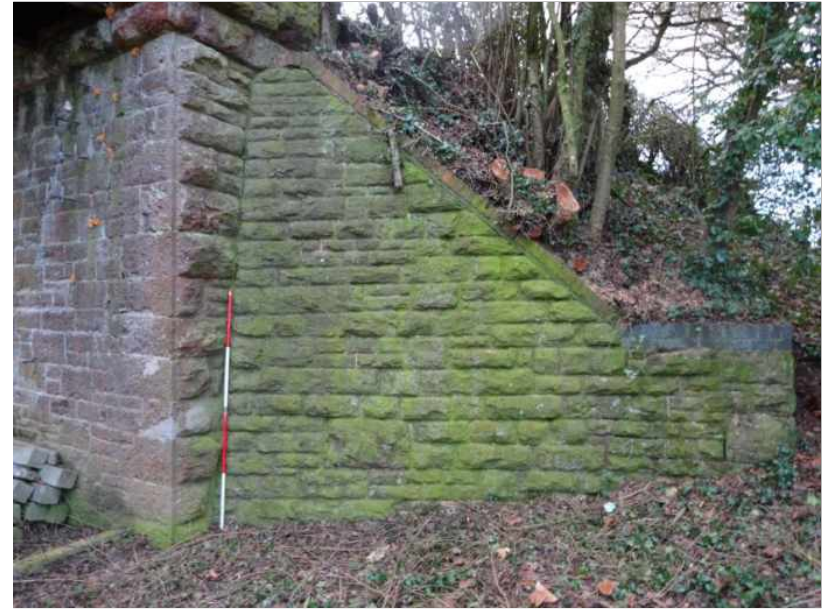
Plate 6: North-facing elevation of south wall abutment (scale 2m)

- 5.3** The embankment is retained by 0.5m thick flanking walls that are separate from and abut the masonry of the north and south facing abutment walls of the bridge (Plate 6). They are constructed of up to 20 courses of variously sized, pitch-faced finished sandstone blocks, bonded in a pale cement mortar. A single course of red bricks lines the top course of the walls, with some of this brickwork showing evidence of replacement or repair, notably on the east side. In a typical arrangement, the abutment walls are slightly battered towards the embankment and splayed outwards from the bridge.

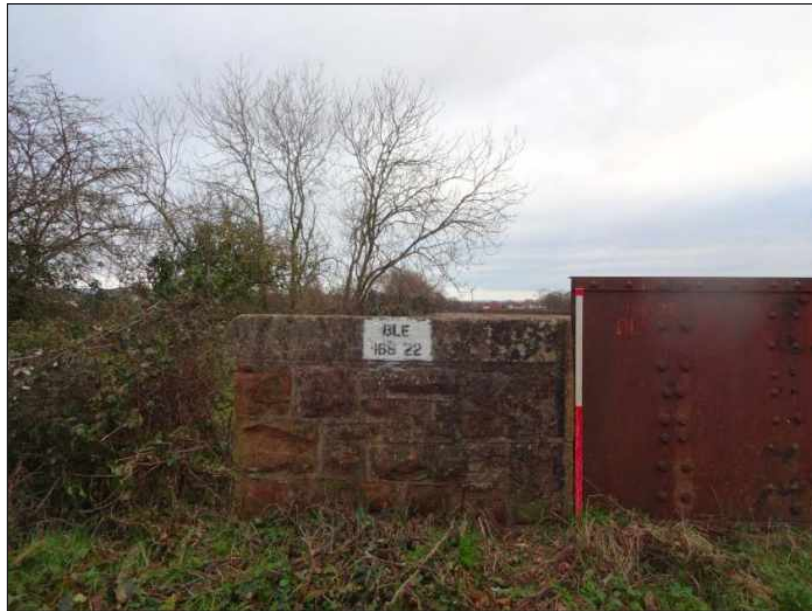
Plate 7: North end of parapet showing the bridge number, viewed from the west (scale 1m)

- 5.4** The parapet comprises iron sheets, held together with rivets, sitting directly on a concrete raft, or slab, which spans the width of the bridge. They are also attached to the base of the bridge superstructure using alternating curved "L"-shaped brackets fixed to the base of the rolled steel joists and straight brackets attached to the ends of short additional 90⁰ rolled steel joists. A bridge reference number "BLE 168 22" (Plate 7) is painted onto the internal face of the stone section of the east side of the parapet at the northern end, and is repeated on the adjacent iron sheet. There is some evidence that the iron sheets had been painted but little of this paint now survives. The current road surface is tarmac and it was not possible to identify any earlier structure below it (Plate 8).

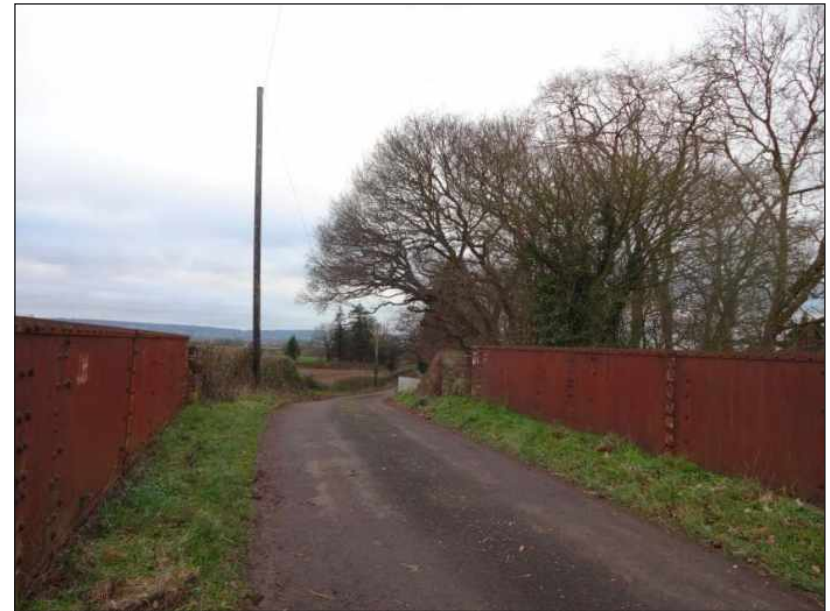
Plate 8: General view of the carriageway from the north
